KILU'UFI HOSPITAL GEOTECHNICAL INVESTIGATION REPORT

Report No: KH202205_GI_001
Report Status: FINAL

July 29, 2022

Kilu'ufi Hospital Improvement Project Geotechnical Investigation

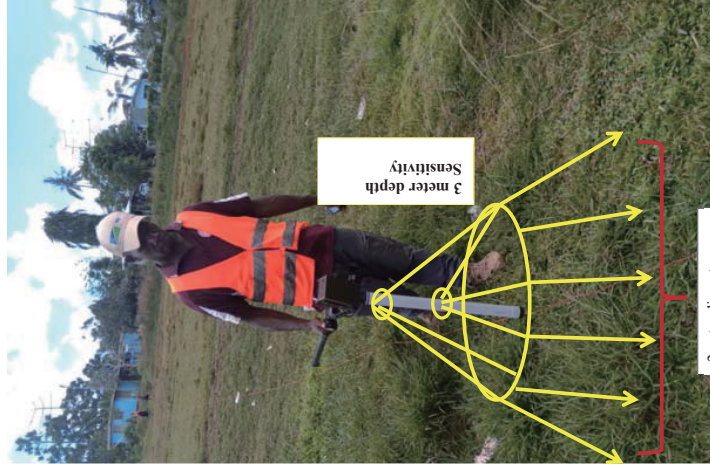
Pin Pointing of Targets using Magnex 120

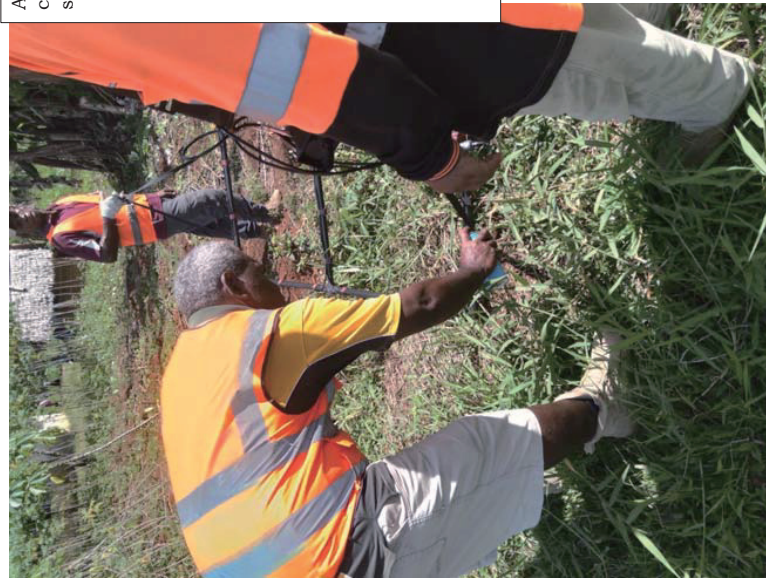
Marking of Targets

All established targets were carefully marked using spray paint

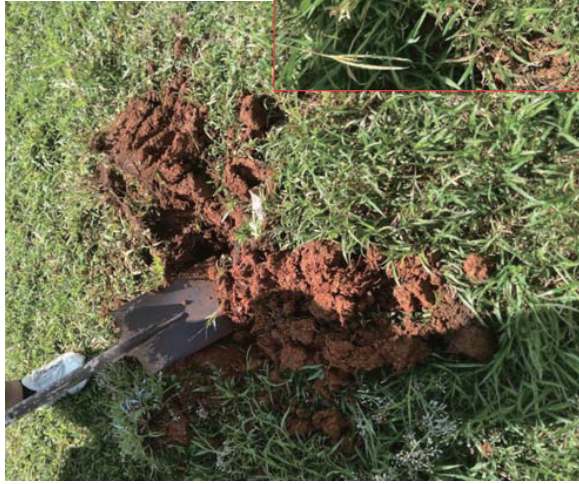
Investigation of Targets

All established Targets were manually investigated using hand tools until no signals are emitted.

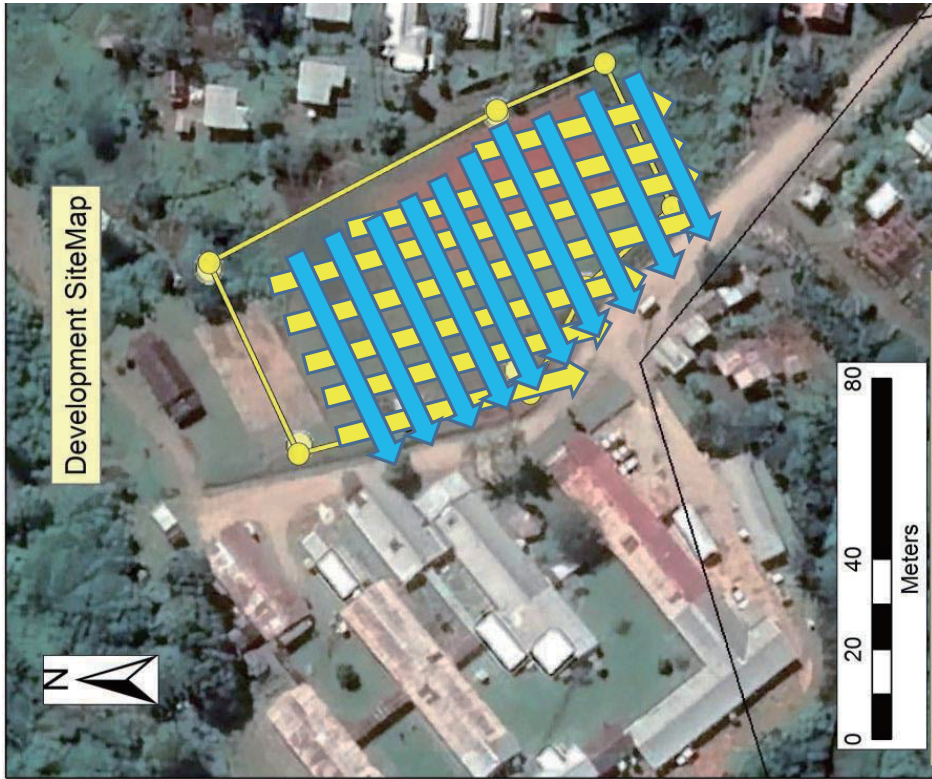
Internal Quality Control & Quality Assurance map set out.

Internal QC & QA process was carried out over the entire area as indicated above
