**Republic of Indonesia, Ministry of Public Works
Directorate General of Water Resources**

**Indonesia
Expert Dispatch Scheme
Dam Design and Construction
Advisory Services**

**Completion Report
Supporting Report 3
Establishment of Risks Management System
in Dam Construction**

**Study on
"The necessity and Methods of Risk Management"
(presented in Workshop, INACOLD Seminar in 2023/2024)**

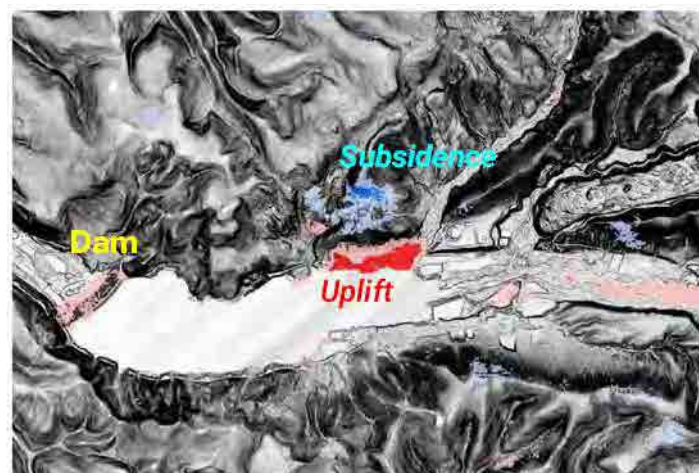
Figure 2.40 Displacement Distribution Map by SAR

As shown in Figure 2.39, large-scale slope movements can be measured using SAR (Synthetic Aperture Radar) mounted on a satellite, and this technology is expected to be useful for monitoring the landslide around the reservoir. In the Figure 2.40, blue indicates subsidence and red indicates uplift. It is estimated to be rotational movement caused by a large landslide.

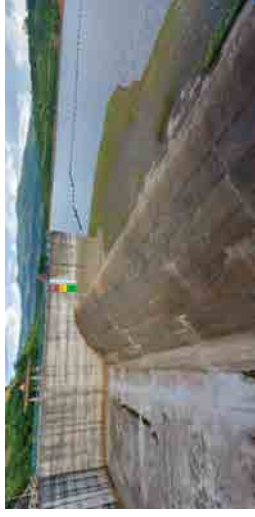
<p>Photo-2 Condition of spillway crack after grouting improvement</p>

How to respond to risk	Measures	How to deal with	Grouting				
	Retention (no measures)	Risk for decision Reason	Safety issues				
Special Notes	Expected impact	Availability and method of monitoring					
	Challenges: 1) Technical issues, 2) Constraints in project implementation requirements (Construction time, costs, etc.) 3) Constraints in dam operation, 4) Issues due to human and organizational factors, results of risk response- 5) Impact on processes, costs, etc., 6) Reflection points (room for improvement of risk management methods), etc.						
Applicable standards	1) Technical issues 2) Spillway function 1) There may be a significant difference in settlement between the embankment and the concrete spillway structure 2) Depth of the crack reaches the reservoir water level, reservoir water will flow into the damage 3) Intensified monitoring of the area should be carried out 4) Investigation should be conducted to ensure the depth of crack

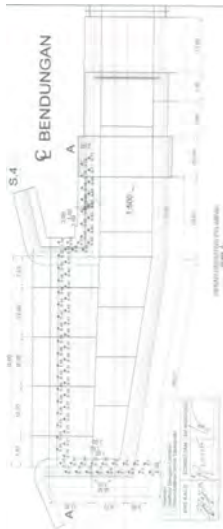
<p>Figure-1 Grouting location of spillway during construction (shop drawing construction)</p>						
	Construction

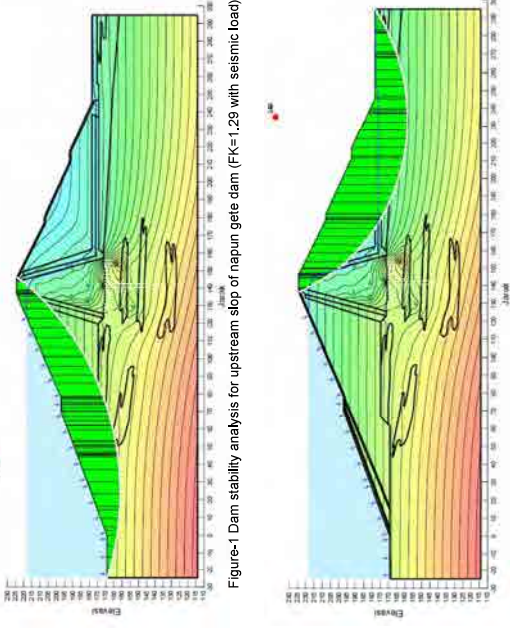
Figure-1 Dam stability analysis for upstream slope of napun gete dam (FK=1.29 with seismic load)

Figure-2 Dam stability analysis for downstream slope of napun gete dam (FK=1.40 with seismic load)

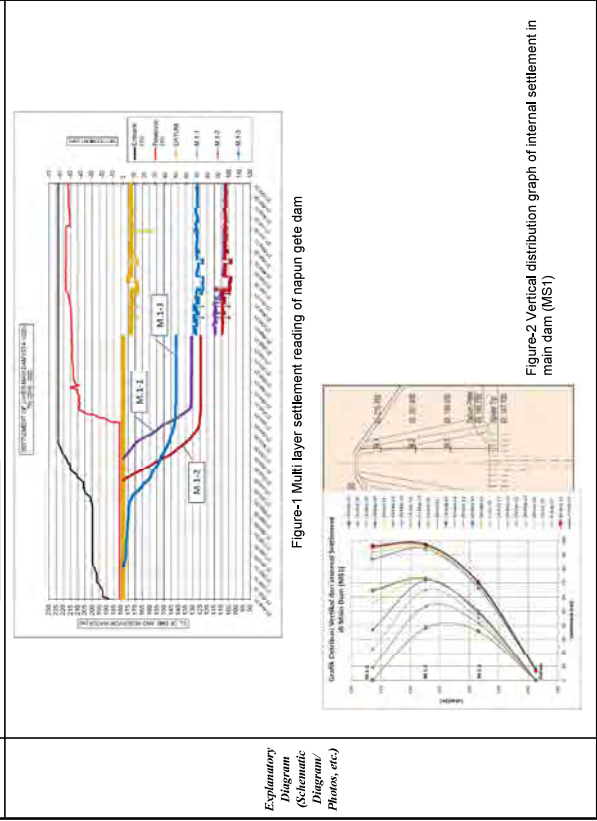
1	When the risk was identified (date)	August 2021
2	Project phase in which risks were recognized	Impounding
3	Location (Structure/Area)	Dam body / core zone
4	Contents of risk	Dam deformation
5	Risk factors	Internal cracking
6	Events in which risks were recognized	during monitoring of multi layer settlement, sudden settlement was observed
7	Conditions/Situation for risk realization	Impounding, loading
8	Impact if the risk realize	Water leakage, dam breach
9	Where risk exists	Dam material, construction
10	Character	<input type="checkbox"/> Mainly caused by external forces <input checked="" type="checkbox"/> Mainly due to technical factors <input type="checkbox"/> Factors other than the above
11	Phase of Realization	<input type="checkbox"/> Project Implementation <input checked="" type="checkbox"/> Operation <input checked="" type="checkbox"/> Due to large-scale external force action <input checked="" type="checkbox"/> Due to long-term use <input type="checkbox"/> Others

Based on investigation during design, the borrow area has clay material that characterized by most of dry density is less 1.2 gram/cm² and liquid limit more than 70%.

Recognition or not in the past	Unrecognized
When the risk was recognized	Project Phase: Impounding
Status of corresponding	Considering investigation and continuing monitoring of dam body and instrumentation
Project Phase	History of correspond to risks
Plan	
Design

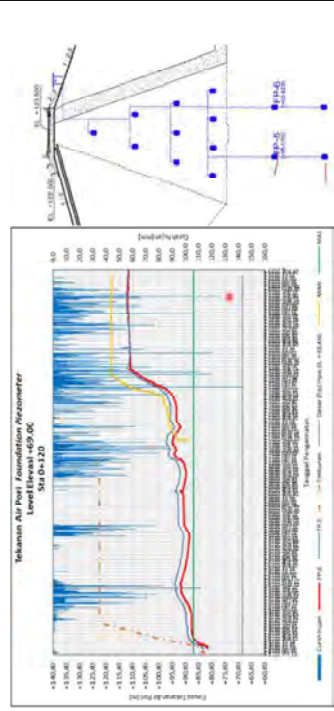
at the time of dam construction the dam foundation piezometer pressure in the downstream section has a smaller value, but at the time of impounding the downstream and upstream piezometer readings are almost the same.

Figure-1 Piezometer reading at dam foundation (downstream and upstream of grouting)

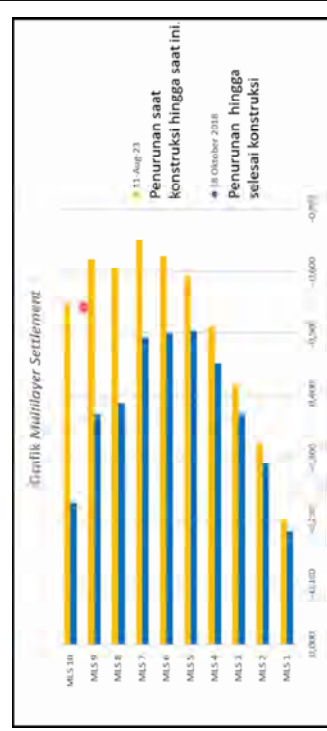
Settlement that occurred on Kuningan Dam is more than 60 cm where the dam is 43 m. The amount of settlement that occurs is highly correlated with the condition of the material at the time it is filled and the way it is filled.

Figure-1 Settlement graph of Kuningan dam

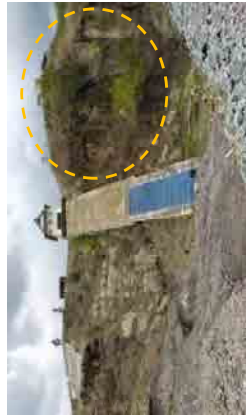
1	When the risk was identified (date)	June 21
2	Project phase in which risks were recognized	Construction
3	Location (Structure/Area)	Intake
4	Contents of risk	Unstable slope
5	Risk factors	Intake slope failure, Intake damage
6	Events in which risks were recognized	Many cracks and discontinuity on intake slope so doublehill during technical season
7	Condition/Situation for risk realization	Impounding, Earthquake
8	Impact if the risk realize	Landslide, Intake damage, Intake malfunction
9	Where risk exists	Discontinuity, Foundation
10	Character	<input checked="" type="checkbox"/> Mainly caused by external forces <input type="checkbox"/> Mainly due to technical factors <input type="checkbox"/> Factors other than the above <input type="checkbox"/> Project Implementation
11	Phase of Realization	<input checked="" type="checkbox"/> Operation <input checked="" type="checkbox"/> Due to large-scale external force action <input checked="" type="checkbox"/> Due to long-term use <input type="checkbox"/> Others

Photo-1 Location of sliding potential near to intake

12	Impact if the risk realize	<input checked="" type="checkbox"/> Affects dam safety <input checked="" type="checkbox"/> Affects dam function <input type="checkbox"/> Affect the schedule and costs of the projects <input type="checkbox"/> Basically risk avoidance <input type="checkbox"/> Consider mitigation measures as risk avoidance is difficult.
13	Corresponding to risks	<input checked="" type="checkbox"/> Risk retention under certain conditions
Overview of Causal Relationships	Incline shaft intake located on steep slope with many	During technical season, intake slope was doublehill about the stability
	protection using sortcrete and reinforcement	unstable slope causing sliding additional reinforcement by sealing grout and surface drainage damage to intake, malfunction of intake Risk reduction

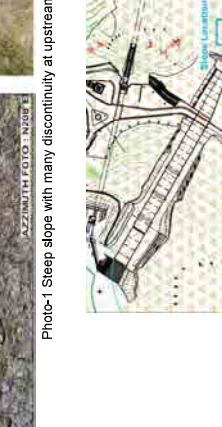
</div> <p style="text-align: center;">Photo-1 Steep slope with many discontinuity at upstream of spillway</p> <div style="text-align: right;">

<p>Figure-1 Location of the slope (blue color)</p> </div>

ID:	6	Name:	Bendo	Dam Type:	Zonal with vertical core	Dam Height:	74.0 m
History	Recognition or realization		Recognized				
	When the risk was recognized	Project Phase:	Construction				
Project Phase	Status of corresponding		Installation of shear stakes for movement monitoring				
	History of correspond to risks						
Plan	during design stage, only slope protection is recommended						
Design	detail condition of the slope had been conducted, shear stakes was installed at the top of slope to monitor the slope movement.						
Construction

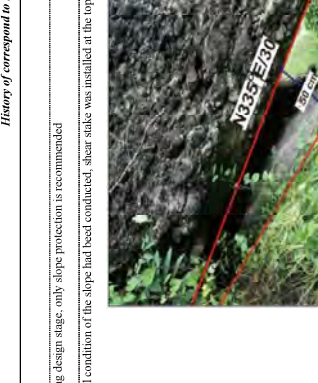
<p style="text-align: center;">Photo-1 wide discontinuity of the slope</p>						
	Impounding Operation/ maintenance						
	Investigation /analysis						
	Investigation/analysis to identify factors, etc. Research/analysis, etc. to assess impact Analysis, etc. to determine the need for and methods of response Contents of measures (avoidance, reduction, transfer or retention)

How to respond to risk	Measures	How to deal with	Installation of shear stakes for movement monitoring			
		Retention (no measures)	Reason	slope condition,			
		Availability and method of monitoring	Expected impact	shear stake monitoring			
		Challenges: 1) Technical issues, 2) Constraints in project implementation requirements (Construction time, costs, etc.), 3) Constraints in dam operation, 4) Issues due to human and organizational factors, results of risk response - 5) Impact on processes, costs, etc., 6) Reflection points (room for improvement of risk management methods), etc.					
	Special Notes	1) Technical issue 2) Potential of dam function disturbance If necessary, instruments can be installed, such as inclinometers and sliding stakes, to monitor movement in areas prone to landslides upstream of the spillway that have the potential for landslides.					
		Because of the dimension of landslide is not to wide, cutting the slope and weak zone to gentle slope is better.

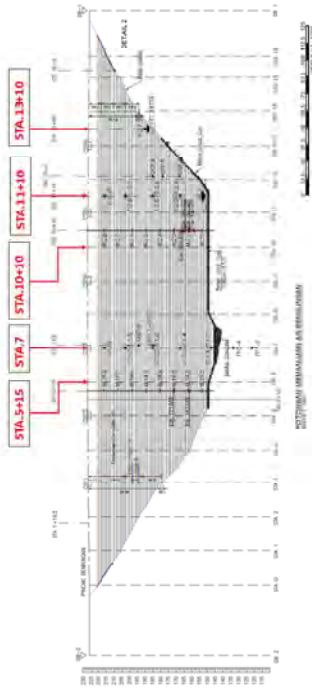
Figure-1 Long section of Bendo dam

-	The inspection after impounding inform that the inclinometer is not working properly due to the bottom of inclinometer is not installed deep enough in foundation.					
Impounding	-	-

Technical issue	-					
Applicable standards	To avoid deep drilling, consider installing inclinometer pipes near the left and right abutment or in areas with geological structures and/or weak zones where the embankment height is less than the maximum height of the dam.	-					
	Drilling in the dam body poses a very high risk to the dam's safety. Before drilling for installation of the inclinometer and OSP is carried out, a Drilling Program Plan (P3) should be prepared.	-					
Keywords	Drilling inclinometer, hydraulic fracture	-					
	Meeting Minutes:	Sidang Teknis Pembahasan Konstruksi Bendungan Bendo, 21 Juni 2021 Sidang Pleno Pembahasan Konstruksi Bendungan Bendo, 29 Juli 2021					
References	Meeting Materials:	Persiapan Impounding Waduk Bendo					
	Other:	Laporan Akhir (PT. Indra Karya,2004); Details Design Bendungan Bendo

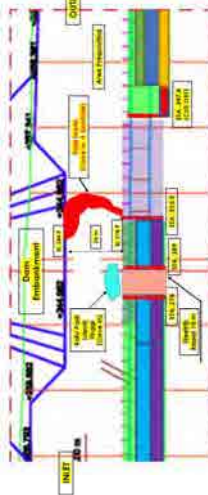
12	Impact if the risk realize	<input checked="" type="checkbox"/> Due to large-scale external force action <input checked="" type="checkbox"/> Due to long-term use <input type="checkbox"/> Others			
		13	Corresponding to risks	<input checked="" type="checkbox"/> Affects dam safety <input checked="" type="checkbox"/> Affects dam function <input type="checkbox"/> Affects the schedule and costs of the projects <input type="checkbox"/> Basically risk avoidance <input type="checkbox"/> Consider mitigation measures as risk avoidance is difficult. <input checked="" type="checkbox"/> Risk retention under certain conditions			
Overview of Causal Relationships	Tunnel collapse	tunnel excavation and loose material collapse from above => Sinkhole distributions => replaced with concrete + additional steel rib	machine vibration during construction => tunnel collapse, sinkhole for dam foundation	unstable dam foundation, dam break

<p>Figure-1 Sinkhole location during tunneling</p>

Revetment replacing sinkhole with concrete, additional steel rib for tunnel			
Explanatory Diagram (Schematic Diagram/ Photos, etc)

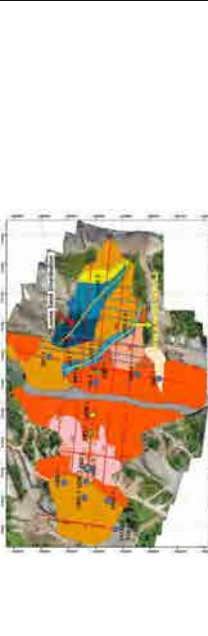
12	Impact if the risk realize	<input checked="" type="checkbox"/> Operation <input checked="" type="checkbox"/> Due to large-scale external force action <input checked="" type="checkbox"/> Due to long-term use <input checked="" type="checkbox"/> Others <input checked="" type="checkbox"/> Affects dam safety <input checked="" type="checkbox"/> Affects dam function <input checked="" type="checkbox"/> Affects the schedule and costs of the projects <input checked="" type="checkbox"/> Basically risk avoidance <input checked="" type="checkbox"/> Consider mitigation measures as risk avoidance is difficult. <input checked="" type="checkbox"/> Risk retention under certain conditions				
	13	Corresponding to risks	<input checked="" type="checkbox"/> Risk retention under certain conditions				
Perspectives on Risk Classification	Cyclog of dam foundation		loose sand was observed during investigation at design stage => foundation treatment by dynamic compaction

Figure-1 Distribution of loose sand at dam foundation (blue and light blue color)

Figure-2 Foundation treatment of loose sand by cyclop concrete replacing

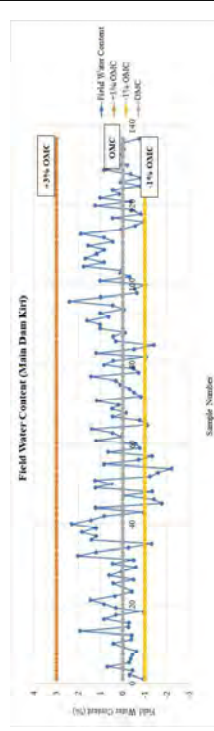
Figure-1 field water content of core material at Margatiga Dam

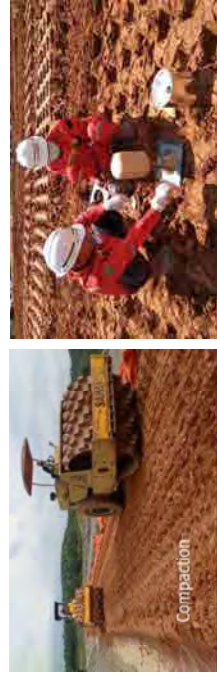
Photo-1 Documentation of core material compaction (left) and field density test (right)

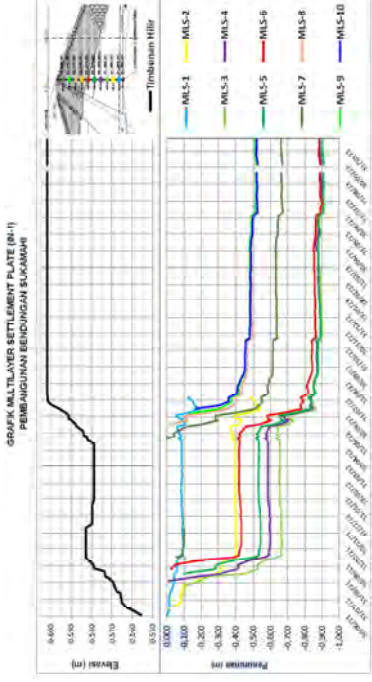
Recognition of risk in the construction	Recognized
When the risk was recognized	Design
Status of corresponding instrument monitoring	Instrument monitoring
History	Date: 2016
Project Phase	History of correspond to risks
Plan	
Design	The material has a difference in NVC and OMC values between 4-12%, where the NVC value is higher than the OMC value, the core material should be lined before compaction.
Construction	No information about embankment implementation of method of sukamahi dam
Impounding	Sukamahi dam is dry dam
Operation/maintenance	Based on the multilayer settlement graph there is a settlement up to 63 cm, where the height of the Sukamahi dam is 50 m, a settlement occurs more than 1%.

Figure-1 Multilayer settlement graph monitoring of Sukamahi Dam

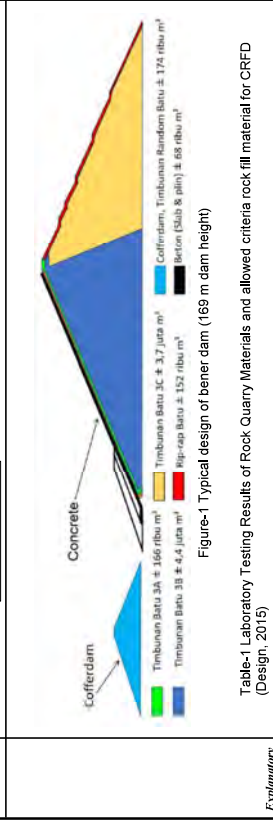
Figure-1 Typical design of bener dam (169 m dam height)

1	When the risk was identified (date)	2015		
2	Project phase in which risks were recognized	Design		
3	Location (Structure/Area)	Dam body / dam material		
4	Contents of risk	Water leakage, dam stability		
5	Risk factors	Cracking on impermeable membrane (concrete slab)		
6	Events in which risks were recognized	During technical discussion of construction implementation		
7	Conditions/Situation for risk realization	Dam deformation, earthquake, in-pounding		
8	Impact if the risk realize	Dam breach, water leakage through dam body		
9	Where risk exists	Dam material, permeability		
10	Character	<input type="checkbox"/> Mainly caused by external forces <input checked="" type="checkbox"/> Mainly due to technical factors <input type="checkbox"/> Factors other than the above		
11	Phase of Realization	<input type="checkbox"/> Project Implementation <input checked="" type="checkbox"/> Operation <input type="checkbox"/> Due to large-scale external force action <input type="checkbox"/> Due to long-term use <input type="checkbox"/> Others

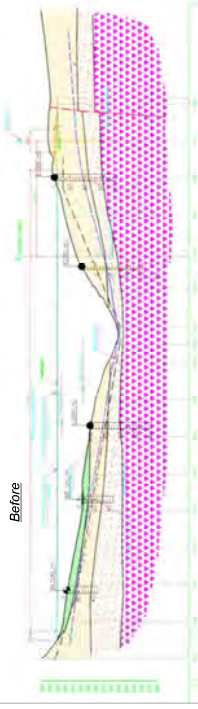
ID:	23	Name:	Bagong	Dam Type:	Rock-fill dam with central core	Dam Height:	82.0 m
History	Recognition or realization		Unrecognized	Project Phase:	Construction	Date:	7-Jul-22
	If the risk was recognized		Unrecognized	Status of corresponding	Considering countermeasure methods		
Project Phase	History of correspond to risks						
Plan	The design was to use bedrock as the foundation.						
Design	As the distribution of thick colluvial soil was confirmed during foundation excavation, the use of colluvial soil as the foundation is being considered.						
Construction	Figure-1 Dam axis geologic cross section (During investigation/design)

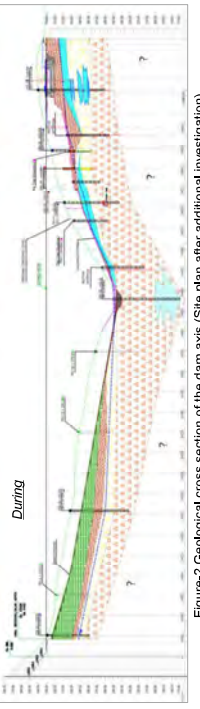
Figure-2 Geological cross section of the dam axis (Site plan after additional investigation)

Contents of measures (avoidance, reduction, transfer or retention)						
Measures	Reduction						
	- Foundation Treatment- Spillway, Pile foundation-Scant Pile Dam-Scant Pile Ground conditions, Construction cost						
Retention (no measures)	-						
Availability and method of monitoring	-						
Special Notes	<p>Challenges: 1) Technical issues, 2) Constraints in project implementation requirements (Construction time, costs, etc.) 3) Constraints in dam operation, 4) Issues due to human and organizational factors, results of risk response - 5) Impact on processes, costs, etc., 6) Reflection points (room for improvement of risk management methods), etc.</p> <p>1) Technical issues.</p> <p>2) Constraints in project implementation requirements (Construction time, costs, etc.)</p> <p>The geological conditions of the dam site differed significantly between the geological investigation/design and construction phases.</p> <p>The following risks should be considered once again when adopting the current countermeasure plan.</p> <p>1) Sliding along the boundary between the collapsed soil and bedrock</p> <p>2) Piping at the foundation where the spillway meets the dam due to unequal settlement</p>

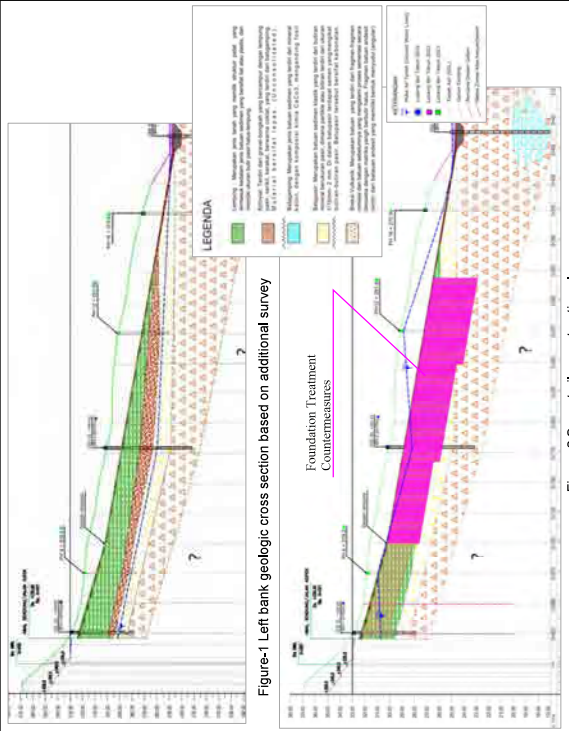
Figure-2 Secant pile construction plan

Overview of Causal Relationships		Foundation excavation as designed		Recessing using colluvium as foundation		Dam breach causing flooding	
		Sliding of the right bank cut slope occurred => Additional geological survey => Recognition of the		Recessing without using colluvium as foundation (to be determined)		Risk avoidance

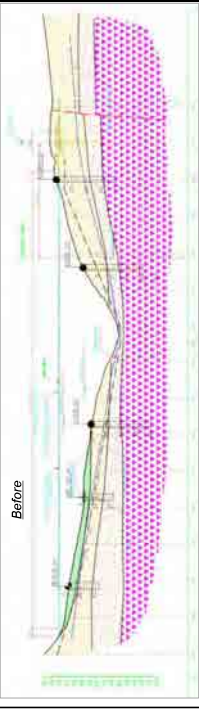
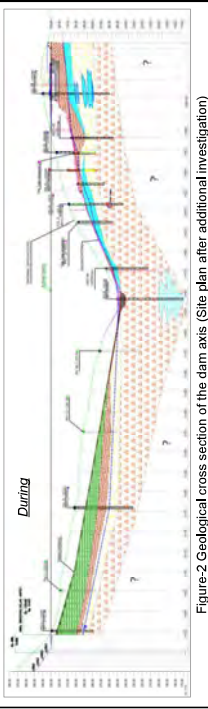
ID:	23	Name:	Blagong	Dam Type:	Rock-fill dam with central core	Dam Height:	82.0 m
History	Recognition or not of the risk	Unrecognized		Project Phase:	Construction	Date:	7-Jul-22
	Status of corresponding	Considering countermeasure methods		History of correspond to risks			
	Project Phase						
Plan	Design	The design was to use bedrock as the foundation. As the distribution of thick colluvial soil was confirmed during foundation excavation, the use of colluvial soil as the foundation is being considered.					
	Construction

Investigation/ maintenance	Investigation analysis to identify factors, etc.						
	Research/analysis, etc. to assess impact /analysis, etc. to determine the need for and methods of response	Reduction					
How to respond to risk	Measures	Installation of an impervious wall with a secant pile in the collapsed soil of the foundation.					
	Reasons for decision	Ground conditions, Construction cost

Applicable standards	Availability and method of monitoring						
	Challenges: 1) Technical issues, 2) Constraints in project implementation requirements (Construction time, costs, etc.) 3) Constraints in dam operation, 4) Issues due to human and organizational factors, results of risk response - 5) Impact on processes, costs, etc. 6) Reflection points (room for improvement of risk management methods), etc.						
Special Notes	1) Technical issues, 2) Constraints in project implementation requirements (Construction time, costs, etc.)						
	The geological conditions at the dam site differed significantly between the geological investigation design and construction phases. It should be noted that unequal settlement between the core zone foundation and the rock zone foundation should be taken into account. It is also recommended to extend the construction area of the secant pile to the top of the dam.

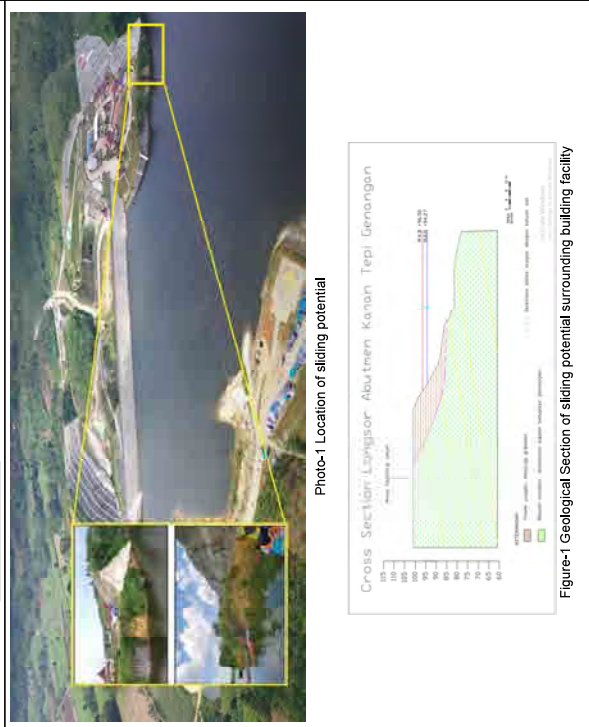
ID:	24	Name:	Randaugingting	Dam Type:	Zonal with vertical core	Dam Height:	31.0 m
Contents of Risk	1	When the risk was identified (date)	1 Jan 2022				
	2	Project phase in which risks were recognized	Impounding				
	3	Location (Structure/Area)	Reservoir area				
	4	Contents of risk	Dam function disruption				
	5	Risk factors	Sliding at reservoir				
	6	Events in which risks were recognized	Sliding potential was observed during inspection after impounding				
	7	Conditions/Situation for risk realization	Rain, earthquake, impounding (water fluctuation)				
	8	Impact if the risk realize	Damage to building facility				
	9	Where risk exists	<input type="checkbox"/> Mainly caused by external forces <input checked="" type="checkbox"/> Mainly due to technical factors <input type="checkbox"/> Factors other than the above				
Perspectives on Risk Classification	10	Character	<input type="checkbox"/> Project Implementation <input checked="" type="checkbox"/> Operation <input type="checkbox"/> Due to large-scale external force action <input checked="" type="checkbox"/> Due to long-term use <input type="checkbox"/> Others

11	Phase of Realization	<input type="checkbox"/> Affects dam safety <input type="checkbox"/> Affects dam function <input type="checkbox"/> Affect the schedule and costs of the projects <input type="checkbox"/> Basically risk avoidance <input type="checkbox"/> Consider mitigation measures as risk avoidance is difficult. <input checked="" type="checkbox"/> Risk retention under certain conditions				
	12	Impact if the risk realize					
Overview of Causal Relationship	13	Corresponding to risks					
			Sliding potential was observed at reservoir are a near to building facility	Sliding potential was observed during inspection after impounding	Rain, earthquake, water fluctuation	Dam function disruption	Damage to building facility
Explanatory Diagram (Schematic Diagram/ Photos, etc)

ID:	24	Name:	Randaugingting	Dam Type:	Zonal with vertical core	Dam Height:	31.0 m
History		Recognition or not in the	Unrecognized				
		When the risk was recognized	1-Jan-22				
Project Phase		Project Phase:	Impounding				
		Status of corresponding	Considering sloping, reinforcement and protection				
Plan		History of correspond to risks					
Design							
Construction							
Impounding							
Operation/ maintenance							
Investigation /analysis							
How to respond to risk							
Special Notes							
Applicable standards							
References

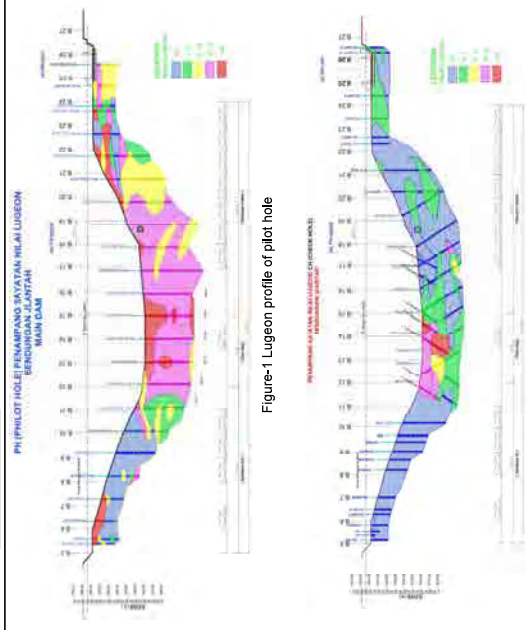
Figure-1 Lugeon profile of pilot hole

<input type="checkbox"/> Impounding of dam				
			using grouting for foundation improvement				
			Lagoon value doesn't meet requirement confirmed by check hole of grouting				
			Material leaching/washout Foundation seepage				
			Instability dam, unreached water level determined, dam break				
			additional cut-off wall				
			Risk avoidance

ID:	25	Name:	Jlajah	Dam Type:	Gravel Pebble Random, Central Core	Dam Height:	70.0 m
History		Recognition or non-recognition	recognized	Project Phase:	Construction	Date:	-
		If the risk was reassessed		Status of corresponding	additional cut-off wall for foundation improvement		
		History of correspond to risks					
Plan		Using grouting for dam foundation improvement					
		after grouting was conducted, the lagoon value doesn't meet requirement then the consultant propose to add cut-off wall for foundation					
Design							
Construction							
Impounding/Operation/maintenance							
Investigation/analysis		Investigation/analysis to identify factors, etc.					
		Research/analysis, etc. to assess impact of response					
How to respond to risk		Contents of measures (avoidance, reduction, transfer) or retention	avoidance				
		Measures	additional insulation of cut-off wall to improve permeability of foundation

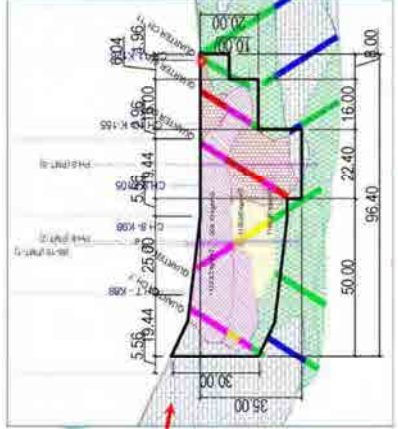
Figure-1 Design cross-section of foundation improvement with cut-off wall

ID:	25	Name:	Jlantah	Dam Type:	Gravel Pebble Random, Central Core	Dam Height:	70.0 m
Contents of Risk	1	When the risk was identified (date)	-	Construction			
	2	Project phase in which risks were recognized		Dam foundation			
	3	Location (Structure/Area)		Water seepage, uplift			
	4	Contents of risk		weak zone of cut-off wall connection			
	5	Risk factors		overlap of curtain grouting and cut off wall is weak zone			
	6	Events in which risks were recognized		Impounding			
	7	Condition/Situation for risk realization		Dam break			
	8	Impact if the risk realize		Geology, permeability, Desain			
	9	Where risk exists		<input type="checkbox"/> Mainly caused by external forces			
	10	Character		<input checked="" type="checkbox"/> Mainly due to technical factors			
Perspectives on Risk Classification	11	Phase of Realization		<input type="checkbox"/> Factors other than the above			
	12	Impact if the risk realize		<input checked="" type="checkbox"/> Project Implementation

13	Corresponding to risks		<input checked="" type="checkbox"/> Operation			
Overview of Causal Relationships	Foundation improvement		Grouting was chosen for foundation improvement => grouting is insufficient for foundation improvement	Several part still has high lugason value after grating	Water seepage still can through foundation that may cause uplift	Dam break	
							Risk reduction
Explanatory Diagram (Schematic Diagram/ Photos, etc)							
	<p>Figure-1 Lugeon profile of check hole / after grouting</p>

1) Technical issues, 2) Constraints in project implementation requirements (Construction time, costs, etc.)					
		the advantages and disadvantages of various alternative foundation improvement methods, the conclusions should be presented in a comparison matrix from the aspects of dam safety/success in achieving quality targets, effectiveness of foundation repair results, ease of implementation, time and cost, taking into account the geological conditions of the foundation					
Applicable standards			(Describe standards related to geological study, dam design, and countermeasure design.)				
Remarks			Grouting, lagoon permeability				
References			Risalah Diskusi Teknis Pemalsuan Perubahan Peraturan Fondasi, 2 Mei 2023				
			Pembangunan Bendungan Jlajah, Feb 2023				
			Other:

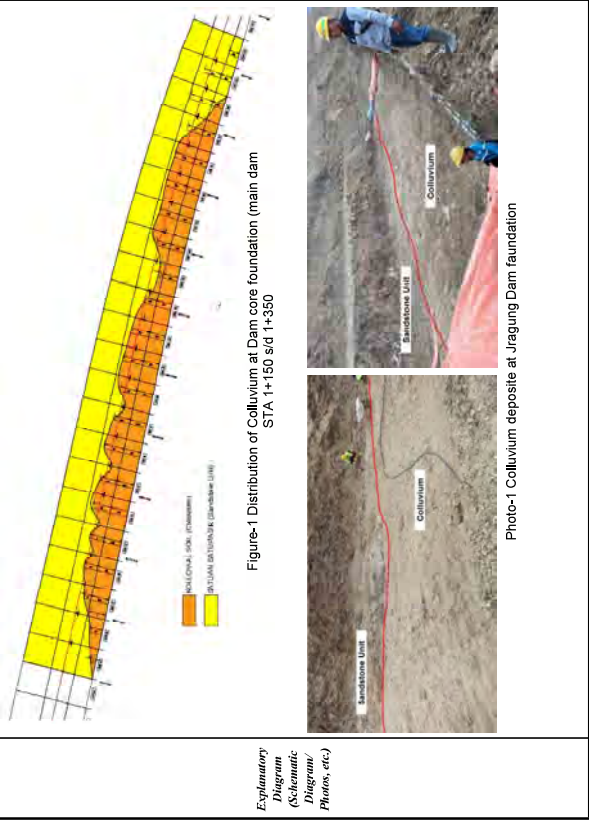
ID: 26	Name: Jragung	Dam Type: Zonal with centre core	Dam Height: 59.5 m	
Concepts of Risk	1	When the risk was identified (date)	January 2022	
	2	Project phase in which risks were recognized	Construction	
	3	Location (Structure/area)	Dam / Foundation	
	4	Contents of risk	Instability of the foundation	
	5	Risk factors	Unequal settlement, groyne damage causing crack	
	6	Events in which risks were recognized	colluvium layer was observed during the foundation excavation	
	7	Conditions/Situation for risk realization	Foundation deterioration over time, groyne cracking due to settlement	
	8	Impact if the risk realize	Dam breach causing flooding downstream	
	9	Where risk exists	Geology / Strength, Permeability, Design / Foundation treatment	
	10	Character	<input type="checkbox"/> Mainly caused by external forces <input checked="" type="checkbox"/> Mainly due to technical factors <input type="checkbox"/> Factors other than the above

Perspectives on Risk Classification	11	Phase of Realization	<input type="checkbox"/> Operation <input checked="" type="checkbox"/> Due to large-scale external force action <input checked="" type="checkbox"/> Due to long-term use <input type="checkbox"/> Others
		12	Impact if the risk realize	<input type="checkbox"/> Affects dam safety <input checked="" type="checkbox"/> Affects dam function <input type="checkbox"/> Affects the schedule and costs of the projects <input type="checkbox"/> Basically risk avoidance <input type="checkbox"/> Consider mitigation measures as risk avoidance is difficult.
	Overview of Causal Relationships	13	Corresponding to risks	<input checked="" type="checkbox"/> Risk retention under certain conditions
			<div style="display: flex; justify-content: space-around; align-items: center;"> <div style="border: 1px solid black; padding: 5px;">Foundation was observed during dam foundation excavation => identify distribution of colluvium</div> <div style="border: 1px solid black; padding: 5px;">Foundation improvement for colluvium</div> <div style="border: 1px solid black; padding: 5px;">Instability of the foundation</div> <div style="border: 1px solid black; padding: 5px;">Dam breach, groyne damage</div> </div> <div style="margin-top: 10px;"> ↓ Dam foundation improvement using CTB (cement treated base). </div>

ID: 26	Name: Jragung	Dam Type: Zonal with centre core	Dam Height: 59.5 m
History	Recognition or non-recognition of the risk	Unrecognized	
	When the risk was recognized		
	Project Phase: Construction		Date: January 2022
	Status of corresponding improvement using CTB (cement treated base)		
Project Phase	History of correspond to risks		
	Plan		
Design	Using sandstone and claystone as dam foundation		
	Construction	<p>Figure-1 Geological profile of STA 1+150</p>	
Impounding Operation/ maintenance			
	Investigation/analysis	Investigation/analysis to identify factors, etc. Research/analysis, etc. to assess impact Analysis, etc. to determine the need for and methods of response	
How to respond to risk	Contents of measures (avoidance, reduction, transfer) or retention	Avoidance foundation improvement using Cement Treated Base	
	Measures	Cost, Groyne installation	
Special Notes	How to deal with	-	
	Retention (no measures)	-

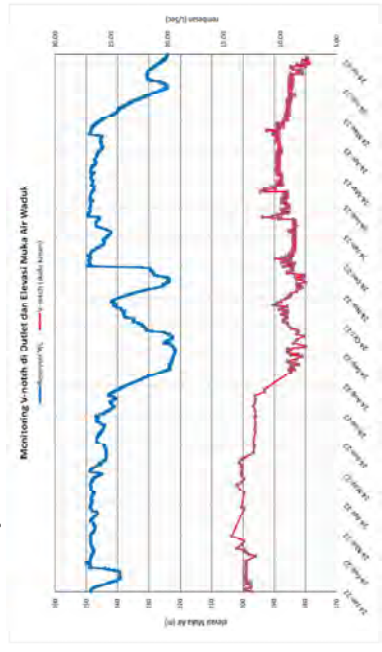
Figure-1 Geological profile along the tunnel of Karalloe Dam

Seepage at intake tunnel → during inspection seepage was observed at the intake tunnel = Debit monitoring

SI water discharge and condition monitoring → Risk retention
