**Indonesia  
Expert Dispatch Scheme  
Dam Design and Construction  
Advisory Services**

**Completion Report  
Data Book**

**February 2025**

# *1. Site Inspection Reports*

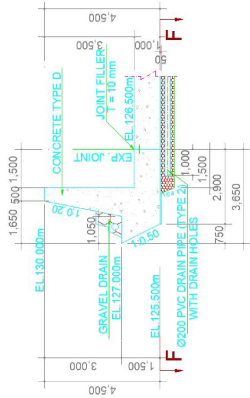
### Sample of Spillway Drain System (Jatibarang Dam)

- Slab concrete : as mentioned above section
  - Side Wall : one hole per 5m<sup>2</sup>
- Diameter of drain holes are 5cm.

It is necessary to pay attention on design of drain system of water-related structure.

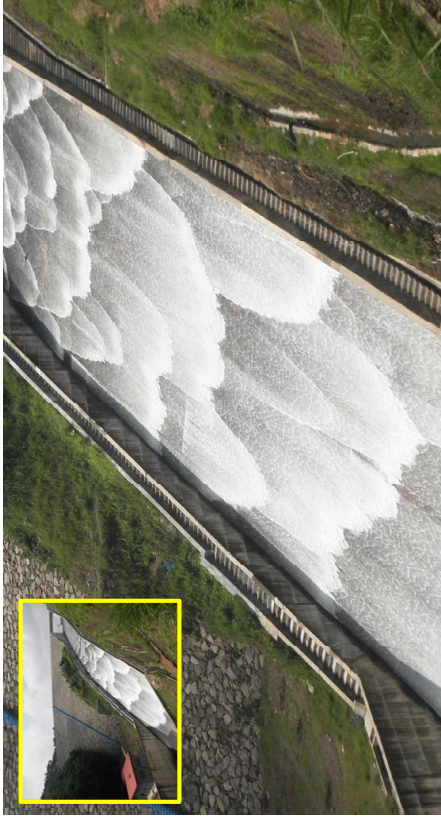
Jatibarang Dam Spillway

Many boulders/sand/clay observed on the spillway channel and in the stilling basin. The site engineer said that boulders and sediments were come into the channel from both side slope of spillway channel. Such solids (boulders and sediment) will be a cause of erosion of spillway concrete. It is important to minimize the flowing the boulders and sediments into spillway channel.

One of protection method is lowering the backfill surface, maybe 1 m below from the top of side wall so as to the boulders and sediments can be stopped on the backfill portion. When the backfill surface is lowered, it is anticipated that rainwater runs on the surface of backfill and erodes the backfill material. As a countermeasure against an erosion of backfill material by rainwater, the spillway channel backfill surface was covered with concrete stairs to protect the erosion and dissipate the energy at the Jatibarang Dam. The stairs is utilized as maintenance path.

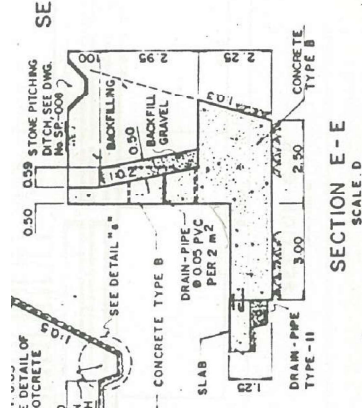
Bili-Bili Dam Spillway Side Wall

The other way is installing drainage channel on the surface of backfill. The water can be flow down the sediments with downstream. Bili-Bili dam applying this system since the slopes on both sides of the spillway channel are composed with solid rocks (diabase/diorite).

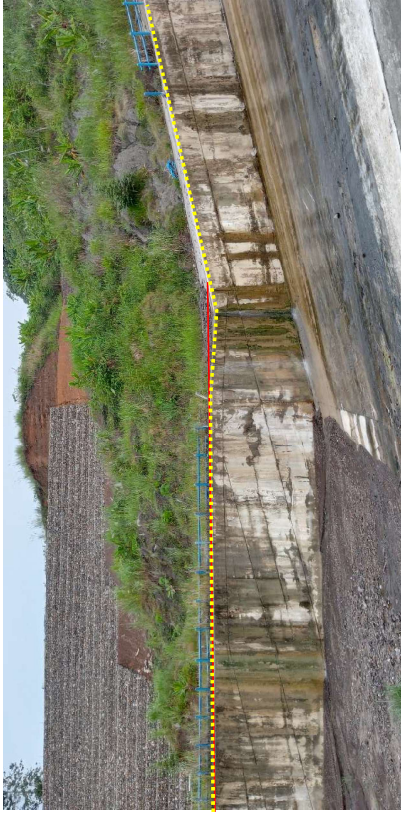
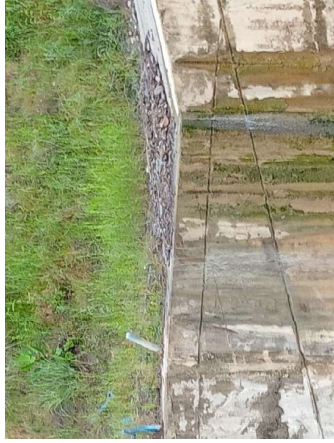
(4) Right Side Wall of Stilling Basin

It is supposed that the right wall of stilling basin was not constructed as design as shown in photo below. Sediments has flow into stilling basin from this portion.

It is recommended that this portion should be repaired as designed.

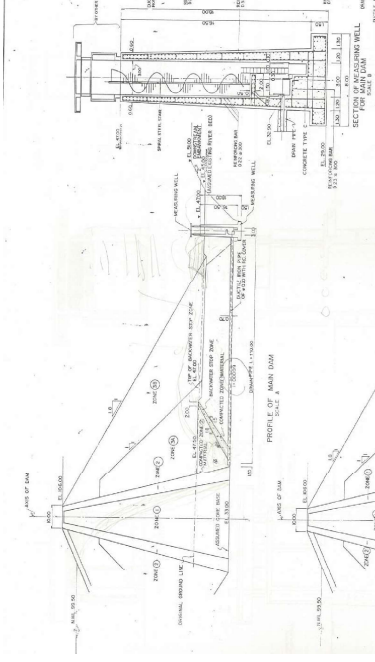
**Bili-Bili Dam Seepage Measuring Device**

The Site Engineer proposed to raise up the position (elevation) of seepage measuring device (V-Notch) to flow the seepage water by gravity, because the downstream water level is higher than designed seepage measuring device.

However, it is not recommendable because a seepage water collecting system (backwater stop zone, refer to following figure) was not installed in Keureuto Dam.

It shall be reminded that seepage discharge when it is measured during rain, the amount of measured discharge is including rainwater.

- ◇ Set the V-Notch at original elevation.
- ◇ Provide Measuring Well Tower to protect the river water flow into V-Notch, and
- ◇ Install a drain pump which runs automatically when water level of the drain pit (downstream of V-Notch) reach to the setting position.

The capacity of pump shall be set depending on the expected seepage discharge examined by means of seepage water analysis including rainwater on the downstream slope.

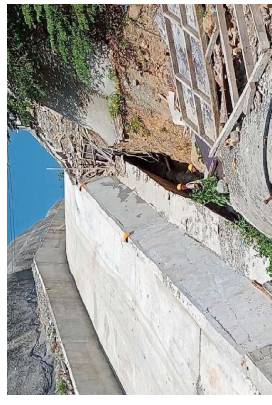
Under slab drain in upstream and downstream direction is not installed while the cross drains are installed. The water in the cross drain will not be able to flow down and uplift pressure under the slab remains. To settle this problem, the Site Engineer started to install drainpipe outside of the side wall connecting cross drain (refer to photo in right). The details of the works are unknown.

To install drainpipe, the foundation of side wall is excavated, therefore it is anticipated that the foundation will be damaged. The works should be carried out very carefully and back fill must be conducted adequately.

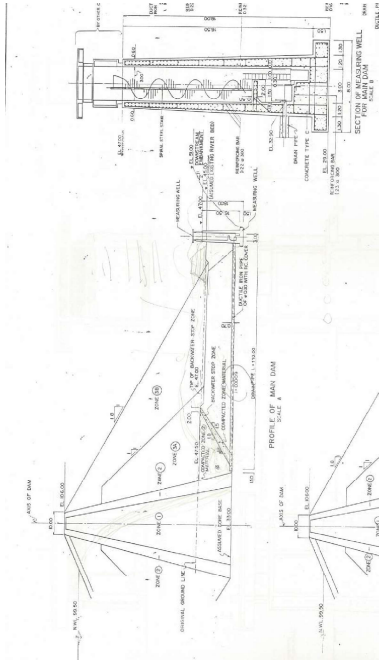
**Bili-Bili Dam Seepage Measuring Device**

However, it is not recommendable because a seepage water collecting system (backwater stop zone, refer to following figure) was not installed in Lukkoh Dam.

It shall be reminded that seepage discharge when it is measured during rain, the amount of measured discharge is including rainwater.

- ✧ Set the V-Notch at original elevation,
- ✧ Provide Measuring Well Tower to protect the river water flow into V-Notch, and
- ✧ Install a drain pump which runs automatically when water level of the drain pit (downstream of V-Notch) reach to the setting position.

The capacity of pump shall be set depending on the expected seepage discharge examined by means of seepage water analysis including rainwater on the downstream slope.

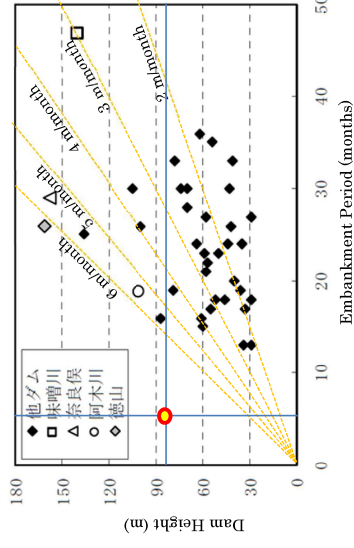
**Relationship between Dam Height and Embankment Period (actual record in Japan)**

The implementation plan should be revised after considering the workable days fro core embankment, settlement of core due to rapid construction of core and the time required for field tests, especially field permeability tests.

Following figure shows actual records of embankment speed in Japanese fill type dams. As shown in the figure, the fastest embankment speed in Japan is 6m/month, but at Keureuto Dam, it is planned to be 17 m/month.

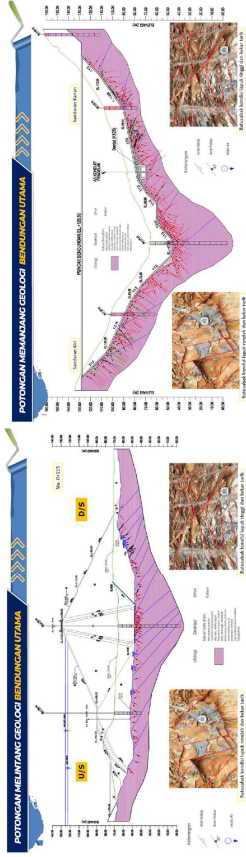
The potential cleavage of the shale strikes a NW-SE (almost parallel to the dam axis) and is inclined downstream (to the east) with an angle of about 20 to 30 degrees.

Besides the cleavage mentioned above, clacks had developed on the excavation slope, with same strike as the cleavage and was inclined downstream with an angle of about 50 to 70 degrees. Weathering has been developed along the cracks. It is supposed that the clacks were formed during the process of upheaving of the ground at this damsite.

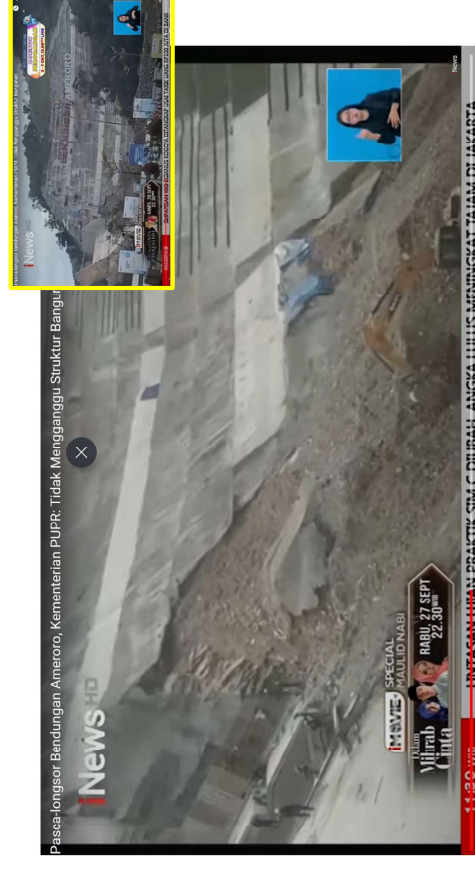
On September 19, 2023, slope failure occurred at left cut-slope of spillway chute. <https://www.youtube.com/watch?v=pEY0wcf5X4>

Proposed countermeasure at present is the "Stretching Construction Method". The works will be conducted slowly and gradually from the top to the bottom by securing it using temporary safety shotcrete.

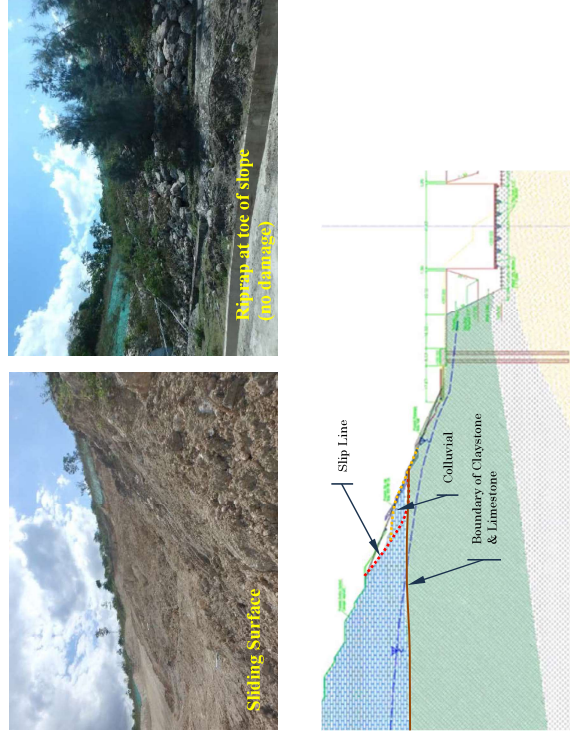
Currently, two types of slope protection has been constructed at the collapsed area, namely wet stone masonry and riprap work. Since there is no collapse on the slope of the riprap work area, it is applicable to adopt riprap or gabion as a slope protection for this area. Since the toe of sliding is assumed at boundary of limestone and claystone, this portion should be covered with counter weight (riprap or gabion).

When the stability analysis is carried out in design of slope protection works, it is necessary to consider the setting of the groundwater level, especially the groundwater rise during rainy season.

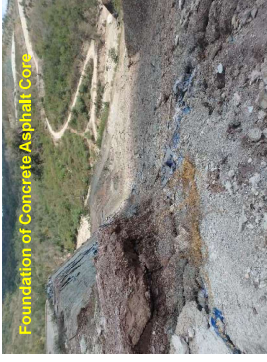
Temporary excavation for grout cap concrete had already been conducted and the excavated surface was currently completely slaked and deep cracks were observed on the surface, which were considered to be the result of shrinkage of the slaking clay (refer to photos) as well as erosion by rainwater. As shown the present condition, the dam foundation rock consists of scaly claystone easily to swell and slake.

However, the possibility of deformation of grout cap and dam foundation after swelling of this foundation rock and the safety of dam, in particular after impounding, was not discussed at the time of our visit. It is necessary to confirm the safety of dam body and foundation after impounding (after foundation rock is saturated). When the claystone, which is the foundation of the Random material, turns to mud, there is a concern that the strength will suddenly decrease so it is recommended to check the stability of downstream dam body by means of "Wedge method".

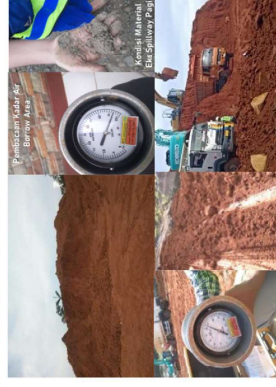
- Kadar Air (OMC) material timbunan Tanah Lempung (Zona Inti) dan Random (Zona 3A) tinggi pada saat pagi hari dan malam hari sehingga tidak masuk ke dalam persyaratan Spk.
- Maksimum kadar air yang diperbolehkan diangkut dari borrow area adalah +5% dari OMC. Dengan harapan pada saat cuaca terik dan ketika sampai di area mandam maka kadar airnya akan turun menjadi +3%. **Jika kadar air melebihi +5% di borrow area dan dipaksa untuk diangkut maka material akan bonyok dan tidak bisa digunakan.**
- Rata - rata penimbunan baru dilaksanakan Pukul 11.00 menjelang siang ketika kadar air material di borrow tidak lebih dari +5%.

Hari/Tanggal	OMC	OMC+5.00%	OMC-3.00%
Friday, 05 May 2023	44.62%	46.33%	49.21%
Saturday, 06 May 2023	39.40%	40.86%	43.56%
Sunday, 07 May 2023	44.62%	52.51%	47.89%
Monday, 08 May 2023	39.40%	42.41%	46.51%
Tuesday, 09 May 2023	42.50%	50.08%	47.38%
Wednesday, 10 May 2023	44.62%	54.33%	49.21%

Pagi kadar air terlalu tinggi, siang hari hanya 1 TP yang dapat dilakukan loading.

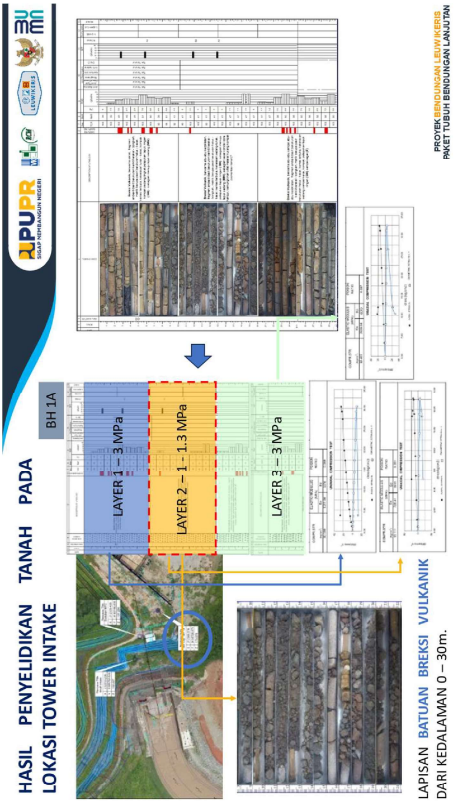
Geological Condition at Foundation of Intake Tower

It was found that a fragile layer intervened in the foundation of the intake tower in the form of a lens during construction of shaft. The Project office changed the location of the tower from just on the tunnel 1 to between tunnel 1 and 2, to avoid the risk of sliding of the tower foundation.

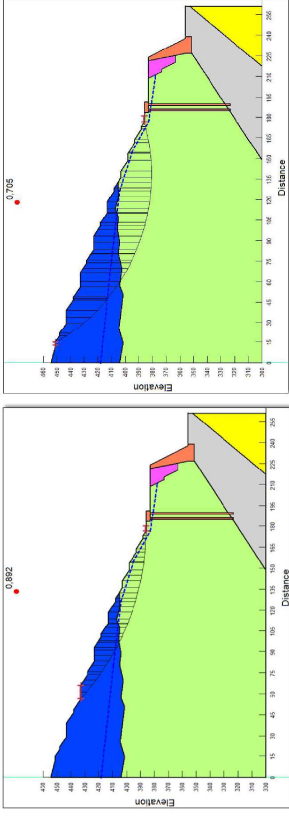
Results of Slope Stability Analysis by the Consultant

The Consultant of supervision made an stability analysis applying circular slip method and the estimated slip-line was crossing the geological boundary. However, if the cause of sliding is swelling of scaly claystone at the boundary, the slip-line might be included the boundary (refer to following figure).

Gambar 9. Bidang Longosor Spillway STA 0+140, (SF = 0.892).

Gambar 10. Bidang Lereng Spillway STA 0+140, (SF = 0.705).

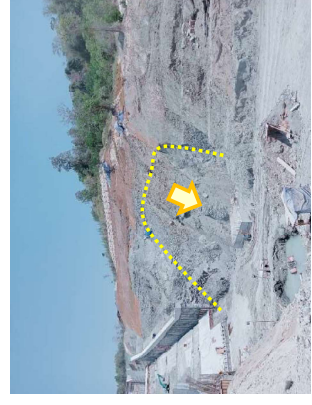
**1.2.2 Slope Failure at Cut Slope of Stilling Basin**

Therefore, it is recommended that protection works at this location is soil nailing and slope surface will be covered with geotextile.

The area of protection works shall cover the whole slope surface consisting of the claystone layer.

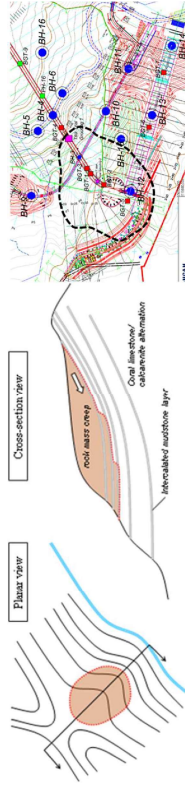
Schematic Diagram of Rock Creep on the Right Bank

Judging from the facts of (a) no landforms suggestive of land sliding (e.g. slip cliffs, gentle gradients at the head) around the right bank slope (by reading of Google Earth satellite image), (b) characters of colluvium (eg. distribution of open cracks, weathering condition and remaining of geological structure in the sliding mass) and (c) the short distance of movement, the colluvium is evaluated to be rock mass creep.

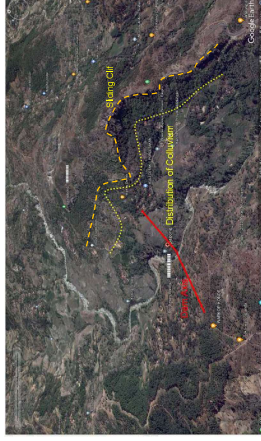
According to Google Earth satellite imagery, steep slopes or cliffs can be seen above the left bank slope (right photo). It is estimated that the sediment generated by the slope failure near the summit has repeatedly moved and accumulated due to colluvium, forming a thick layer of colluvium below the slope, and the area where colluvium is distributed forms a gentle slope.
