### Consideration on Geology of Bagong Damsite

## Suggestion on Treatment of Colluvium at Bagong Damsite Right Abutment and Spillway Foundation

JICA Dam Construction Advisors  
Hiroshi Shimizu  
Naoya Mizuno

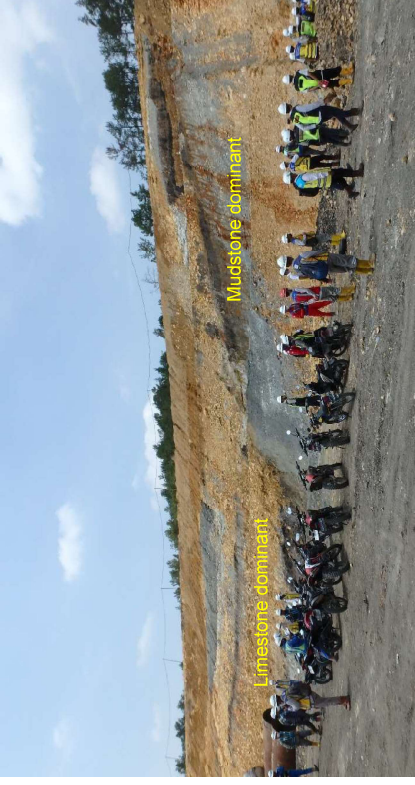
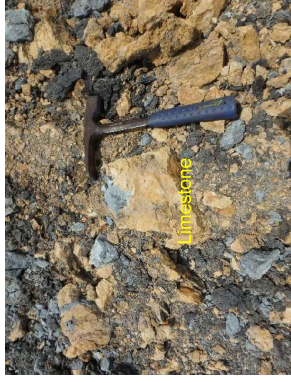
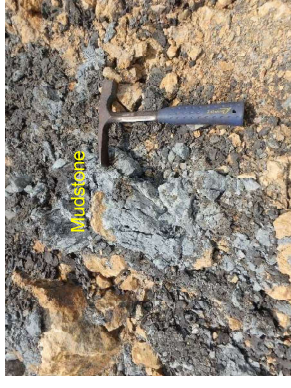
Photo-1 Colluvium on the Right Bank

- After the start of construction, it was found that "Colluvium" was thickly distributed on the slopes on both banks of the dam site (Figure-2). However, the properties of colluvium differ between the right and left banks. The colluvium classified on the right bank is very loose rock mass, the origin of which is estimated to be creep or landslide (Photo-1, Photo-2).

The grey layer rocks are dominated by limestone and the brown layer rocks by limestone. The colluvium is weathered but retains its stratigraphic structure.

- The retention of geological structures within the colluvium (see photo 1) suggests that the

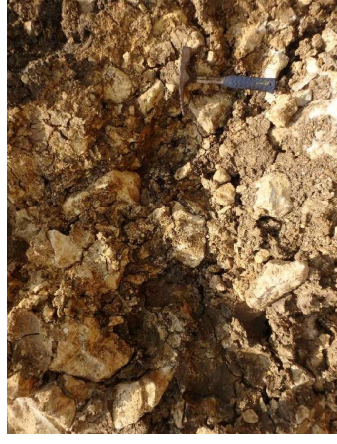
Photo-2 Colluvium on the Left Bank

- Overlying the colluvium classified on the left bank is a relatively thick layer of volcanic ash classified as "clay". This volcanic ash is estimated to be the product of the Kawi-Butak volcano, located approximately 20 km north of the dam site.

The colluvium is a gravel-mixed sediment, with a high proportion of limestone as gravel.

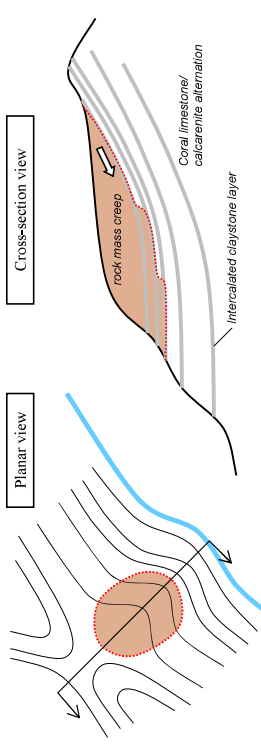
Figure-3 Schematic diagram of rock creep on the right bank

colluvium has crept or moved as a mass. The slope is close to the summit, indicating that the distance over which the mass has moved is short (Figure-3).

- Based on the material provided for the site inspection and interviews with the site engineer, the distribution area of the colluvium is estimated to be approximately the area indicated by the red circle in the Figure-3.
- According to Google Earth satellite imagery, no landforms suggestive of land sliding (e.g. slip cliffs, gentle gradients at the head) are recognized around the slope, and the short distance of movement is estimated to be rock mass creep.

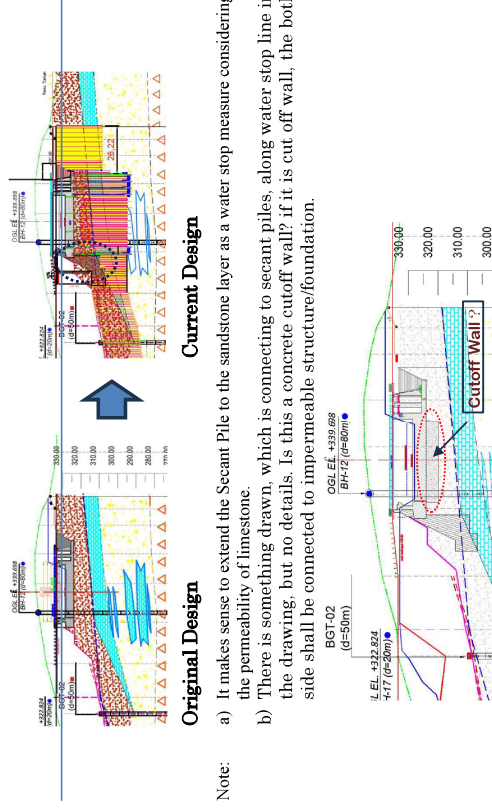
Based on the drawings, the structural features are:

- ✓ Foundation : Limestone Layer
- ✓ Height of Wall : 27.5 m
- ✓ Front Slope : H:V = 1:0.5 (Spread Foundation)

- Note:**
- a) It makes sense to extend the Secant Pile to the sandstone layer as a water stop measure considering the permeability of limestone.
  - b) There is something drawn, which is connecting to secant piles, along water stop line in the drawing, but no details. Is this a concrete cutoff wall? if it is cut off wall, the both side shall be connected to impermeable structure/foundation.

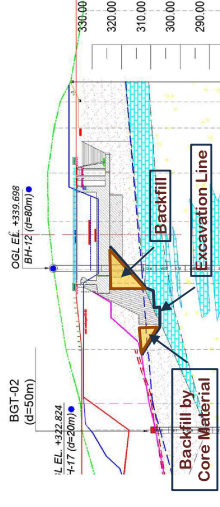
**(ii) Care of Backfill between Cut Slope and Wall**

When constructing the wall between the core and spillway, it is necessary to excavate deeply in section, and the excavated area shall be filled with backfill material. That means creating a weak point in the foundation of the spillway. Backfill material will settle due to consolidation, but spillway concrete does not settle because it is supported by concrete piles. Therefore, there is only one point to ensure water stoppage: the connecting point of the Secant Pile and the spillway concrete. It is not sure how reliable a watertightness at connection between the secant pile and concrete spillway will be, and whether it will be able to ensure watertightness for long term. Once piping occurs, the backfill materials will flow out and the wall tilts, leading to the dam braking.

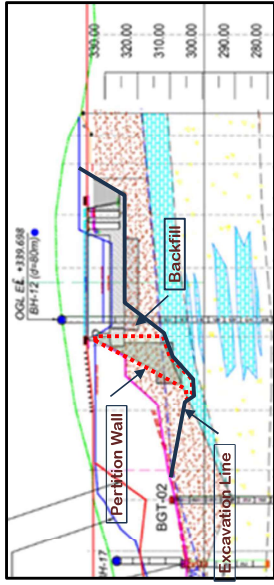
(iv) Proposal of Design Modification

If deep excavation and remain the Colluvium, it is necessary to pay attention a design of connection point of the wall and core foundation. Generally, core foundations are excavated smoothly without leaving noticeable protrusions, but in the current design, the toe of the concrete protrudes, so it is recommended to lower the foundation another around 1 meter and embed it in Limestone.

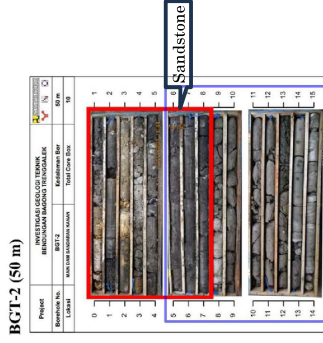
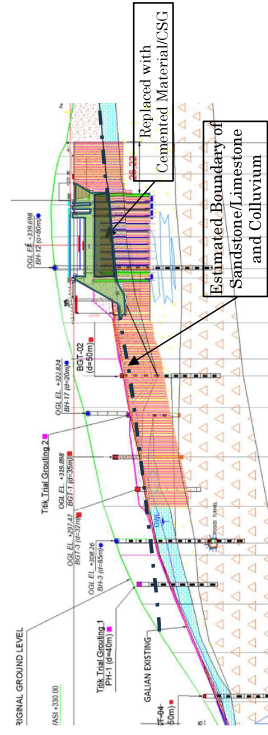
**Spread Foundation of Spillway and Separate Wall**

The deepest additional excavation depth is more than 20 m based on the geological map. However, judging from drilling core phot (BGT-2) which is located the deepest position, sandstone layer good for core foundation can be confirmed at the 8 m from the excavation surface. Therefore, only additional 8 m deep excavation will be required even remove all colluvium.

As for another practical use of the original design, which can be secure a more safely condition, remove all the colluvium on the foundation of core and below spillway, and replacing concrete such as soil cement or CSG.

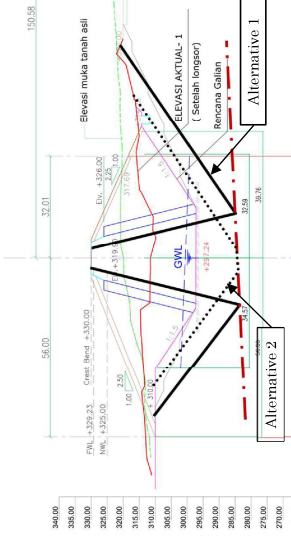
**Excavation of Core Foundation**

- ✓ Alternative 1 is foundation excavation in accordance with core design.
- ✓ Alternative 2 is just secure minimum core width at the bottom. In this case, it is anticipated that an arch action occurs and brake core by hydraulic fracturing. Therefore, the core material must select (mixed

material of cores material, fine sand and clay) to minimize the consolidation after embankment.

It is recommended that the Engineer reconfirm the geological conditions around the right bank abutment and spillway, and then make a comparison study on the construction cost, safety, and workability of the excavation method and the Secant Pile method.

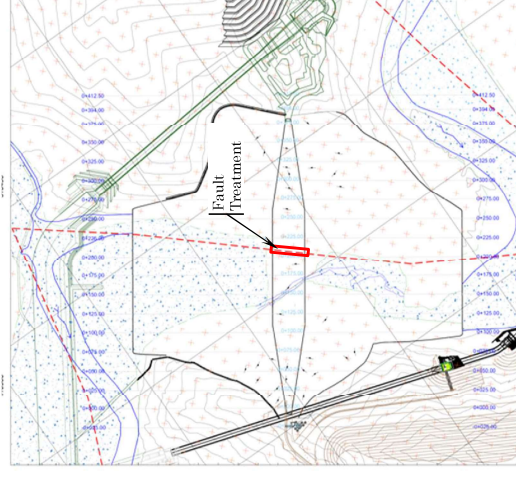
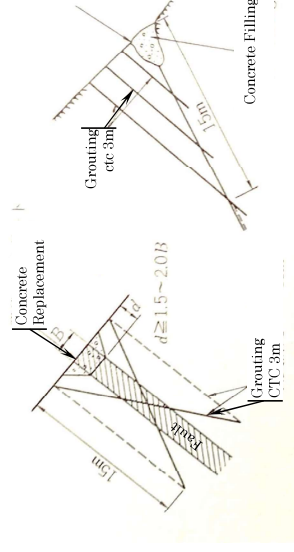
**Figure 4 Fault Treatment of Dam Foundation (Sample of Dam in Japan)**

In general, faults in fill-type dam foundations will not pose a major problem as long as watertightness is ensured, as the fill dam body itself has the ability to follow the deformation of the foundation. However, it will need to be replaced with concrete if significant displacement is expected at the fault zone after embankment, in particular there are concrete structures on the core foundation, such as galleries, spillways, grout caps, etc.,. The concrete replacement for fault treatment will be the shape shown in the figure below, similar to the case of gravity dams.

Since the core foundation of Bulango Ulu Dam will be covered with grout cap concrete, it is recommended that to conduct a trench excavation and replace it with concrete along the fault at the core foundation area, if necessary.

In addition to the faults, at the location of the ancient river, it is recommendable to excavate until hard rock is found and then dental concrete is applied so that the surface is flat.

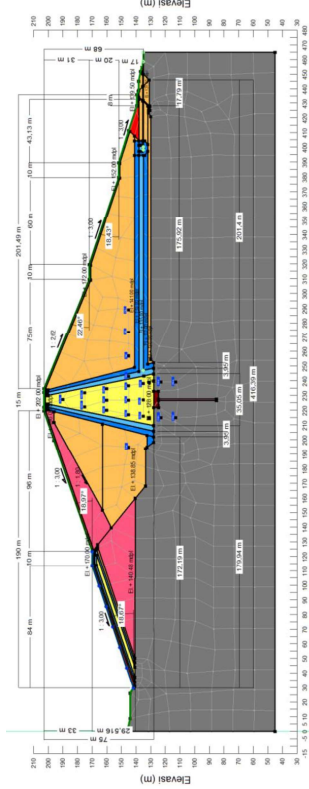
In the random zone, clay components are richly contained and it is almost the same condition as the core material. Filter is provided between core and random zone. However, there is no filter zone between rock zone composed with coarse material and random zone.

It is recommended to check the necessity of the filter between random and that core and the filter between random and rock zones. Dam stability shall also be rechecked applying the new seepage line.

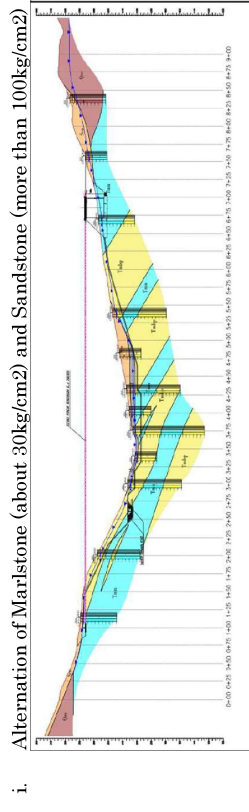
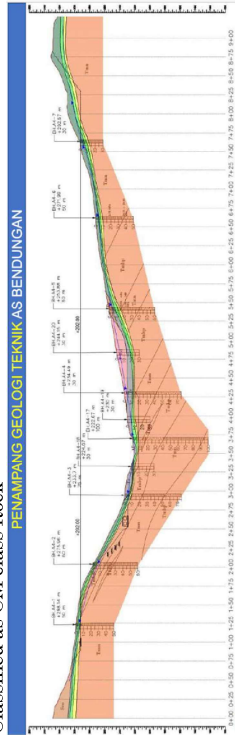
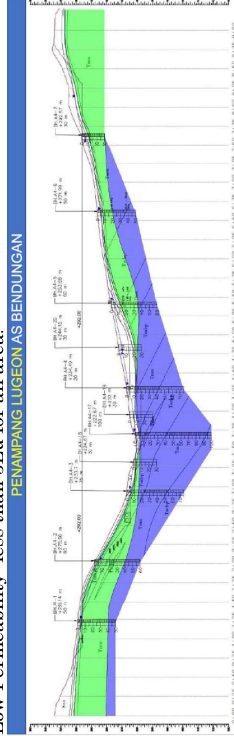
ii. Axis of anticline runs upstream to downstream.

iii. Classified as CM class Rock

iv. Low Permeability: less than 5Lu for all area.

But it is assumed that some part of foundation rock contains high permeability zone (need to confirm).

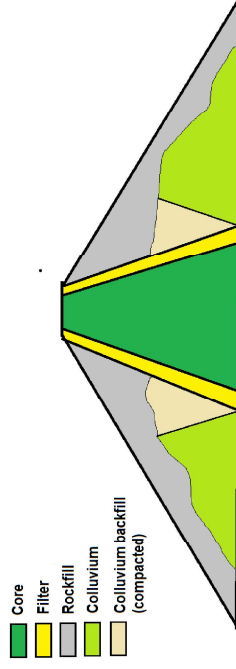
Figure 1 Sketch of Bagong dam design with remain colluvium deposit

- (1) Alternative 1 is the safest condition (accepted), but constrained with financial issue. Alternative 2 might not be applied to Bagong dam due to difference condition of colluvium condition between Bagong dam and Tugu dam and secant pile cannot be used as reinforcement. The colluvium condition of Tugu Dam is coarse grained colluvium that settlement is not occurred (in Bagong Dam has settlement potential). Alternative 3 may be applied but take more time and not economical.
- (2) The best condition of dam foundation is all of dam body lie on good bedrock foundation. For Bagong dam, it is possible that "Core" and "Filter" materials should be placed on bed rock and remaining colluvium in the dam body may be remained as tolerated, as

shown Figure 1 (should be confirmed by stability analysis).

(3) The colluvium will be regarded to be a part of dam body in all cases. Therefore, it is anticipated to ne required several countermeasures such as counterweight based on the results of stability analysis and the several facilities such as inspection road, instruments might be relocated.

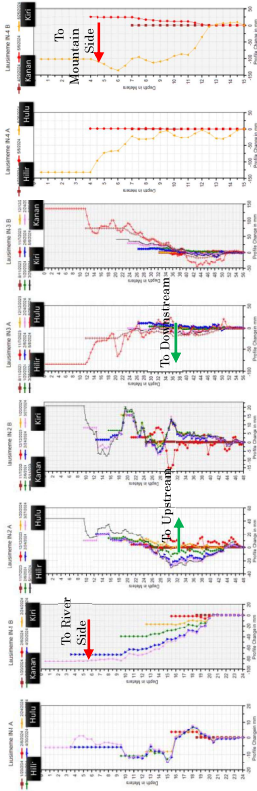
**Monitoring Data of Inclinometer**

In general, the displacement of inside of core zone for both abutments inclines towards the center of the dam where settlement is the largest, and the displacements to the upstream and downstream sides are small.

However, there is displacement to upstream and downstream in Lausimeme Dam, with 4cm at IN-2 to upstream and 8cm at IN-3 to downstream in the opposite direction. Additionally, IN-4, installed on the right bank abutment, is inclined towards the mountain side. One possible cause is differential settlement, but the reason is unclear.

Since soil materials such as core materials have the ability to self-recover, it is thought that such problems will be resolved once consolidation is complete.

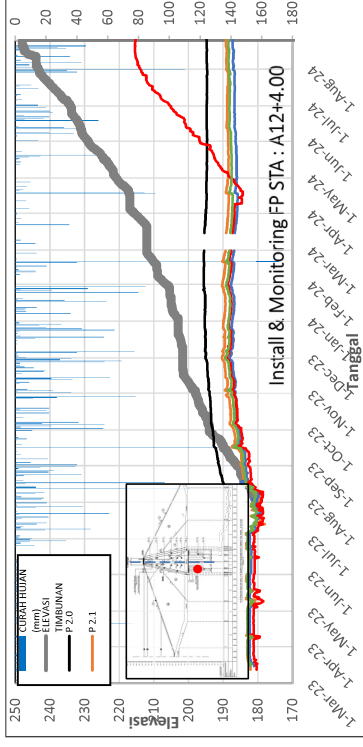
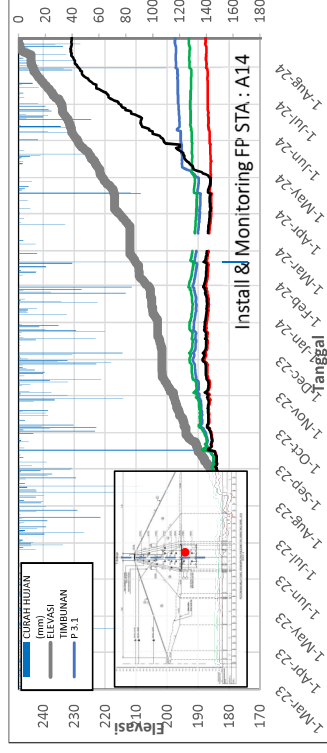
Monitoring Record of Piezometers at STA A12+400 & STA A14

Among the piezometers installed in the dam foundation, pore water pressure has been rising suddenly since May 2024 at P2.3 (upstream of dam axis) on A12+400 section and P3.4 (downstream of the dam axis) on A14 section. And pore water pressures of only these two piezometers increase in accordance with embankment height. The installed locations of these piezometers are considered to be in a weak zone (CL class). No such phenomenon, however, has observed at the other two sections (A6 and A18).

The information from these piezometers suggests that part of the foundation rock in the weak zone, connecting upstream and downstream of the dam, may have collapsed due to the extra load of the embankment. Judging from the proportional increase of pore water pressures to the load of the embankment, it is estimated that the collapsed rock is now directly affected by the overburden load of embankment. Furthermore, since the collapsed bedrock is expected to have deformed, there is a possibility that there are cracks that connect to upstream and downstream in the cover concrete (grout cap).

Before impounding the reservoir, it is necessary to clarify the cause of sudden change of pore water pressure and consider measures to be taken in the event of excessive leakage after impounding reservoir.

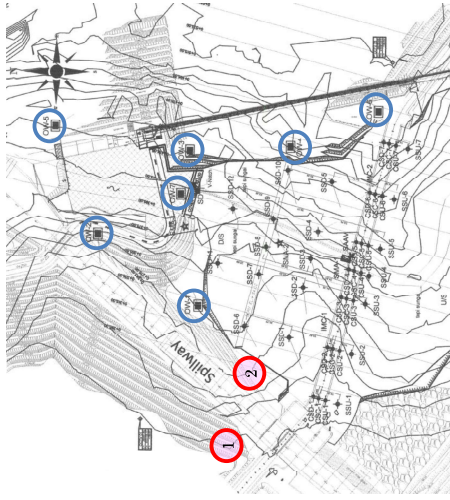
Seven (7) ground water observation wells have been installed at site but there is only one well on the left abutment. Since the water level is lowered at present, it is recommended to install several observation wells on the left abutment (refer to figure below).

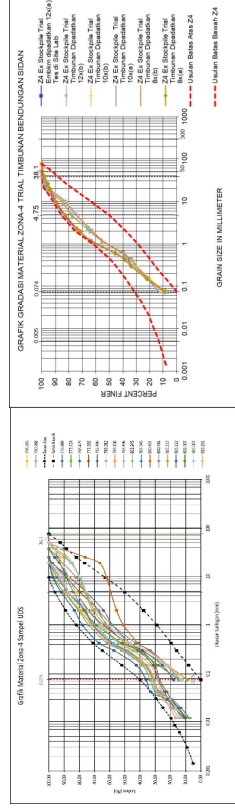
Actual Zone 4 Materials in Construction

- For materials whose consistency is judged as non-plastic, it is acceptable to include cohesion in a design parameter or not?
- It is anticipated that the compaction of random materials was carried out appropriately. The grain size of the material for which the compaction standard was determined, is 10% of silt/clay and 50% sand, while the actual embankment material contained 30% of silt/clay with a significant difference in the fine particle content.
- If the material has a characteristic of sand, there is concern about settlement when impounding and the sweeping away of the embankment materials when the water drawing down.
