1. Minutes of Meetings

Dam Discussion by Balai Teknik Bendungan

**TECHNICAL DISCUSSION ON THE CONSTRUCTION OF THE TEMEF DAM, TIMOR
TENGGAH SELATAN AND MANIKIN DAM, KUPANG REGENCY, EAST NUSA
TENGGARARA PROVINCE**

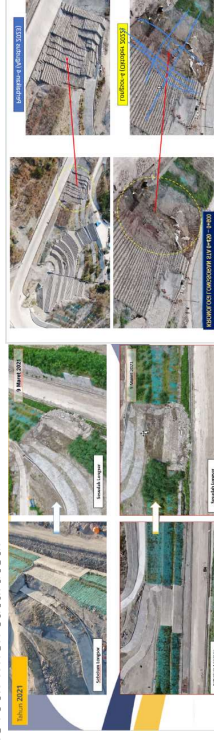
1) Handling landslides that occurred on road slopes initially used plants, but landslides still occurred, then they were replaced with gabions, but landslides still occurred. The visible condition of the gabions shows that the gabions installed tend to put an additional load on the rock when saturated.

2) Movement analysis must receive a more in-depth study, after which the appropriate method for handling can be decided. Can be done with a borepile

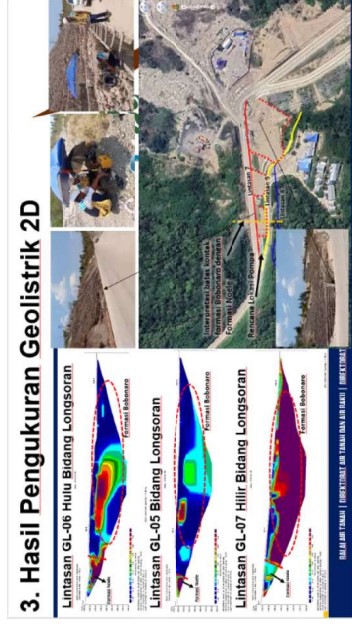
- 3) The weak zone is between the boundaries of the Noele and Bobonaro formations, where the water is dominated by water originating from the Noele formation. So it is necessary to carry out a dewatering method between the boundaries of the Noele and Bobonaro formations.

- 4) It should be modeled according to field conditions. Apart from that, the parameters used should not be used immediately, engineering judgment is needed by taking smaller lab parameters.

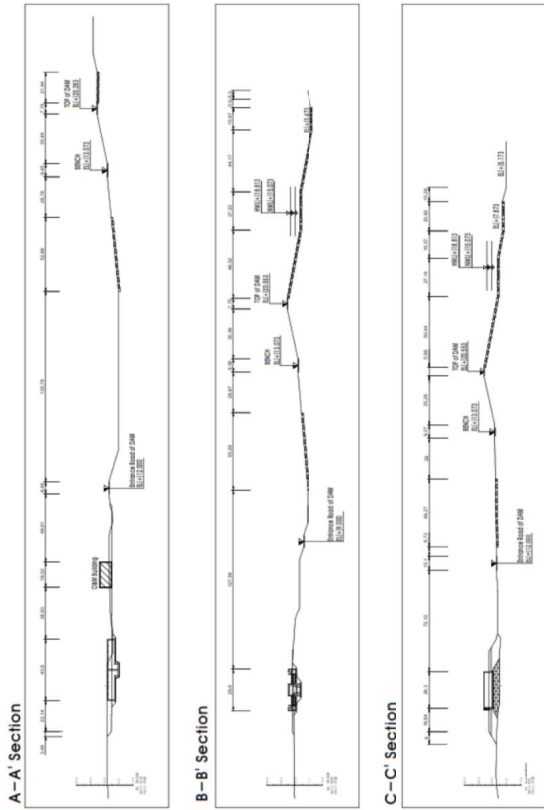
Figure 2. WTP Design for Sepaku Semoi Dam Cuts A - A', B - B', and C - C'

1. The design layout map for the Sepaku Semoi Dam WTP has been submitted (Figure 1), and its sections are (Figure 2, Figure 3, Figure 4).
 - a. It appears that the layout map and the cut do not match. For example, in the E-E' cut, there are circular buildings on the layout map that are not depicted on the cut. According to the Consultant, this is because these buildings were planned to be built after the WTP was operational (Phase 2 & 3). It should be noted that these buildings will later become a burden that can affect the safety of the dam, so they need to be completely depicted on the layout and cross-section map and taken into account in the stability analysis.
 - b. The cut image should also be equipped with a numbering symbol that is adjusted to the layout image. (see Figure 5).

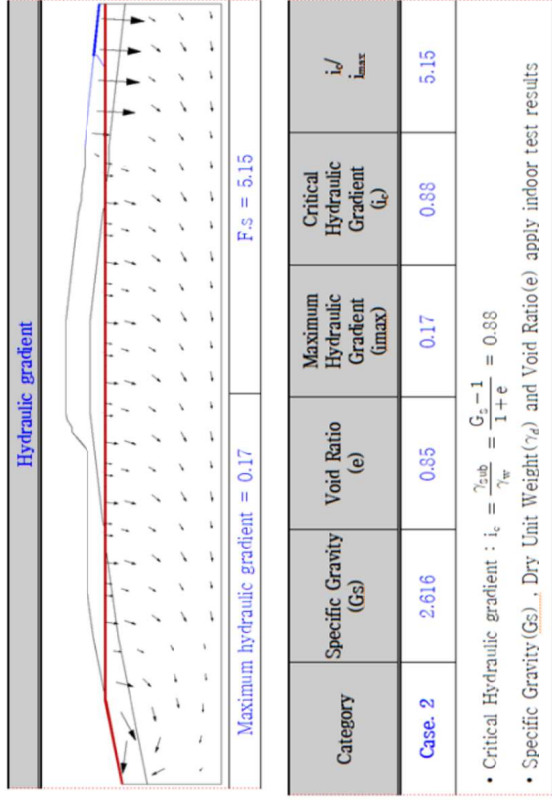
From the safety analysis of piping, it is explained that an analysis was carried out, which produced a value of $F_s = 5.15$. However, the hydraulic gradient image being analyzed is not complete

- 3.
4. Below is the planning layout for the Water Treatment Plant (WTP) on the left side of the Sepaku Semoi Dam.
- To facilitate the evaluation of WTP designs, design drawings should be drawn at a normal scale of 1:1 for vertical and horizontal comparisons and equipped with distances and dimensions.
