| No | URAIAN/SARAN | TINDAK LANJUT OLEH PEMRAKARSA BENDUNGAN/ KONSULTAN SUPERVISI | TANGGAPAN KAJIAN BALAI TEKNIK BENDUNGAN |

1. Discussion on RCC Foundation
2. Quarry Material Evaluation

DAM ISSUES & RECOMMENDATIONS

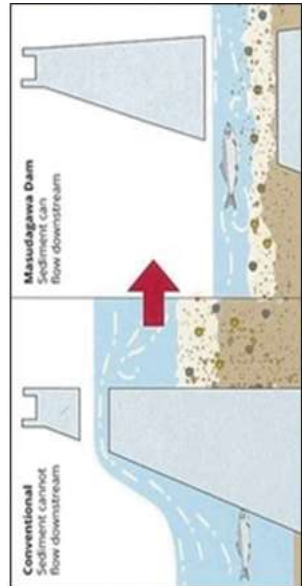
Figure 1. Sketch of Masudagawa Concrete Dry Dam (KNI-BB, 16-18 May 2017 Padang, YZ&AM)

- 4. The concept of dry dams is very common in the form of gravity concrete/RCC dams both in Japan and the United States, because it is relatively easy to control, and because rapid draw down often occurs, concrete/RCC dams are relatively safe.

- 5. The dry dam concept at Melawi Dam will be quite good because there is a traditional water traffic route for the people of Kalimantan. In addition, the biota that usually live downstream and back can also play their role as usual without being disturbed.

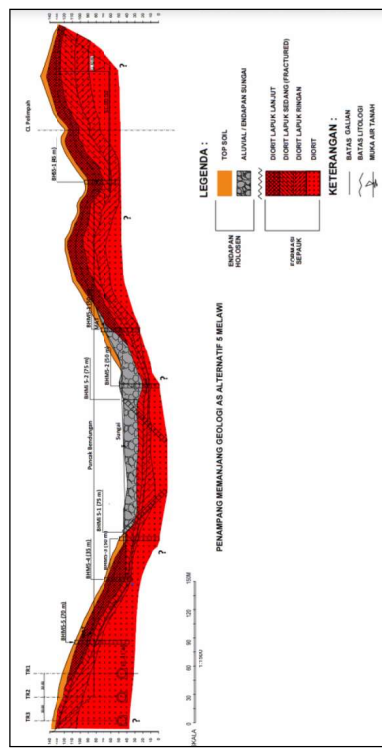
Figure 4. Longitudinal Geological Cross Section of Alternative Axis 5 of Melawai Dam

- b. The plan is that the deepest excavation of the dam foundation will be reduced to 30 m, considering the large amount of igneous rock material excavated, as well as the type of dam foundation rock which is composed of igneous rock, the dam design should be considered to be a type of heavy-duty concrete or Roller Compacted Concrete (RCC).

- c. By replacing the type of dam from rockfill to concrete/RCC, the length of the dam body will likely be reduced, because the foundation excavation does not need to follow a maximum gradient of 45°.

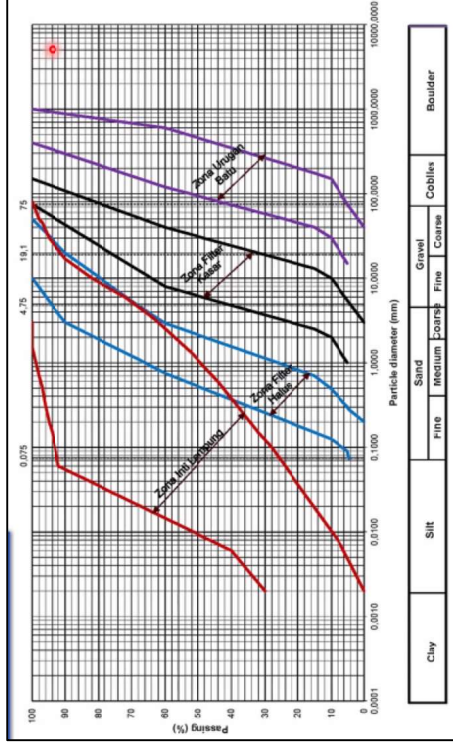
Figure 11. Design of Embankment Material Gradation

- c. To avoid overburden excavation of approximately 17 meters (quite deep) and to utilize the excavation results, it is necessary to consider designing an alternative dam body using random rock material (if not using a gravity concrete dam type).

- d. If the embankment material still only uses rockfill material, the location and complete design of the disposal area as a place to dispose of waste material should also be planned.

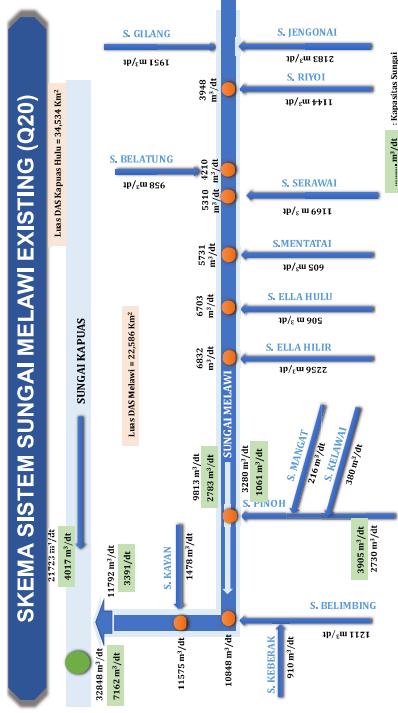
Figure 13. Existing Melawi River System Scheme (Q20)

- Flood reduction from each alternative dam should be shown specifically based on land cover area.
- The calculation of peak discharge in Sintang should not be the result of an algebraic summation between the flood peaks at the Kapuas Hulu outlet and the meeting point of the Melawai flood peak, but rather based on the summation of the two hydrographs which produces a different flood peak from the first approach.

- c. A conclusion matrix should be made on the reduction of the magnitude of flooding in a certain recurrence period with the presence of Dry dams in Sintang, Melawi - Kapuas Confluence, Pinoh Confluence - Melawi River, and the downstream of Melawi Reservoir and its impact (area of inundation) on settlements or rice fields, complete with notes on settlements including Villages, Sub-districts, and Regencies or cities.
