マーシャル諸島共和国
マジュロ病院整備計画
フォローアップ協力調査報告書

2023年4月

独立行政法人
国際協力機構（JICA）

株式会社 梓設計

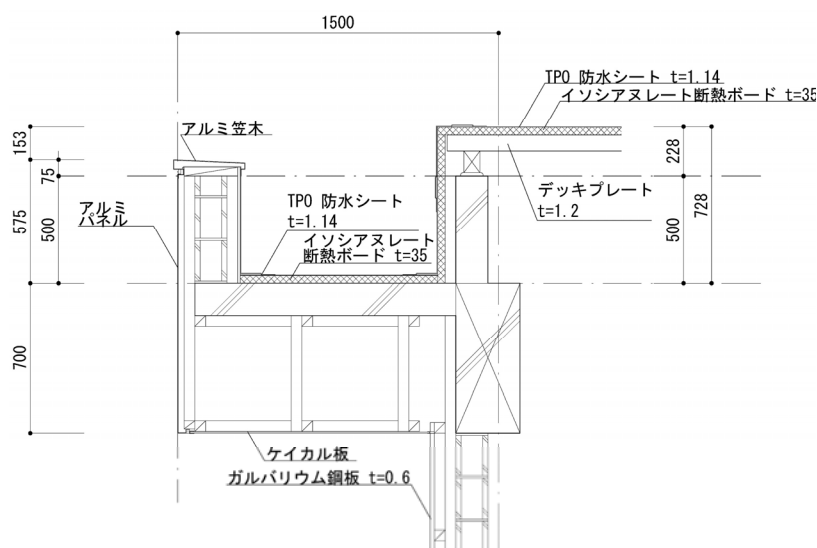
図 1-1 軒先雨水排水溝部分断面図

ビルディング 1～3 共通の仕様として、屋根はデッキプレート t=1.2 mm 及び断熱材（ポリイソシアヌレートボード）t=35 mm の上 TPO シート（オレフィン系熱可塑性エラストマーシート）t=1.14 mm が敷設されている。敷地の地耐力が見込めず建物の軽量化を図る必要があったことが鋼製のデ

デッキプレートを採用した理由である。防水シートは機械的固定工法が採用されており、防水シート端部及び中間部を固定ディスク及びビスで固定し、シート重ね部分は溶融圧着されている。また、中間部で機械的固定した部分を同材の圧着工法でカバーされている。

竣工当時及び太陽光パネル設置の際に施工された防水シートは、オレフィン系熱可塑性エラストマー（TPO）シートであり、露出タイプ（非歩行）機械的固定工法で施工されている。TPOシートは、紫外線や熱による劣化が少なく、シートとシートの接合部は熱融着させるため、剥がれにくいのが特徴である。一般的に防水シートの耐用年数は10年～15年程度であるが、太陽光パネル設置工事中の2011年に病院から太陽光パネル施工者へビルディング1の防水シートの補修が依頼されており、2005年12月竣工から少なくとも5年程度で雨漏りが発生したと見られる。想定される防水シートの損傷原因として、非歩行タイプのシート上の日常的な歩行等が考えられる。加えて、本敷地は、低緯度で常時強烈な日射を受ける為、防水シートは日中高熱状態にあり、かつ強い紫外線等で温帯地域より劣化の進行が早かった可能性も考えられる。

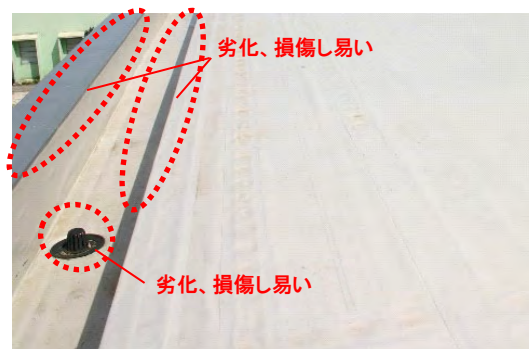
図 1-2 漏水懸念箇所

平坦部分以外での漏水が想定される箇所として、ドレン回り、笠木回り、防水立ち上がり部分に不具合が発生しやすい。これらの部分では、経年劣化や風等でシート端部を固定する金物やシーリング材、シート自体が破損して、シートが剥がれることで水が浸入することが多い。また、マジュロ病院では棟をつなぐ渡り廊下の屋根についても雨漏りが報告されており、これらは、竣工後に手を加えられた部分ではない

ため、耐久年数超過によるものと考えられる。

これら平坦部以外の漏水箇所について状態を入念に確認し、改修方法検討に必要な情報を入手する。

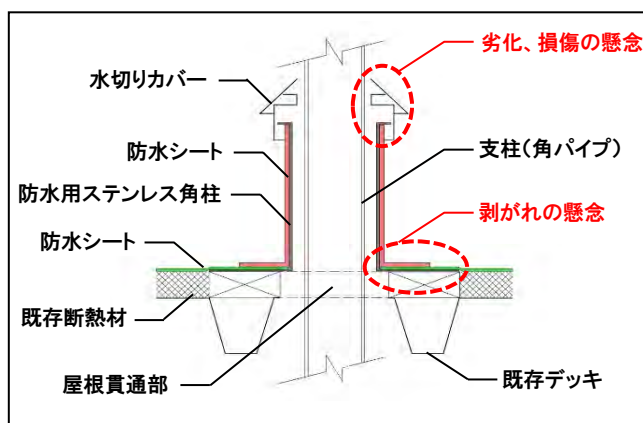
図 1-3 支柱断面図

ビルディング 2 及びビルディング 3 の太陽光パネル架台の支柱は、既存屋根デッキプレートに穴を開け、防水層を切り取って貫通した後、構造体である鉄筋コンクリートの梁に固定し、その後再度防水処理を行っている。一度防水層を切っている為、経年変化等により材料間に隙間が生じれば、雨水が浸み込み、漏水に発展した可能性がある。特に、既存建物の屋根は乾式である為、コンクリートに比べ柔らかく、開口部が設けられると、応力が集中し、歪みが発生しやすい。

支柱部分の防水施工方法は、屋根を貫通する柱にステンレス製の筒を被せ、その上に防水シートを張り、防水シート立ち上がり上端はステンレス製プレートで固定した上にシーリング及びステンレス製の水切りカバーが設置されており、十分な漏水対策が取られていると考えられる。しかし施工後、年数が経過することにより、防水シートの亀裂や接着剤の劣化による剥がれ、上端のシーリング材の劣化等が生じている可能性があるため、状況を確認する。

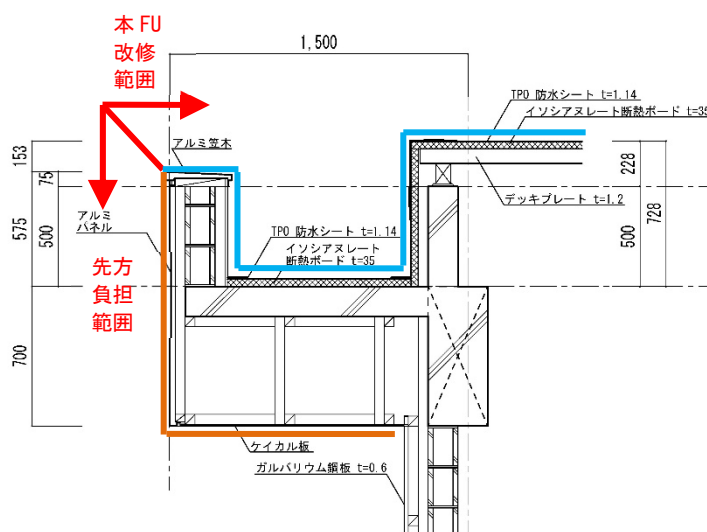
図 3-3 パラペット付近の FU 対象範囲

2-3-7 で示したとおり、パラペットのアルミパネルと軒天ボードが一部脱落している。漏水の直接的原因とはなっていないが、笠木の木下地やパラペットを構成するブロック等の耐久性を低下させる可能性があるため、早急に脱落したアルミパネルや軒天ボードを修繕することが望ましい。試算においては、直接工事費のみで 83,000USD 程度であり、25,000USD を超えるため公共事業省の管轄と想定される。
