**The Republic of the Marshall Islands
Ministry of Health and Human Services**

**Follow-up Cooperation Survey Report
on
The Project for Improvement of
the Majuro Hospital
in
The Republic of The Marshall Islands**

April, 2023

**Japan International Cooperation Agency
(JICA)**

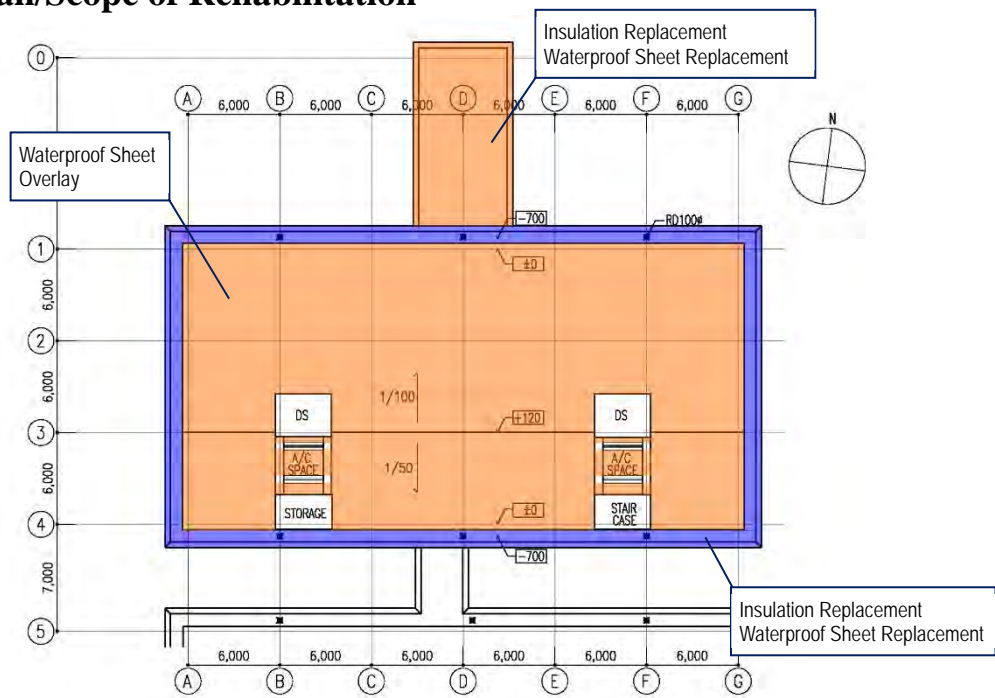
Roof Floor Plan/Scope of Rehabilitation

- Flat Area Waterproofing Renovation Scope
- Eaves Rain Gutter Drainage Area, Scope of Waterproofing Renovation

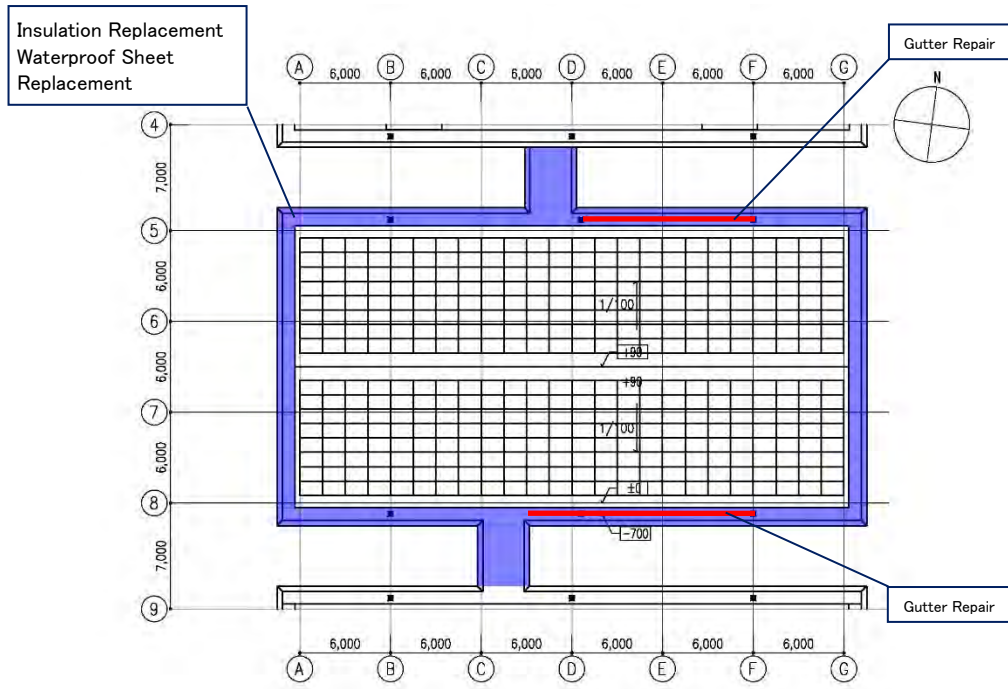
Building 1 Roof Floor Plan/Scope of Renovation

■ Eaves Rain Gutter Drainage Area, Scope of Waterproofing Renovation

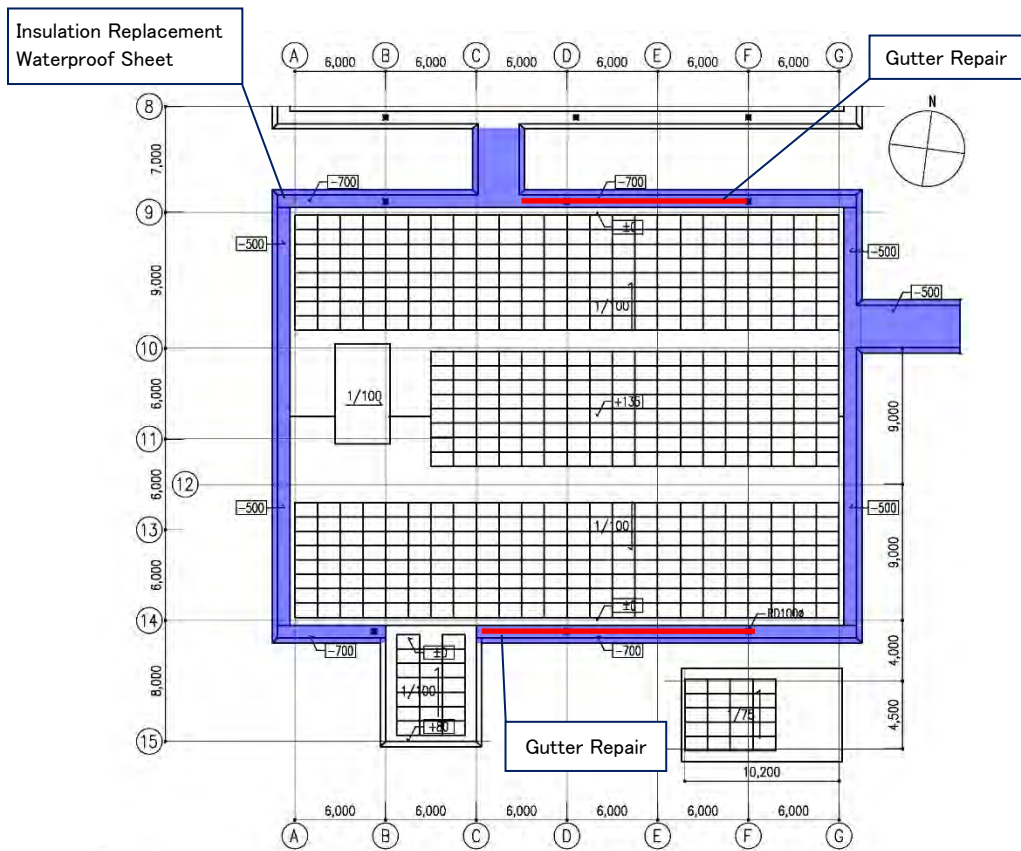
Building 2 Roof Floor Plan/Scope of Renovation

■ Eaves Rain Gutter Drainage Area, Scope of Waterproofing Renovation

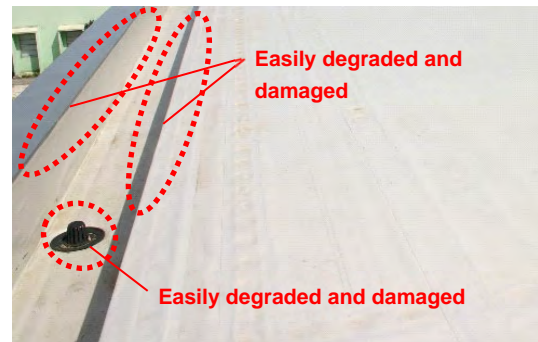
Figure 1-2 : Risk Areas of Leakage

The coping, waterproofing risers, and floor drains are potential leakage areas other than flat areas. In these parts, the hardware and sealant that fix the sheet edges and the sheets themselves are often damaged by age, wind, and other factors that often cause the sheets to peel away, allowing water to leak inside. Leaks from the roofs of the corridors connecting the buildings were also reported; these were not renovated after construction was completed, suggesting that the cause is the waterproofing exceeding its service life.

These leaks outside flat areas should be carefully monitored to obtain the information needed to consider how to repair them.

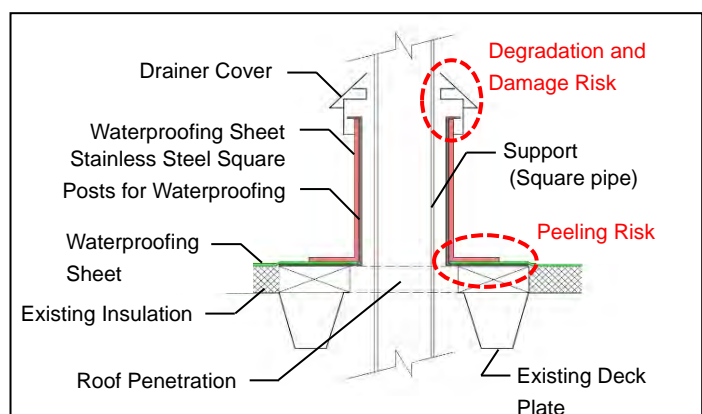
Figure 1-3 : Cross Section of Pillar

To fix the supports for the solar panel mounts on Buildings 2 and 3 to the reinforced concrete girders of the buildings, holes were drilled through the existing roof deck plates to cut through the waterproofing layer, which was later waterproofed again. The waterproofing layer has been cut; therefore, if gaps form between the materials due to aging or other factors, rainwater could have seeped in and developed into leaks. Specifically, because the roofs of the existing buildings are the dry method, they are softer than concrete, and when openings are made, stress is concentrated and distortion is likely to occur.

The waterproofing method for the supports involved covering the supports with stainless steel tubes where they penetrate through the roof, wrapping them in waterproofing sheets, using stainless steel plates to fix the upper edges of the sheet risers, and installing stainless steel drain covers and applying sealant on the top. This is considered to be a sufficient measure for preventing leaks. However, as years pass after the construction, the penetrations should be checked because the waterproofing sheets may crack, or peel away due to deterioration of the adhesive, or the sealant on the top covers of the sheet risers may have deteriorated over time.

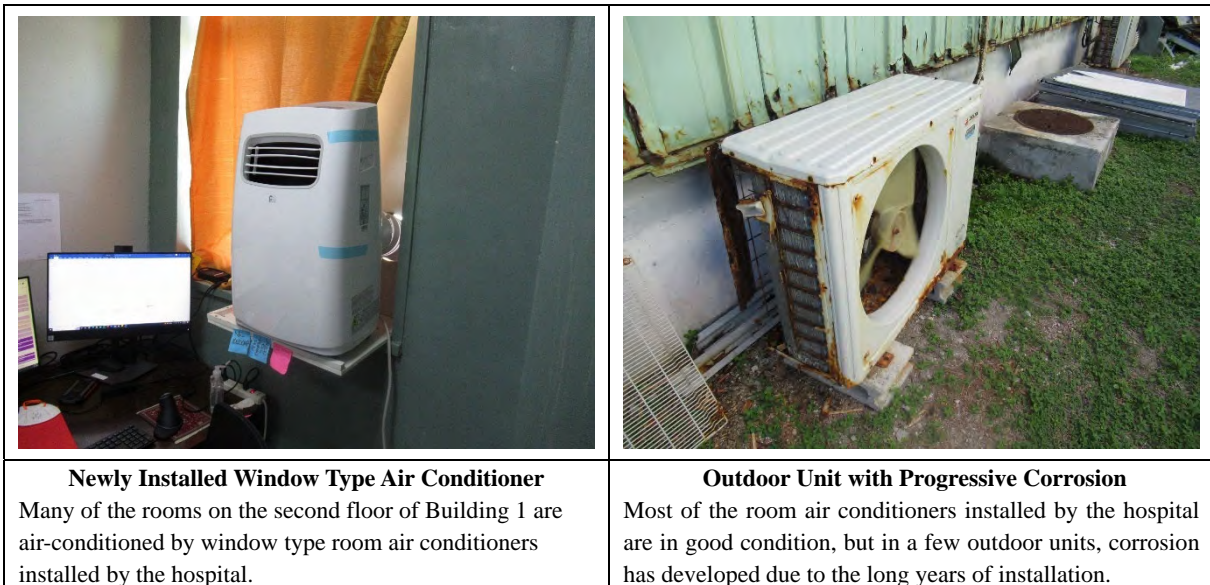
Figure 2-7: Photographs concern with Air Conditioning Equipment

Indoor Unit of Newly Installed Room Air Conditioner
Condition of indoor unit of room air conditioner.

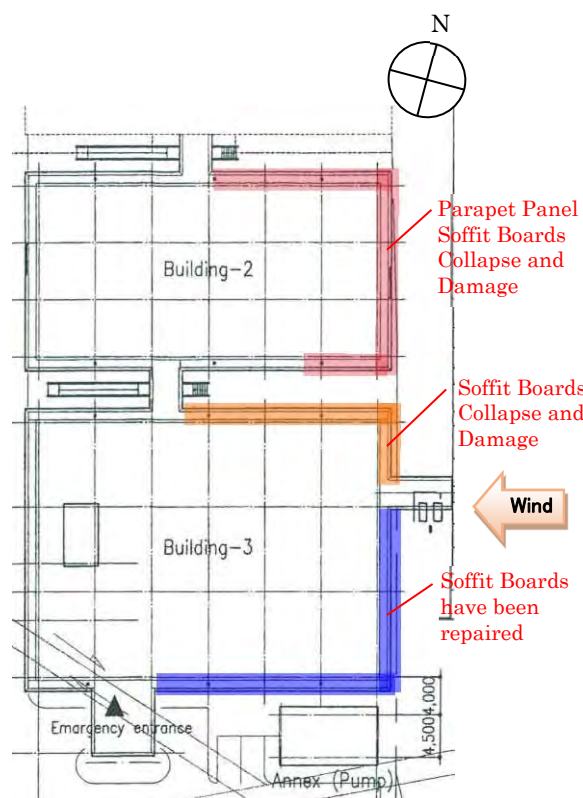
Figure 2-12: Extent of Damage to Parapet and Eaves

As for Building 3, although no aluminum parapet wall panels have collapsed, numerous soffit boards (especially on the north side of the east wall) are damaged or have fallen off. The hospital repaired the soffits on the south side of the east wall, and the finish is in good shape. The parapet walls comprise concrete block walls with wooden base materials on top of which bent aluminum panels are fixed with screws as the exterior finish. The soffits are made of roof boards (calcium silicate boards) nailed to a wooden support and coated with paint.

The aluminum parapet wall panels and soffits may have collapsed in the following process.

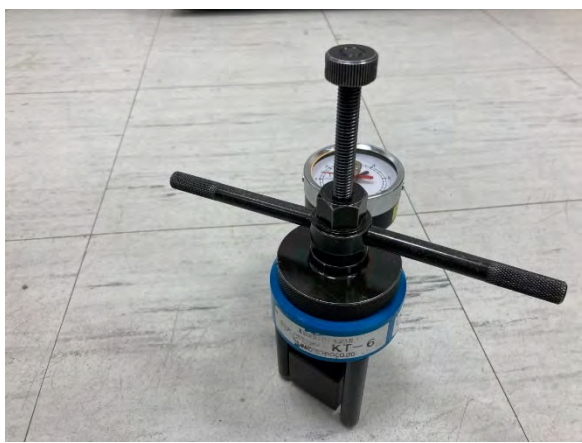
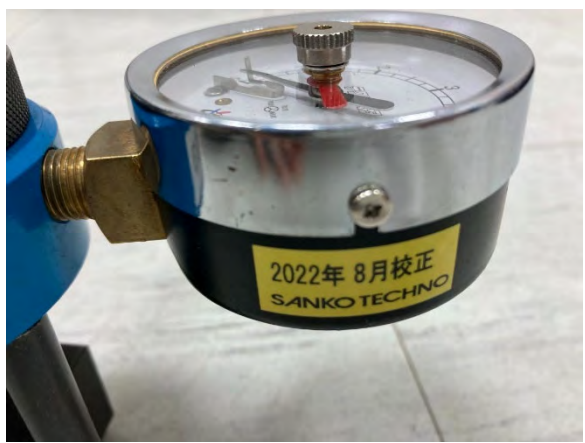
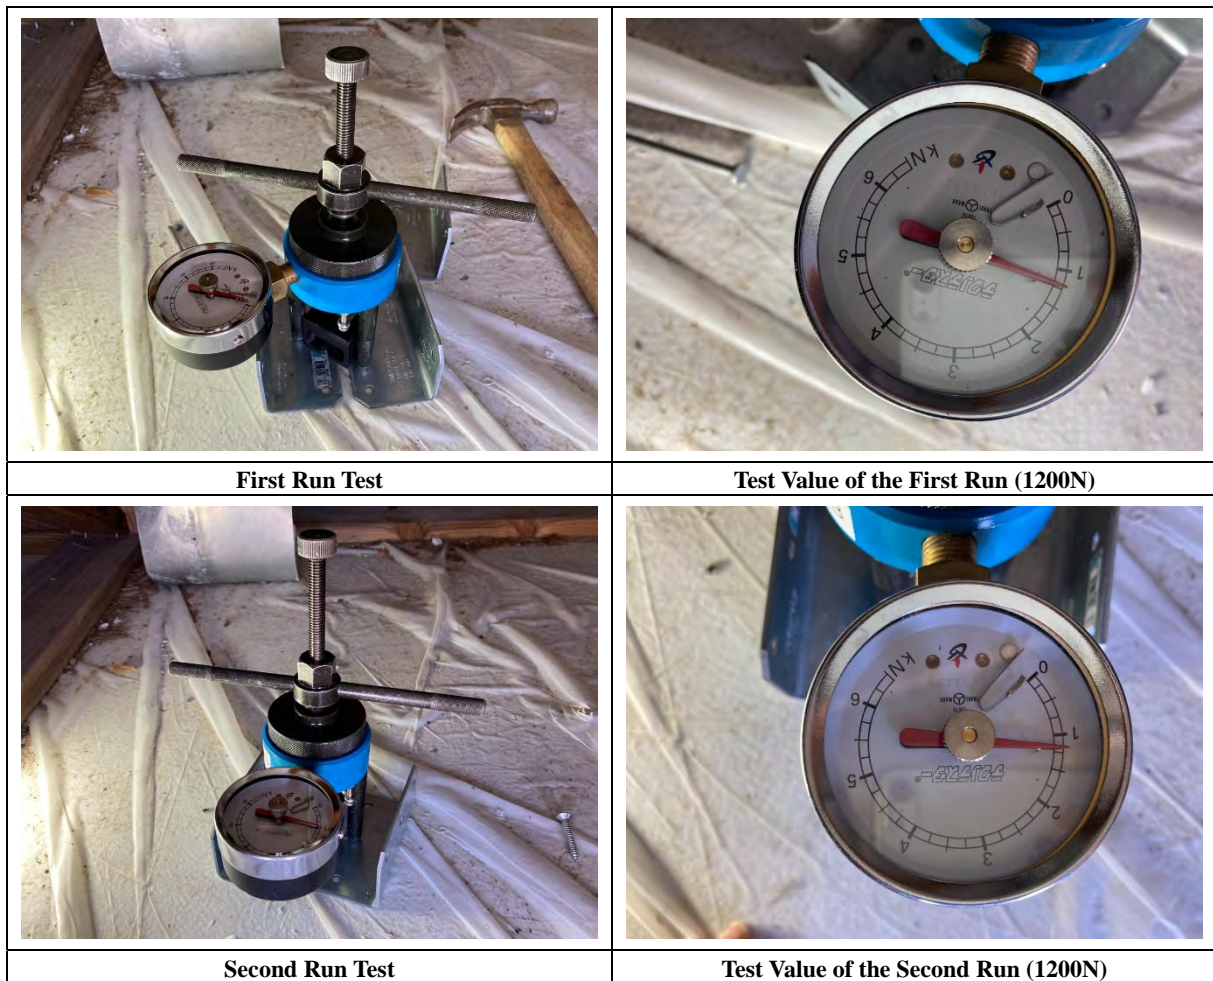
Figure 3-1: Photographs of Deck Plate Pullout Tests

4-mm holes were drilled in the deck plates, 5-mm screws were inserted, and the testing equipment was used to check the pullout resistance of the deck plates.

The design pullout resistance per sheet under the presumed waterproofing sheet method is estimated as 600 N; therefore, tests were conducted to double that level (1,200 N), at which point the loads were removed and the tests concluded. The test results confirmed that the pullout resistance of the deck plates is sufficient.

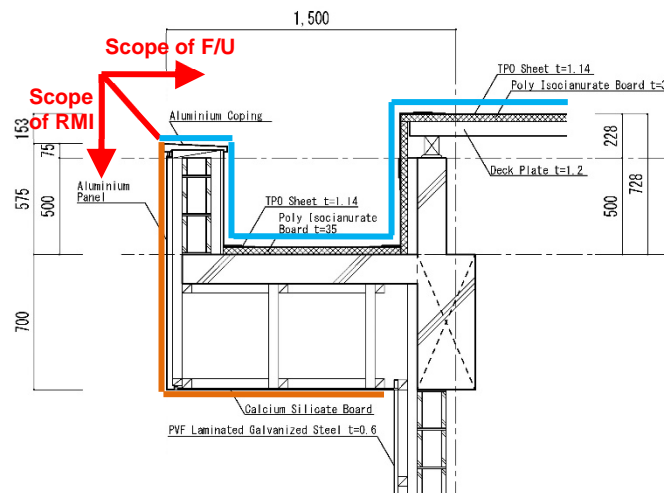
Figure 3-3: Scope of F/U around parapet

As indicated in 2.3.7, some of the aluminum panels and eave boards of the parapet are collapsed. Although this is not a direct reason of leakage, it is desirable to reinstall the aluminum panels and eave boards that have collapsed at the earliest possible stage, as it may reduce the durability of the wooden base of the shade trees and the blocks and other components of the parapet. In the estimation, the direct cost is about 83,000USD, which is assumed to be under the jurisdiction of the Ministry of Public Works because it exceeds 25,000USD.

(2) Refurbishment and installation of parapet aluminum panels and eave boards
