**PREPARATORY SURVEY
FOR THE PROJECT
FOR RECONSTRUCTION OF BRIDGES
ON PRIMARY NATIONAL HIGHWAY NO. 1
IN MONGAR DISTRICT**

FINAL REPORT

JAPAN INTERNATIONAL COOPERATION AGENCY

ORIENTAL CONSULTANTS GLOBAL CO., LTD.

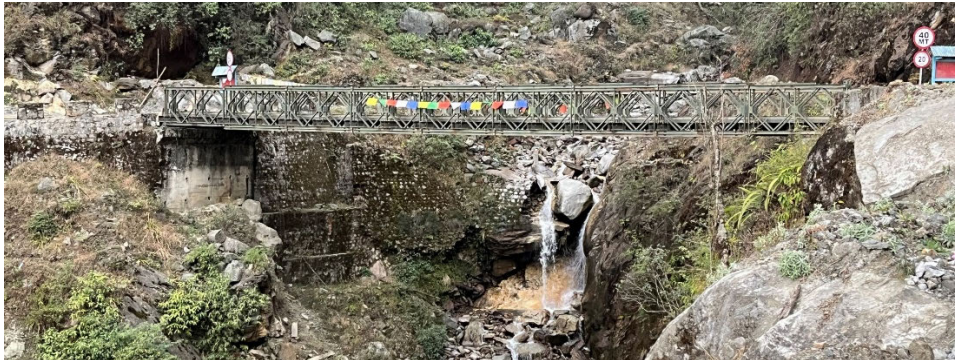
<p style="text-align: center;">Existing Bridge</p>

The superstructure of the current bridge is a baily bridge, which is a temporary bridge, and sagging has been observed in the centre of the bridge under dead load conditions. The bridge is considered to have insufficient loading capacity, so the existing bridge needs to be replaced with a permanent bridge as soon as possible, and slope protection is urgently required as the slope around the area is very steep and rock falls are common.

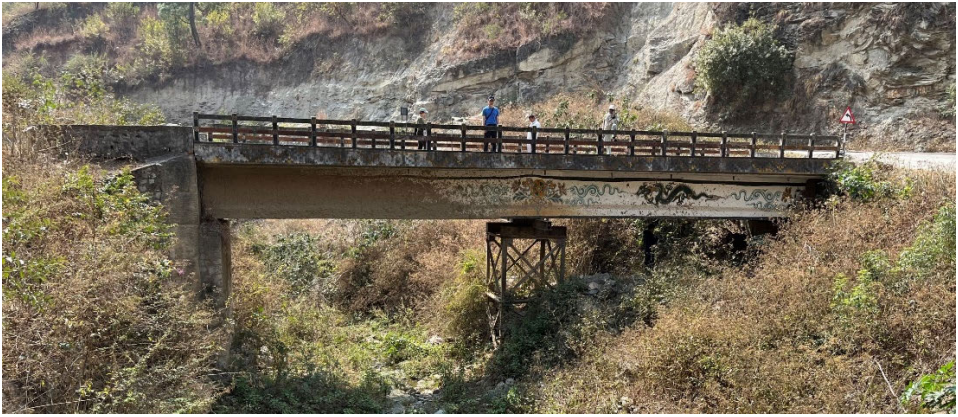
Existing Bridge

The Revidrang Bridge was reinforced in 2019 by the installation of a support vent at the center span for the countermeasure of bending moment. However, the bridge was closed due to the progress of damage. Vehicles are currently using a diversion road constructed in 2020 after the bridge was closed. Rainfall in the rainy season the same year caused overflow on the diversion road, but impact on traffic was minor. Basic information on the Revidrang Bridge is shown in Table 1-2-4. The PNH-1 between Mongar and Trashigang has been closed several times from 2018 to 2020 due to landslides.

The bridge is currently closed, and overflow on diversion road has been observed during rainy season. Function as the PNH-1 is insufficient. Therefore the existing bridge needs to be replaced with a permanent bridge as soon as possible.

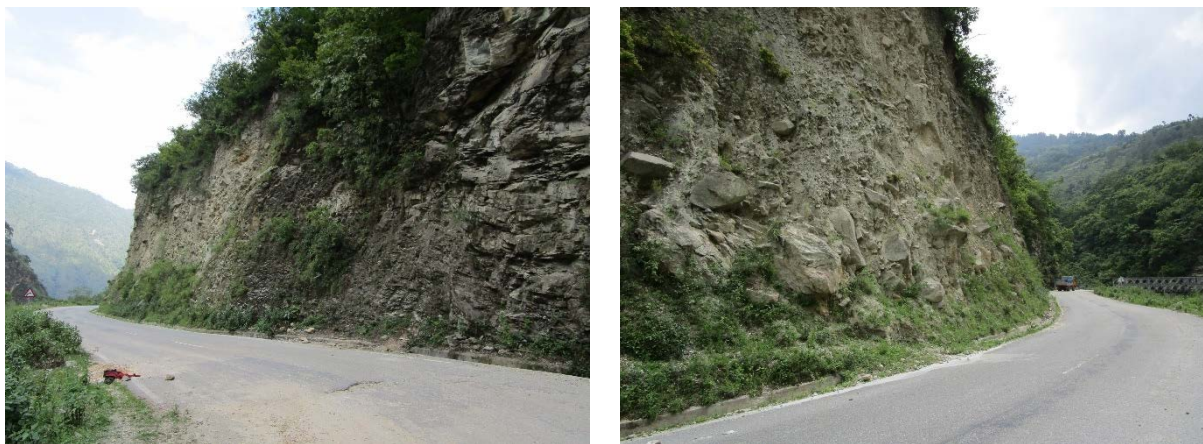
On the right bank side, the road slope displays areas where schist is exposed, as shown in Figure 1-3-60, alongside sections with a mix of large boulders and gravel. The current road alignment predominantly forms nearly linear cut slopes, where the exposed rock parts reveal a structure with a bedding plane gentler than the cut slope (approximately 65 degrees).

Figure 1-3-60 Right side of Durdari Bridge

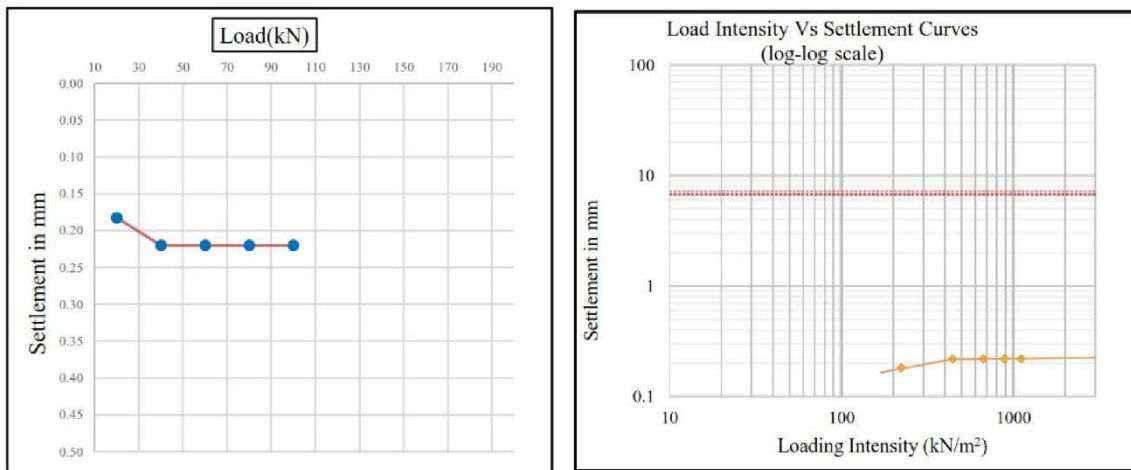
Figure 1-3-68 Relationship between Settlement S and Load Pressure P (Namling Right side)

Below are the results of the plate load test on the right bank of the Namling Bridge. In the right bank area, bedrock emerged near the surface. Consequently, with a final load of $P = 1,111 \text{ kN/m}^2$, the settlement was very small at $S = 0.22\text{mm}$. Within the range of the applied load for this test, it was determined that the ultimate bearing capacity limit (P_u) was not reached.

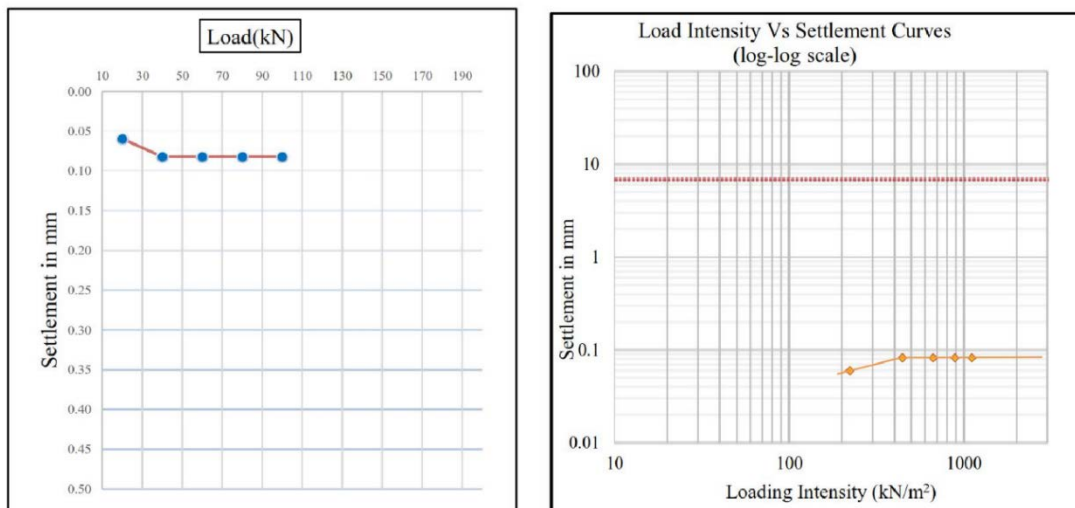
Figure 1-3-69 Relationship between Settlement S and Load Pressure P (Namling Left side)

Here are the results of the plate load test on the left bank of the Namling Bridge. In the left bank area, bedrock emerged near the surface. As a result, with a final load of $P = 1,111 \text{ kN/m}^2$, the settlement was very minimal at $S = 0.08\text{mm}$. Within the range of the applied load for this test, it was determined that the ultimate bearing capacity limit (P_u) was not reached.

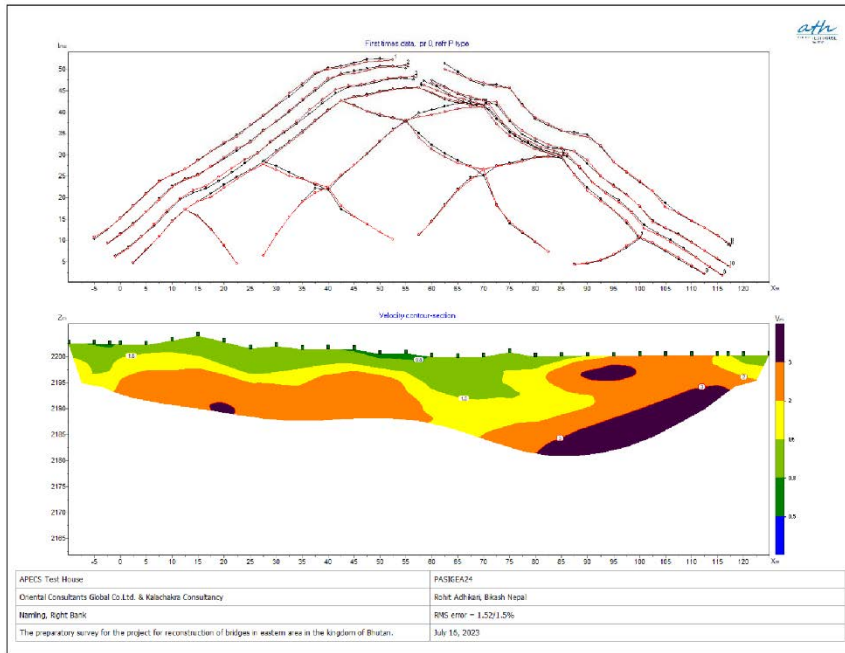
Below are the results of the seismic wave survey conducted on the right bank slope of the Namling Bridge. It generally shows $V_p = 800-1,500\text{m/s}$ near the surface. Referring to the example in Figure 1-3-72, the rock types are classified with $V_p = 500\text{m/s}$ or above. This result aligns with the emergence of bedrock layers at the borehole point (BH-No.2). Additionally, it is conceivable that the P-wave velocity increases significantly in the depth direction, gradually indicating a hardening of the rock formations.

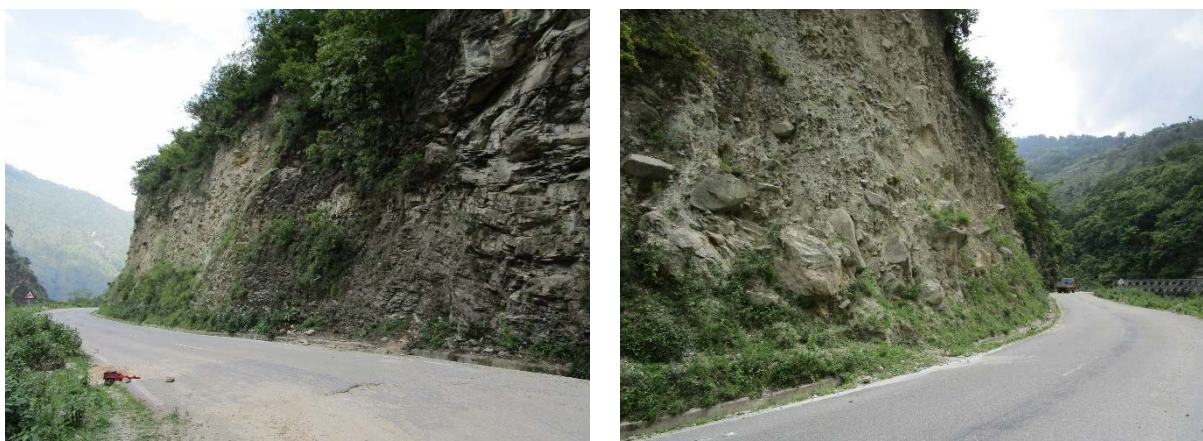
On the right bank side, the road slope displays areas where schist is exposed, as shown in Figure 1-3-75, alongside sections with a mix of large boulders and gravel. The current road alignment predominantly forms nearly linear cut slopes, where the exposed rock parts reveal a structure with a bedding plane gentler than the cut slope (approximately 65 degrees).

Figure 1-3-75 Right side of Durdari Bridge

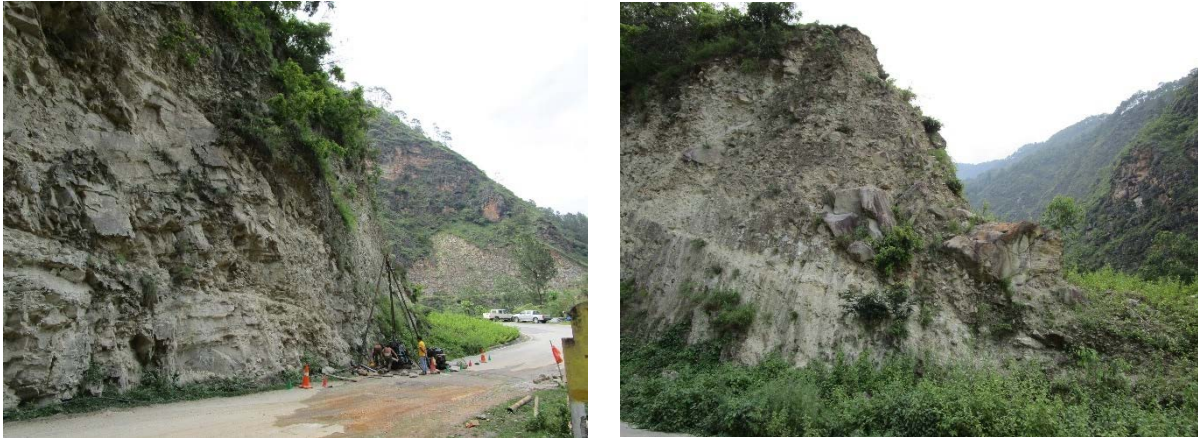
The left bank road slope exhibits areas where rocks (schist) are exposed, as shown in Figure 1-3-76, similar to the right bank side, along with sections of conglomerates containing large boulders. Moreover,

at the planned bridge location on the left bank, the exposed rock surfaces along the current road alignment show a gentle bedding structure.

Figure 1-3-76 Left side of Durdari Bridge

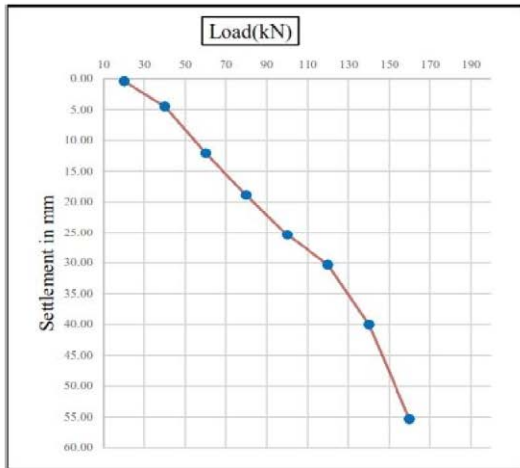
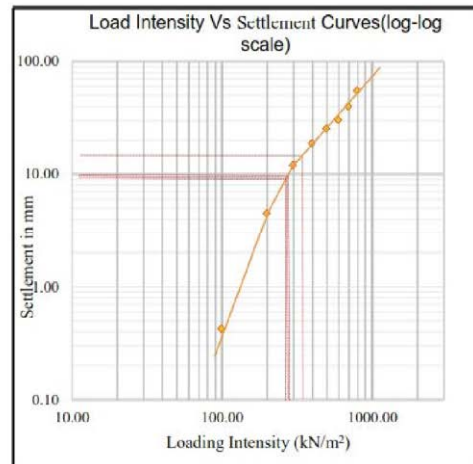
Figure 1-3-82 Relationship between Settlement S and Load Pressure P (Durdari Right side)

Here, at the 7th load increment ($P = 691.36 \text{ kN/m}^2$), the settlement (S) measures $S = 40 \text{ mm}$, surpassing the specified settlement criterion of 30mm for test termination, indicating adequate settlement. Moreover, considering the increasing settlement from the 6th load increment in both graphs, a decision is made to determine the load of the 6th stage ($P_u = 592.59 \text{ kN/m}^2$) as the ultimate bearing capacity.

Generally, when plotting the relationship between load and settlement on a log-log graph (log P - log S curve), a distinct inflection point often appears, which corresponds to the yield load (P_y). Here, based on the log P - log S curve shown in Figure 1-3-82, the yield load is determined as $P_y = 296.3 \text{ kN/m}^2$ at the point of inflection.

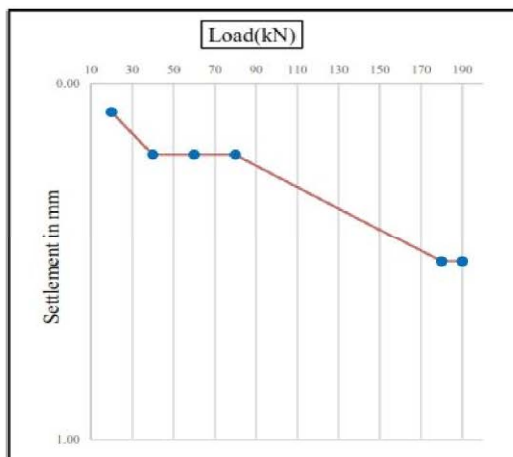
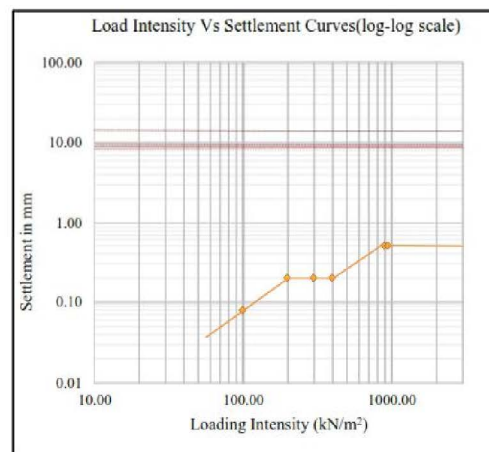
Figure 1-3-83 Relationship between Settlement S and Load Pressure P (Durdari Left side)

The result of the plate load test at Durdari Bridge's left bank are shown below. According to the tests, the final load was at $P = 938.27 \text{ kN/m}^2$, and the settlement observed was $S = 0.50 \text{ mm}$.

This settlement was minimal, indicating that within the applied range of load, the ultimate bearing capacity (P_u) had not been reached.

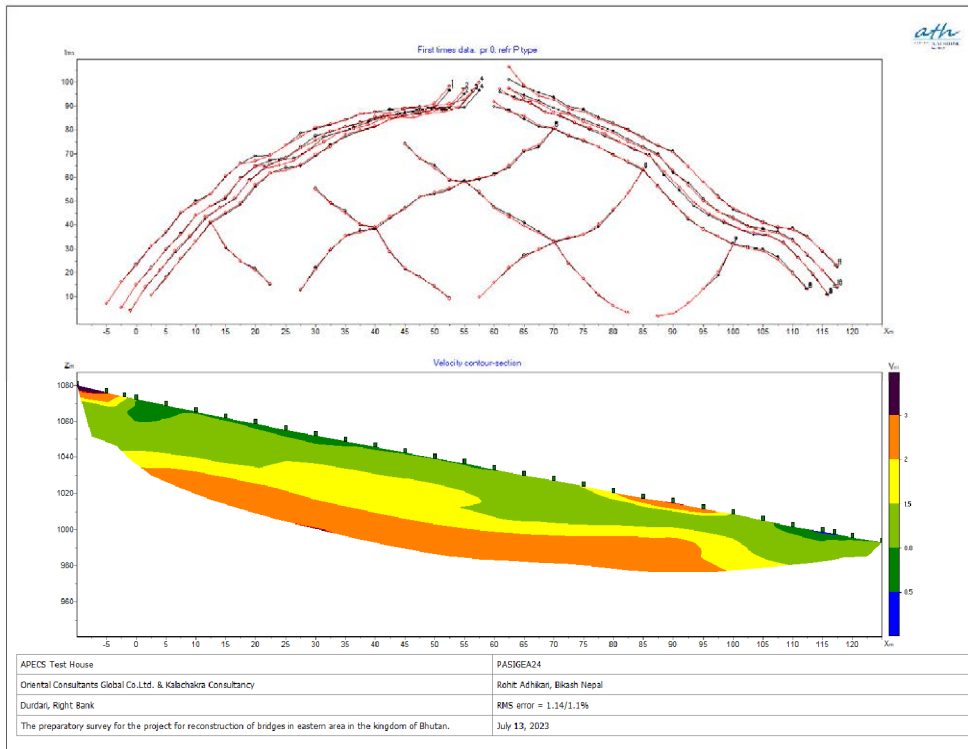
Figure 1-3-85 P wave Speed Distribution (Durdari Bridge Right hand slope)

The results of the seismic exploration on the slope at the right bank of the Durdari Bridge are presented below. This exploration was carried out laterally across the slope from the steep cliff, and the detected P-wave velocities ranged approximately between 800 to 1500m/s near the surface. According to the example provided in Figure 1-3-57, the rock quality is categorized at $V_p = 500\text{m/s}$ or more, coinciding with the emergence of a rock layer at the drilling point (BH-No.2) directly below the steep cliff. It indicates the presence of rock layers extending across the lateral direction of the slope. Moreover, there is an observed increase in the P-wave velocities with depth, suggesting a gradual hardening of the geological structure.

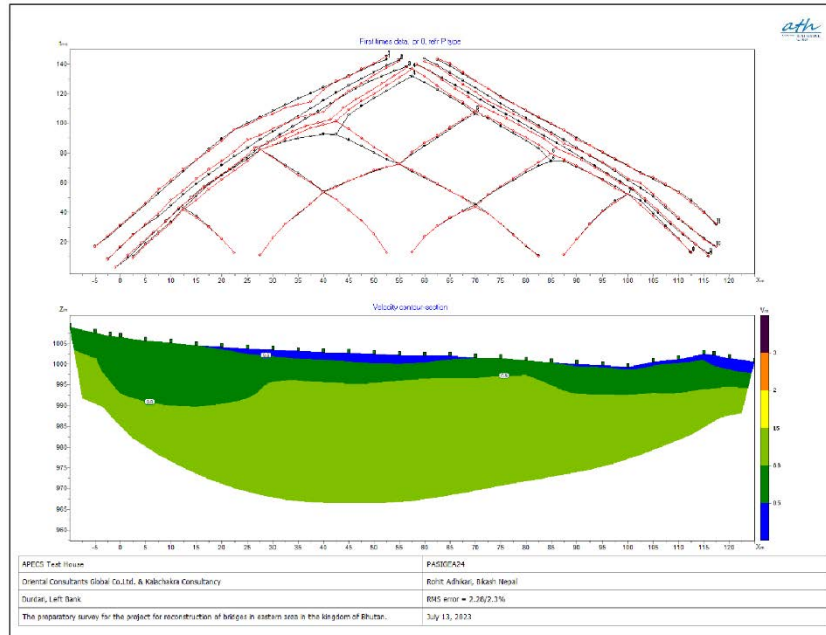
The results of the seismic exploration on the slope at the left bank of the Durdari Bridge are presented below. The examination showed relatively lower values ranging approximately between 500 to 800m/s near the surface, suggesting the possibility of a thick deposit of either debris layers or heavily weathered rock strata. However, considering that the exploration was conducted on a gentle slope on the back face of the steep cliff, it is presumed that the rock layer confirmed at the drilling point directly beneath the cliff (BH-No.4) is not distributed near the surface.

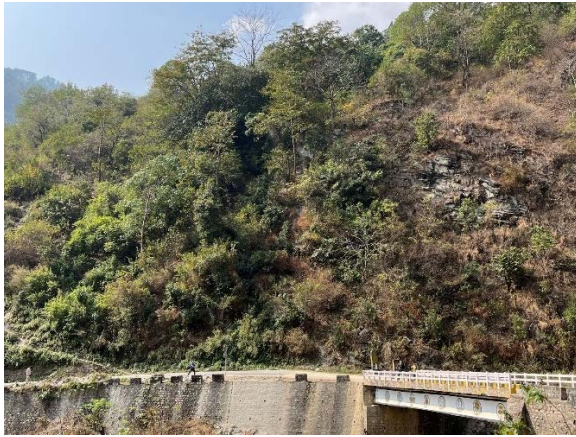
Right slope(Trashigang side)

The surrounding road situation is shown in Figure 1-4-8. Right side slope is relatively gentle, and there is a local path for residents to access to the cultivated land at the top of the area. The slope is lower than left side slope and covered with grasses and trees. Therefore, the risk of rock fall is relatively low. On the other hand, left side slope is steep and observed a deposit of debris. Therefore, the risk of landside is considerable during the rainy season.

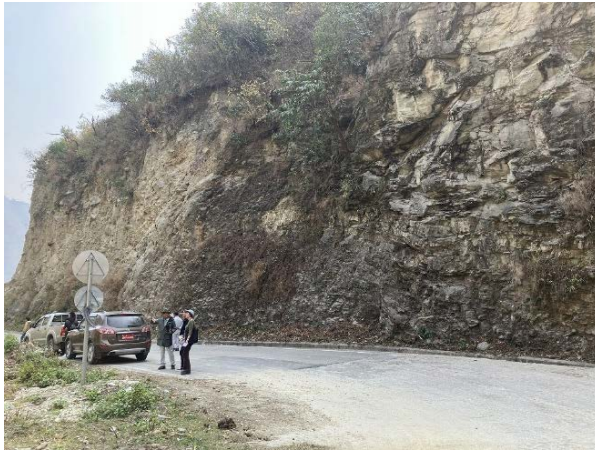
Right slope (Trashigang side)

The surrounding road situation is shown in Figure 1-4-11. Both right side and left side slope is steep, and coble and rock are exposed on the slope. Therefore, the risk of debris flow is considerable during the rainy season.

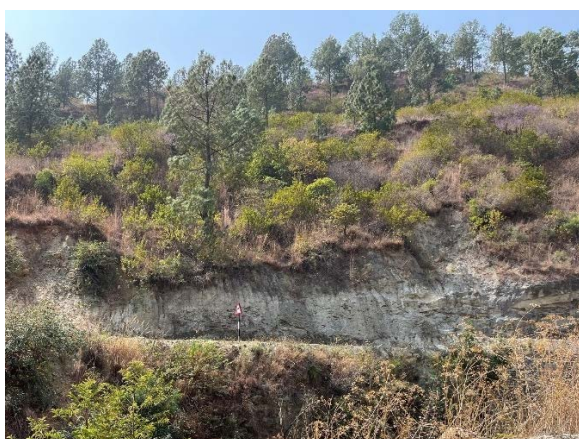
Right slope (Mongar side)

The surrounding road situation is shown in Figure 1-4-14. Rock is exposed to right slope, on the other hand, debris is exposed to left slope. Both slopes are steep and have the risk of rock fall.

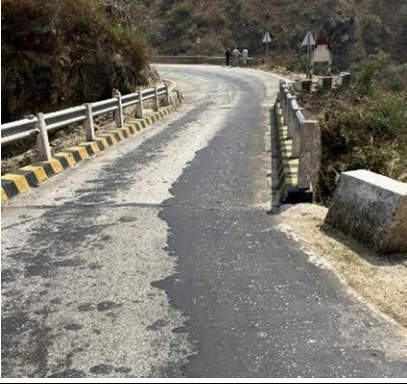
Bridge Name	Rollong Bridge	Road No.	PNH-1	
Site situation	Photo No. 1	From Mongar side	Photo No. 2	From Trashigang side

- Overall: Foundation is exposed by scouring (see inspection pic No. 1), but bridge length is short. Therefore, counter measure required is not complicated.
- Superstructure: Cover concrete at the deck bottom is pealed and rebar is exposed (see inspection pic No. 2).
- Substructure: Partial loss was observed (see inspection pic No. 3).
- Others: Expansion joint is damaged (see inspection pic No. 4).

Photograph									
Category	e	Type of Damage	Scouring	Pic.No.1	Category	d	Type of Damage	Rebar exposure	Pic.No.2

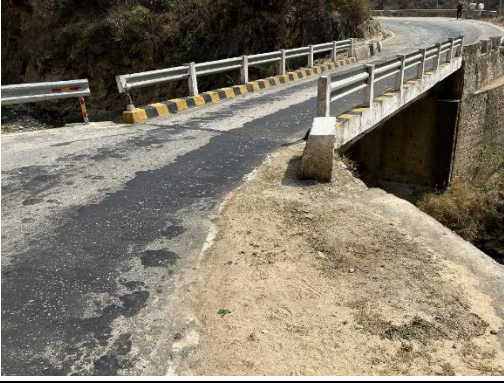
Photo No. 3	From Mongar downstream side	Photo No. 4	From Trashigang downstream side

Category	c	Type of Damage	Damage	Pic.No.3	Category	c	Type of Damage	Abnormity	Pic.No.4

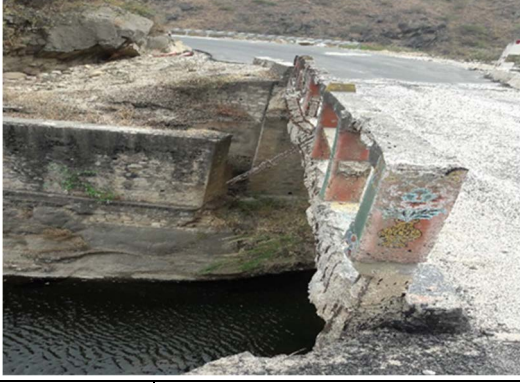
Photo No. 5	From Mongar upstream side	Photo No. 6	From Trashigang upstream side

Category	e	Type of Damage	Unevenness	Pic.No.5	Category		Type of Damage		Pic.No.6
