Republic of Türkiye
Data Collection Survey on Development
of Disaster Prevention Capability for
Railways in Türkiye
Final Report

May 2025

Japan International Cooperation Agency (JICA)

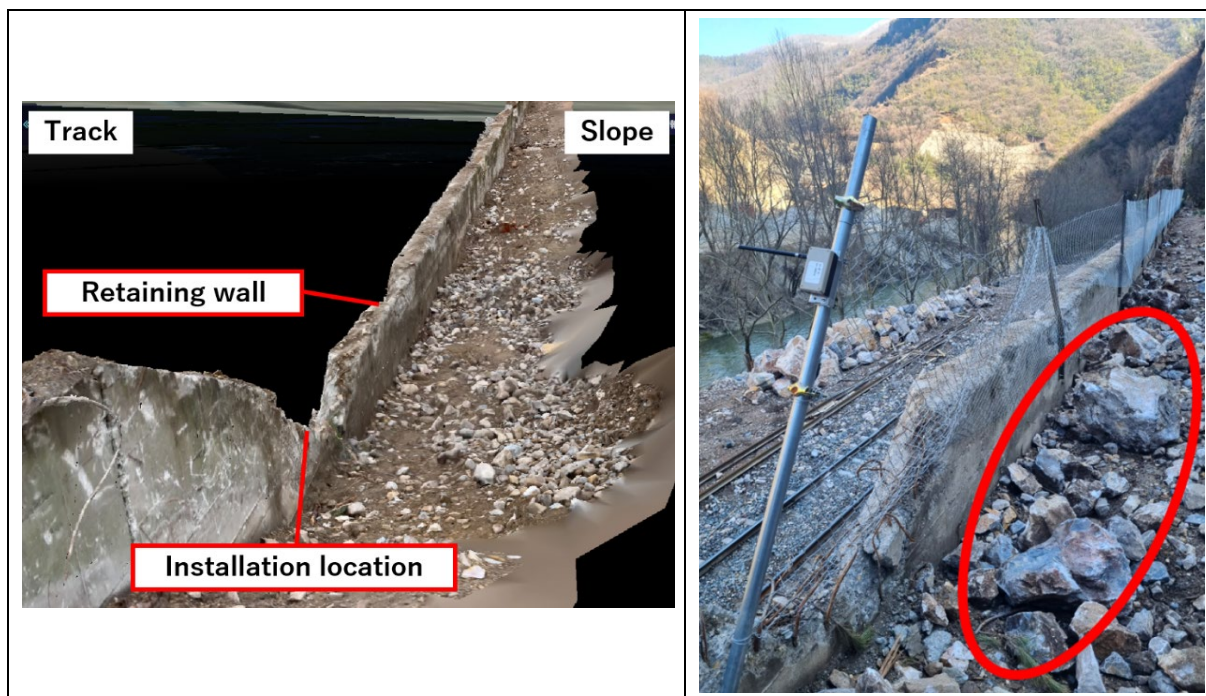
Figure 5 Before (Left) and After (Right) the Accident

At 23:40 (local time) on March 3rd, the accelerometer installed on the No. 6 rockfall detector detected a 22 degree inclination parallel to the track and 6 degrees outward from the track. As a result, there was no impact on the train, but the rockfall itself occurred, proving that the rockfall detection was functioning.

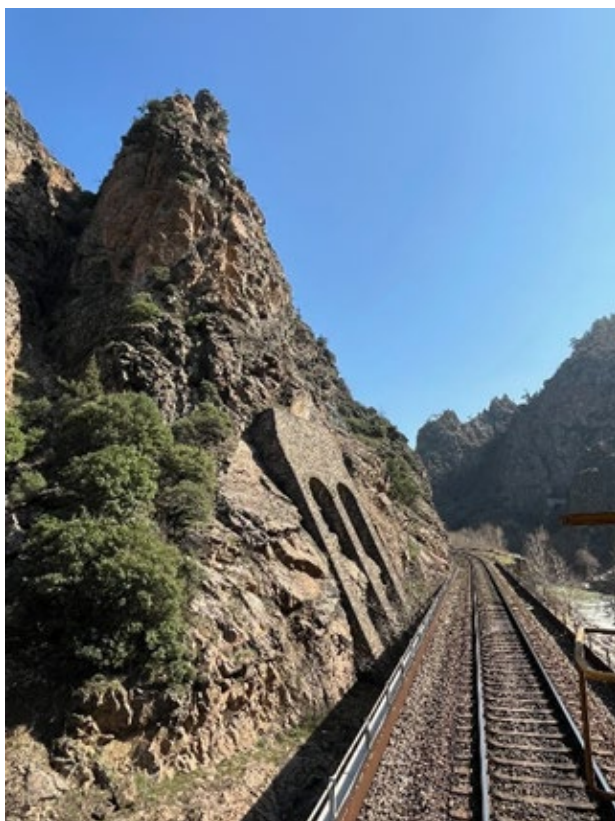
**Figure 2-8 Rock Fall Protection Wall
Constructed 100 Years Ago**

During the tour, it was confirmed that TCDD had implemented tangible countermeasures against falling rocks, such as rock fall protection retaining walls (Figure 2-8), which were initially constructed nearly 100 years ago, rock fall protection nets (Figure 2-9), and corrugated tunnels. Also, because the limited budget of TCDD limits its ability to take structural measures, it confirmed the possibility of taking non-structural measures, such as using sensors and railway disaster prevention system.

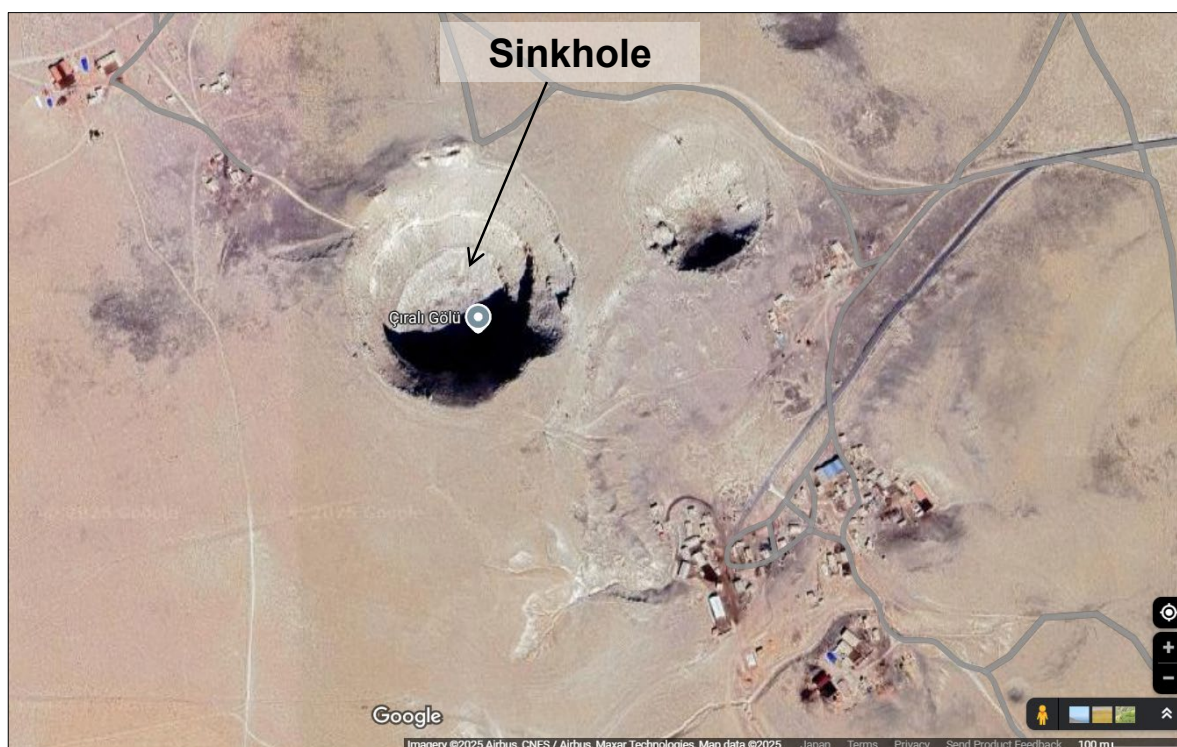
Figure 2-19 Example of Sinkhole in Karapınar District, Konya Province

At the time of the initial on-site survey and investigation in February 2024, the TCDD high-speed rail section around Konya and Karaman was not included in the target section for an on-site demonstration. In response to a subsequent request from TCDD, it was decided to conduct an on-site demonstration in the TCDD high-speed rail section where sinkholes have occurred in the surrounding area (Figure 2-19). Due to the occurrence of subsidence and cracks in the ground near TCDD high-speed rail tracks, TCDD is concerned that there is a risk of sinkholes occurrence along the railway line.

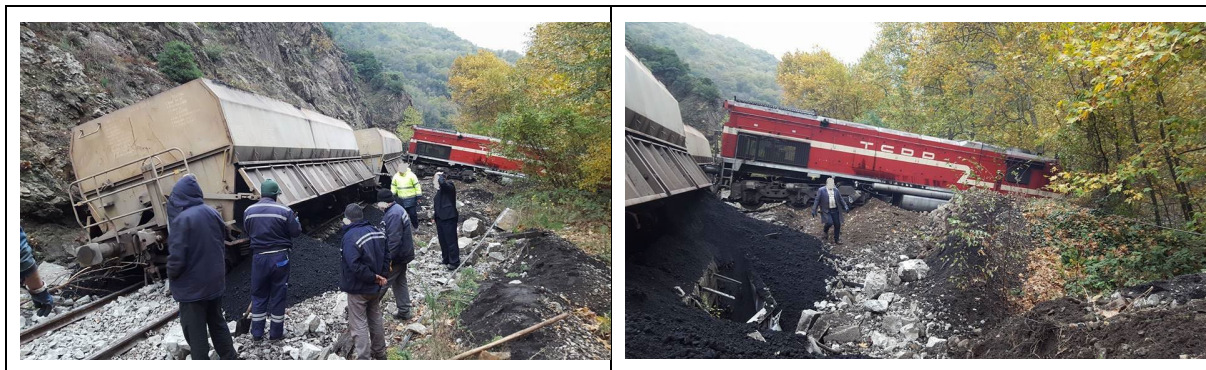
Figure 2-23 Damage to Railway Vehicles

- Injury/Loss of Life : No fatalities
- Damage/Loss in Infrastructure : 120,743.44 TL
- Damage/Loss to Vehicles and Cargo: 141 tons of coal (4 freight wagons derailed)

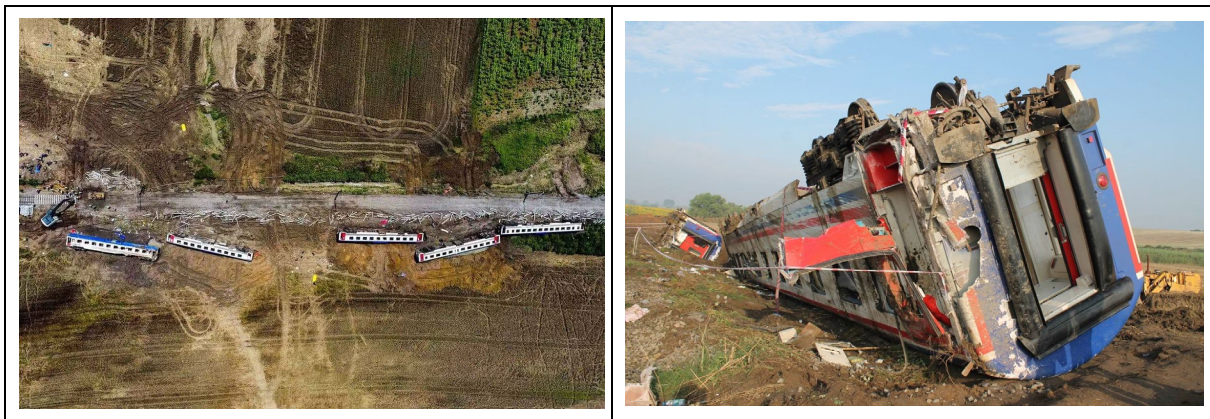
Figure 2-27 Post-Accident Situation

The train 12703, which was going from Uzunköprü to Halkalı (Istanbul), departed from Balabanlı station with 342 passengers. When approaching the 110 km/h accident site, the locomotive experienced a vertical jolt and passed the site. Then, the rear bogie of car 1 derailed, and cars 2 to 5 derailed completely and overturned. Moreover, after the derailment of the other cars, car 6 stopped on a tilt at a 45-degree angle (Figure 2-27).

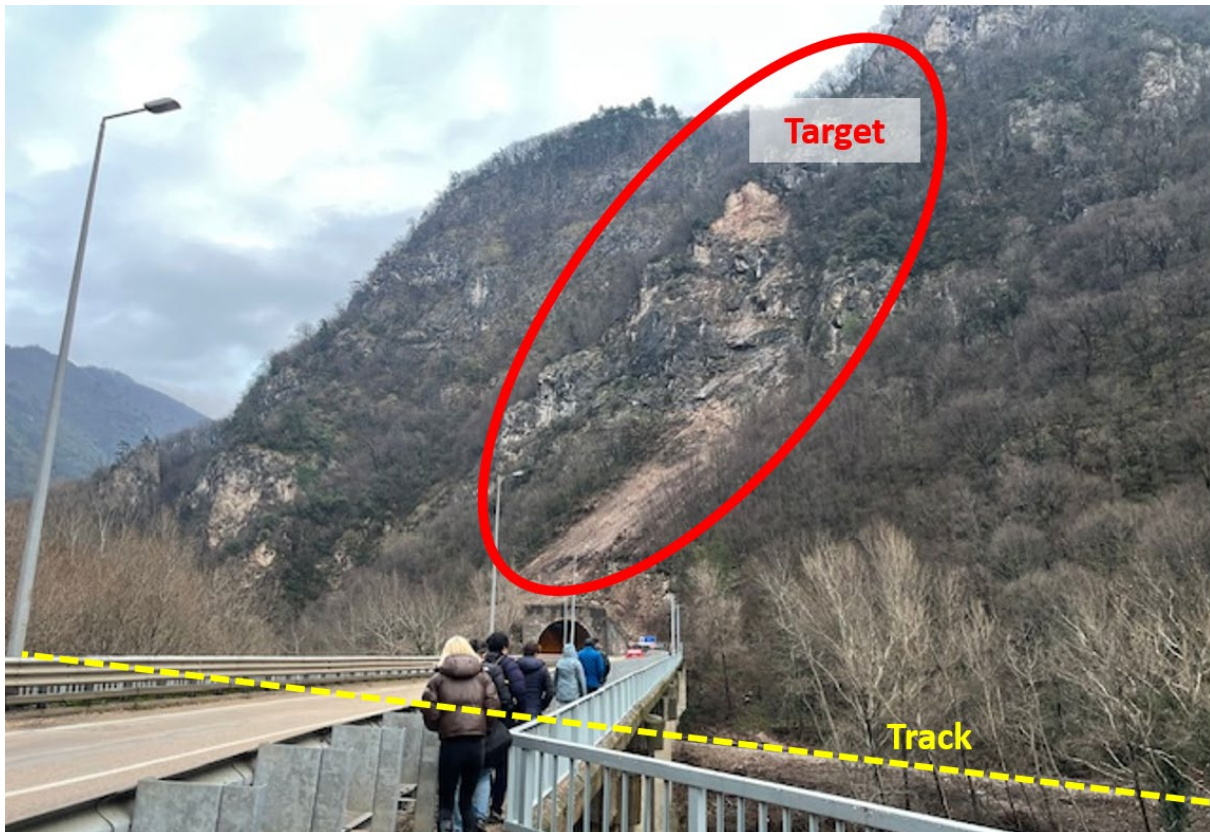
Figure 4-7 Target Rock Slope

The affected area experienced a rockfall in November 2024, and as a countermeasure, all trains passing through the area are required to stop and slow down. The rock face itself remains unstable, posing a high risk of rockfalls, and effective countermeasures must be implemented. Currently, only regular patrols are conducted by inspectors, and constant monitoring using monitoring equipment is required to ensure safety.

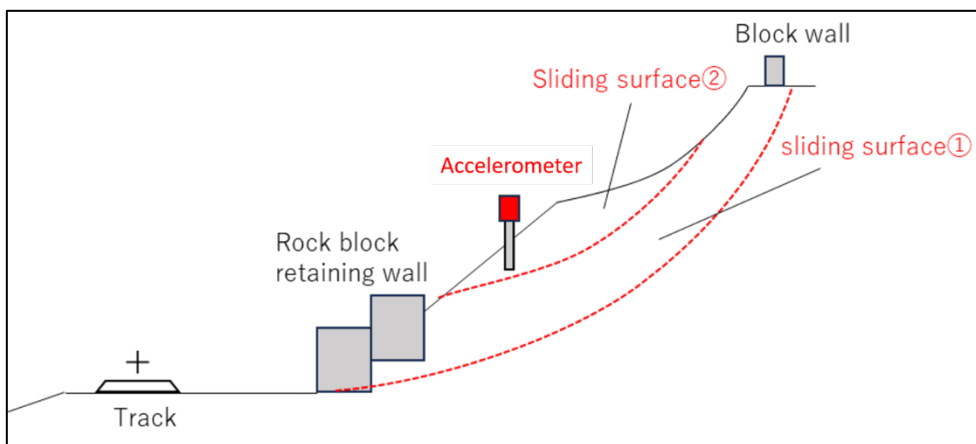
Figure 4-8 Expected Slip Surface

The affected area experienced a landslide in 2020, and as a countermeasure, slope shaping and stone retaining wall construction have been implemented, but these measures are insufficient and there is still a high risk of slope collapse, making slope monitoring necessary. Currently, only periodic patrols are carried out by inspectors, but the installation of monitoring equipment will enable constant monitoring.

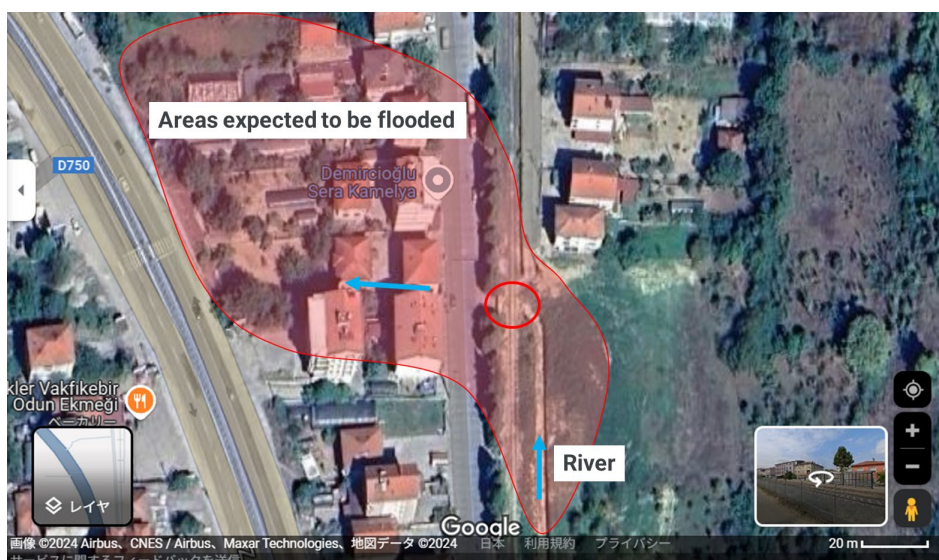
Figure 4-9 Expected Area of Flooding

The affected area experienced large-scale flooding in 2022, which resulted in train service suspension. Currently, the area relies on reports from residents, and no concrete measures have been put in place. There is no way to observe if flooding occurs at night, so monitoring is necessary. If a train enters a flooded area, there is a risk of derailment or vehicle failure.

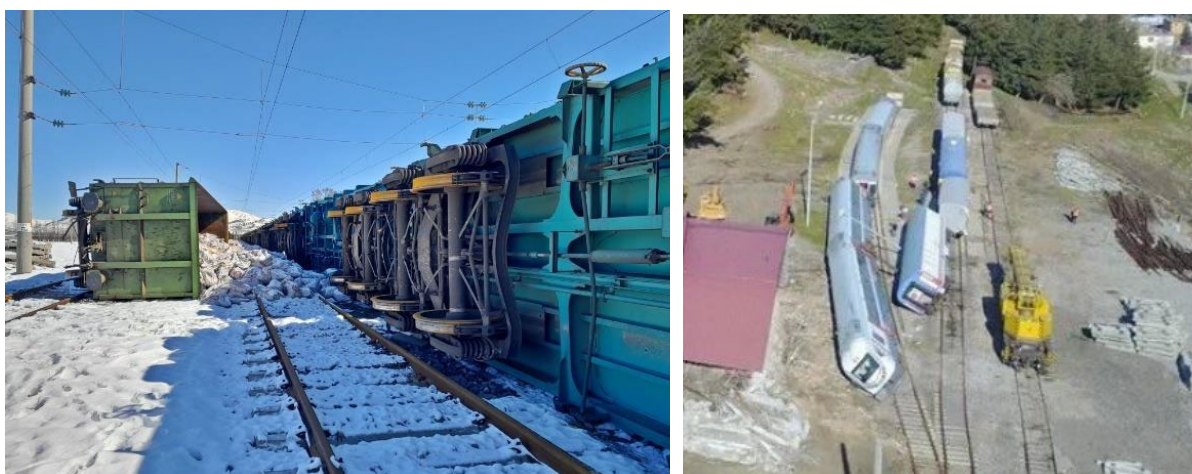
Figure 6-2 Derailment Due to the Earthquake (Left: Gölbaşı Station, Right: Fevzipasa Station)

Derailment of rolling stock included one passenger train, four locomotives, and 30 freight wagons. All of these vehicles were owned by TCDD Transport. Damage was also observed on high-speed rail lines that were under construction. The table below summarizes the earthquake damage to the rail network (Table 6-1).

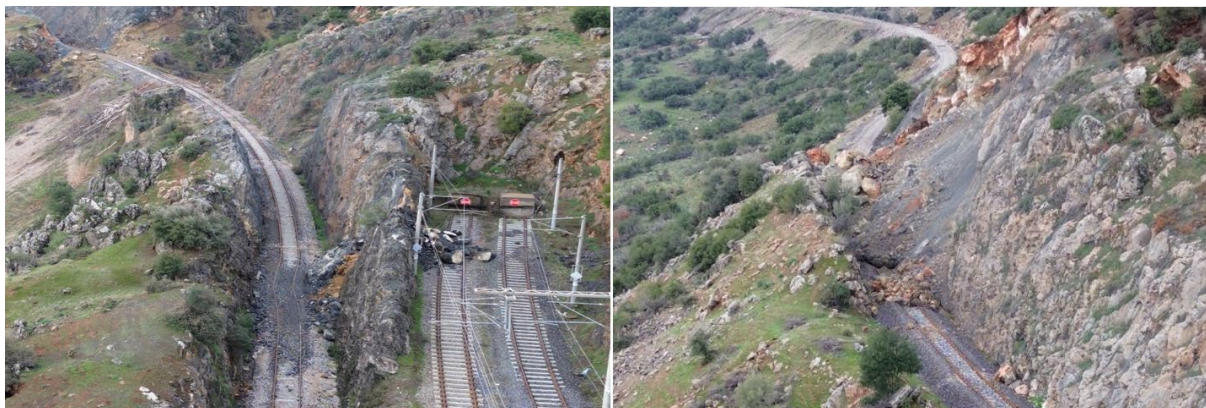
Figure 6-3 Landslides and Rock Fall Near Fevzipasa Station

The earthquake motion, liquefaction, ground cracks, ground deformation, rock falls, and slope hazards were the cause of damage to railway destruction and derailments.

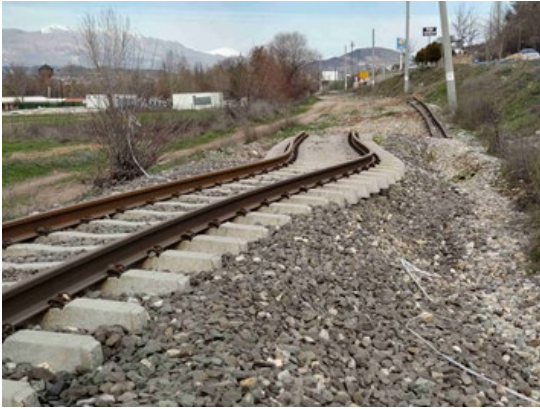
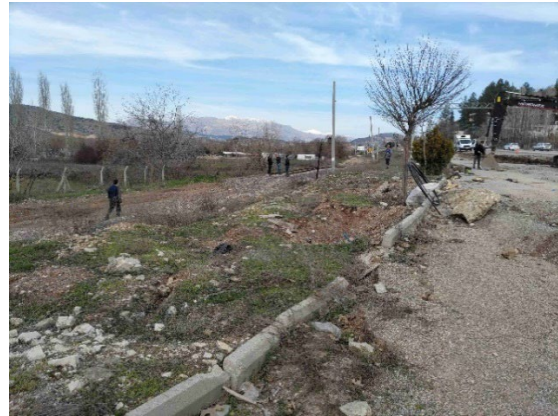
Figure 6-10 Large Deformed Track Near Gölbaşı Station

In the survey conducted in May 2023, damage around the Gölbaşı station was observed as a lowering of the ballast due to roadbed subsidence and cavities under the sleepers. Several areas where the track had been deformed significantly and overhung were observed toward the end of the station. The high groundwater level around the station, traces of liquefaction, and the large curvature of the track due to the settlement of the roadside structure and displacement to the railway side suggest that the cause of the damage around Gölbaşı Station was the occurrence of lateral flow due to liquefaction.

In this survey, the track around Gölbaşı Station had only been removed, and no significant restoration work had been done. A heavily deformed track section was preserved on the Malatya side of the station (Figure 6-10).

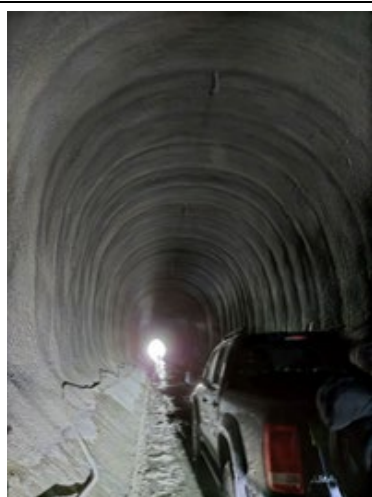
Figure 6-13 NATM Section

At the time of this survey, the tunnel restoration work had just been completed. The section on the starting point of the tunnel was excavated without a lining and had not been damaged by the earthquake. The middle part of the tunnel was being restored using the NATM (Figure 6-13 to Figure 6-14). Because fore-poling was performed on the outer upper part of the original cross section, the excavated area of the tunnel was increased from the original tunnel.

The cross-section of the NATM is an encompassing section of the original tunnel cross-section. Fore-poling is used for excavation to prevent collapse of the upper section. In order to fore-pole the upper section without a face, excavation faces of holes for poling are provided at intervals of 4.5 m. In addition, the rear of the excavation face needs to be excavated so that steel rods can be inserted, so the cross section repeatedly expands and contracts at 4.5 m intervals in the direction of the rail, requiring six different heights of supports. The end of the tunnel was constructed using the open-cut method, and the cross section was even larger than that of the NATM section.

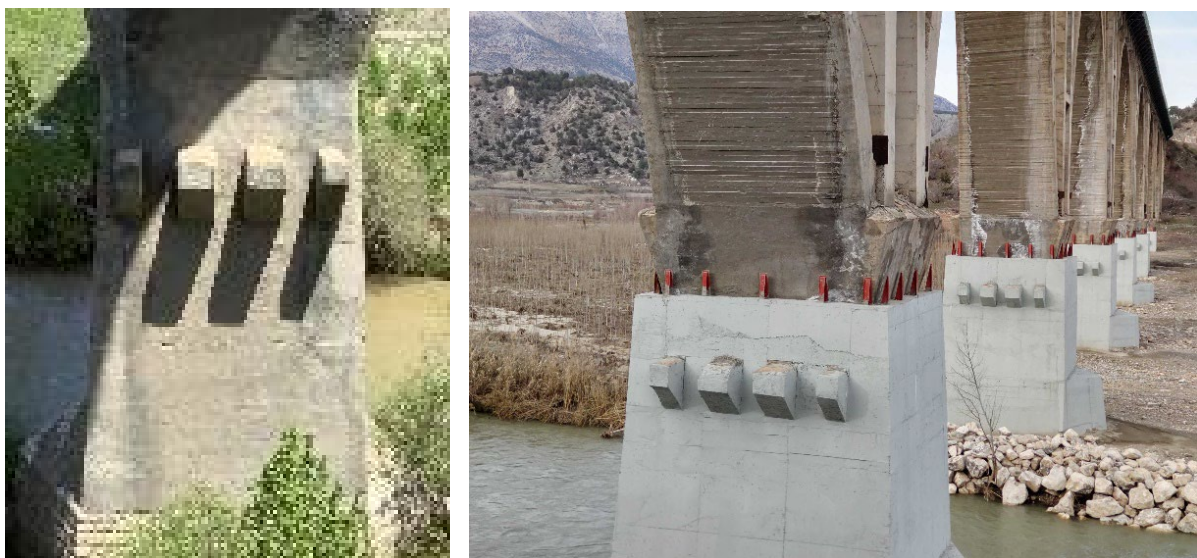
Figure 6-18 View of Pier C (Left: Before Restoration, Right: After Restoration)

<p>Cracks and chips in the piers causing the cross-sectional load capacity to become insufficient</p>	<p>Vertical and eccentric axial forces acted on the arch base, causing cracks in the unreinforced structure.</p>	<p>Wrapping unreinforced concrete column bases with RC</p>
<p>Earth structure</p>

The restoration work was performed using the RC wrapping method, which was a common proposal on both the Turkish and Japanese sides. The concrete was placed by press-in, but cracks were noticeable on the surface.

Since there was no connection between the piers and the superstructure, the survey team had advised the Turkish side to consider how to deal with horizontal displacement of the superstructure at the time of the May 2023 survey, but as a result of the Turkish side's investigation, metal fittings were installed in the RC wrapping.

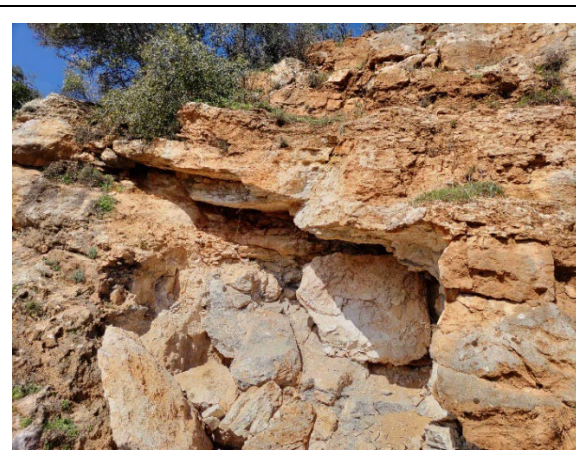
Figure 6-23 Accelerated Weathering by Plant Roots

At the site, there were various types of rock falls depending on the location (Figure 6-23 and Figure 6-246), and they were having trouble selecting countermeasures using structures, mainly box tunnels with RC structures, corrugated tunnels, a method of covering the slope with a net (Figure 6-25), and protective fences. JST asked for provision of the slope management maps that were necessary for the selection of countermeasures in place. The TCDD answered that they have the map, but JST was not able to examine the actual maps.

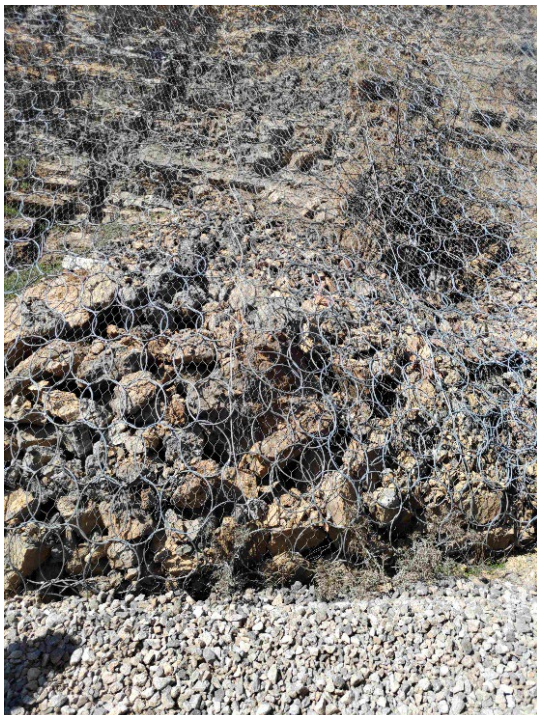
Figure 6-25 Rock Fall Prevention Net

The diameter is small, but the frequency of falling rocks is high

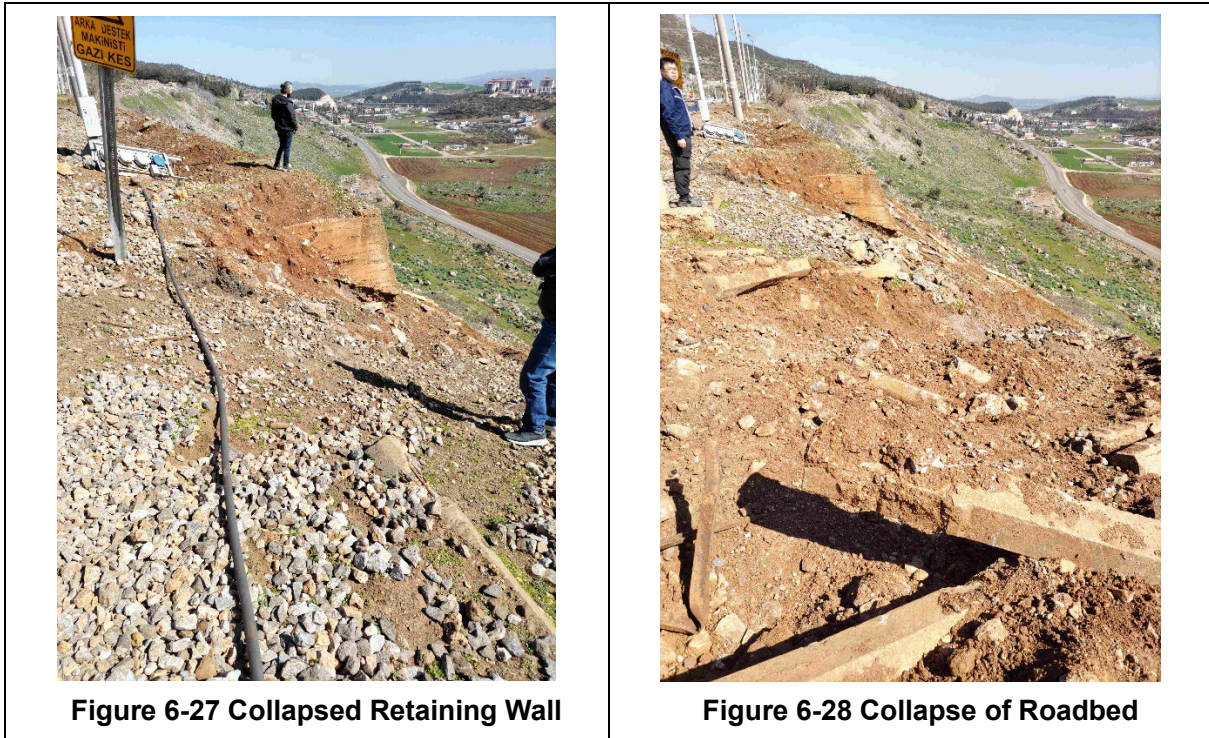
At the northern end of the 3 km section, a slope collapse was observed on the southeast-facing slope on the southwest side of the Fevzipaşa Station premises, and it appears that the retaining wall collapsed (Figure 6-27). TCDD reported that this was a major landslide and that there may be deep cracks beneath the slope at Fevzipaşa.

TCDD is considering a design to resist slope collapse by driving piles into the slope, but the site above-mentioned is at the top of a very high slope, and it seems that there are problems with the construction plan.

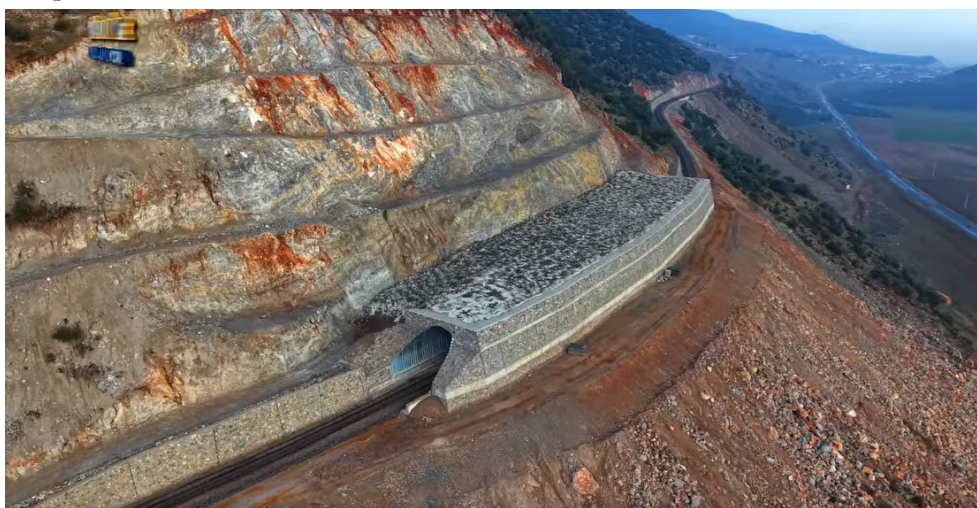
Figure 6-32 Rockfall Protection Using Corrugated Tunnel

It appears that TCDD adopted corrugated tunnels as the basis for their rockfall protection facilities (Figure 6-32). In the corrugated tunnel shown in Figure 6-32, the valley-side retaining wall seen in Figure 6-21 has not been constructed, and it appears that the backfill material of reinforced soil has been raised. Comparing it with the rockfall protection facility in Figure 6-20, it can be seen that the specifications have been greatly improved. On the mountain side of the rock shed, the surface weathering layer has been removed and flat areas have been set on the slope to absorb the energy of falling rocks as they fall. On the left side of the photo, the rockfall protection retaining wall and ditch work (rockfall pocket) have been constructed, and it appears that the surface weathering layer has been

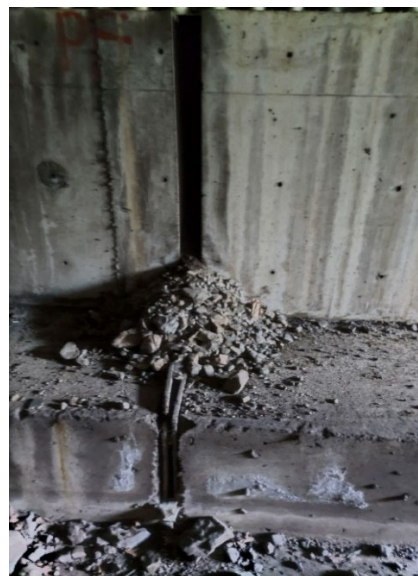
Figure 6-35 Gravel has spilled into the tunnel

TCDD has adopted corrugated plate arch rock sheds as a rockfall protection structure (Figure 6-20). A corrugated arch rock-shed has been constructed between Karabük and Zonguldak. It was constructed in 2019, and there have been no major rockfalls since then, but the gravel at the top, which acts as a buffer, has been washed away by water flow, and gravel has spilled into the tunnel (Figure 6-34, Figure 6-35). The biggest problem is the lack of adequate surrounding soil pressure and ground springs, and even a small rockfall could cause significant deformation. In the design of the restoration work this time, a reverse L-shaped retaining wall or earth retaining wall was placed on the valley side of the rockfall protection structure. Since it was impossible to obtain the design calculation sheet for the corrugated plate arch culvert from TCDD, a simple framework analysis was used to perform a simple investigation of the deformation of the structure and the energy of the rockfall.

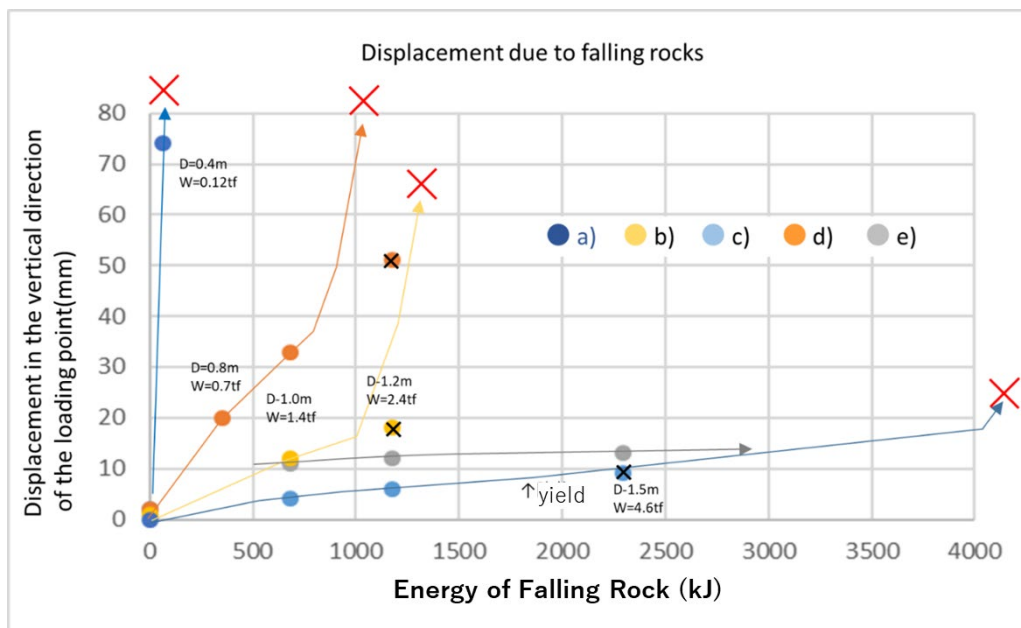
Figure 6-44 Displacement of Structures Due to Falling Rocks

a height of 50m (with an energy of around 62 kJ) would cause a displacement of 70mm and reach the ultimate bending moment (Figure 6-44).

This is the case where the track is at the bottom of a valley and forms a complete tunnel. This is a situation that makes the most of the characteristics of corrugated arch culverts. Backfill soil (thickness 0.8m) is placed on top of the corrugated arch, and on top of that is a concrete drainage layer (thickness 0.20m) and a buffer material of sand (1m). It was thought that the load would be dispersed from the bottom of the buffer material sand and transmitted to the arch culvert. It was also thought that a 1.2m diameter falling rock would cause compressive stress to exceed the limit, resulting in excessive displacement (Figure 6-44).

In Case d), it was only able to withstand a falling rock energy of around 700 kJ, but with the three-layer buffer material, it will be possible to handle a falling rock energy of up to 2000 kJ, so it is thought that there will be significant benefits in applying it to the corrugated arch rock sheds currently under construction (Figure 6-44).

JST attempted to compare corrugated plate arch tunnel rock sheds with RC rock sheds. The RC rock shed in c) can be adjusted to withstand the expected falling rocks by changing the thickness of the components and the amount of steel reinforcement, and it is also possible to withstand up to 10,000 kJ of energy, as shown in Figure 6-44. On the other hand, corrugated plate arch tunnel rock sheds can only withstand a maximum of 1,000kJ of falling rock energy, which is 1/10 of that of RC tunnel type rock sheds, and there is also a possibility that the rock shed will suddenly deform greatly.

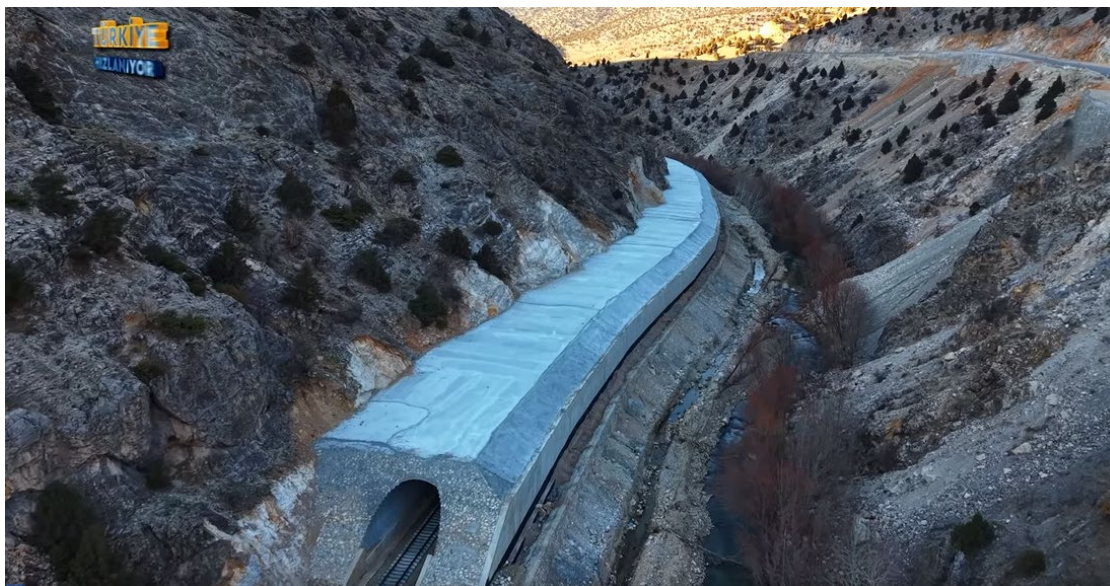
Figure 6-45 Completed Corrugated Tunnel

According to the TCDD video, the construction of the corrugated steel sheet tunnel appears to be in accordance with the plans, but the distance to the valley side retaining wall appears to be larger than the design (Figure 6-45). Figure 6-46 shows the construction in progress.
