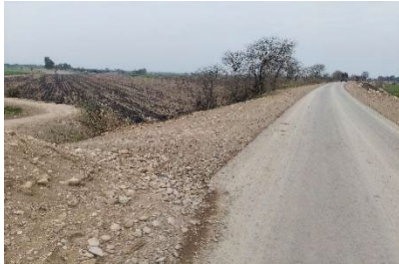
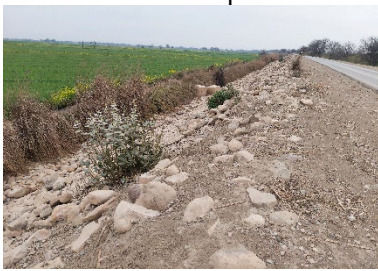
| Observation Record ⁴ (Current status, effect of countermeasure, development of erosion, deformation, deterioration) | | | |
|---|---|---|---|
| 25/2/2024 | Visual Inspection | <ul style="list-style-type: none"> • Main river creek is located approximately 3 km from this location. • Metaled road runs along on top of Link bund • Cultivated area is observed on both sides of the bund <p>Metaled road on top of Link bund</p> <p>Cultivated area is present around the bund</p> | a |

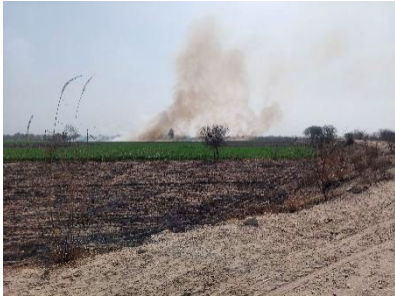
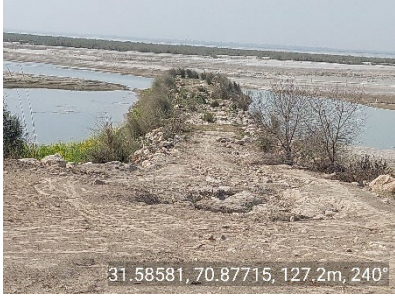
| Observation Record ⁴ (Current status, effect of countermeasure, development of erosion, deformation, deterioration) | | | |
|---|---|---|---|
| 23/2/2024 | Visual Inspection | <ul style="list-style-type: none"> • River is Approximately 3 km away from the bund. • Cultivated area is observed on the country side. • Bottom level is Approximately 20 feet below the top level. • Between RD 73+000 to 74+000, there were 4 solid stone studs (non-vulnerable). This area is now silted, and the river has shifted away from the bund. <p>Cultivated area is present on the country side</p> <p>Solid stone stud can be observed at RD 73+000</p> | a |

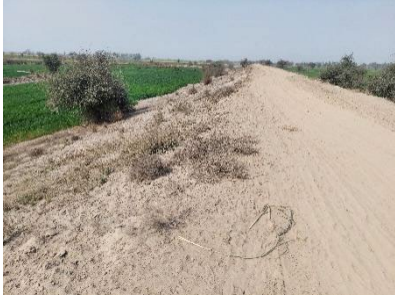
| Observation Record ⁴ (Current status, effect of countermeasure, development of erosion, deformation, deterioration) | | | |
|---|---|--|---|
| 23/2/2024 | Visual Inspection | <ul style="list-style-type: none"> • River is situated approximately 3 km away from the bund. • Cultivated area is present on the country side. • Bottom level is approximately 20 feet below the top level. <p>Cultivated area is present on the country side</p> | A |

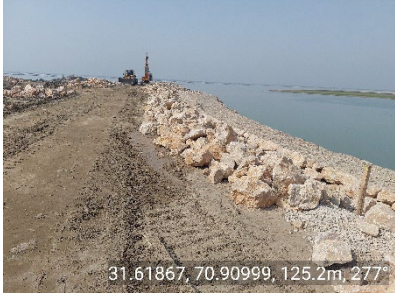
| Observation Record ⁴ (Current status, effect of countermeasure, development of erosion, deformation, deterioration) | | | |
|---|---|---|---|
| 22/2/2024 | Visual Inspection | <ul style="list-style-type: none"> • 35000 cusecs discharge is observed along this spur Restoration of the stone pitching and apron is underway on both sides of the spur. • The trend of river is towards this spur. <p>31.61867, 70.90999, 125.2m, 277°</p> <p>Rehabilitation work in progress at site</p> | a |

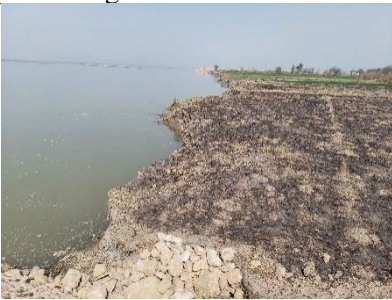
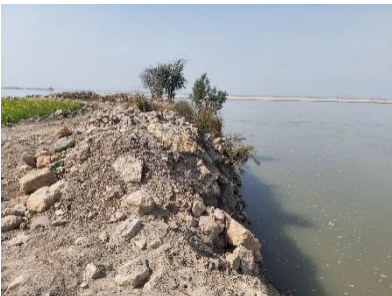
| Observation Record ⁴ (Current status, effect of countermeasure, development of erosion, deformation, deterioration) | | | |
|---|---|---|---|
| 22/2/2024 | Visual Inspection | <ul style="list-style-type: none"> Turbulent flow is observed near the solid stone inverted hockey stud at RD 60+250 (31°36.70 N, 70° 54.80 E). Turbulent flow is observed near the mole head spur at RD 60+700 (31°36.281 N, 70° 54.237 E). Extreme turbulent flow and erosion were observed at newly constructed solid stone studs (construction completed in 2023) at RD 62+500 (31°36.014 N, 70° 54.051 E) and RD 63+000 (31°35.96 N, 70°54.00 E) respectively. However, due to drifting of the river towards left side, these studs were under direct hit of the river. Apron and nose of inverted hockey stud at RD 63+700 (31°35.883 N, 70°53.866 E) were observed damaged. Also, Extreme turbulent flow and erosion observed at this stud. J-Head Spur (5462 feet length) at RD 70 +000 (31°35.810 N, 70°52.966 E) has also been under extreme turbulent flow and severe erosion. 2 newly constructed small studs at RD 34+05 and RD 39+05 of J-Head Spur also under extreme erosion (nose damaged). Apron, nose and stone pitching of the J-Head Spur at RD 70+000 also damaged. The estimate of which (187 Million) is under approval stage. | c |
| | | <p>Erosive action at RD 62+500</p> | |

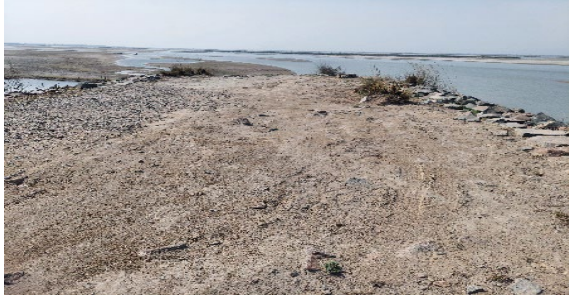
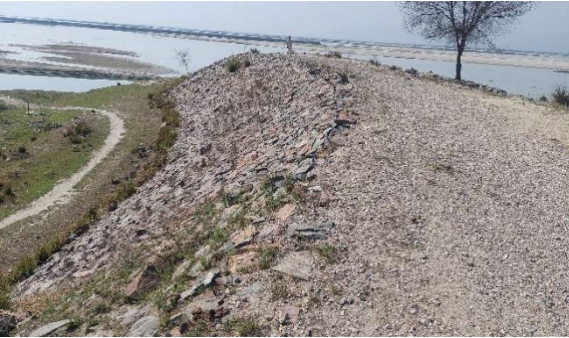
| Observation Record ⁴ (Current status, effect of countermeasure, development of erosion, deformation, deterioration) | | | |
|---|---|--|---|
| 21/2/2024 | Visual Inspection | <ul style="list-style-type: none"> • Reserve stock of stones is located near Village Daggar Noon, approximately one km away from the Stud. • River bed is observed on both sides of the stud. • Stone pitching is present on river side. • A 409 feet curved portion of stone pitching is observed on both sides. <p>River bed observed on either side of the stud</p> <p>Stone pitched side slopes observed on either side</p> | a |

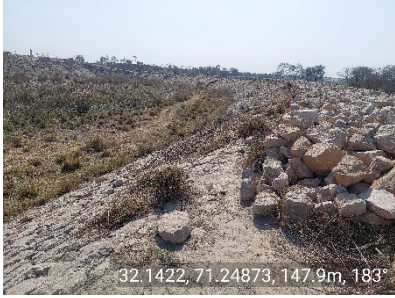
| Observation Record ⁴ (Current status, effect of countermeasure, development of erosion, deformation, deterioration) | | | |
|---|---|---|---|
| 21/2/2024 | Visual Inspection | <ul style="list-style-type: none"> • 100 % reserve stock of stones is distributed along the entire length of J-Head Spur. • Ravi village is located a approximately 300 meters situated away from the Spur. • Cultivated area has been observed on country side. <p>Reserve stone stock on top of bund and cropped area of country side</p> | a |

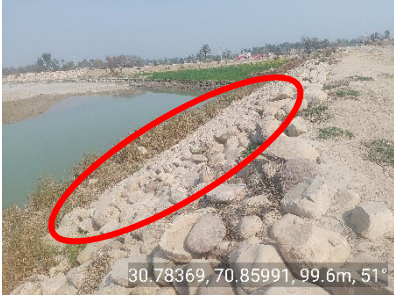
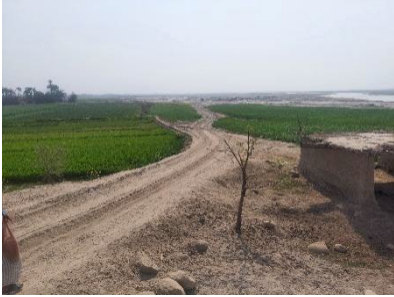
| Observation Record ⁴ (Current status, effect of countermeasure, development of erosion, deformation, deterioration) | | | |
|---|---|--|---|
| 24/2/2024 | Visual Inspection | <ul style="list-style-type: none"> • Apron of the sloping spur is directly hit by the small creek of the river. • Nose portion is also damaged due to erosion. • Cultivated area are observed downstream of the river around the spur. <p>Apron of the sloping spur is under direct impact of the small creek of river</p> <p>Cultivated area is observed in the downstream of the river</p> | c |

| Province | Zone | Division | Circle |
|---|--|---|---|
| Reason for the Vulnerability | <ul style="list-style-type: none"> The entire reach is directly impacted by the small river creek, which usually becomes active during low floods. Stud number 2 is completely damaged, while other studs are partly damaged due to stones settlement. | | |

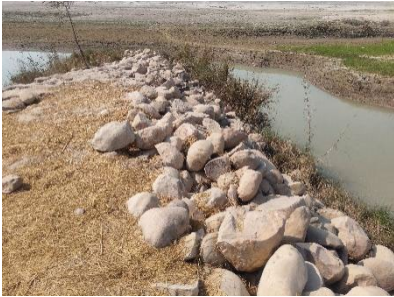
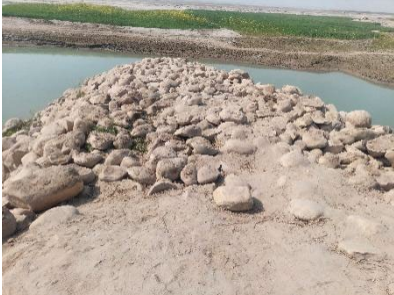
| Observation Record ⁴ (Current status, effect of countermeasure, development of erosion, deformation, deterioration) | | | |
|---|---|---|---|
| 24/2/2024 | Visual Inspection | <ul style="list-style-type: none"> • Stud Number 2 is completely damaged due to Stone settlement • Stud Number 1, 3, and 4 are partially damaged. • Active turbulent flow is observed along either side of the studs. <p>Damaged stone Stud No. 02</p> <p>Partially damaged stone Stud No. 01</p> | c |

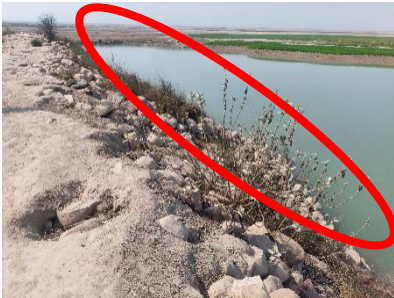
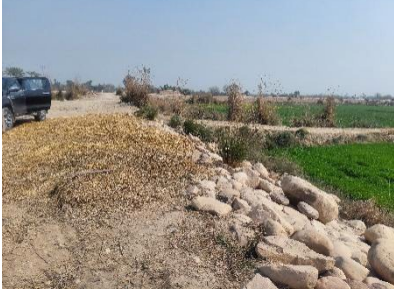
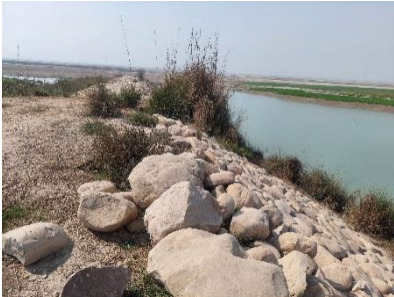
| Observation Record ⁴ (Current status, effect of countermeasure, development of erosion, deformation, deterioration) | | | |
|---|---|---|---|
| 24/2/2024 | Visual Inspection | <ul style="list-style-type: none"> • Apron of the sloping spur is under direct impact of the small creek of river. • Nose portion is damaged due to erosion. • Cultivated area is observed in the downstream of the river around the spur. • A pit/pond observed on the upstream side of the spur. <p>Apron of the spur found damaged</p> <p>Cultivated area is observed in the downstream of the river</p> <p>A pit pond observed on the upstream side of the spur</p> | c |

| Province | Zone | Division | Circle |
|---|---|---|---|
| Reason for the Vulnerability | <ul style="list-style-type: none"> Apron of the J-Head Spur is directly impacted by the river, with continuous erosion occurring around the spur. Apron is damaged from RD 7+633 to RD 9+002. Nose portion is also completely damaged due to continuous erosion. | | |

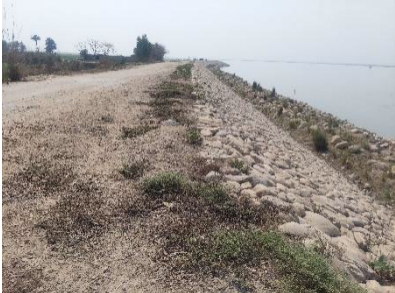
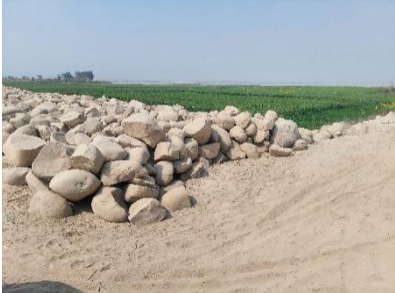
| Observation Record ⁴ (Current status, effect of countermeasure, development of erosion, deformation, deterioration) | | | |
|---|---|---|---|
| 24/2/2024 | Visual Inspection | <ul style="list-style-type: none"> • A reserve stock of stones is present along the entire length of J-Head Spur. • The trend of the river is directly towards the J-Head Spur. Extreme turbulent flow observed. • Apron of the J-Head Spur is under direct hit of the river and continuous erosion occurring around the spur. • Nose portion is completely damaged due to continuous erosion. • Cultivated area is observed in the river bed around the mole head portion. <p>Reserve stock of stones present throughout the length of J-Head Spur</p> <p>Damaged apron of the spur</p> <p>Cultivated area is observed in the river bed around the mole head portion.</p> | c |

| Province | Zone | Division | Circle |
|---|---|---|---|
| Reason for the Vulnerability | <ul style="list-style-type: none"> • X Spur at RD 60 +000 of Shah Wala Groyne Apron and stone pitching damaged over a length of 180 feet. • X Spur at RD 62+000 of Shah Wala Groyne; slope, nose portion upstream, and downstream apron and pitching portion damaged in 2023 flood. | | |

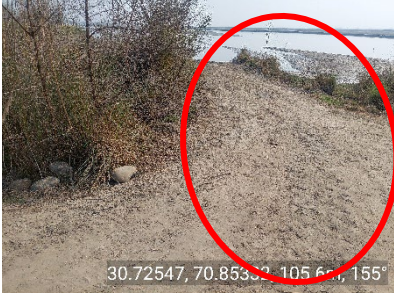
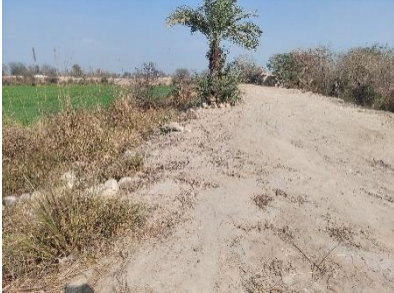
| Observation Record ⁴ (Current status, effect of countermeasure, development of erosion, deformation, deterioration) | | | |
|---|---|--|---|
| 24/2/2024 | Visual Inspection | <ul style="list-style-type: none"> • Cultivated area is observed on the country side of this reach. • Main river directly impacts the spurs in this reach. • Extreme turbulent flow is observed. <p>Nose portion lower than the shank portion</p> <p>Cultivated area is observed on the country side</p> | c |

| Province | Zone | Division | Circle |
|---|--|---|---|
| Reason for the Vulnerability | <ul style="list-style-type: none"> • Apron is damaged during 2024 at the time of inspection. • River directly hits the spur in this reach. | | |

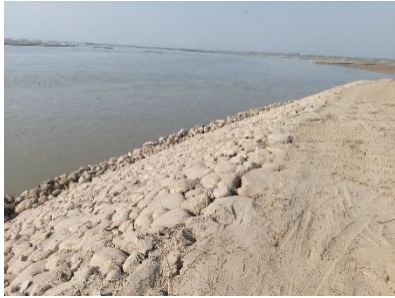
| Observation Record ⁴ (Current status, effect of countermeasure, development of erosion, deformation, deterioration) | | | |
|---|---|--|---|
| 24/2/2024 | Visual Inspection | <ul style="list-style-type: none"> • Village is approximately one km away from the spur. • Cultivated area is observed on the country side. • Main river is directly impacting the spur. • Extreme turbulent flow is observed. <p>Cultivated area is observed on the country side</p> <p>Main river directly impacting the spur</p> | c |

| Province | Zone | Division | Circle |
|---|---|---|---|
| Reason for the Vulnerability | <ul style="list-style-type: none"> Inverted hockey spur is directly impacted by the river, with continuous erosion occurring around the spur. 480 feet apron of solid stone portion plus nose portion is damaged. | | |

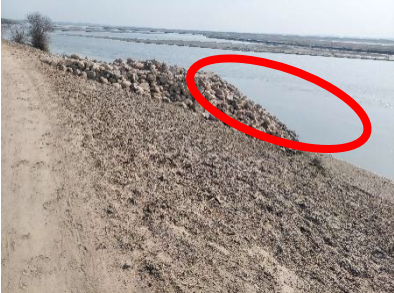
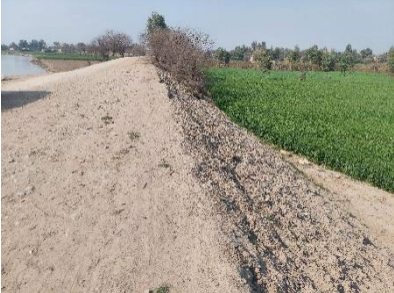
| Observation Record ⁴ (Current status, effect of countermeasure, development of erosion, deformation, deterioration) | | | |
|---|---|--|---|
| 24/2/2024 | Visual Inspection | <ul style="list-style-type: none"> • Cultivated area is observed on the country side of this reach. • Main River directly impacts the studs, causing repeated damage. • Extreme turbulent flow is observed. <p>Damaged stone stud</p> <p>Cropped area observed on the country side</p> | c |

| Province | Zone | Division | Circle |
|---|--|---|---|
| Reason for the Vulnerability | <ul style="list-style-type: none"> • Inverted Hockey Spur is directly impacted by the river, with continuous erosion occurring around the spur. • 480 feet apron of solid stone portion, along s with the nose portion is damaged. • Four solid stone studs in between RD 4+400 to RD 5+700 of protection bund is directly hit by the main river. | | |

| Basic Information of the Bund | | | |
|---|---|---|---|
| 2024 | A proposal for the restoration of the studs, apron, and solid stone portion damage has been submitted for approval. | Rs. 153 Million | Maintenance and repair works of PID |

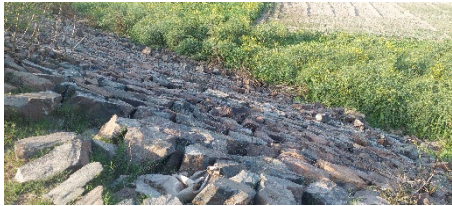
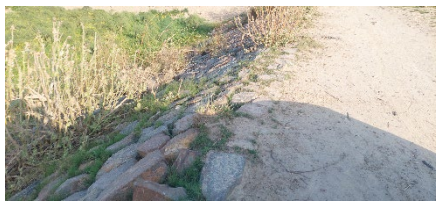
| | <p>Facing Downstream Side</p> | <p>Facing Upstream Side</p> |

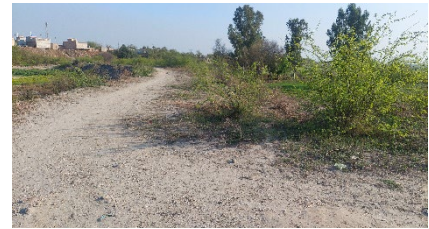
| | <p>Facing Downstream Side</p> | <p>Facing Upstream Side</p> |

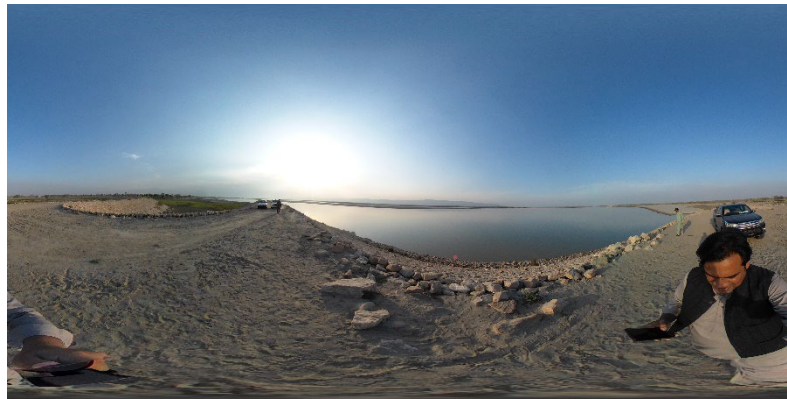
Photo with 360° angles

Apron found damaged at the nose of the spur

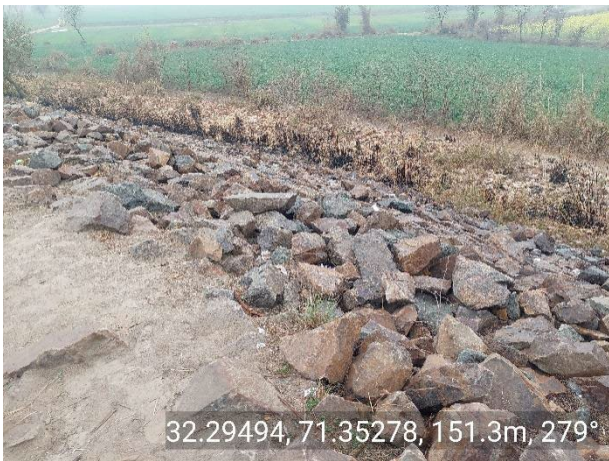
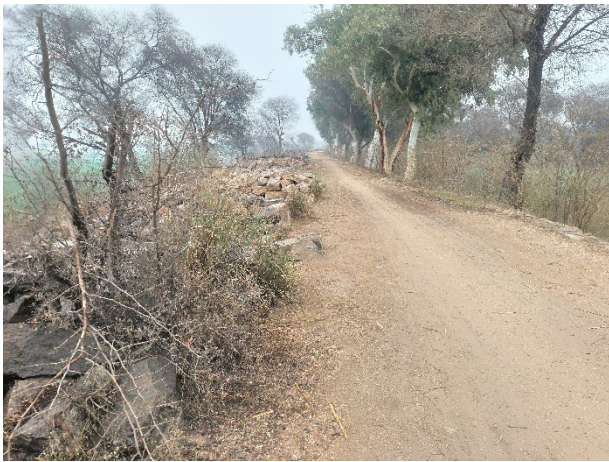
| Observation Record ⁴ (Current status, effect of countermeasure, development of erosion, deformation, deterioration) | | | |
|---|---|---|---|
| 19/2/2024 | Visual Inspection | <ul style="list-style-type: none"> • Cultivated area is observed on both sides of the spur. • Reserve stock of stones was present on the river side of the bund. <p>32.29494, 71.35278, 151.3m, 279°</p> <p>Cultivated area is observed</p> <p>Reserve stock of stone on top of the bund</p> | a |
