**Ministry of Agriculture and Animal Resource  
The Republic of Rwanda**

**STUDY REPORT  
ON  
THE PREPARATORY STUDY FOR  
FORMULATION OF THE PROGRAM  
FOR  
RURAL DEVELOPMENT IN EASTERN  
PROVINCE  
IN  
THE REPUBLIC OF RWANDA  
(IRRIGATED AGRICULTURE)**

**JAPAN INTERNATIONAL COOPERATION AGENCY**

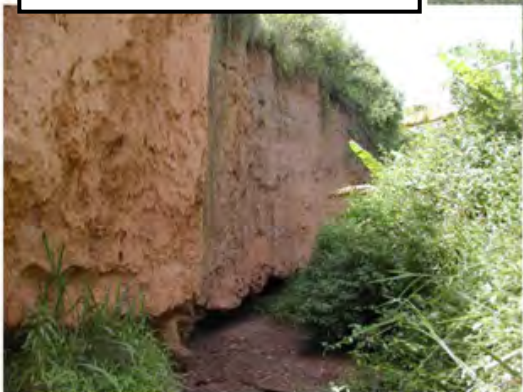
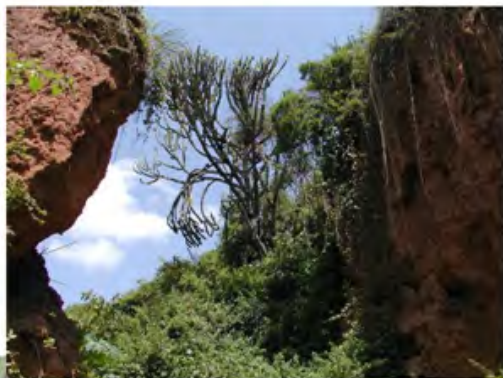
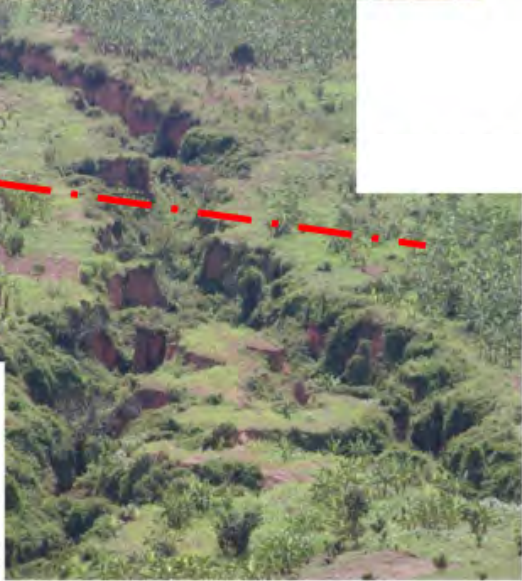
Gulley of Gatsibo 31 Rugarama

The wall of the gulley

As many as 3 gullies with having steep mountain at the back join together at around the requested site and flows down further as a single gully. Being gullies, the both banks are of bluff ones and the cross section is not suitable for any dam construction. The difference of elevations between the flat bank ground and the river bed surface (No water flow but sand and gravel can be seen.) is observed at about 15 m and if the flat ground of both banks be used as reservoir area, then the dam height should exceed

15 m at the minimum. There found some low ridges stretched over both banks and if fix the dam axis to contact with those ridges, dam construction might be possible but careful attention shall be paid on the possible difference in subsidence on the part of dam body inside the gully and the transition part to connect with the dam body of flat ground on the bank.

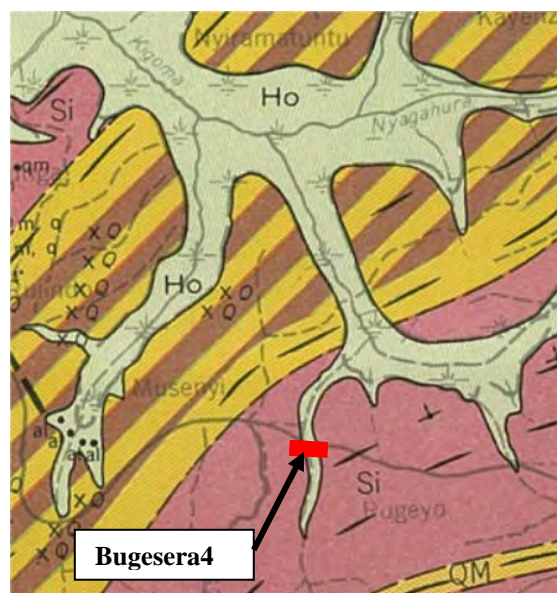
Figure 2.1.11 Geological Map of Bugesera4

The base rock foundation in general is of pre-Cambrian and in and around the site is covered by metamorphic rocks predominantly consisting of mica-schist including quartz. On the slopes of both banks of reservoir, there found outcrops of mica-schist and the same is highly weathered. These rocks form sloped foundation both to up and down stream directions and is considered that the same indicate both joint and surface of discontinuity. The rocks are featured by quartz vein crossing the mother rock and are hydro-thermally altered. The mother rocks are widely covered by residual silt and highly weathered up to considerable depth.

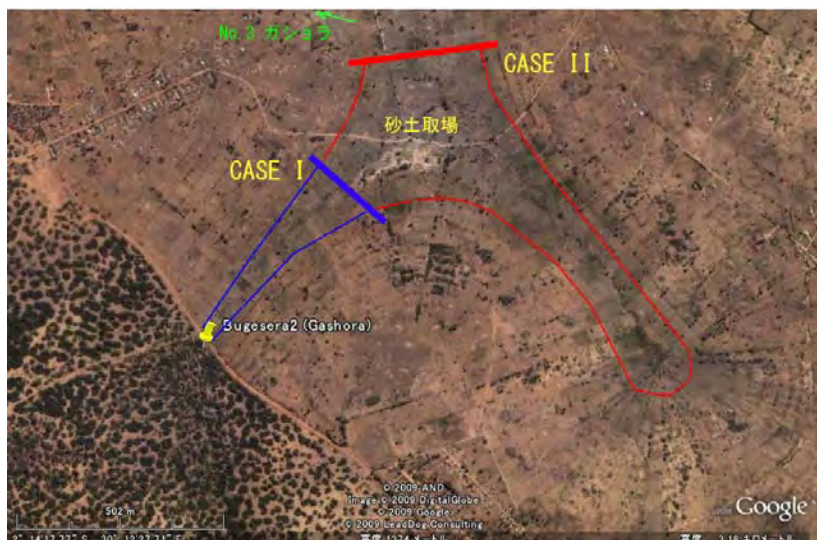
Figure 2.1.13 Location of Bugesera 2 Case I and Case II

There has been a request that for this planning the storage capacity of reservoir be fixed as large as

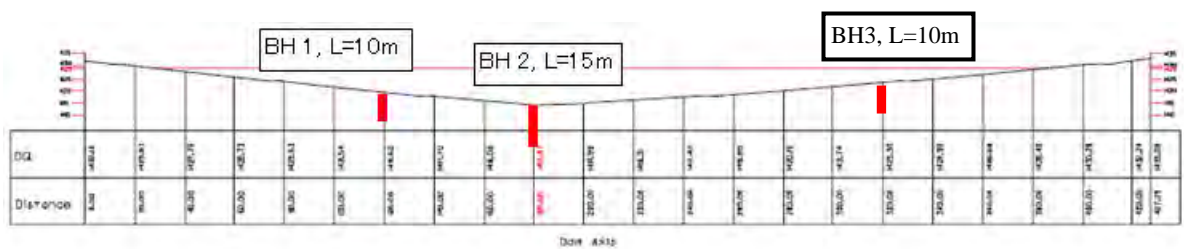
Figure 2.1.26 Location of Borehole at Ngoma21

BH 1: From the surface to the depth of 7.5 m, silty clay in reddish brown color. Between the depth 7.5-10 m, color changes to yellowish gray being silty clay mixed with gravel. N-value 5 for 0-1.5 m, 12 for 3 m, 8 for 4.5 m 21 for 7 m and 54 for 9 m. (As per the test pit observation, below the ground surface there found clayey silt and sand mixed with gravel being different from the result of boring survey.)

It is judged that if N-value of clayey soil is 12 at 3 m depth, there is no problem on the safety as the foundation for the homogeneous dam with 16 m dam height.

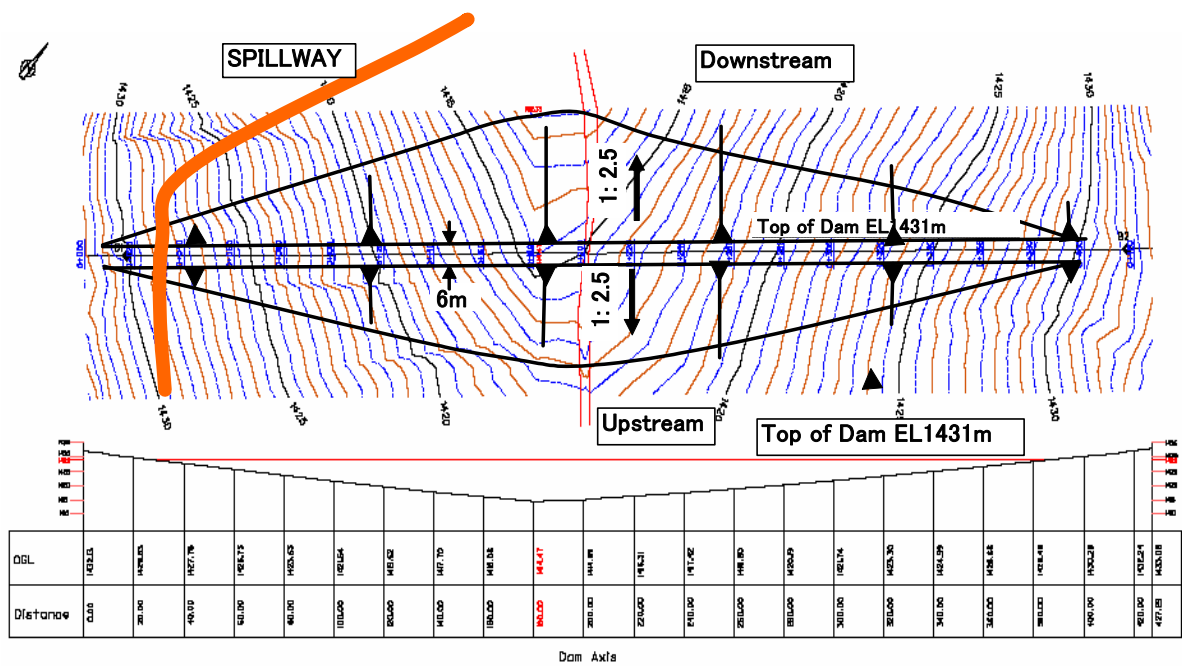
Figure 2.1.27 Ngoma21 Longitudinal Section and Plan

The following Figure shows the longitudinal section and plan of dam axis as assumed as the most probable under the present study result.

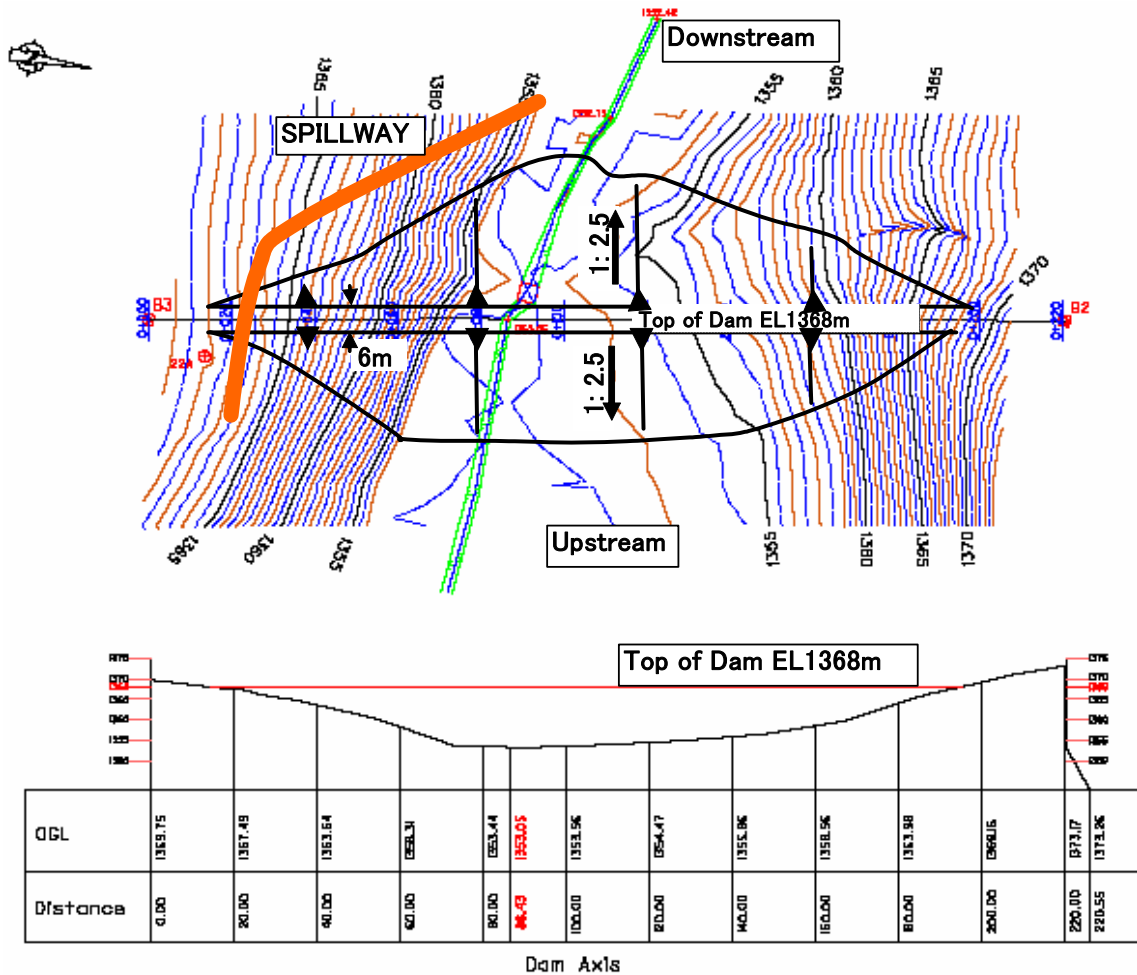
Figure 2.1.30 Ngoma22 Longitudinal section and Plan

The following Figure shows the longitudinal section and plan of dam axis as assumed as most probable under the present study.

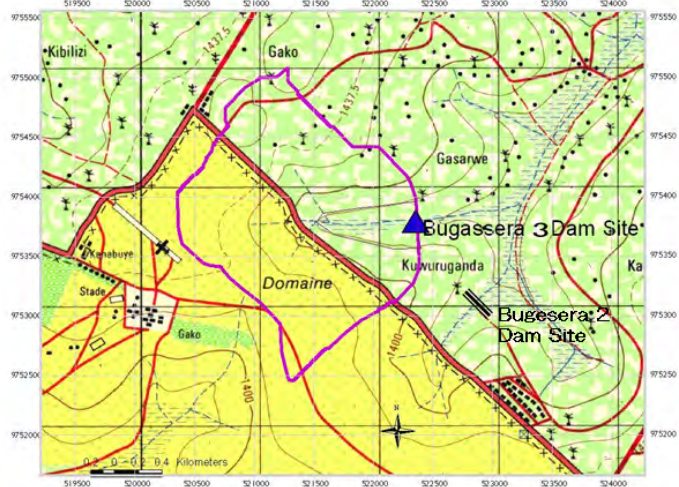
Figure 2.1.37 Location of Bugesera3 during initial stage

As shown in the Figure 2.1.37, original location of Bugesera 3 dam axis, the catchment area includes forest-covered military area and those hilly areas in and around, and the full water level is so decided that the stored water would not reach to the military area. From the result of topographic survey conducted afterward, when fixing the full water level as high as possible within the limit not affecting to the military area, the dam height might exceed 20 m due to the low elevation of river bed. Therefore the idea was changed to fix the full water level to secure the beneficiary area first and moved the dam axis up, calculate the storage capacity and as the result 16.2 m of dam height was obtained, as assumed by the study team. In comparison with Bugesera 2, Bugesera 3 is featured with steeper river bed slope as well as the steeper topographic gradient of both banks.

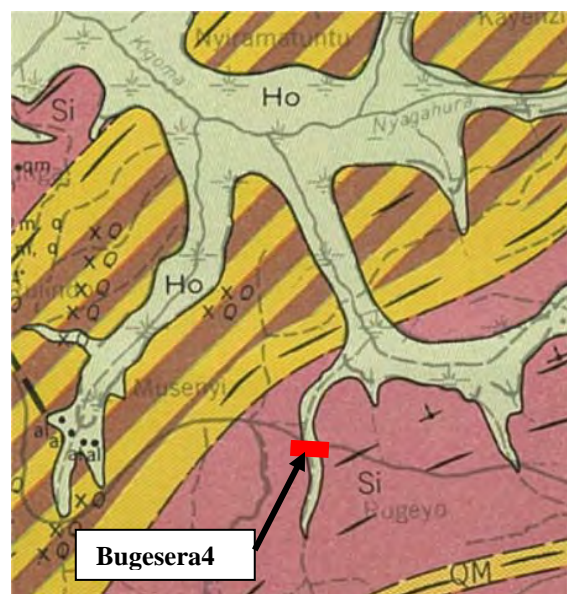
Figure 2.1.45 Geological Map of Bugesera4

The base rock foundation in general is of pre-Cambrian and in and around the site is covered by metamorphic rocks predominantly consisting of mica-schist including quartz. On the slopes of both banks of reservoir, there found outcrops of mica-schist and the same is highly weathered. These rocks form sloped foundation both to up and down stream directions and is considered that the same indicate both joint and surface of discontinuity. The rocks are featured by quartz vein crossing the mother rock and are hydro-thermally altered. The mother rocks are widely covered by residual silt and highly weathered up to considerable depth.

The valley portion is covered by dark-brown color and

non-organic silty clay with about 4 m thickness. The both banks are covered by thick silt/sand layer derived from the weathered base rocks. Geology at the upstream of spillway is of highly-medium weathered rocks and the layer is measured at about 5 m in thickness.

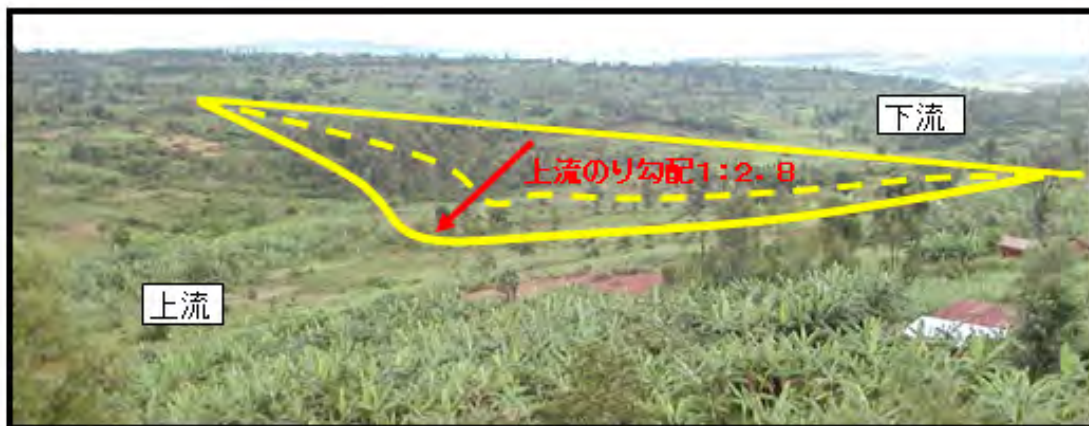
Figure 2.1.51 Image of completed dam body

6) Image of completed dam body

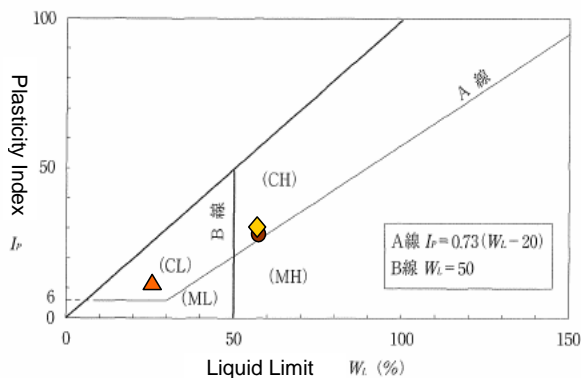
Figure 2.1.57 Soil Test Result Ngoma21 (1)

0.3m-1m	1m-3m	3m-5m
Liquid Limit	34.2	57.7	57.6
Plasticity Index	14.5	28.4	28.7
Symbol	▲	●	◆
Classification	CL	CH	CH
	Clay	Clay	Clay

The materials tested on both right and left banks showed the similar result and can be used as impervious material except those from the river bed.
