Appendix 12.1 Geology evaluation of the most promising site Maha 3 (geology survey (phase 2))

In this Appendix are detailed the result the Geology survey (phase 2) and the evaluation made by JICA Study team on the geology over the Maha 3 site.

The major interest in the geology survey in this Study (Development Planning on Optimal Power Generation for Peak Demand in Sri Lanka) is to 1) conduct the investigation which contributes to the selection of the most promising site from all listed candidates, and 2) reveal the geology features and risks lying in the candidate sites, and above all, most likely in the most promising site Maha 3.

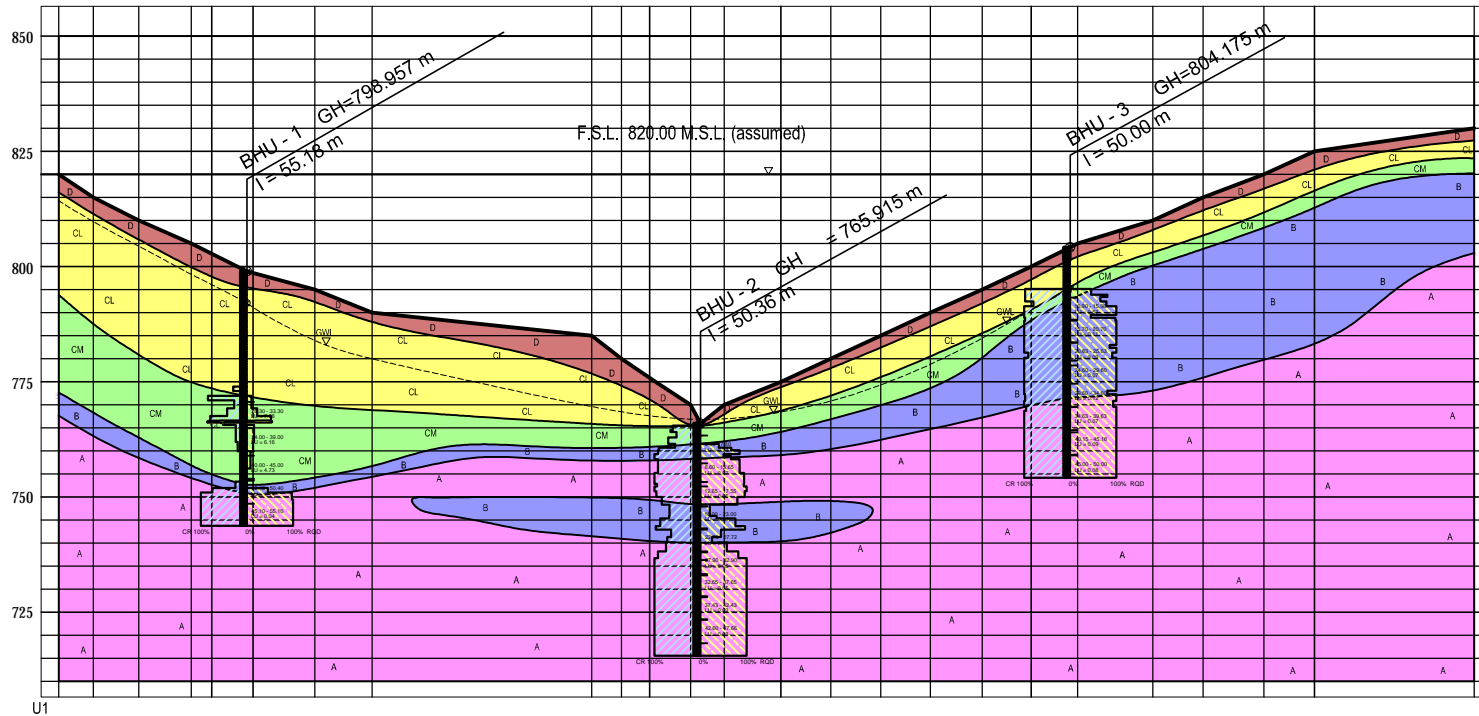
U1 - U1 Dam Axis
 Geological Section Based on tentative Rock Mass Classification by CECB

CLASS	CONDITION OF ROCK
A	Fresh and hard, no deterioration in the rock - forming minerals. Crack spacing larger than about 30cm.
B	Fresh and hard. Weathering along cacks. Crack spacing larger than about 15cm.
C	Feldspar is deteriorated, but quartz particles are hard. When struck by hammer breaks into pieces. In the form of small pieces, rock pieces remain. No circular core.
CM	Breaks when struck by hammer. Deterioration of feldspar developed. Clay is sandwiched along the opening face. Crack spacing smaller than 5cm
D	Extremely soft. Very friable and tends to powderize. Residual soil form

Note)
 The ROCK MASS CLASSIFICATIONS on this section were applied by CECB but were not supported by firm evidence, thus JICA Study Team considers these only as tentative and not corresponding to solid criterias including CRIEPI.

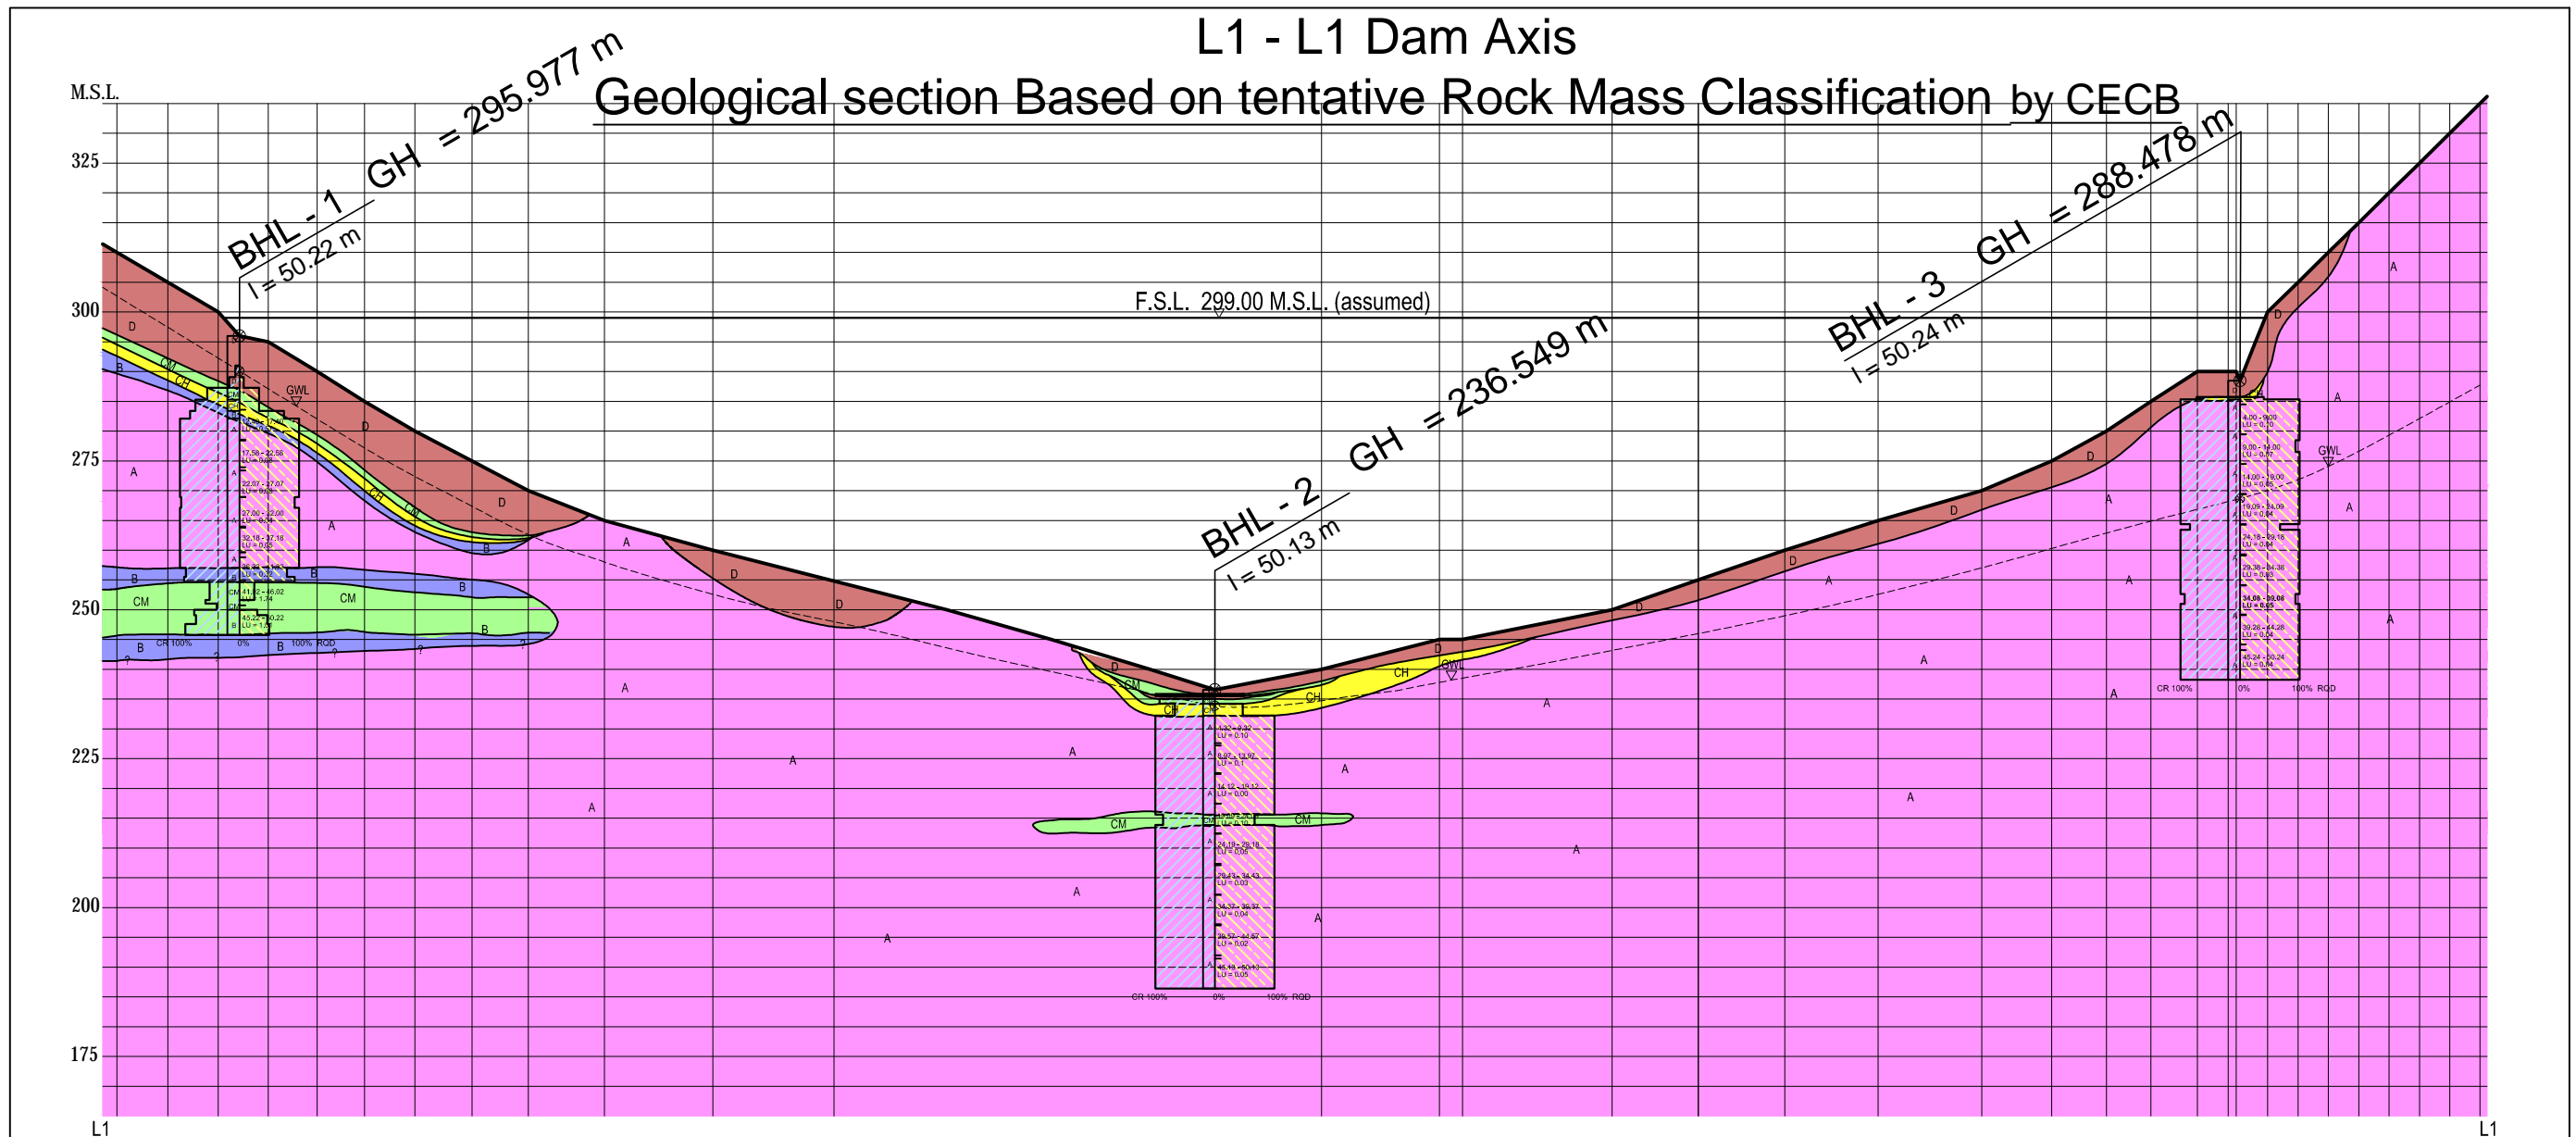
Figure A.12.1.4-1 (2) Geological cross section on lower dam axis

CLASS	CONDITION OF ROCK
A	Fresh and hard, no deterioration in the rock - forming minerals. Crack spacing larger than about 30cm.
B	Fresh and hard. Weathering along clacks. Crack spacing larger than about 15cm.
CII	Relatively hard. Biotite and feldspar are somewhat deteriorated. Crack spacing larger than about 5cm.
CM	Breaks when struck by hammer. Deterioration of feldspar developed. Clay is sandwiched along the opening face. Crack spacing smaller than 5cm
D	Extremely soft. Very friable and tends to powderize. Residual soil form

Note)
The ROCK MASS CLASSIFICATIONS on this section were applied by CECB but were not supported by firm evidence, thus JICA Study Team considers these only as tentative and not corresponding to solid criterias including CRIEPI.
