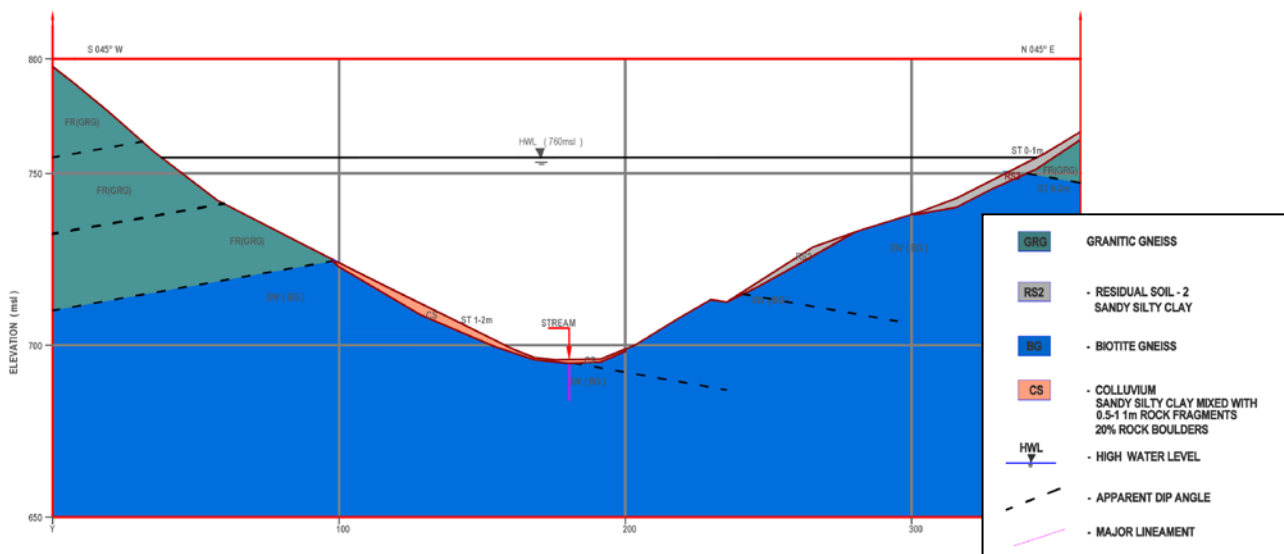
Figure 10.4.2-3 Geological Cross Section along Upper Dam Axis of Maha 2 Site (1:10,000)
