Ex-Post Project Evaluation 2016 :
Package IV-2 (Peru, Nicaragua, Paraguay, Honduras)

FY 2016 Ex-Post Evaluation of Japanese ODA Loan Project

“Provincial Cities Water Supply and Sewerage System Improvement and Expansion Project”

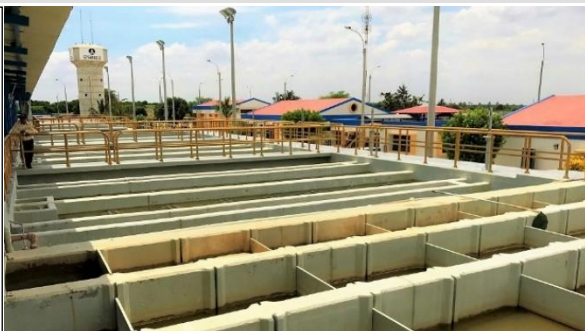
Water Treatment Plant in Piura

In both cities, water production using surface water as the supply source to replace part of groundwater became possible with the implementation of the Project and the production cost was reduced.⁴³ In particular, the WTP in Piura is now capable of conducting low cost and efficient water production and has become a model for the design and operation of WTPs in Peru. This WTP is used for training organized by the Piura SSC and MVCS and receives frequent visits from university researchers and students.

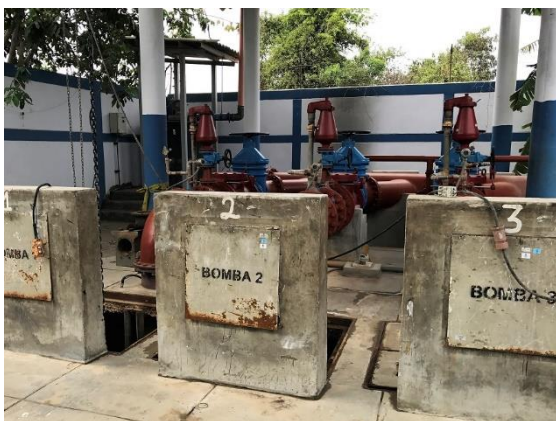
Sewerage pumping station (Piura)

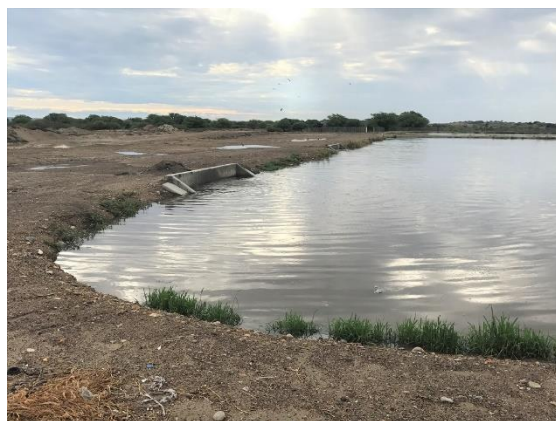
El Indio STP (Piura)

In regard to the sewerage in Piura, during the process of reducing the project scope mentioned above, the scale as well as the planned treatment level of STPs (planned water quality of treated sewage) was reduced while not changing the planned volume of sewage to be received. This change was judged not to cause any major problems as the range of crops benefitting from the treated sewage used for irrigation was limited. Of the two planned new STPs, the work to construct the San Martin STP was delayed because of failure to acquire part of the planned land after signing for the work. The subsequent discovery that the actual volume of sewage to be treated was much larger than the original forecast made it necessary to plan a larger facility. Because the revised plan could not be completed by the final disbursement date (December 2011) of the ODA loan at the time, it was decided in May 2011 that this plant would be constructed using MVCS's own funds (within the scope of the Project). As of June 2017, the procurement process is in progress for this plant. At the El Indio STP, the treated sewage is used for irrigation. The outlet channel from this completed plant was connected to an existing small irrigation channel which was actually too small to handle the volume of treated sewage from the plant, causing standing water around the plant. To rectify the situation, the Regional Government of Piura constructed a temporary irrigation channel (outside the project scope) in 2014.

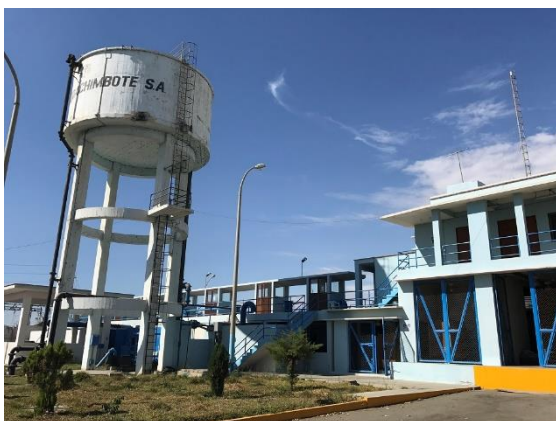
Distribution Reservoir (Chimbote)

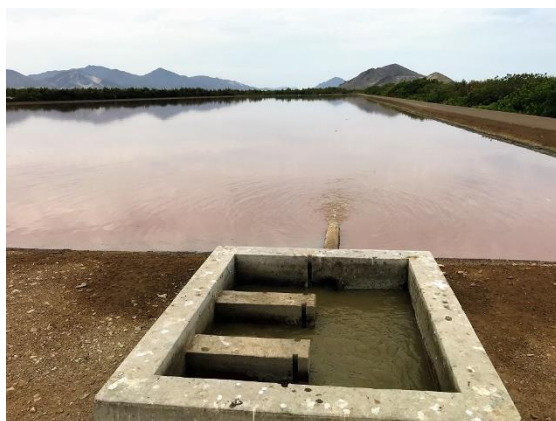
Centro Sur STP (Chimbote)

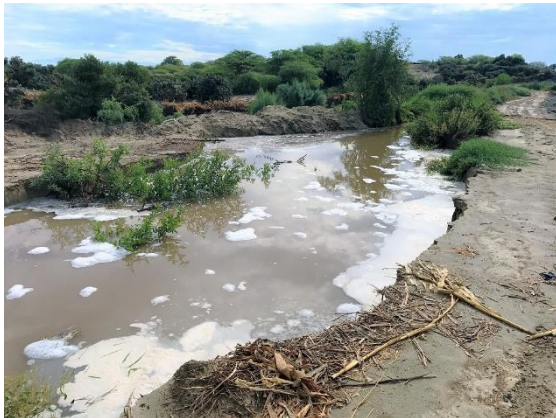
Extension of outlet channel for El Indio STP
(Piura)

the El Indio STP by preparing an environmental adjustment and management program.⁴²

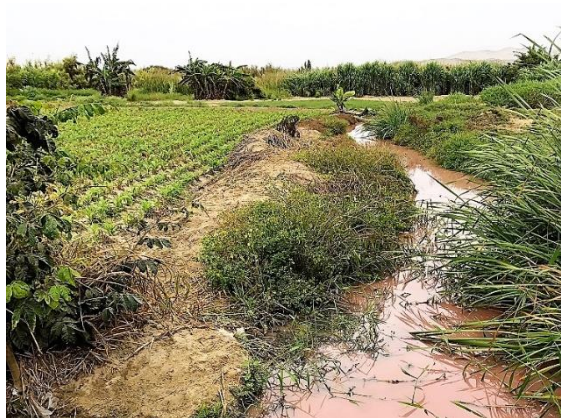
Irrigation channel connected to Centro Sur
STP
(Chimbote)

There is a private airfield near the Centro Sur STP in Chimbote. After the implementation of the Project, marshes were formed at the side of this airfield and water birds visiting these marshes began to disrupt airfield operation. According to the Chimbote SSC, the marshes are believed to have emerged due to a rise of the groundwater level. However, it cannot be denied that the discharged treated sewage from the Centro Sur STP may have also been a remote cause. Although this STP is over-loaded, further expansion is difficult because of its limited land. In view of these, the Chimbote SSC plans to close this STP and expand the Las Gaviotas STP so that the sewage currently sent to the Centro Sur STP will be diverted to the Las Gaviotas STP via a new pumping facility for treatment. At the Las Gaviotas STP in Chimbote, an outlet channel to the sea has been constructed with the government's own funding and the recycling of treated sewage is restricted to reeds, etc. Because of this, the partial excess of the quality standard for treated sewage at this STP does not pose any major environmental problems. In contrast, the continued practice of discharging untreated sewage from northern Chimbote causes concern in regard to seawater contamination. In this regard, the Chimbote SSC plans to expand the Las Gaviotas STP in the future so that it can treat the entire sewage from both southern and northern Chimbote.

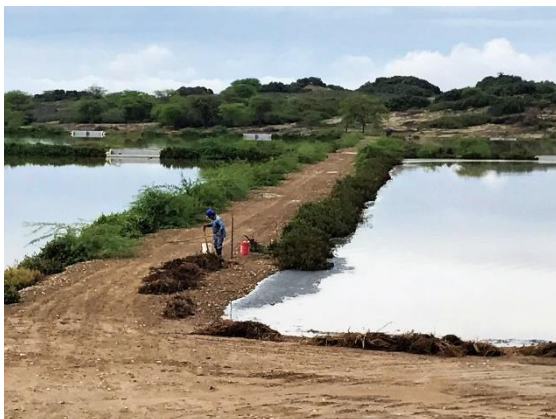
Left: Cleaning works around the treatment pots (El Indio STP, Piura)

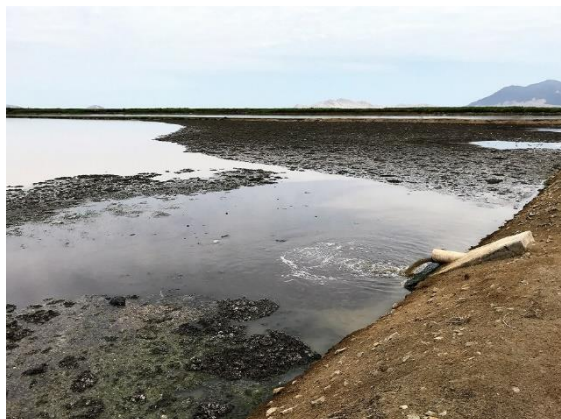
Right: Las Gaviotas STP (Chimbote)

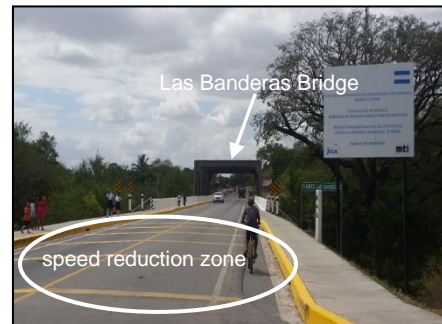
Speed reduction zone at Las Banderas Bridge (towards El Rama)

- (1) Increase of the average travelling speed: At the time of planning, the target average travelling speed was set at between 60 km/hour and 80 km/hour which was the speed limit in Nicaragua. However, a traffic accident near Las Banderas Bridge¹⁴ led to the introduction after project completion by the Nicaraguan side of speed reduction zones with a maximum speed limit of 30 km/hour on both side of the target bridges of the Project. While these speed reduction zones have contributed to securing safe transport, the average travelling speed has decreased, which kept the target achievement rate between 38% to 57%. However, it must be noted that the introduction of these speed reduction zones has not caused any traffic jams which were a regular occurrence prior to the Project and the average travelling speed has increased compared to the pre-project period at all three bridges.

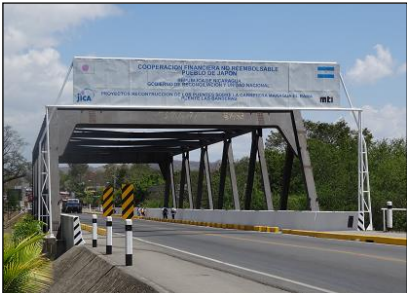
State of Maintenance and Points for Future Improvement	
【Las Banderas Bridge】

<ul style="list-style-type: none"> • Generally in good condition. • Rust is observed in the steel girders, mounting members, nuts and bolts of the superstructure. After analysing the rust, if it is rust caused by corrosion, it is necessary to clean any dirt, maintain a dry condition, and take necessary measures to prevent further corrosion by procuring the special paint from Guatemala*. Some of the hydraulic cylinders connecting the superstructure and substructure have bird droppings stuck to the neoprene cover. These droppings should be removed during periodic maintenance.
<ul style="list-style-type: none"> • Surface cracks are observed with the paving near the joints between the bridge and access road. While urgent repair is not required, it is desirable for the work to be included in the scope of periodic maintenance. • The superstructure of the bridge when going from Managua to La Tonga has graffiti done with a sharp blade as well as with paint. Special paint should be procured from Guatemala to repair the area to prevent any corrosion from these graffiti.

* For Las Banderas Bridge and Tecolostote Bridge, the Report for Defect Inspection in 2014 already pointed out that “Although the two newly constructed bridges are steel girder bridges using atmospheric corrosion resistant steel, the good quality of the members cannot be maintained if they are in a wet condition for a long period of time. Therefore, it is necessary to clean rubbish and dirt stuck to the steel members during periodic maintenance to keep them dry.” (Report for Defect Inspection, 2014).

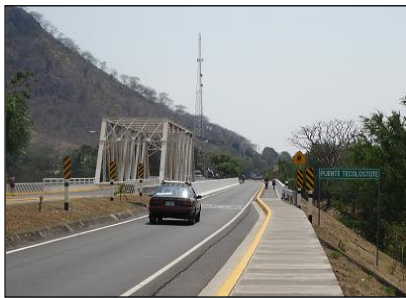
【Tecolostote Bridge】

- Generally in good condition.
- Superstructure: rust is observed with the vertical and horizontal girders, diagonal and mounting members, nuts and bolts. After analysing the rust, if it is rust caused by corrosion, it is necessary to clean any dirt, maintain a dry condition, and take necessary measures to prevent further corrosion by procuring the special paint from Guatemala*.
- As many drivers appear to urinate towards the steel abutment, erosion in this area is advancing more rapidly compared to that of other areas. As there is also bad smell, it is necessary to adopt certain measures, including regular cleaning and the installation of a signs.
- Surface cracks of the paving near the joints between the bridge and access roads are observed. While urgent repair is not required, it is desirable for the work to be included in the scope of periodic maintenance as necessary.

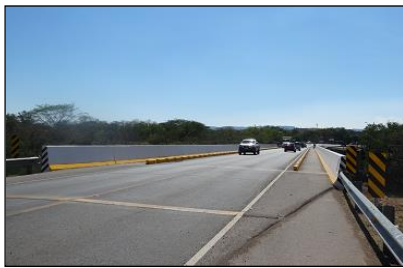
【La Tonga Bridge】

- Generally in good condition.
- Because of the absence of a steel structure in both the superstructure and substructure, the problem of rust does not occur thus the condition of the bridge is good.
- Many drivers appear to urinate at the concrete pier. In addition to regular cleaning, some measures, including the installation of signs, should be taken.
- It is necessary to install lighting which existed before the Project for night-time security.

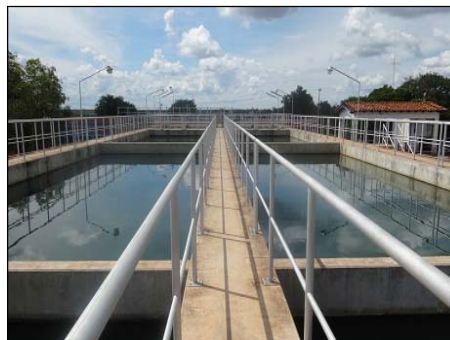
Concepcion Water Treatment Plant: Chemical Sedimentation Tank

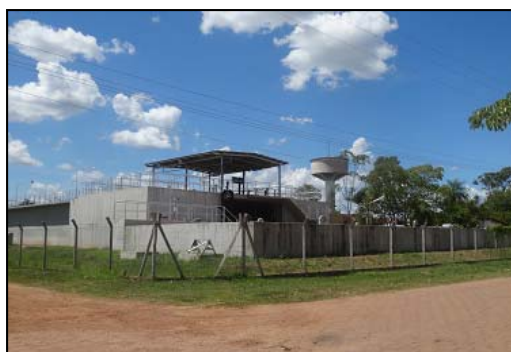
Concepcion Water Treatment Plant

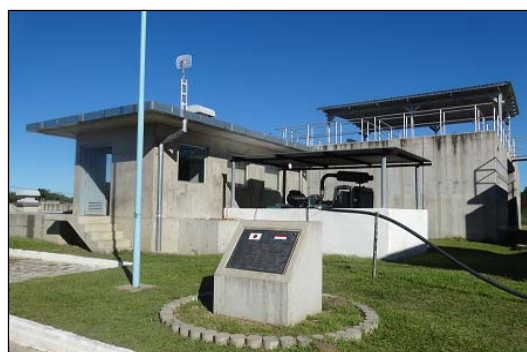
Pilar Water Treatment Plant

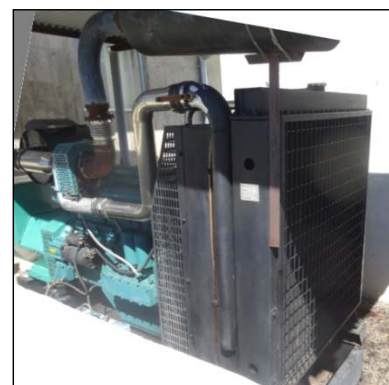
Private power generator at
Pilar Water Treatment Plant

- Construction of a revetment on both sides of the intake tower in Pilar: Work to protect the river banks using gabions was conducted to ensure the safety of the conduction pipes from the intake tower to maintain stable water intake operation in the face of more than anticipated bank erosion.
- Installation of a private power generator at each WTP: A private power generator was installed at each WTP (300 KVA at the Concepcion WTP and 200 KVA at the Pilar

WTP) in 2015 as the unstable power supply in Paraguay meant a series of power cuts which caused cutting off of the water supply in the early days of the operation of the new WTPs.

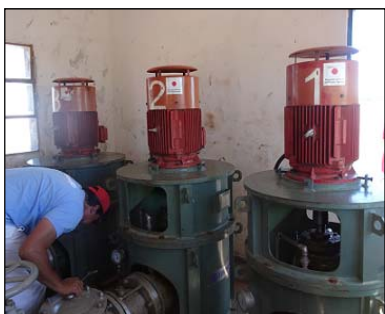
Pilar Water Treatment Plant:
Inspecting the water intake
pump

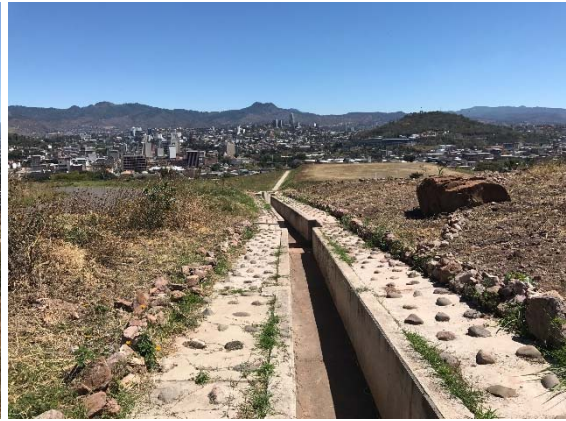
Open canal (El Berrinche)

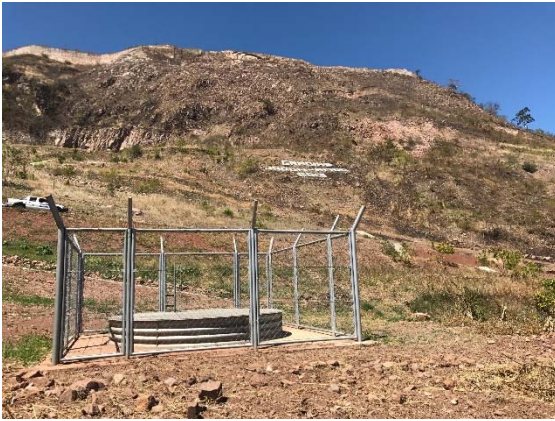
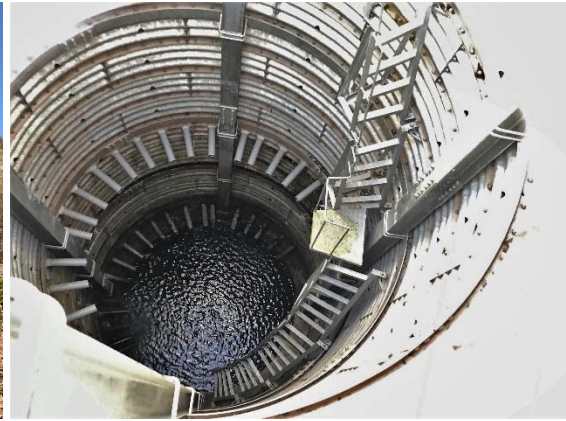
Catchment well and its interior in El Berrinche
(water collection boring works deployed in a fan-like fashion can be observed)

At the time of constructing catchment wells, neither photographs of geological sections, soil samples from the sliding surface were preserved nor observation data on preconstruction groundwater level were preserved. In Japan, 360-degree photographs of a geological section are taken at 1 m intervals of the drilling depth at the time of the drilling and construction of a catchment well. As these photographs show the conditions of geological structure, inclination and conditions of sliding surface much better than drilling cores, they are extremely useful as reference materials for understanding mechanism of the landslide and also for visitors after the completion of the construction work. Soil samples from the sliding surface are essential to determine, through a soil test, the strength parameter which is the most important element of stability analysis and also important for future examination of countermeasures. Meanwhile, data related to the changes of groundwater level before and after the well construction is the most important data used for judging effects of the well after its completion. It is regrettable that the precious opportunity to obtain these materials and data was not seized.

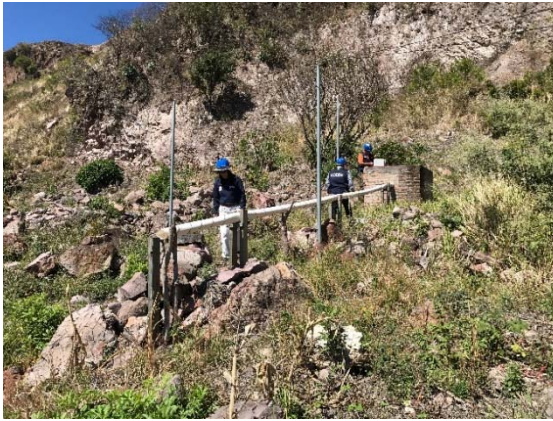
Extensometer (El Reparto)
