**THE PROJECT FOR  
CAPACITY DEVELOPMENT FOR  
ROAD DISASTER PREVENTION MANAGEMENT  
IN THE KYRGYZ REPUBLIC**

**Meeting on the Completion Report for Sustainability of the Project**

# Management of Bridges on Expressway in Japan

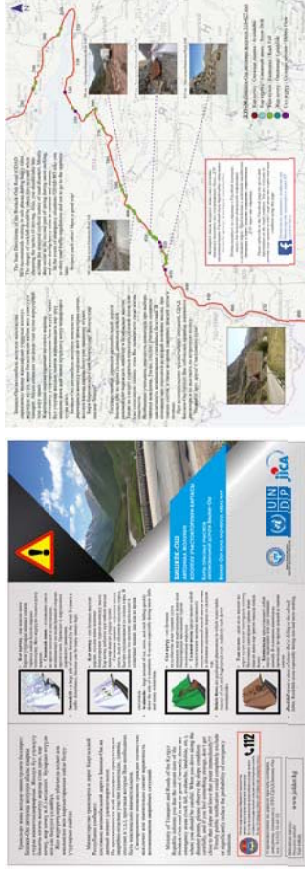
- Under the cooperation of MOTR and JICA project team, a map of hazardous areas along the Bishkek-Osh road (Hazard Map) was prepared on January 2018.
- The number of copies to be printed is about 169 500 copies (for DEUs 9 & 23: 127 000 copies, for DEU 30: 42 500 copies) with financial assistance of UNDP.
- Hazard Map was distributed to the school, the café and the tollgate along BO road by MOTR and MES.

| <p><b>Hazard Map Distribution</b></p> | <ul style="list-style-type: none"> <li>A map of hazardous areas along the Bishkek-Osh road (Hazard Map) was prepared by MOTR.</li> <li>In total 169 500 copies assisted by UNDP were distributed to the school, the café and the tollgate along BO road by MOTR and MES.</li> <li>This activity was institutionalized by RMD Director's Order.</li> </ul> |

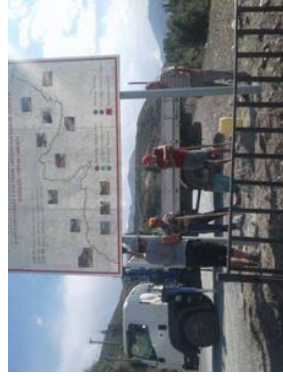
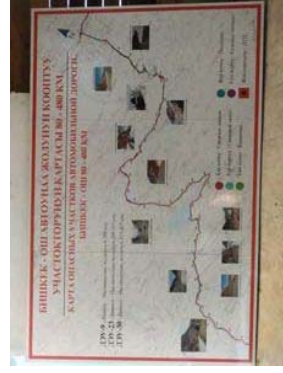
- Two emergency boards (Sosnovka Tollgate and 80.7km of BO Road) were installed by MOTR in September 2018.
- A emergency board in Kara-Kul city was installed by MOTR in December 2018.

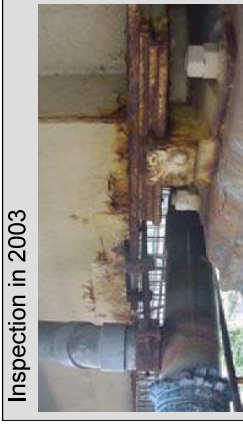
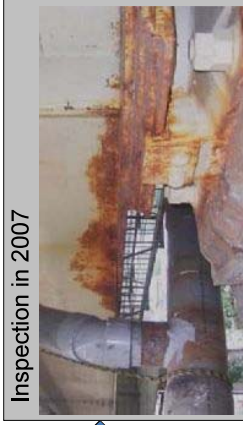
### 4-1. Steel Structure 4-1.3 Corrosion of Steel Structure (Progress of Corrosion in Steel Structure)

Advanced corrosion caused by water leakage from drainage pipe

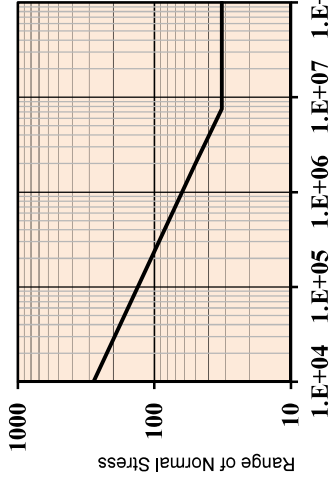
Example of the Fatigue Design Curve of a Joint in which Right Stresses are Applied\*

Cracking starts from a stress concentration part. In some location where cracks have occurred, the progress of the crack may lead to the occurrence of brittle fracture, having significant impacts on the safety of bridges.

Number of Repeats: n

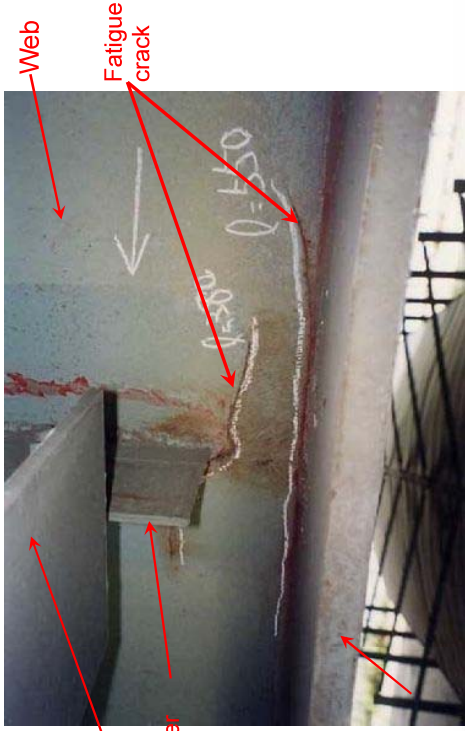
#### 4-1.4 Fatigue of Steel Structure (Joint between web and cross beam)

- Crack in the welded joint between cross beam and vertical stiffener

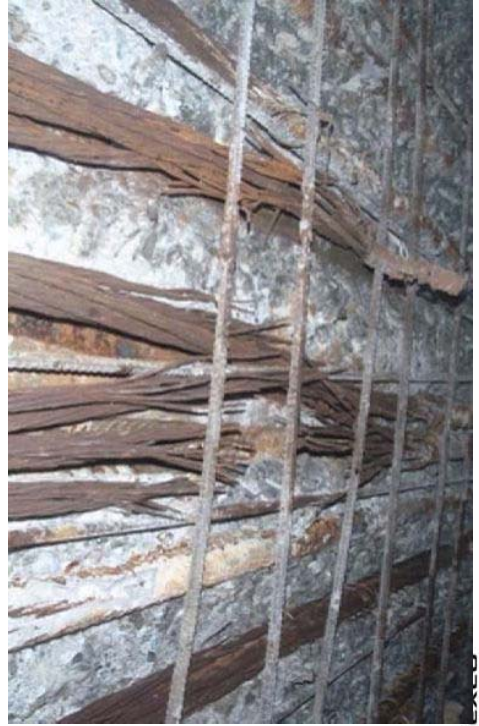
#### 4-2.6 Deterioration of PC steel materials

Corrosion/Rupture of PC Steel Materials and Reinforcing Bars due to Poor Grout Filling and Water Penetration

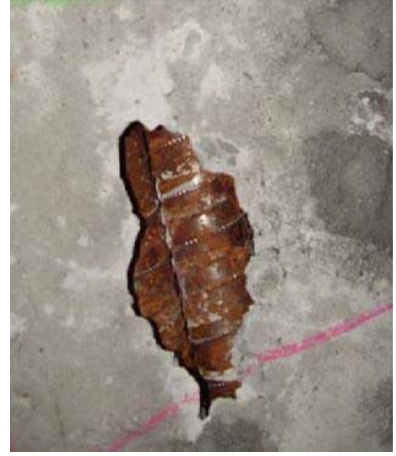
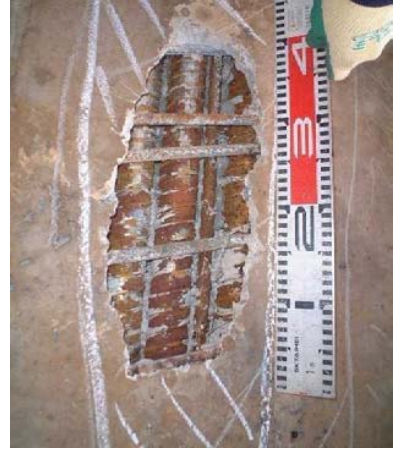
#### 4-2.6 Deterioration of PC steel materials

Corrosion/Rupture of PC Steel Materials and Reinforcing Bars due to Poor Arrangement of PC Steel Materials (Insufficient Covering Thickness)

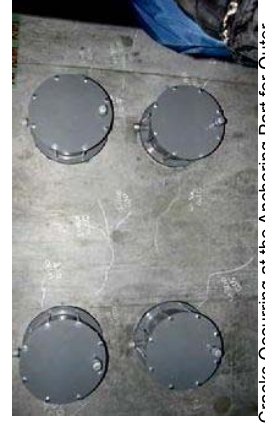
Cracks Occurring at the Anchoring Part for Outer Cables of the Cross Beam

| Condition of the Cracks | Primary Cause |
|---|--|
| Cracks occurring around the anchoring part and/or the deflection part | The cracks occurred as a result of stress concentration of the anchoring part and of the deflection part |

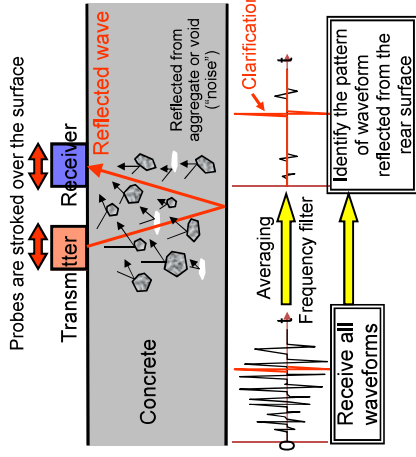
When an inspector strokes an ultrasonic probe over the surface of target structure, its ultrasonic wave gets absorbed into the concrete. The reflected wave is examined to find out the concrete's internal conditions.

By averaging and filtering the results, more accurate results can be obtained, which are not affected by other waveforms such as aggregate and air void.

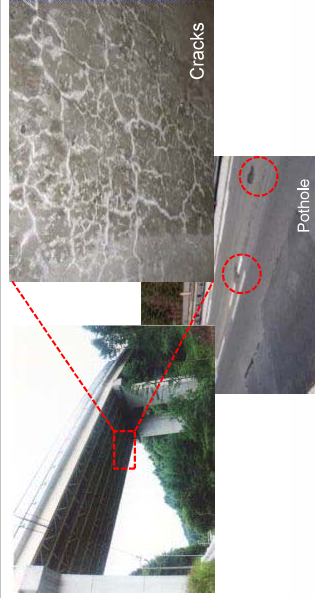
- Replacement (RC Deck Slab to PC Deck Slab)
  - Kobayakawa Bridge (Chuo Expressway, Nagano Pref.)
    - Opening: 1981 (33 years old, as of 2014)
    - Extension: 132m (outbound lane)
  - Bridge condition
    - Fatigue due to the heavy traffic volume (29,000 vehicles per day, as of 2013)
    - Chloride attack due to anti-freezing agents

In spite of the reinforcement/repair, cracks and peeling have been progressing due to aging.

- FY1998:
- Overlay
  - High performance deck slab waterproof
- FY2006
- Overlay
  - High performance deck slab waterproof

- Replacement (RC Deck Slab to PC Deck Slab)
  - Kobayakawa Bridge (Chuo Expressway, Nagano Pref.)
    - Opening: 1981 (33 years old, as of 2014)
    - Extension: 132m (outbound lane)
  - Bridge condition
    - Fatigue due to the heavy traffic volume (29,000 vehicles per day, as of 2013)
    - Chloride attack due to anti-freezing agents

In spite of the reinforcement/repair, cracks and peeling have been progressing due to aging.

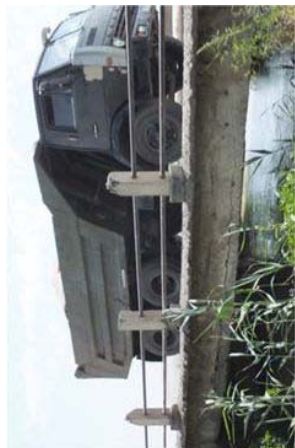
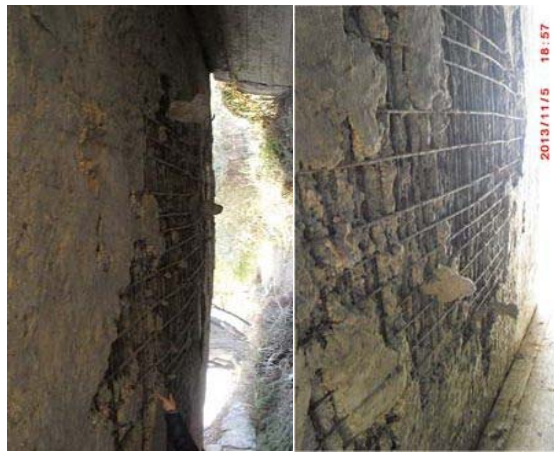
- PLUAD 1 DEP 958 30.5KP (National Road)

- ☆ Lack of load carrying capacity by extremely deteriorated main structure

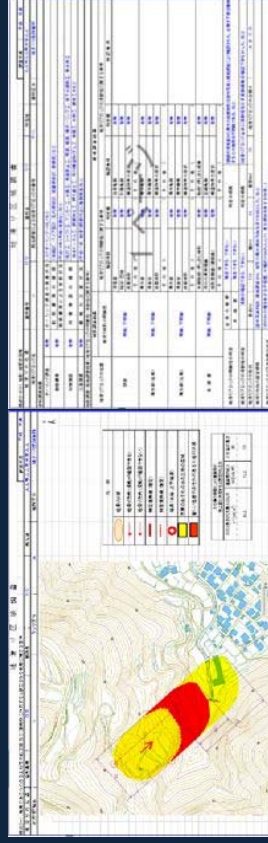
## Inventory

- Location map
  - Geomorphology
  - Geology
  - Property of preservation
- ➔
- Description
  - Active level
  - Plan of countermeasure

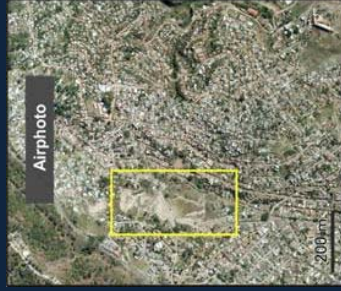
Airphoto

## Methods of monitoring for wide area

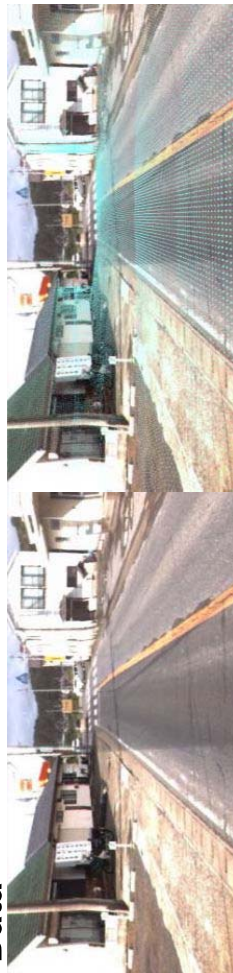
Image data

3D Point Cloud data

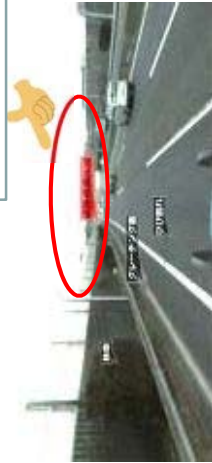
Information Tag with Attribute information

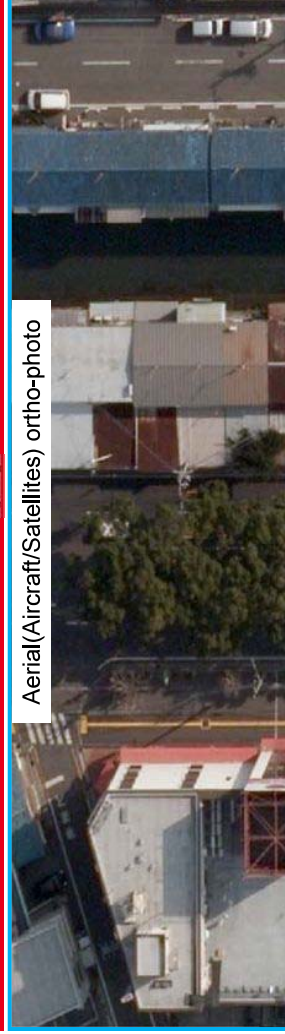
Aerial(Aircraft/Satellites) ortho-photo

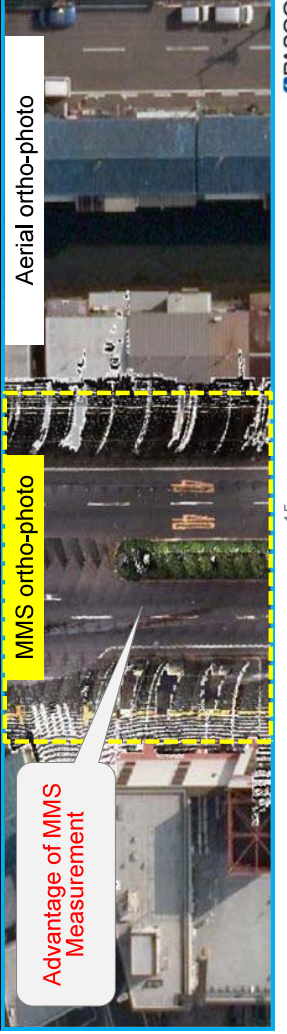
MMS ortho-photo

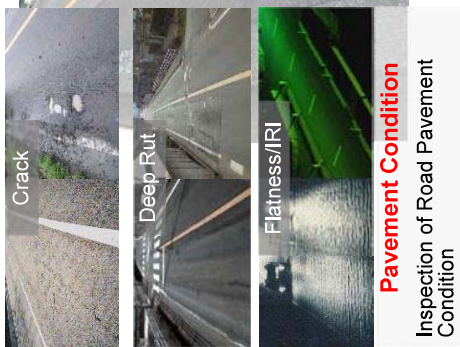
### Road Surface Condition
