### JICA PROJECT

**VERIFICATION SURVEY WITH THE PRIVATE SECTOR  
FOR DISSEMINATING JAPANESE TECHNOLOGIES  
FOR GROUND IMPROVEMENT USING CHEMICAL GROUTING TECHNOLOGY  
“TABLE TEST AND BENCH SCALE OBSERVATION REPORT”**

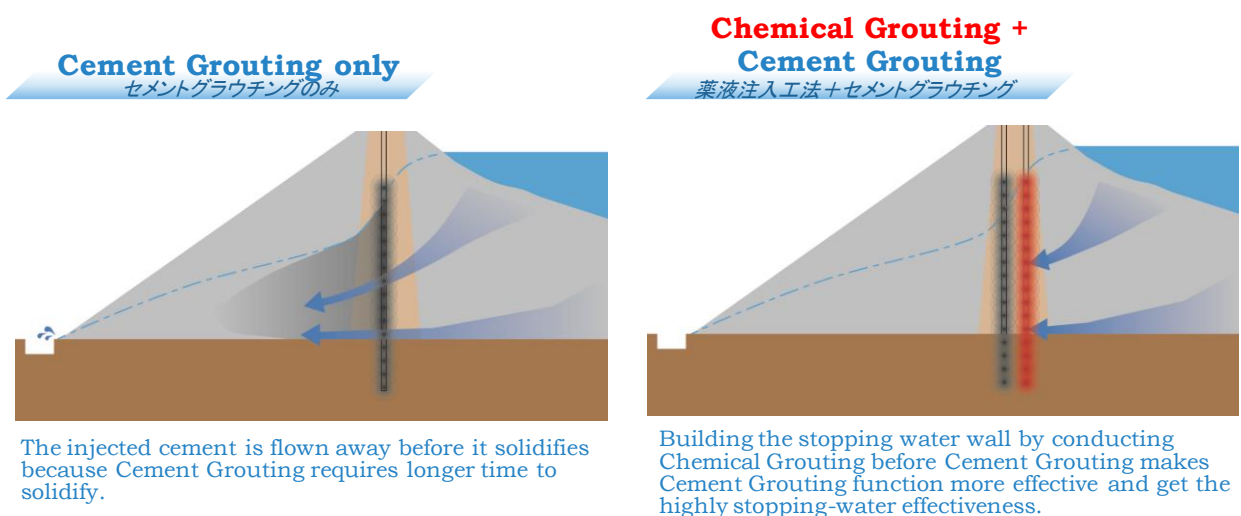
Chemical grouting is used in wide application of construction field. An example of application is used in DAM repairing. As a part of grouting method, an advantage of this application in DAM repairing methods is not needed to decrease water level while working (Figure 3). The chemical grouting acts as barrier for cement grouting that need long time to work and prevent the change of cement grouting shape from designed shape (Figure 4).

Figure 4 Application of Chemical Grouting in DAM Repairing

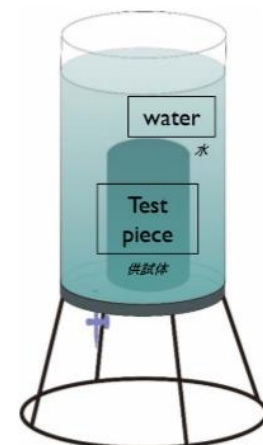
Tank Leaching Test  
Equipment  
溶出試驗裝置

Figure 6 Dutch Leaching Test Apparatus

Specimen is immersed in pure water with 5 times volume ratio (see Figure 6).

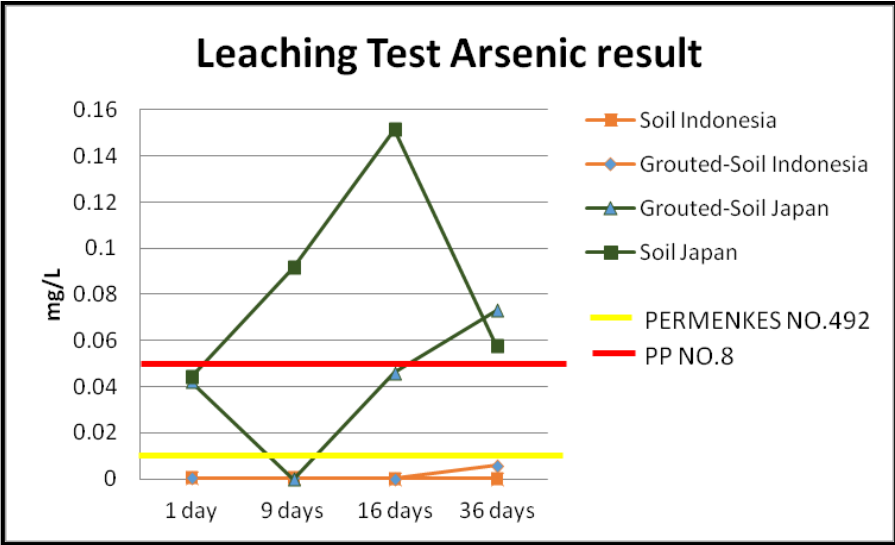
From the leaching test result of Japanese sand, except pH, elements elution were below standards. The amount of arsenic elution exceeded Indonesian standards on both samples of Japanese Sand, however the fact is presence of chemical grouting can reduce the arsenic elution. Arsenic slightly exceeded the standard (Both of Standards) value in the elution test result on day 36 of grouted soil leaching (see Figure 10). However it is significantly lower than leaching test result of only sand leaching test. As shown in Table 3, Indonesian sand does not contain arsenic. It is only detected in Japanese sand (16ppm).

Figure 10 Leaching Test Result (Arsenic)

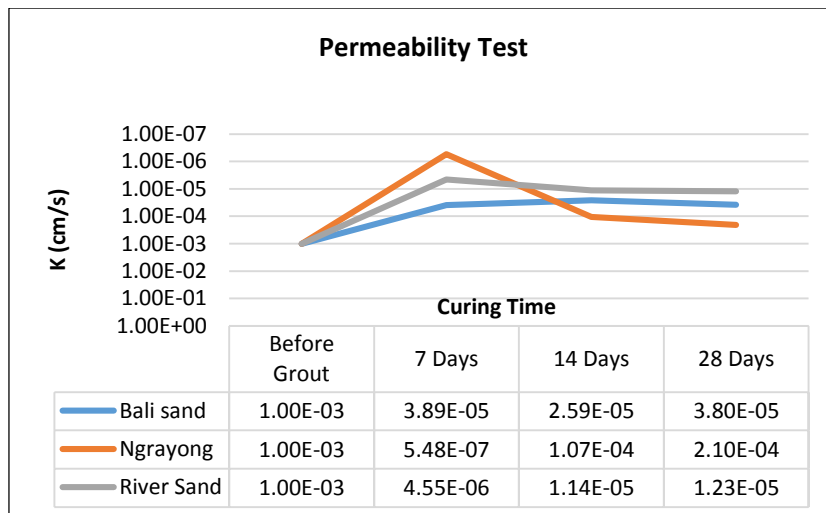
Figure 13 Permeability Test Result

The result of permeability test is shown in Figure 13. In spite of the differences in the three types of sand, it was confirmed that the improvement column was improved to a permeability coefficient around  $10^{-4}$  to  $10^{-6}$ . From this result, it can be concluded that chemical grouting method demonstrated sufficient effect on permeability improvement. This is a sufficient permeability used to temporary prevent leakage during improvement work by cement grouting in dam repair.

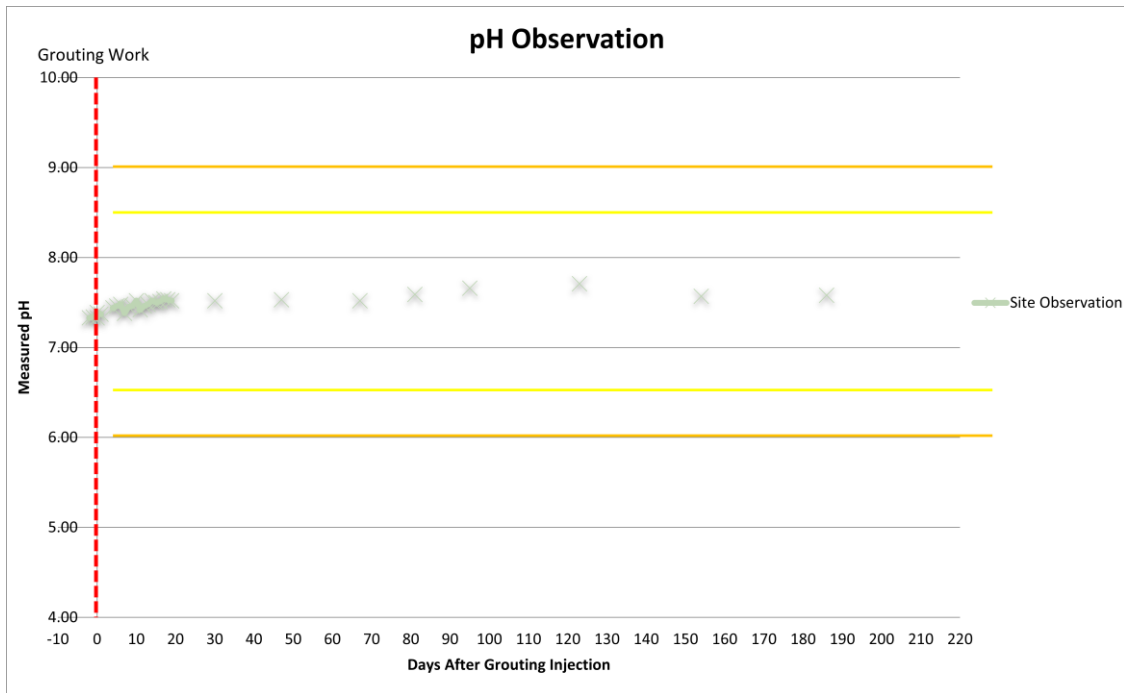
Based on the Japan standard of chemical grouting method, ground water pH monitoring in observation hole is done with the aim to confirm the influence of grouting material on groundwater. The monitoring result of pH is shown in Figure 21. The monitoring was carried out for 6 months since the chemical grouting injection. From the monitoring results, it shows that pH before the injection was 7.33 but after the injection, it was slightly increased and on the 17th day after the injection, pH value is 7.54. Subsequently, the pH raising is settled and pH on day 122 after injection was 7.71. In monitoring result, a slight rise in pH was observed after injection but according to the Indonesian standards (PP, No.82, 2001 and PERMENKES, No.492, 2010), the value is completely acceptable and it can be assumed that there is no problem on safety regarding pH.

Figure 22 pH Monitoring and Laboratory Test

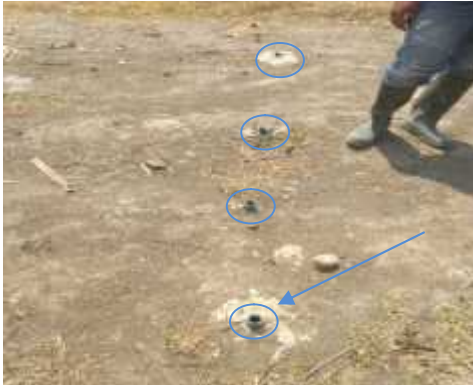
**Contoh foto masalah bocor/rembes:**

Grouting on the floor spill way,  
Grouting approximately along 200 m, to the left 100 m and  
to the right 100 m from Spill way including in the body spill  
way

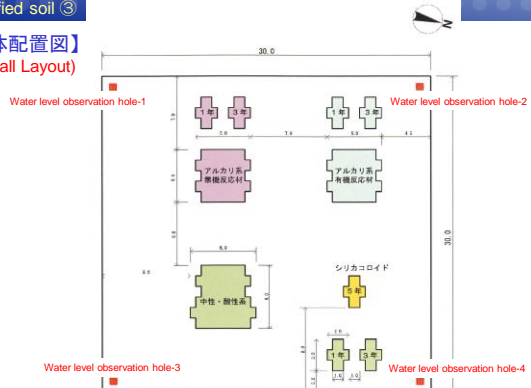
**薬液注入固結土の原位置長期耐久性確認試験③**  
Long-term durability confirmation test in-situ for chemical injection solidified soil ③

**【全体配置図】 (Overall Layout)**

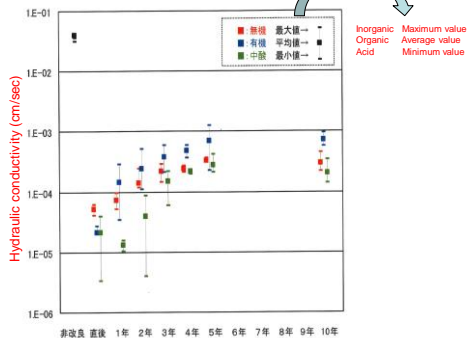
**薬液注入固結土の原位置長期耐久性確認試験⑤**  
Long-term durability confirmation test in-situ for chemical injection solidified soil ⑤

**【現場透水試験】 (On-site permeability test)**

- i) 遮水性等に関しては、いずれの薬液でも改良効果を持続している  
 In case of water stop, any chemical solutions continue to improve
  - ii) 強度面に関しては、コア採取できたことや水平載荷試験結果より、高い低いはあるものの改良効果が持続している。  
 In case of strength, based on the result of core sampling and horizontal loading test, the improvement effect has been increased even not stable
  - iii) 10年間の耐久性は確認されたと思われる。  
 10 years of durability has been confirmed
- 薬液注入することにより、粒度構成が粘性分の増加に寄与した(シリカ分の増加) By injecting the chemical solution, the particle size composition contributed to increase the viscosity (silica content)
  - その結果、粒子間にシリカ分が残り、間隙が小さくなり、遮水性に寄与した。As a result, silica remained between the particles and the gap was reduced, contributing to water stop
  - 砂質土でありながら粘性土の性状が付与され、コア採取が可能となった。Although it was sandy soil, it was given the property of cohesive soil, and core collection became possible.

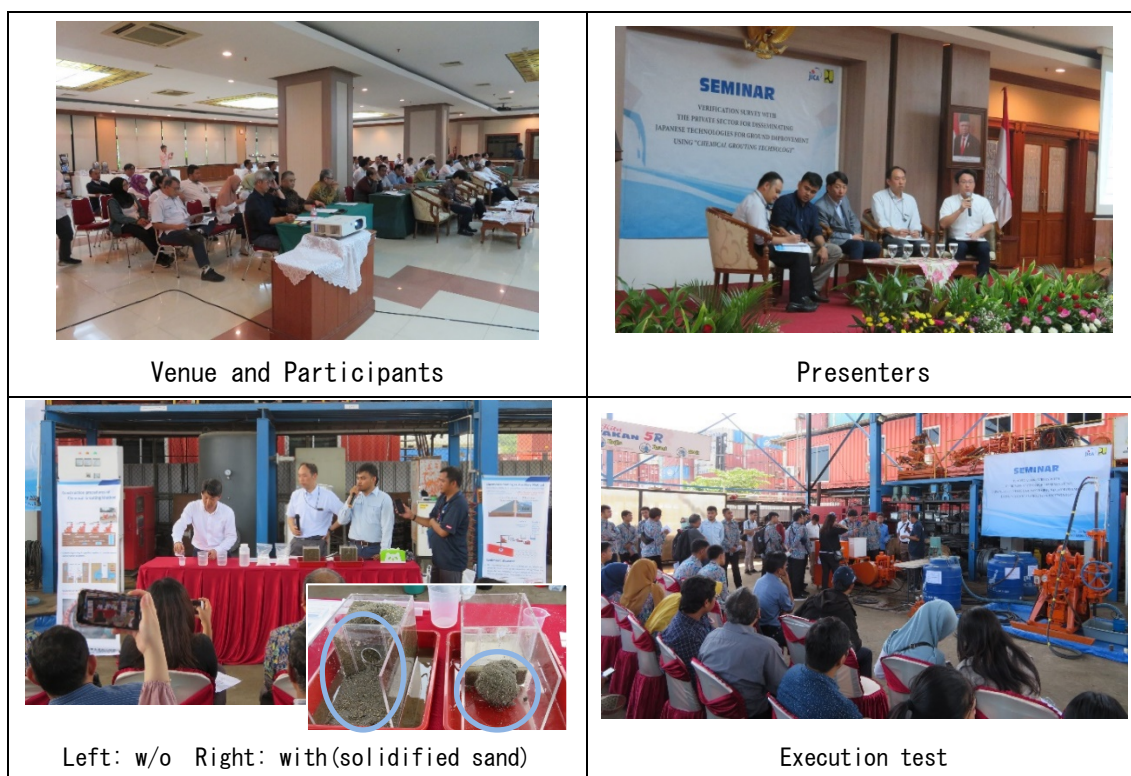
Figure-8 Demonstration Test of Execution and Closing Seminar

The Project was summarized, and the technical manual, the mechanism, the construction method, the quality control and the dissemination were introduced. Approximate 150 experts participated from public works agencies, construction companies, consultants and others. Both Japanese and Indonesia side confirmed the ground improvement effects, the safety, and importance of the quality management and the technology development.
