**ISLAMIC REPUBLIC OF PAKISTAN
FEDERAL FLOOD COMMISSION (FFC)**

**TECHNICAL ADVISOR
ON
FLOOD MANAGEMENT
IN
ISLAMIC REPUBLIC OF PAKISTAN**

**FINAL REPORT
VOLUME-2
PRELIMINARY FEASIBILITY STUDY**

CTI ENGINEERING INTERNATIONAL CO., LTD.

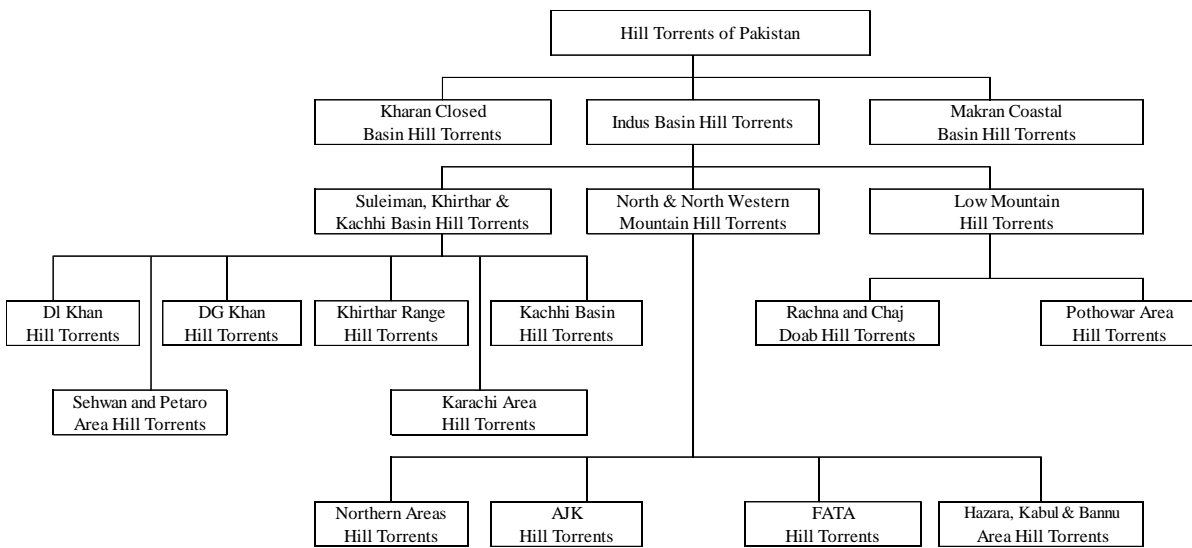
Figure 2.2.1 Classification of Hill Torrent Region

As shown in Figure 2.2.1, the Hill Torrent area is broadly classified into the following three categories based on the topographical characteristics and the locations to which the flood flowed. Figure 2.2.2 and Figure 2.2.3 show all the Hill Torrent areas and the IRB (Indus River Basin) areas directly flowing into the Indus River, respectively.

- Indus River Basin Hill Torrents.
- Kharan Closed Basin Hill Torrents
- Makran Coastal Basin Hill Torrents.

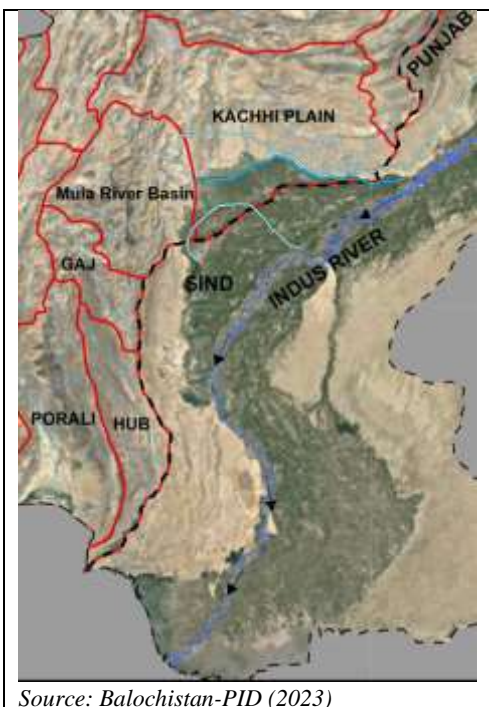
Figure 2.5.1 RBOD Area

The target area is generally divided into Hill Torrent mountainous area (Mula River Basin and GAJ districts comprising the Kachhi and Khirthar Hill Torrents of Figure 2.5.1) in the Balochistan province and low-level area in the Sindh province (Right Bank Outfall Drain area: RBOD area). Flooding in Balochistan-Hill Torrent mountainous area will flow into low-level areas in the Sindh province. To be exact, there is the Nari river basin in the lower GAJ area, and the two are called Gaj-Nari Hill Torrent.

On the Sindh province side, the Flood Protection (FP)-Bund has been constructed and maintained along the Hill-Torrent foothills from north to south, and the flood water from the western Hill Torrent mountains is stored around the foothills, and the FP-Bund is channeled into Lake Manchar. After that, the flood water is discharged from Lake Manchar into the Indus River through the sluice gates and spillway.

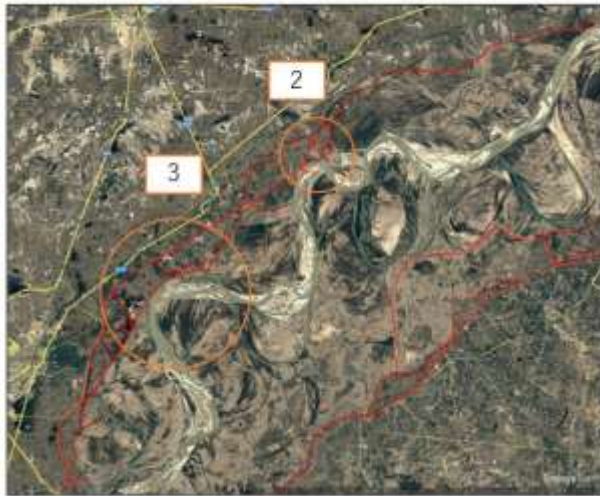
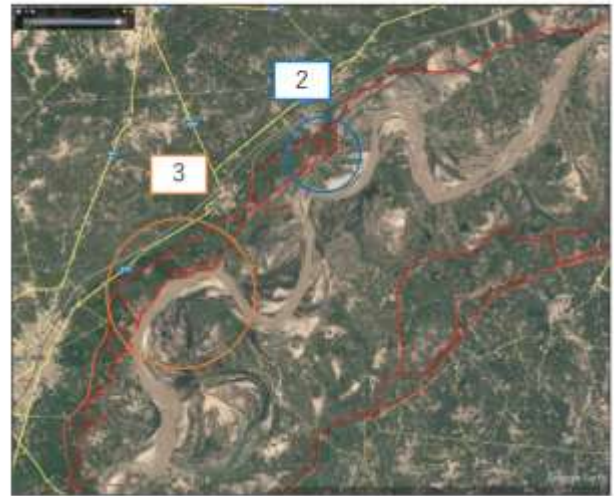
Figure 3.1.2 (2) Satellite Image of Sukkur to Lake Manchar Section of the Indus River

○ : Vulnerable Points
○ : The mainstream line of the river and the bund are not close to each other at that time.
Source: Created by the Advisory Team from Google Earth

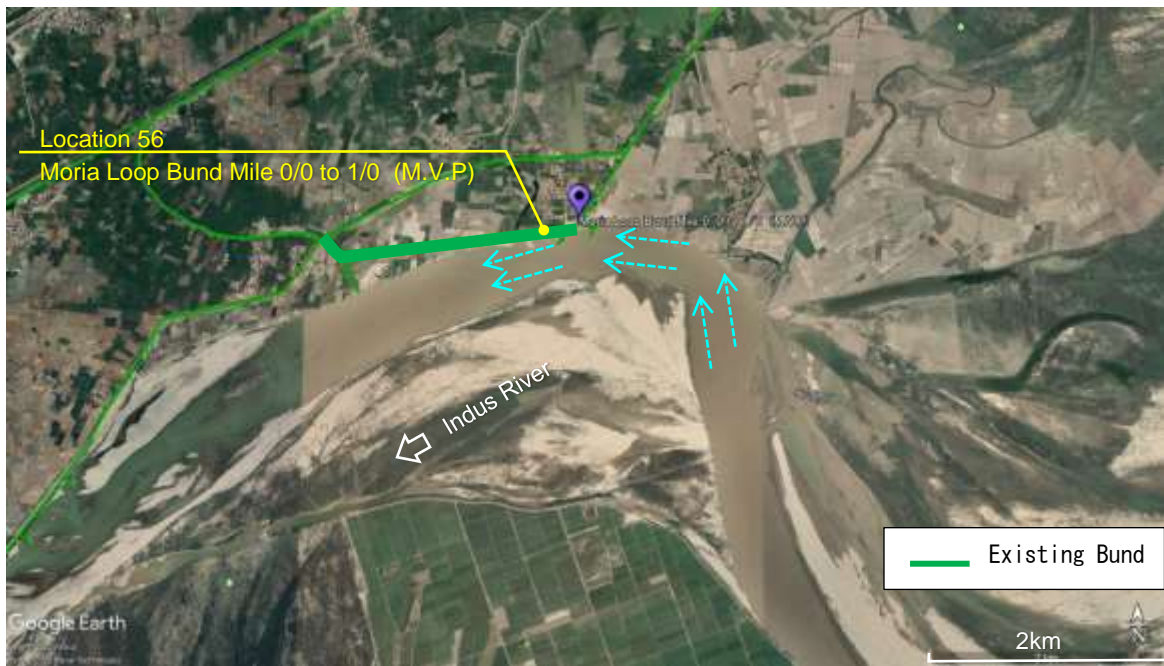
Figure 3.2.6 Situation around Location No.56

The waterway during the ordinary time is in front of the existing bund. The bund is located on the outer side of the steep curve of the waterway. Due to such a situation, erosion and scouring around the riverbank have been serious issues and it was damaged also during the 2022 Flood.

The bund here is double-layered. Hence, although a breach or collapse of the bund in this stretch occurs, the inundation due to the overflow from the Indus River may not expand significantly. Some residential area exists between the first and second lines of the bunds.

Based on the joint site inspection with the engineers from PID-Sindh from 2/8/2023 to 4/8/2023, the rehabilitation work for the existing spur was ongoing.

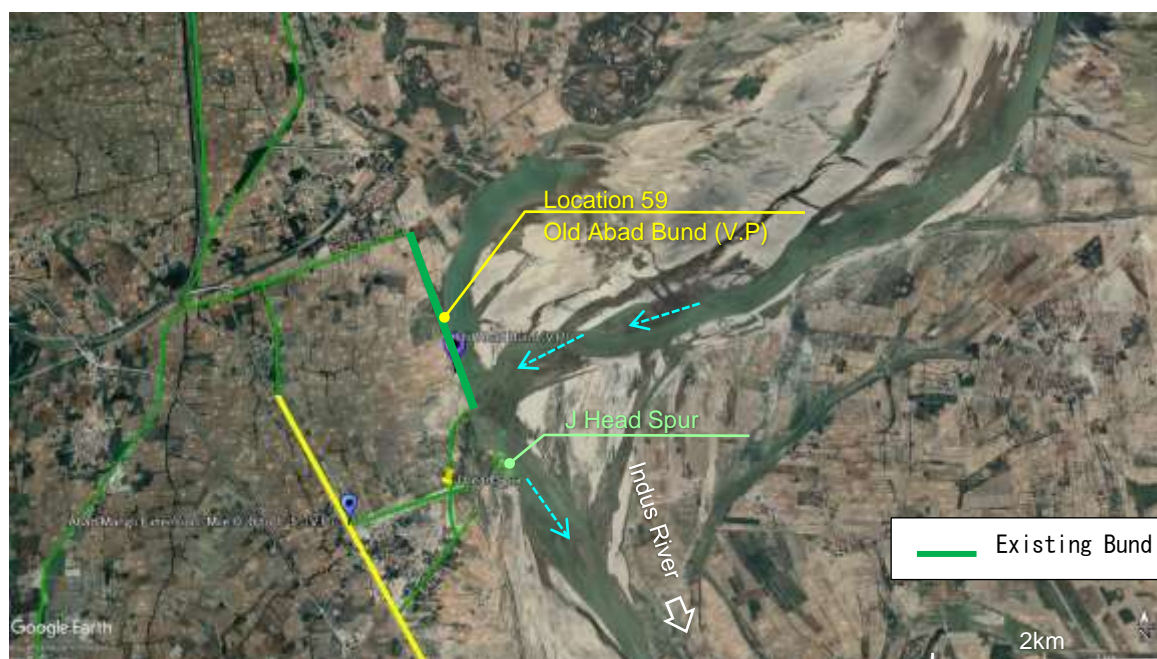
Figure 3.2.7 Situation around Location No.59

The area between the first line bund and the second line bund is used as agricultural land. although the population concentration area is not located close to the second-line bund, the urban area of Larkana is located only about 10 km upstream of the second-line bund.

A joint site inspection was conducted between 2/8/2023 and 4/8/2023 with engineers from the Sindh Irrigation Department. The bund height at this location was about 1m from the ground in the land side, and the bund height was significantly lower than the bund on the upstream and downstream sides. Protective structures using straw and wood were installed in front of the bund to prevent erosion of the existing bund by waves.

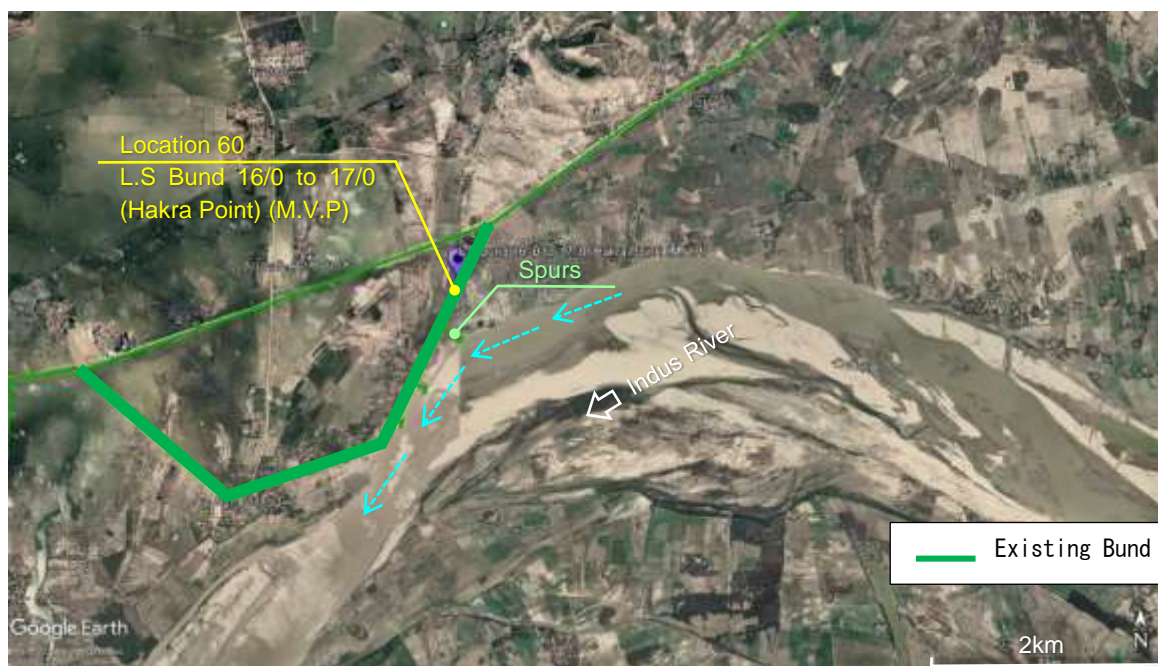
Figure 3.2.8 Situation around Location No.60

The bund here is double-layered. Hence, although a breach or collapse of the bund in this stretch occurs, the inundation due to the overflow from the Indus River may not expand significantly. Some residential area exists between the first and second lines of the bunds.

From 2/8/2023 to 4/8/2023, a joint site inspection was conducted with engineers from the Sindh Irrigation Department. According to the information of the Sindh Irrigation Department at the site, the front side of the existing spur needed repair. However, when it was inspected at the site, there was no noticeable damage at present, and it seems to have already been repaired.

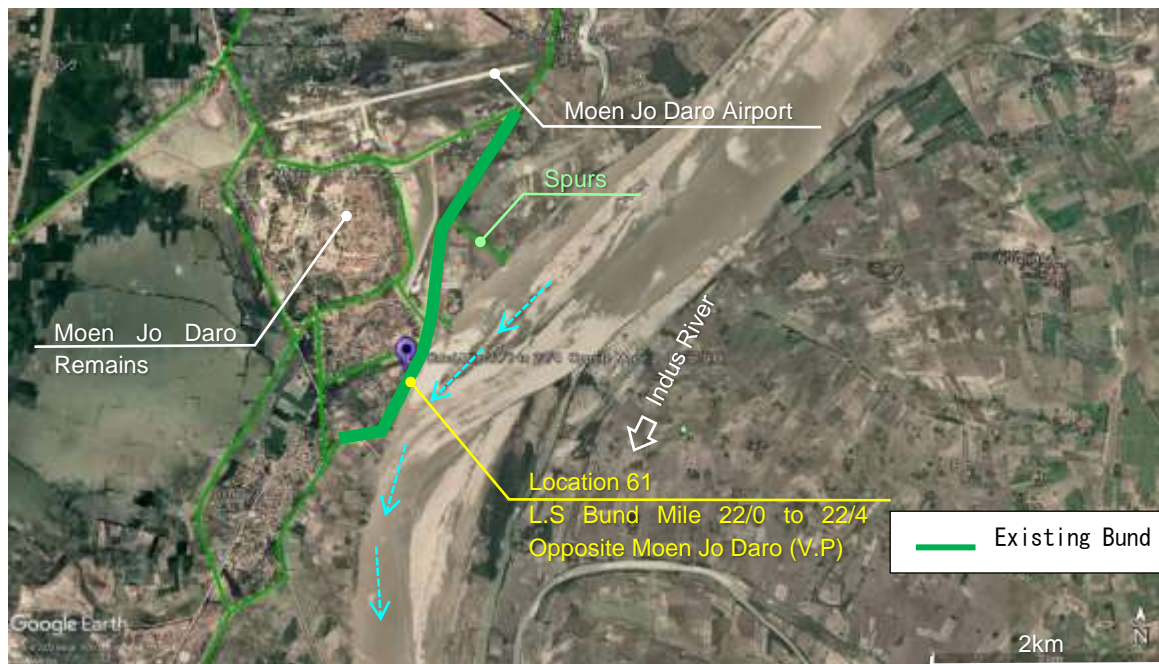
Figure 3.2.9 Situation around Location No.61

From 2/8/2023 to 4/8/2023, a joint site inspection was conducted with Sindh Irrigation Department engineers. According to the information from the Sindh Irrigation Department, the front side (apron

part) of the existing spur was damaged by the scouring and needed to be repaired.

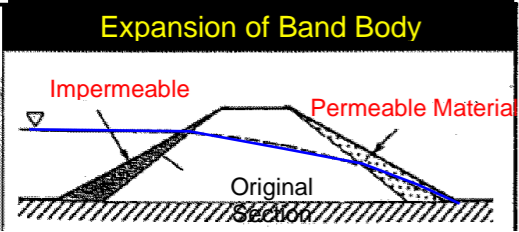
<p>Expansion of Band Body</p>	<ul style="list-style-type: none"> By expanding the cross-section of the embankment to extend the length of the seepage path, reducing the mean hydraulic gradient to increase the safety of the bund body. Safety against slip failure is increased with a milder slope. It also functions as a counterweight to prevent piping of the foundation ground near the toe of the bund body. Impact on both the riverside and landside is the most significant 	<ul style="list-style-type: none"> Requires area in the front and rear side of the bund. In this case, it should be noted that securing the flow area on the riverside and the land on the land side is needed. The bund material used will be less permeable than the existing embankment for the riverside and will be more permeable than the existing embankment for the landside. If the foundation ground is soft, consider the impact on the existing embankment (cracks at the top, etc.). 	<ul style="list-style-type: none"> Easy availability of bund materials is desirable. To make it fit well with the existing bund body, step cuts have to be made. 	<ul style="list-style-type: none"> Since the bund body may settle on soft ground, continuous monitoring of the settlement at the crest to secure the crest height and management is needed. 	<ul style="list-style-type: none"> Easy to combine with other reinforcement methods. Some liquefaction prevention effects can be expected due to the increase in effective overburden pressure, and stability against earthquakes will be improved with the milder slope. 	○	⊙	<p>High</p> <ul style="list-style-type: none"> This method is effective in reducing the hydraulic gradient in the bund body.

Table 3.6.1 Major Reinforcement Method for Seepage (Reinforcement of Bund Body)

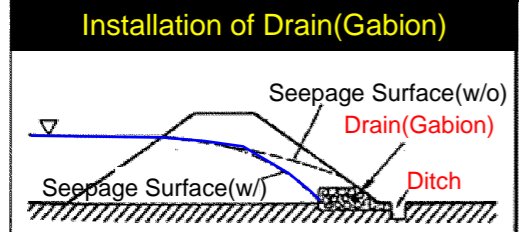
<p>Installation of Drain (Gabion)</p>	<ul style="list-style-type: none"> Replacing the bund material around the toe with a permeable material and draining the water inside the bund body quickly. Suppresses the rise of the water surface in the bund body and the decrease of the shear strength of the body. Increased stability by replacing the toe with a draining material (gabion) with greater shear strength. Impact on the land side is a little, but the reliability and effectiveness are better than the other options. 	<ul style="list-style-type: none"> This is especially effective when the permeability of the bund is on the order of 10^{-3} - 10^{-4} cm/sec. Bund foot drainage is necessary (The area on the land side must be secured). The thickness of the drain shall be 0.5m or more, and the width shall be set not to exceed the 0.3 of average hydraulic gradient. Use manic or fine-grained crushed stone as the drain material and cover it with a filter material (usually an artificial material) such as geotextile. 	<ul style="list-style-type: none"> Attention not to create gaps between the bund and the joints of the filter material must be paid. Damage to the filter material (artificial material) with heavy equipment must be avoided. 	<ul style="list-style-type: none"> To monitor the long-term stability of the effect, it is desirable to install water-level observation holes in the bund body and drains. Observe the state of drainage during floods or heavy rains, and check for soil runoff after floods. 	<ul style="list-style-type: none"> When covering with soil for greening, attention to prevent the intrusion of soil into the drain is needed. Some effect in preventing liquefaction is expected because it dissipates pore water pressure. 	⊙	⊙	<p>High</p> <ul style="list-style-type: none"> This method is the best way to drain the water in the bund body rapidly.

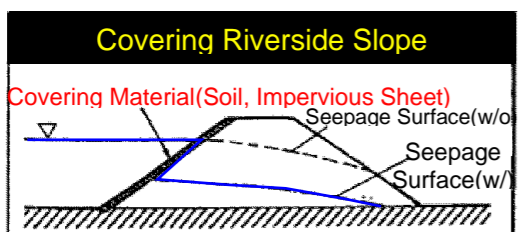
<p>Covering Riverside Slope</p>	<ul style="list-style-type: none"> The river-side slope is covered with impervious material. Refrain rainfall and river water at high water levels from permeating to bund body. Impact on both the riverside and landside is hardly expected. 	<ul style="list-style-type: none"> Effective for the bund body with highly permeable gravel or sandy soil. It is necessary to examine the stability against sliding of the covering material (soil material or artificial material such as impervious sheet). When an impervious sheet is used, cover it with concrete blocks or soil to prevent it from lifting and deteriorating due to residual water pressure. In the case of less permeable ground, drainage measures are required. 	<ul style="list-style-type: none"> In the case of covering with soil, To make it fit well with the existing bund body, step cuts have to be made. Installation of the joints and edges of the impermeable sheet needs to be careful. Firmly compact the cover soil. 	<ul style="list-style-type: none"> When using soil, attention to the generation of cracks due to drying is needed. When using impermeable sheets, attention to damage caused by piling or root growth of plants shall be needed. It is important to note that groundwater in the bund body tends to stay around the toe of the riverside slope. 	<ul style="list-style-type: none"> If an impervious sheet is used, it is necessary to check the deformation or damage after earthquakes. 	○	○	<p>Moderate</p> <ul style="list-style-type: none"> This method is effective in preventing seepage flow in the bund body from the riverside slope.

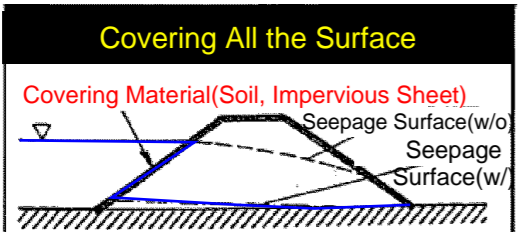
<p>Covering All the Surface</p>	<ul style="list-style-type: none"> All the surface of the bund is covered with impervious material. Refrain rainfall and river water at high water levels from permeating to bund body. 	<ul style="list-style-type: none"> It is necessary to examine the stability against sliding of the covering material (soil material or artificial material such as impervious sheet). When an impervious sheet is used, cover it with concrete blocks or soil to prevent it from lifting and deteriorating due to residual water pressure. It is necessary to consider drainage and ventilation measures to prevent wetting of the bund body and increase of air pressure. 	<ul style="list-style-type: none"> In the case of soil material, To make it fit well with the existing bund body, step cuts have to be made. Installation of the joints and edges of the impermeable sheet needs to be careful. Firmly compact the cover soil. 	<ul style="list-style-type: none"> When using soil, attention to the generation of cracks due to drying is needed. When using impermeable sheets, attention to the damage caused by piling or root growth of plants shall be needed. Groundwater in the bund body tends to stay around the toe of the riverside slope, attention to the deformation around it is needed. 	<ul style="list-style-type: none"> The effect of suppressing rainfall infiltration can be expected just by covering the top and berms. If an impervious sheet is used, it is necessary to check the deformation or damage after earthquakes. 	○	○	<p>Moderate</p> <ul style="list-style-type: none"> Ventilation of the bund body is needed.

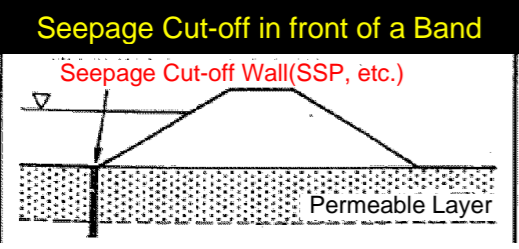
Major Reinforcement Method	Principle	Planning & Design	Construction	Maintenance	Others	Piping	Slope Stability	Applicability
Reinforcement of Foundation Ground	<p>Seepage Cut-off in front of a Band</p>

<ul style="list-style-type: none"> By installing the seepage cut-off wall such as steel sheet piles at the edge of the riverside slope, the seepage water into the foundation ground is reduced. 	<ul style="list-style-type: none"> Followings are used as materials for cutoff walls. <ul style="list-style-type: none"> ✓ [Sheet Piling] Steel Sheet Pile, Concrete Sheet Pile, ✓ [Consecutive Underground Wall] Slurry Trench, Concrete Wall ✓ [Grouting] Cement Grouting To halve the seepage water, it is necessary to penetrate 80 to 90% of the thickness of the permeable layer. 	<ul style="list-style-type: none"> The piling method of the cutoff wall shall be selected considering the surrounding environment. Attention to the construction of the joints of cutoff walls. Attention to the treatment of the joint between the existing bund body and the cutoff wall head. 	<ul style="list-style-type: none"> Since the cutoff wall is installed in the ground, basically no maintenance is required. 	<ul style="list-style-type: none"> It will block groundwater flow, so it is necessary to consider the impact on the surrounding area. Since it constrains the side directions, it can be expected to have some effect against deformation due to liquefaction in the riverside. 	○	△	<p>High</p> <ul style="list-style-type: none"> This method is effective in preventing seepage flow in the foundation ground.

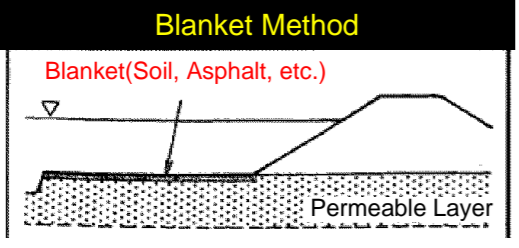
<p>Blanket Method</p>

<ul style="list-style-type: none"> With covering flood plain in front of a bund covered with an impervious material (mainly soil material), the seepage path is extended to reduce the seepage pressure around the toe. 	<ul style="list-style-type: none"> Effective when the flood plain consists of gravel soil or sandy soil. Blanket length of 30m or more can bring effect. When soil material (good quality soil) is used, the thickness must be 50 cm or more to prevent scouring and must be covered with sodding. 	<ul style="list-style-type: none"> When soil material is used, it should be firmly compacted to improve impermeability. Attention to the treatment of the joint between the existing cut-off wall and the blanket. 	<ul style="list-style-type: none"> When using soil material, pay attention to the generation of cracks due to drying is needed. It is important to note that groundwater in the bund body tends to stay around the toe of the river-side slope. 	<ul style="list-style-type: none"> It does not lead to the improvement of seismic resistance. However, if a flood plain is newly installed, the overburden pressure on the riverside will increase, and some effect against liquefaction can be expected. 	○	△	<p>Low</p> <ul style="list-style-type: none"> The existing floodplain is very spacious, and it will be costly and ineffective.

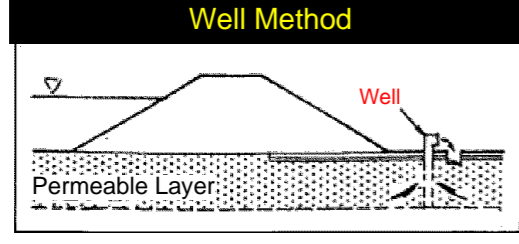
<p>Well Method</p>

<ul style="list-style-type: none"> Seepage pressure around the toe is reduced by draining the seepage water from the foundation ground by a pressure-reducing well-installed rear of the toe. 	<ul style="list-style-type: none"> It is necessary to install a well and bund foot drainage and an area on the land side is required. As a short-term, emergency response, it is recommended to consider applying it to rivers with beds above ground and rivers in alluvial fans. 	<ul style="list-style-type: none"> Wells, etc. shall have a structure that does not cause clogging. 	<ul style="list-style-type: none"> Attention to soil runoff and clogging of filter materials is needed. A facility to control the operation of the pump is required. 	<ul style="list-style-type: none"> It is desirable that there is a drainage in the surrounding area and that the water can be drained appropriately. 	○	△	<p>Low</p> <ul style="list-style-type: none"> This method is for short-term emergency response.

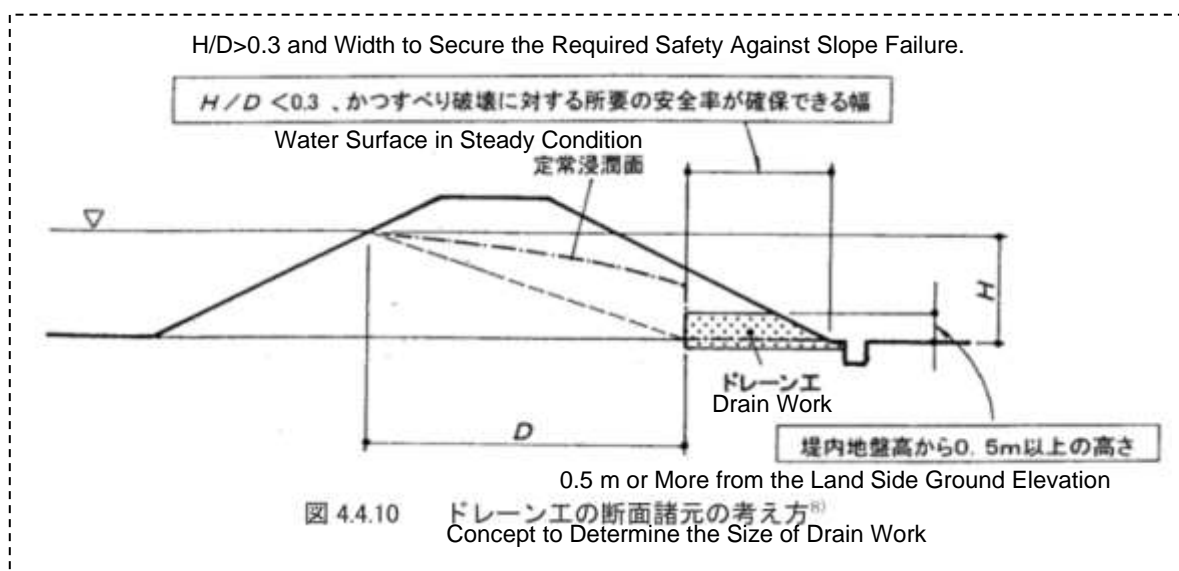
Figure 3.6.5 Concept to Determine the Size of Drain Work

The recommended size for the drain work is 0.5 m or more in height, 1/10 in bund width and an average hydraulic gradient not exceeding 0.3. Figure 3.6.5 shows the concept for determining the drain dimensions. Here, the size of the drain is set to B x H = 0.5 m x 1.0 m considering the sample cases in Japan.

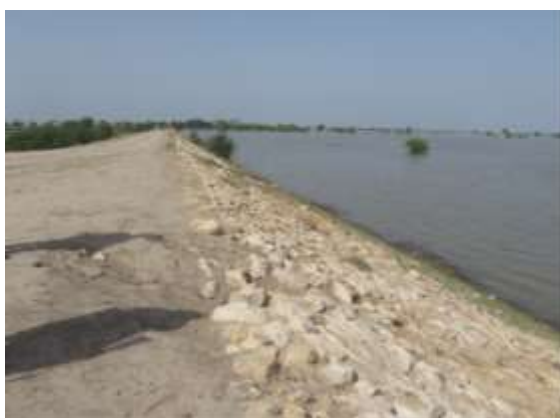
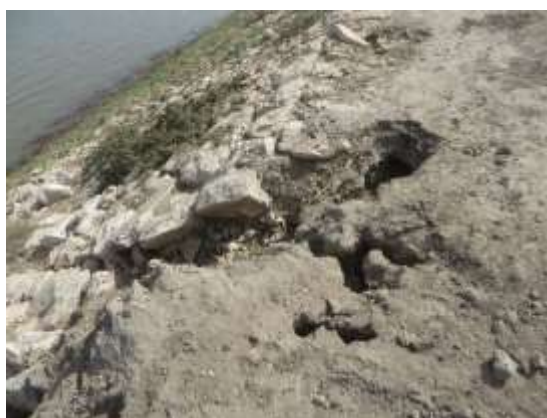
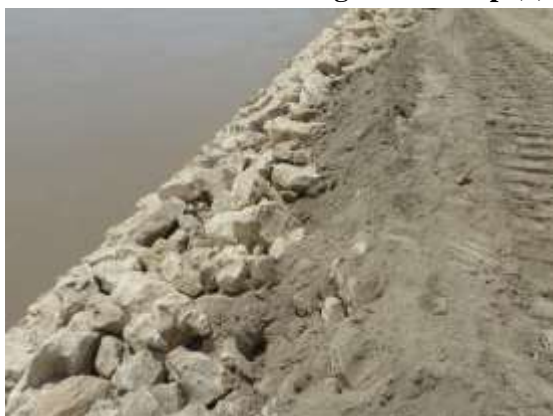
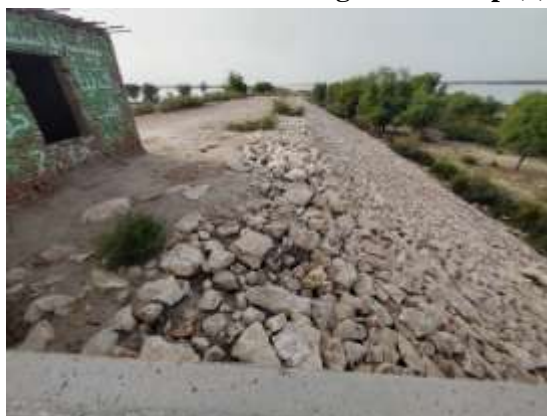
Photo 3.6.1 Stone Pitching around Top (1)

Photo 3.6.2 Stone Pitching around Top (2)

Photo 3.6.3 Stone Pitching around Top (3)

Photo 3.6.4 Stone Pitching around Top (4)

Stone Pitching is commonly used for the protection of the riverside slope of existing bunds. When the existing bund was observed during the site inspection, the following issues were observed in several locations. Photos from the site inspection are shown in Photo 3.6.1 to Photo 3.6.4.

- The size and quality of stones used in stone pitching vary depending on the sites and include small particle sizes that are easily washed away by running water.
- It can be considered that the filter material between the stone pitching and the slope does not function well or is not installed because the slope behind the stone pitching has been sucked out and the cavities are observed.
- At the locations where stone pitching stops up to the slope shoulder, there is damage on the slope shoulder.

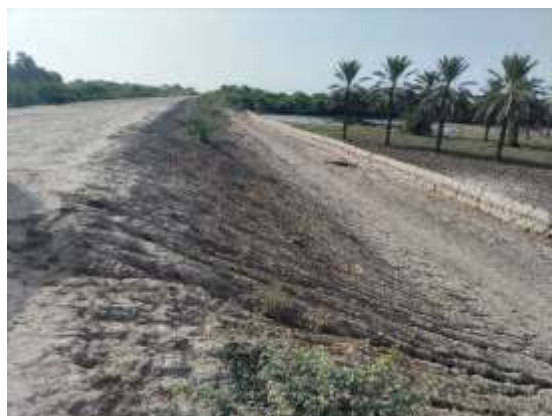
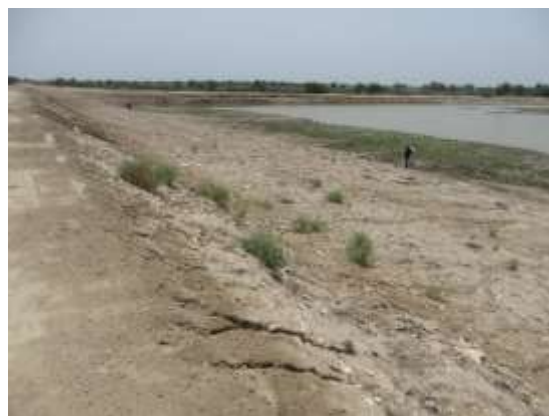
**Photo 3.6.5 Situation of Land Side Slope
(1)**

**Photo 3.6.6 Situation of Land Side Slope
(2)**

At most of the sites, no protection work is installed on the land side slope of the existing bund. When the existing bund was inspected, it was found that erosion of the slope by rainwater occurred in most places and that damage was observed due to the lack of protection work on the shoulder (See Photo 3.6.5, Photo 3.6.6).

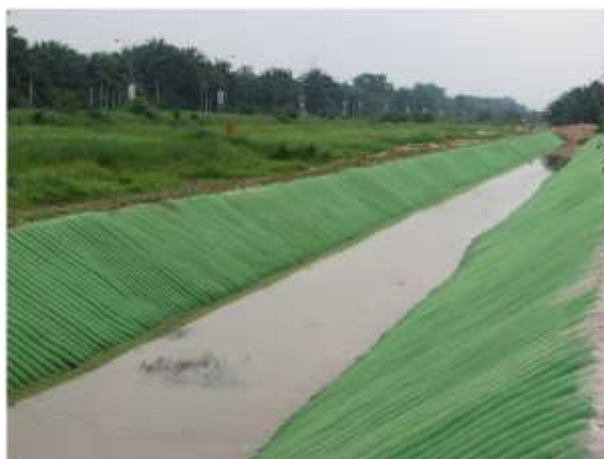
Photo 3.6.7 Sand Filled Mattress

- Covering Material Using Geotextile
→ A material called Sand Filled Mattress, which is a sheeted bag made of geotextile that is filled with sand and used as a revetment (see Photo 3.6.7). Although the material is imported from a third country, it can be used under some flow velocity, and the color of the surface can be similar to that of vegetation, so the lightness can be reduced compared with concrete facing. However, it requires sand to be filled inside.

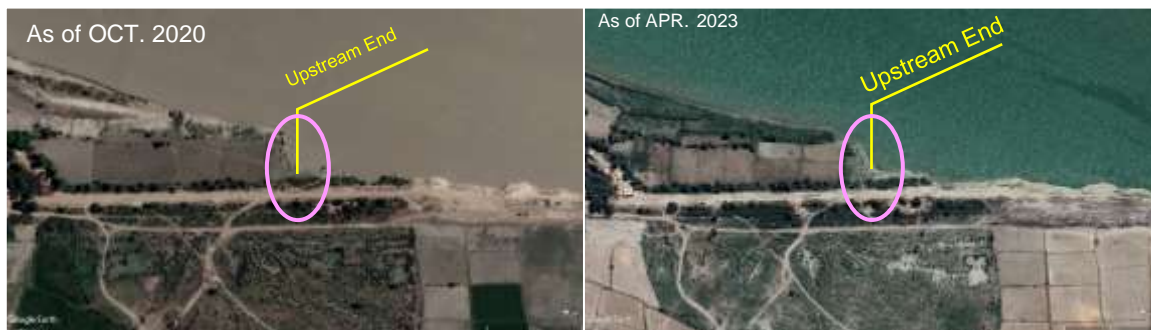
Figure 3.6.9 River Bank Erosion near the Upstream End of the Erosion and Scouring Protection Works

The upstream end of the countermeasure is the point where the erosion has not been in progress since 2020 (Figure 3.6.9), referring to the past satellite image, and the downstream end is the connection point with the existing bund. The extension of the countermeasure is about 850 m. Figure 3.6.10 shows the area of the erosion and scouring protection works.

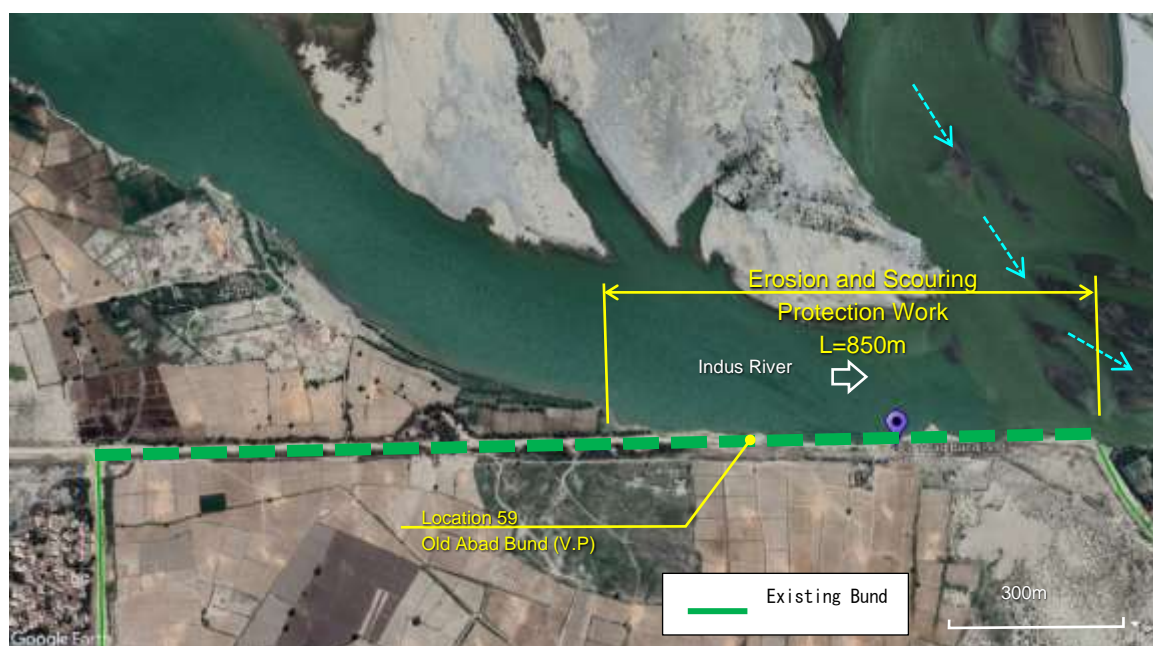
Figure 3.6.10 Area of Erosion and Scouring Protection Work

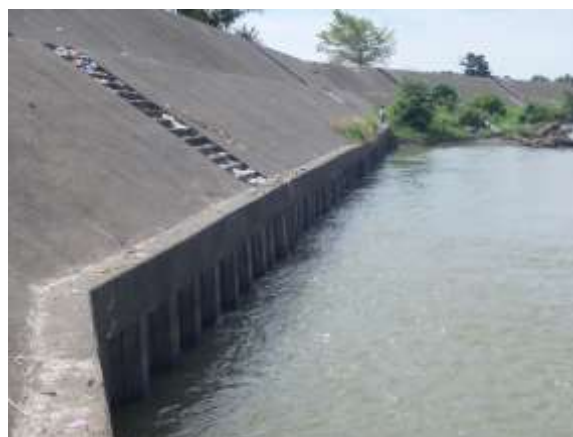
**Photo 3.6.8 Sample of Sheet Pile Revetment
in Front of a Bund (Philippines)**

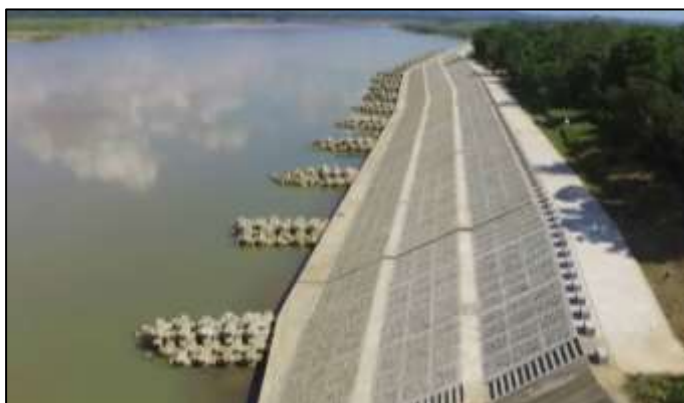
**Photo 3.6.9 Spurs with Concrete Blocks
(Philippines)**

necessary to determine the required weight of the concrete block in consideration of the design flow velocity and flow condition at the F/S or the subsequent stage. In this study, a 1-ton type block is used. Photo 3.6.9 shows short spurs with concrete block.

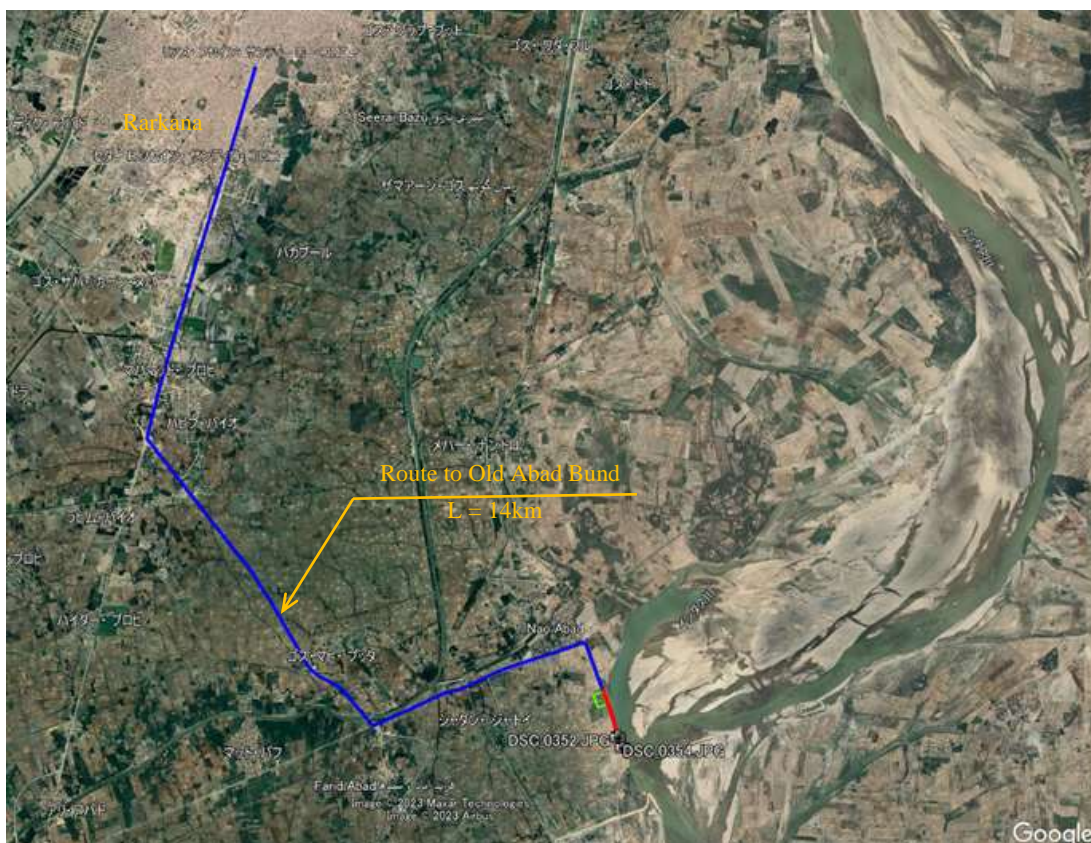
Figure 3.6.17 Transportation Route to Erosion Measures Area

Figure 3.6.17 shows the transportation route set under the above conditions, and Figure 3.6.18 shows the stockyard. The stockyard will be approximately 150m x 150m.

- ✓ As a general rule, no cofferdam will be constructed.
- ✓ Enter the construction site from the north. A stockyard (materials and equipment storage area) will be established on the flat ground inside the bund near the entrance.
- ✓ The construction road will use the existing bund.
- ✓ Materials and equipment will basically be procured at Larkana (L=15km).

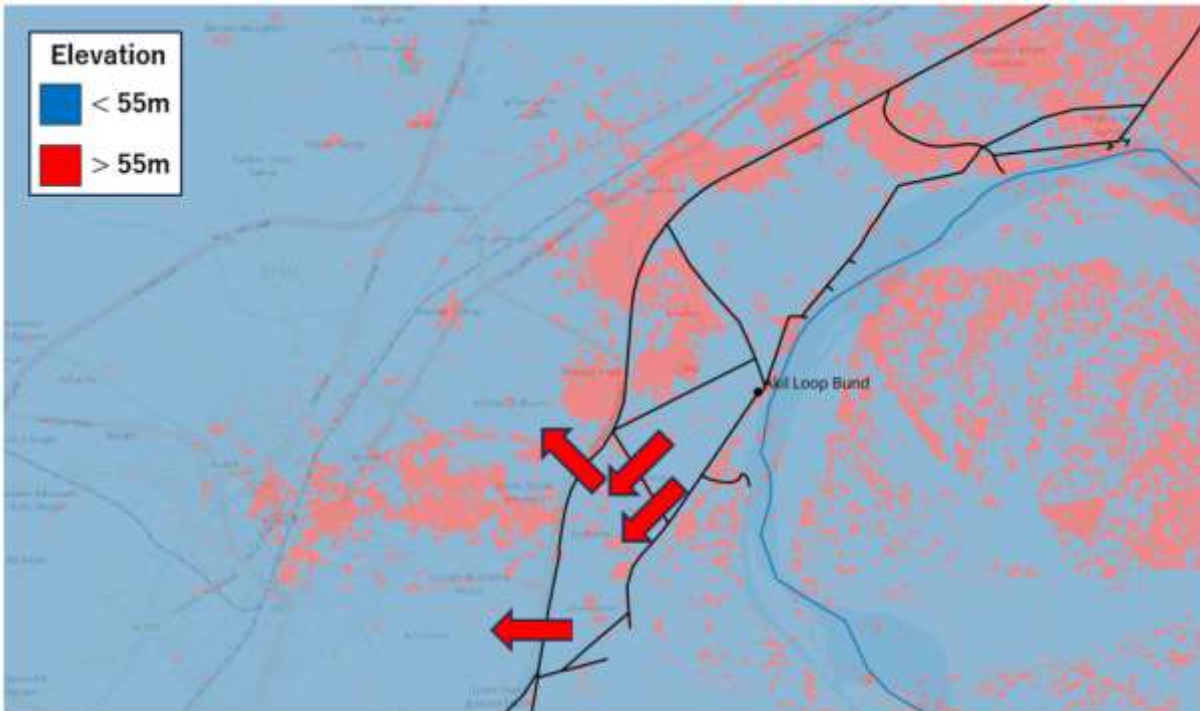
Figure 3.7.3 Assumption of Flood Expansion near Akil Loop Bund with Ground Elevation Map

However, if the rear bunds fail to prevent flooding, the flooding area may extend to areas where the ground elevation is lower than that near the bunds (55 m = 180.45 ft). Figure 3.7.3 and Figure 3.7.4 show the assumption of flood expansion near Akil Loop Bund with a ground elevation map and surrounding map.

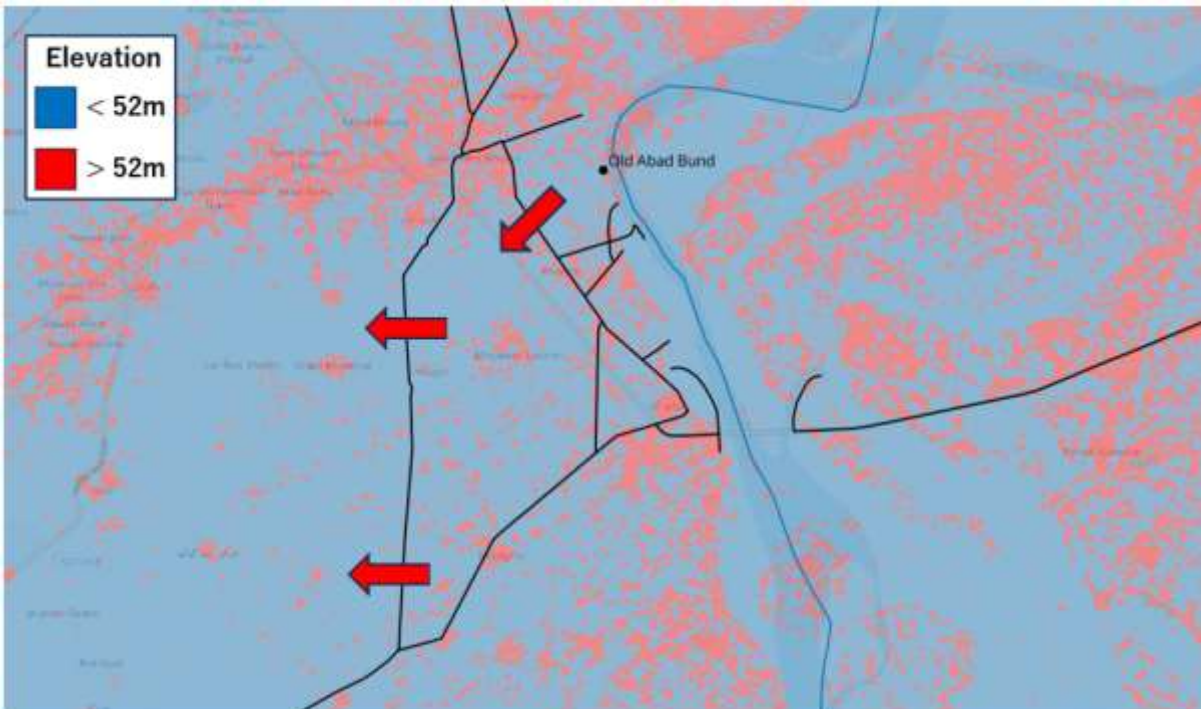
Figure 3.7.8 Assumption of Flood Expansion near Old Abad Bund with Ground Elevation Map

However, if the rear bunds fail to prevent flooding, the flooding area may extend to areas where the ground elevation is lower than that near the bunds (52 m = 170.60 ft). Figure 3.7.8 and Figure 3.7.9 show the assumption of flood expansion near Old Abad Bund with a ground elevation map and surrounding map.

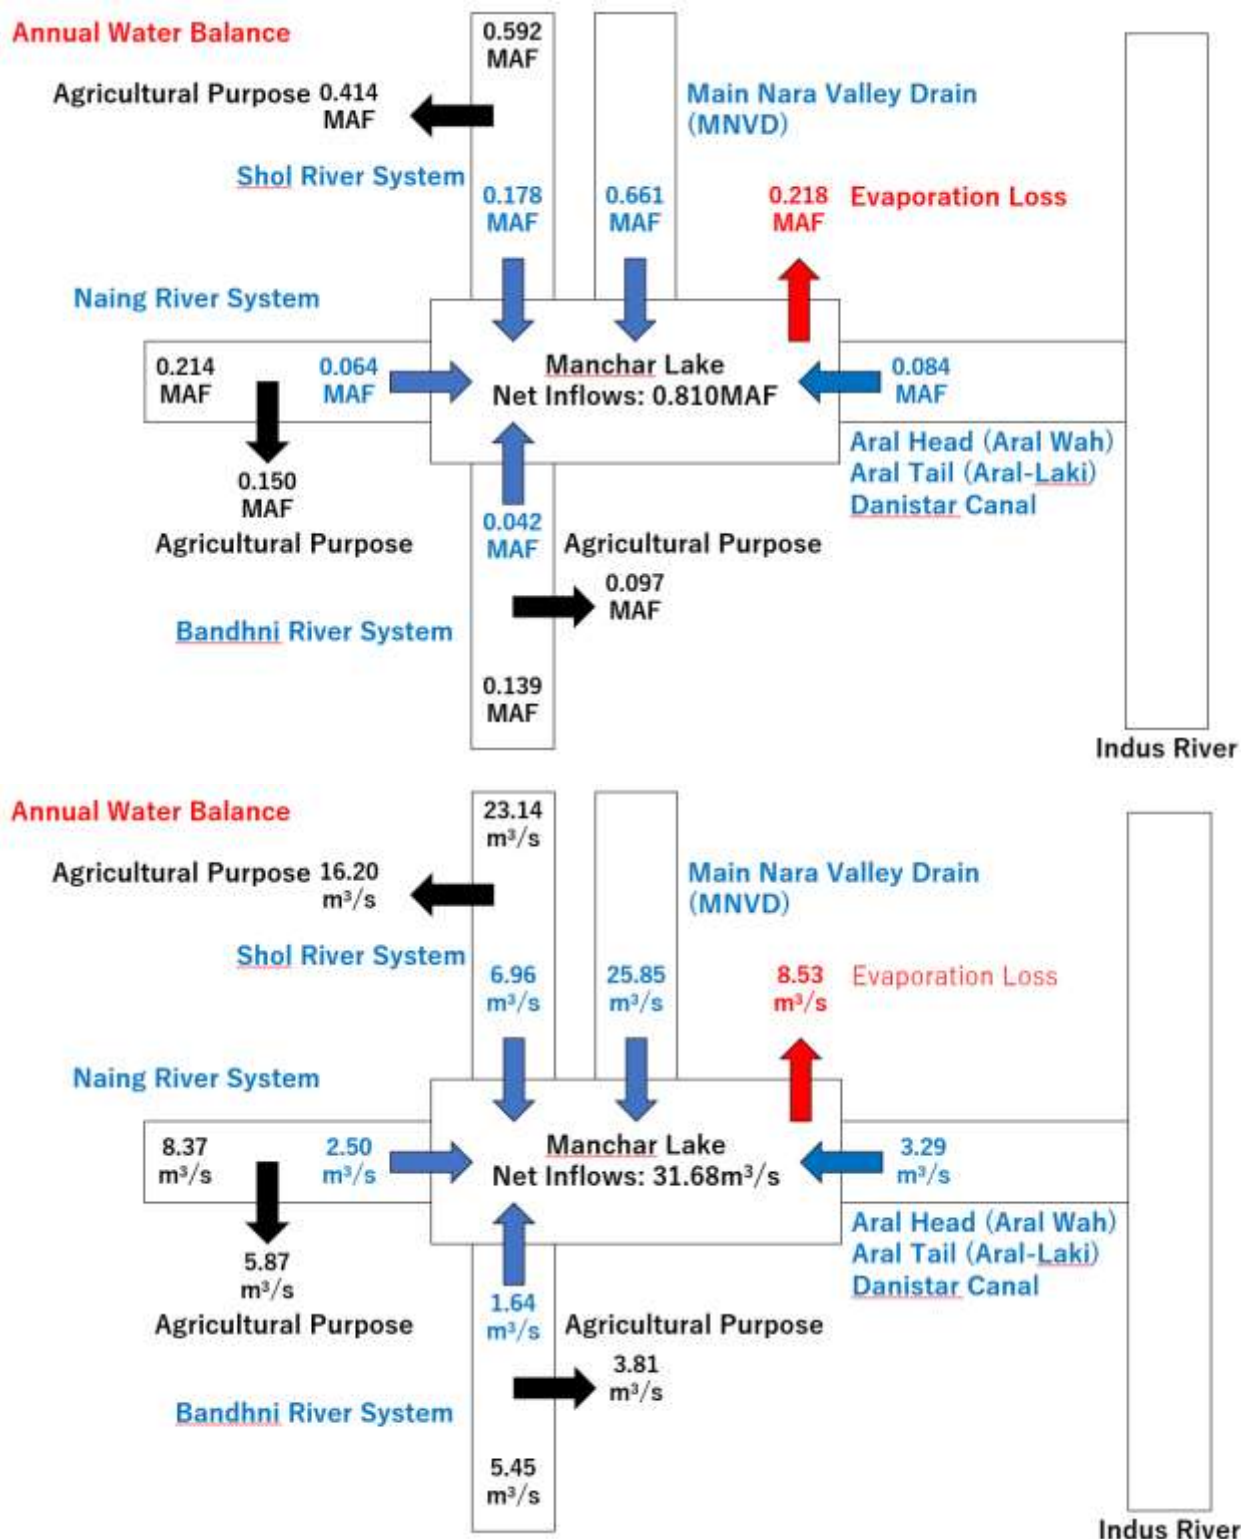
Figure 4.1.5 Current Water Balance Around Lake Manchar

According to “Feasibility Study / Planning for Supplying Ecological Flows in Manchar Lake” (2017 F/S Report), the current and future water balances around Manchar Lake can be summarized in Table 4.1.1, Figure 4.1.5 and Figure 4.1.6. Proposed measures to improve the water quality of Lake Manchar is listed in Table 4.1.2, and the location map of these measures is shown in Figure 4.1.7.

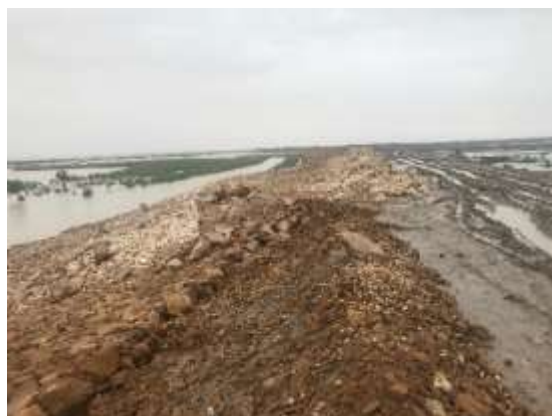
Also, as of July 2023, at some parts of the existing MCB rehabilitation of stone pitching was ongoing. The site inspection was carried out immediately after several days of rain, but at that time, the top of the bund was not paved, which hindered the running of vehicles (see Photo 4.2.1). In addition, the area immediately behind the MCB was a low-lying area, and at the site inspection in July 2023, it was widely flooded (see Photo 4.2.2).

Photo 4.2.1 Situation of the top and lake side of the MCB

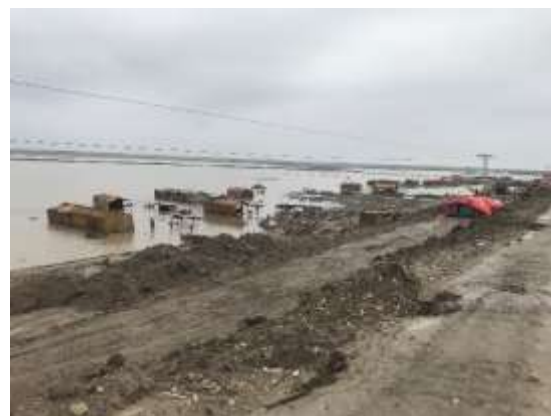
Photo 4.2.2 Situation of the landside of the MCB

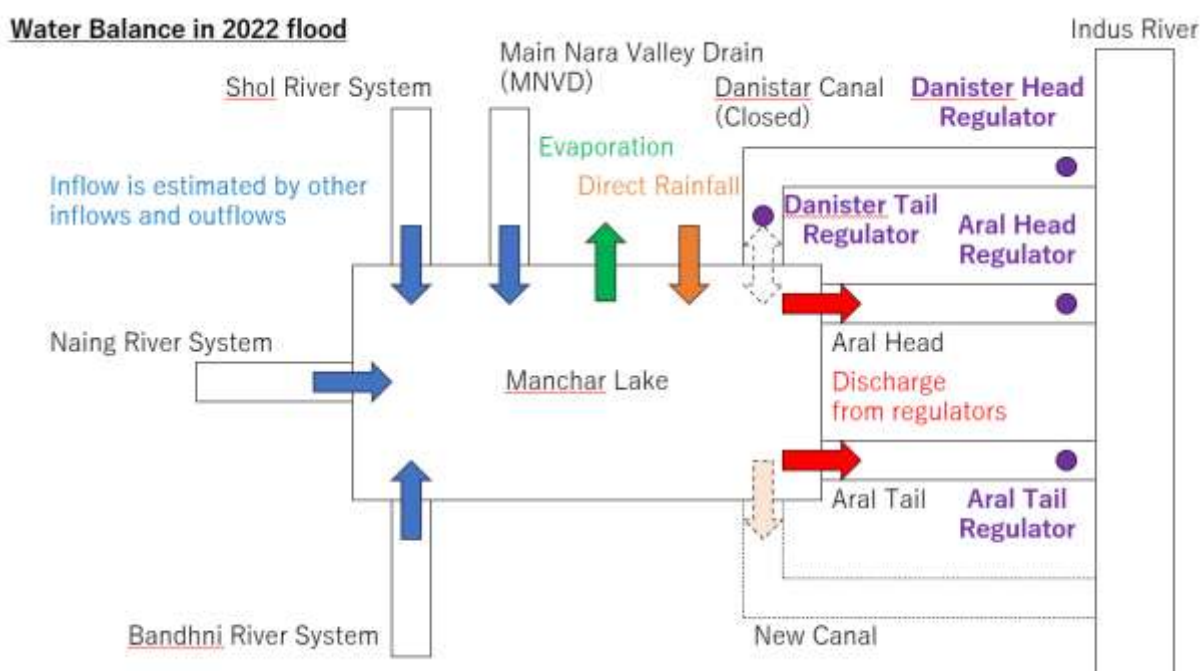
Figure 4.6.9 Water Balance During the 2022 Flood

Based on the water balance during the 2022 flood shown in Figure 4.6.9, the inflow during the 2022 flood was estimated. The total inflow to Lake Manchar was back-calculated from various time series data of discharge of each regulator during the 2022 flood, direct rainfall to Lake Manchar (using data from nearby rain stations), evaporation (assuming 0.8 times PAN evaporation), and water level of Lake Manchar. The waveform of the estimated inflow was also scrutinized.

In addition, in Lake Manchar, the artificial breach was carried out in early September. The amount of flood caused by artificial breaches was also considered in this study.

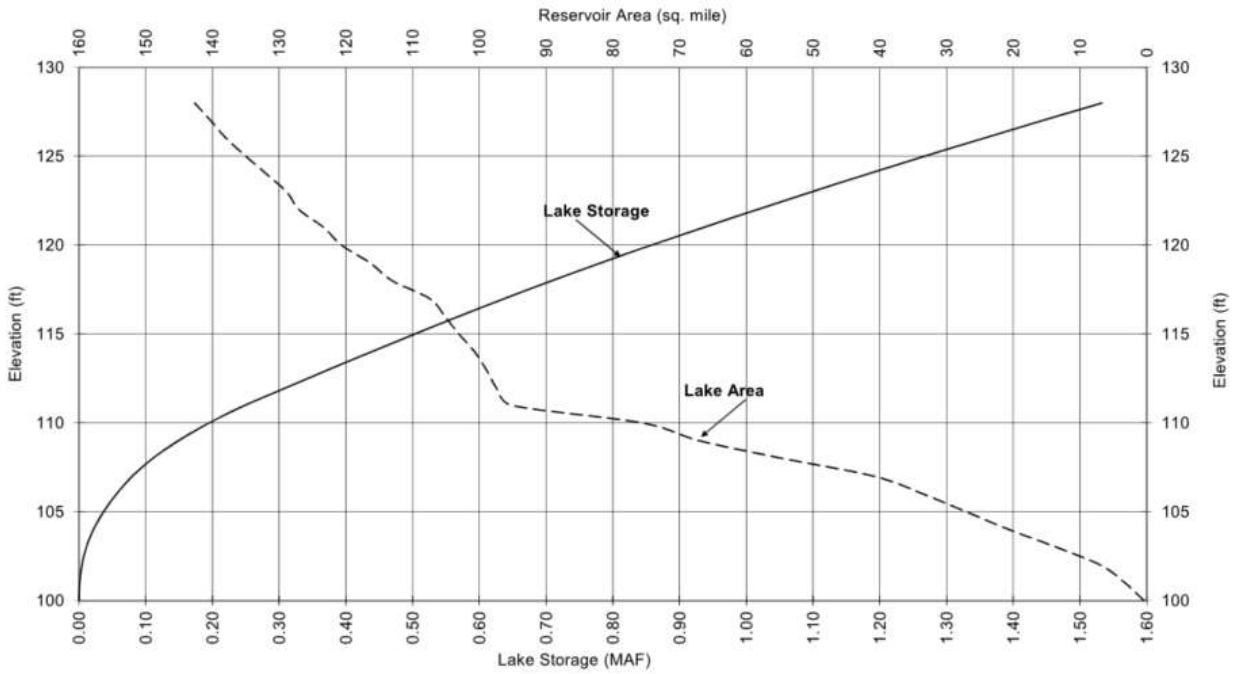
Figure 4.6.10 Relationship between HAV (Water Level, Surface Area, and Capacity) of Lake Manchar

The relationship between the HAV (water level, surface area, and capacity) of Lake Manchar is shown in Figure 4.6.10, and the diagram published in the 2017 F/S Report is quoted.
