**ISLAMIC REPUBLIC OF PAKISTAN
FEDERAL FLOOD COMMISSION (FFC)**

**TECHNICAL ADVISOR
ON
FLOOD MANAGEMENT
IN
ISLAMIC REPUBLIC OF PAKISTAN**

**FINAL REPORT
VOLUME-2
PRELIMINARY FEASIBILITY STUDY**

CTI ENGINEERING INTERNATIONAL CO., LTD.

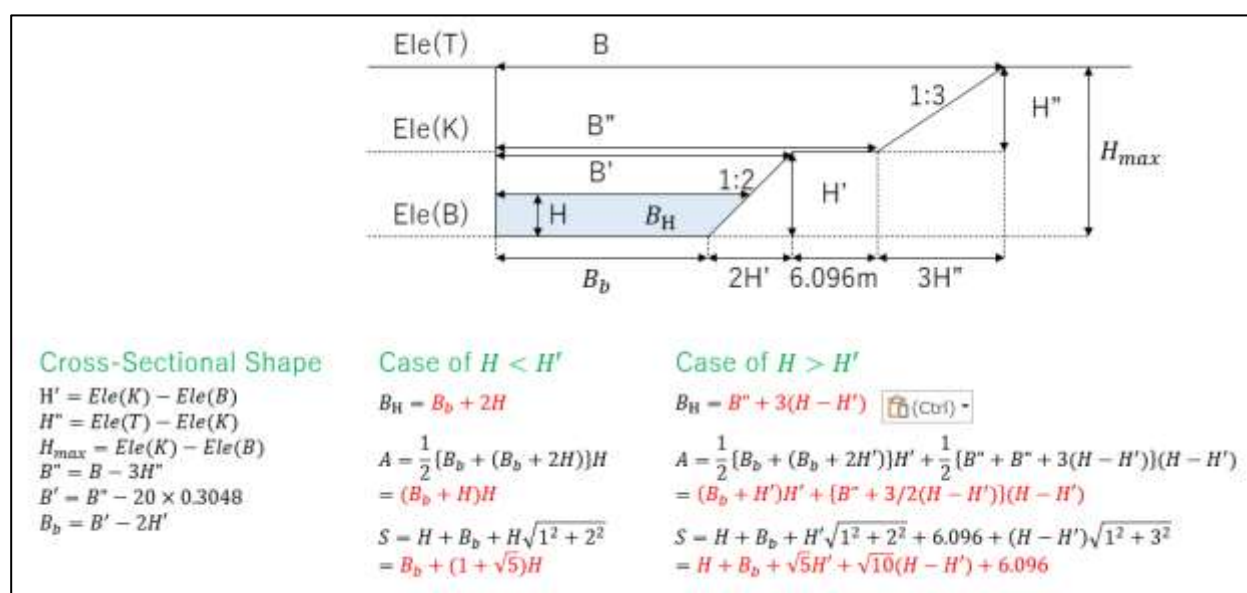
Figure 4.6.40 Section Setting of Widening of the Existing Waterways (Aral Tail and RBOD-II) (ALT2)

Part	Station	Cross-Sectional Form	
Method	—	—	Non uniform flow calculation is conducted as 2 separate canals (original direction and RBOD2)
RBOD2	0+000~2+100	Bund Elevation	131ft at 2+100 Bund height decreases by slope of 1/9000 toward downstream
		Flood Fringe Elevation	113ft at 2+100 Bund height decreases by slope of 1/9000 toward downstream
		River Bed Elevation	98.5ft at 0+000 River bed height increases by slope of 1/9000 toward upstream
Aral Tail	2+300~5+300	Bund Elevation	131ft (the same as current height)
		Flood Fringe Elevation	113ft (the same as current height)
		River Bed Elevation	98.5ft (the same as bed level of Aral Tail Regulator)
Inside Lake	5+500~6+500	—	Not modeled. Water level sets the same as Manckar Lake

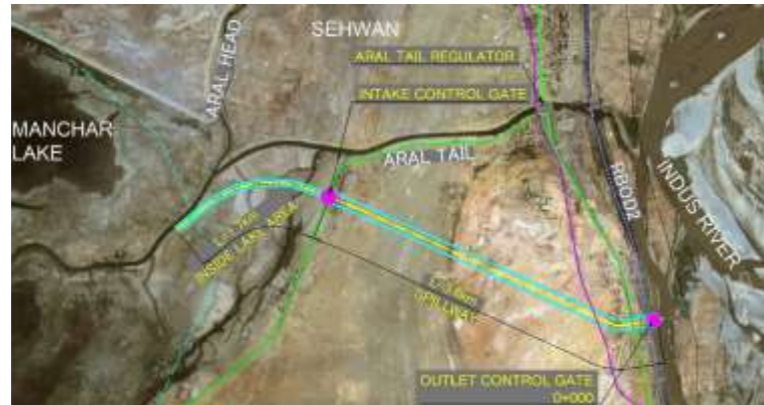
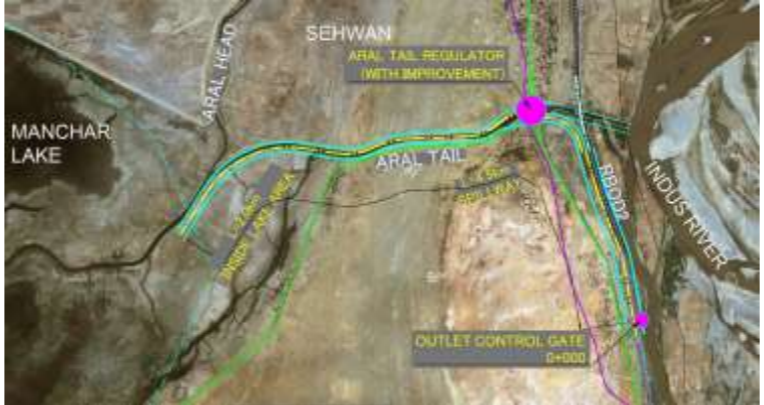
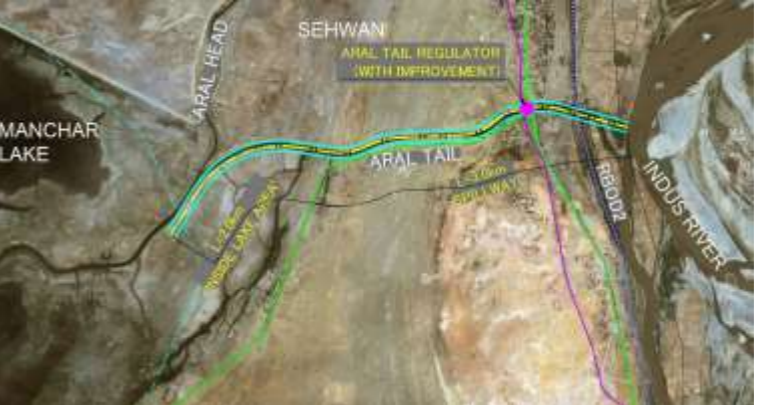
Alternative 1: New Spillway	Alternative 2: Widening Existing Canal(Aral Head)	Alternative 3: Widening Existing Canal(Aral Tail)																																																				
Overview (Plan)

General	<ul style="list-style-type: none"> Establish a spillway to discharge directly from the eastern shore of Manchar Lake to the Indus River by natural flow Assuming that the channel would be used only when the water level of Manchar Lake is high, water gates will be installed on the inlet side (on the Manchar Lakeside) and the outlet side (on the Indus Riverside). The existing Aral Tail and Regulator will remain as they are. 	<ul style="list-style-type: none"> Widen the Aral Tail and RBOD and release the flood water naturally into the Indus River via these existing canals from the eastern shore of Manchar Lake. The purpose is to avoid a cut section in the middle of "Alternative 1: New Spillway" and to set the outlet towards the downstream side along the Indus River via the RBOD-II to ensure a longitudinal slope. 	<ul style="list-style-type: none"> Widen the Aral Tail and discharge the flood water to the Indus River by natural flow via an existing canal from the eastern shore of Manchar Lake The purpose is to avoid a cut section in the middle of "Alternative 1: New Spillway" and to use the existing canal effectively.

Route	Route connecting the eastern shore of Manchar Lake to the right bank of the Indus River which is 2.5 km downstream from the confluence of Aral Tail.	The route connecting the right bank of the Indus River which is 2.5 km downstream from the confluence of Aral Tail via Aral Tail and RBOD-II	Same route as Aral Tail																																																				
Canal Dimensions	<table border="1"> <thead> <tr> <th></th> <th>Canal Width (m)</th> <th>Slope</th> <th>Length (km)</th> </tr> </thead> <tbody> <tr> <td>Spillway</td> <td>100</td> <td>1/1500</td> <td>3.6</td> </tr> <tr> <td>Lake Area</td> <td></td> <td>LEVEL</td> <td>1.7</td> </tr> <tr> <td>Total</td> <td></td> <td></td> <td>5.3</td> </tr> </tbody> </table>		Canal Width (m)	Slope	Length (km)	Spillway	100	1/1500	3.6	Lake Area		LEVEL	1.7	Total			5.3	<table border="1"> <thead> <tr> <th></th> <th>Canal Width (m)</th> <th>Slope</th> <th>Length (km)</th> </tr> </thead> <tbody> <tr> <td>Widening RBOD-II</td> <td>140</td> <td>1/9000</td> <td>2.0</td> </tr> <tr> <td>Widening Aral Tail</td> <td>110</td> <td>LEVEL</td> <td>2.5</td> </tr> <tr> <td>Lake Area</td> <td></td> <td>LEVEL</td> <td>2.0</td> </tr> <tr> <td>Total</td> <td></td> <td></td> <td>6.5</td> </tr> </tbody> </table>		Canal Width (m)	Slope	Length (km)	Widening RBOD-II	140	1/9000	2.0	Widening Aral Tail	110	LEVEL	2.5	Lake Area		LEVEL	2.0	Total			6.5	<table border="1"> <thead> <tr> <th></th> <th>Canal Width (m)</th> <th>Slope</th> <th>Length (km)</th> </tr> </thead> <tbody> <tr> <td>Widening Aral Tail</td> <td>100</td> <td>LEVEL</td> <td>3.0</td> </tr> <tr> <td>Lake Area</td> <td></td> <td>LEVEL</td> <td>2.0</td> </tr> <tr> <td>Total</td> <td></td> <td></td> <td>5.0</td> </tr> </tbody> </table>		Canal Width (m)	Slope	Length (km)	Widening Aral Tail	100	LEVEL	3.0	Lake Area		LEVEL	2.0	Total			5.0

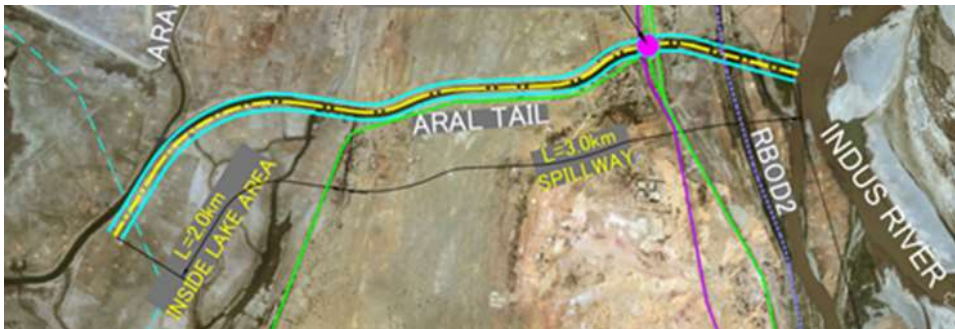
Figure 4.8.2 Canal Widening Range

1) Canal widening (see Figure 4.8.2)

- Canal widening: Excavation to expand the river width from 80m to 100m, dredging of the canal bottom
- Canal bund construction; embankment

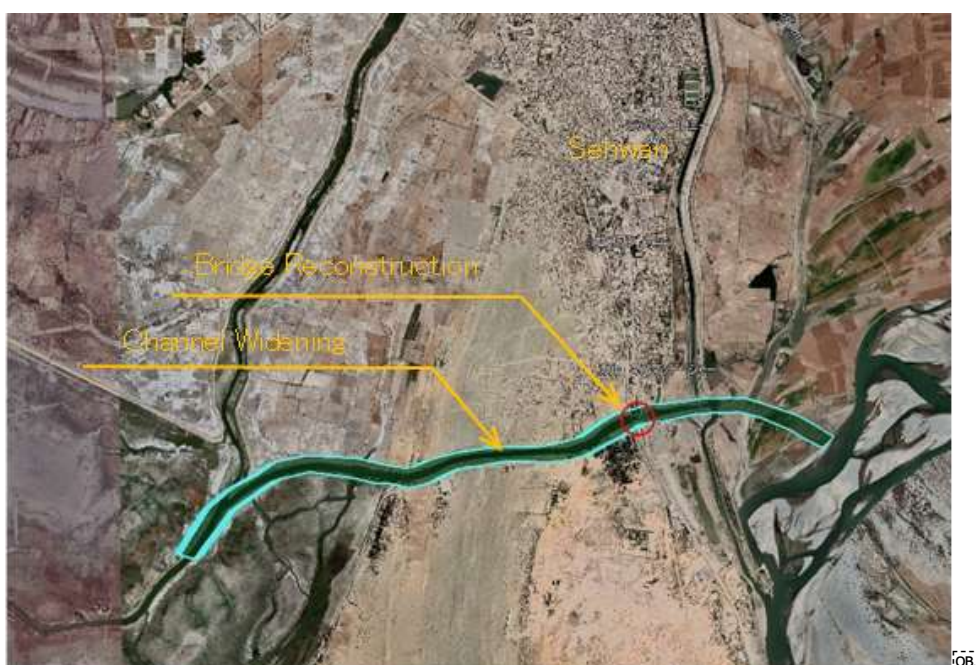
Figure 4.8.4 Sewan and Canal Widening Locations

Figure 4.8.4 shows the construction location and the neighboring city of Sehwan.

- Basically, construction will be carried out from October to June when the water level is low.
- Separate the construction area and construct a cofferdam to secure the flow path.
- The construction road will be installed inside the widening bund.
- The work yard will be located on flat land within the bund adjacent to the work area.
- Materials and equipment will basically be procured in the adjacent Sehwan (L=1km).

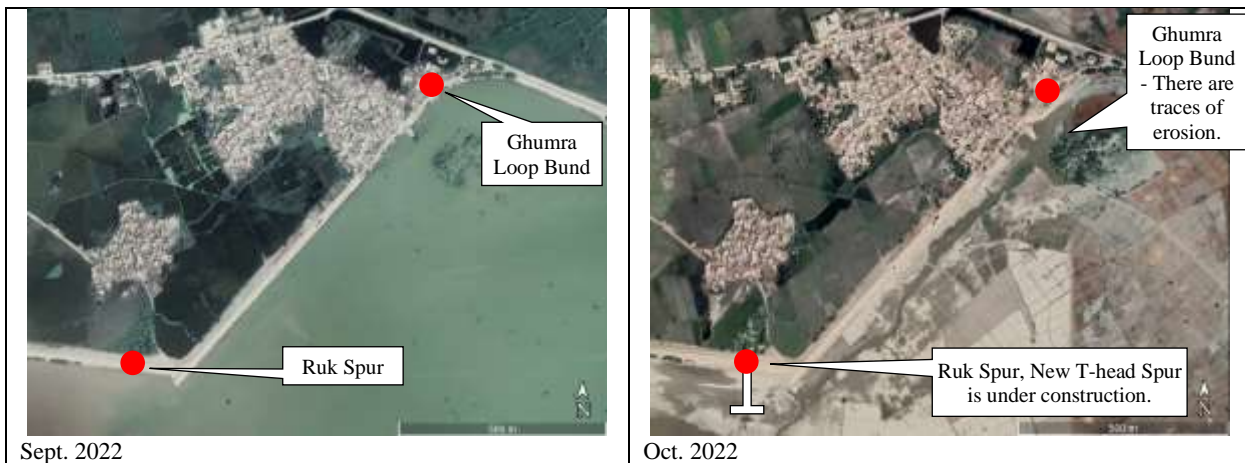
A new T-Head Spur Dike is being constructed in Ruk Loop Bund. The construction material, limestone, is being brought from a quarry in Mount Arror, Rohri (southeast of Sukkur).

In Ghumra Loop Bund, Stone Pitching on the slope and Stone Aprons on the slope bottom (foot of the dike) are required.

Figure 1.1.4 Ruk Spur and Ghumra Loop Bund, Condition during 2022 Flood

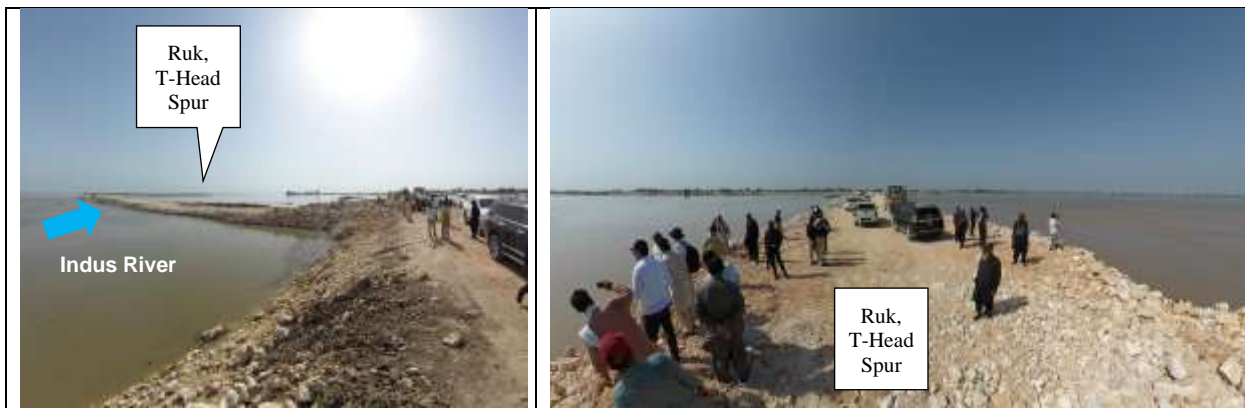
Photo 1.1.1 Ruk Spur, August 2, 2023

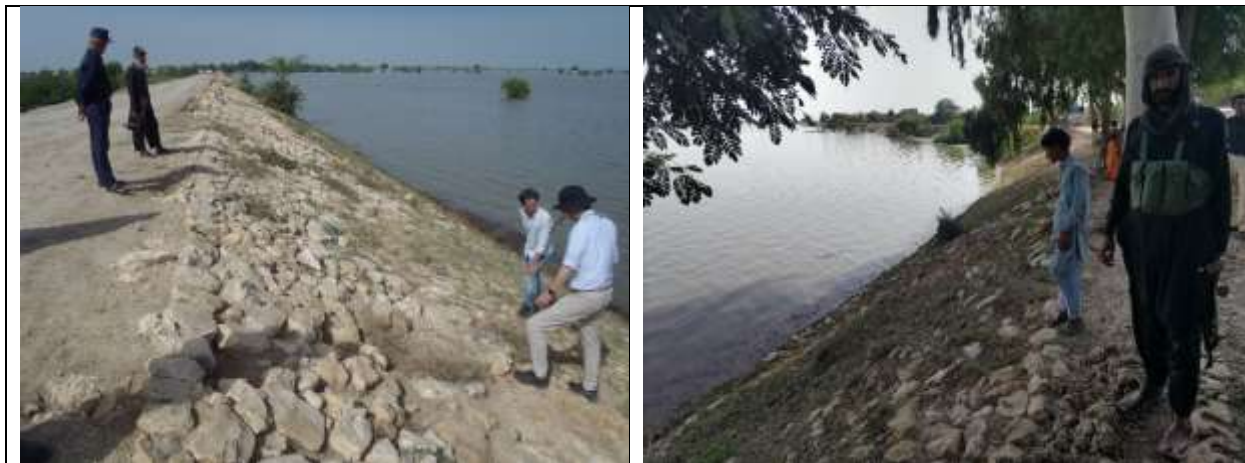
Photo 1.1.2 Ghumra Loop Bund, August 2, 2023

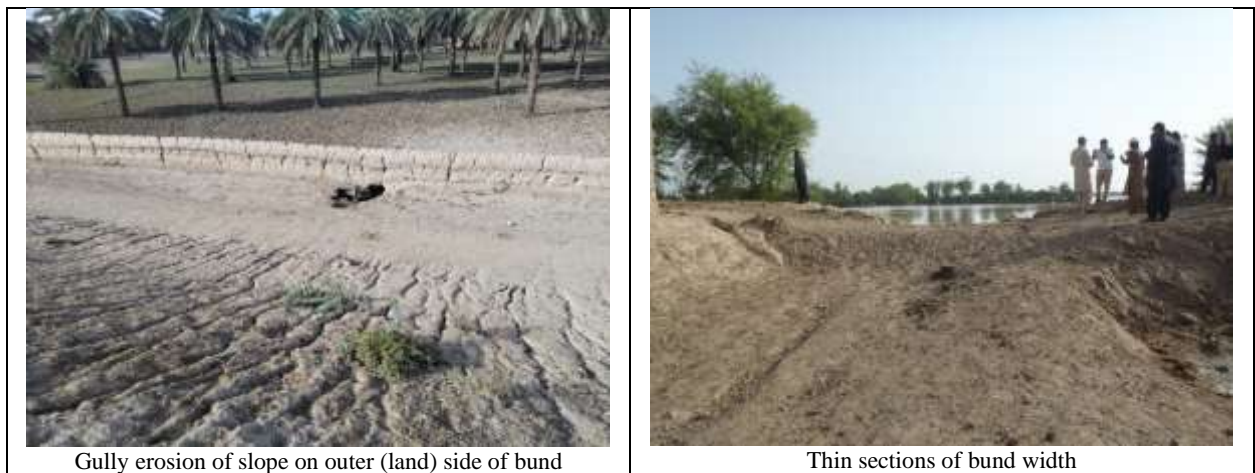
S.L.-Bund can be considered an important bund to protect the Sukkur airport from river flood, and although it was categorized in vulnerable point, no major problems were found in the field survey.

Photo 1.1.3 S.L Bund, August 2, 2023

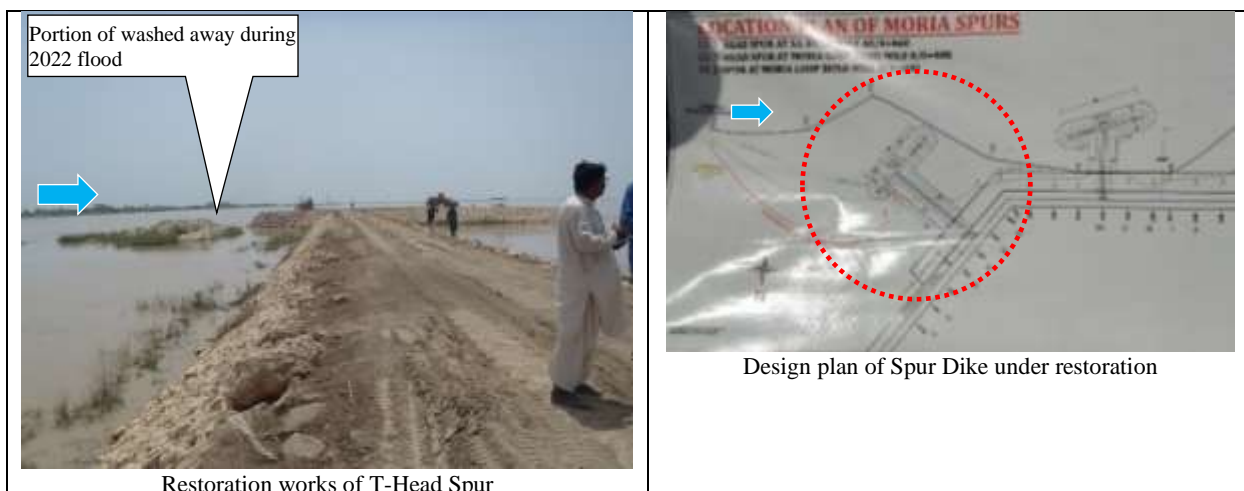
Rehabilitation of the T-Head Spur Dike, which was constructed in 2018 and damaged by the 2022 flood, is underway at Moria Loop Bund.

Photo 1.1.5 T-Head Spur Dike under restoration at Moria Loop Bund, August 3, 2023

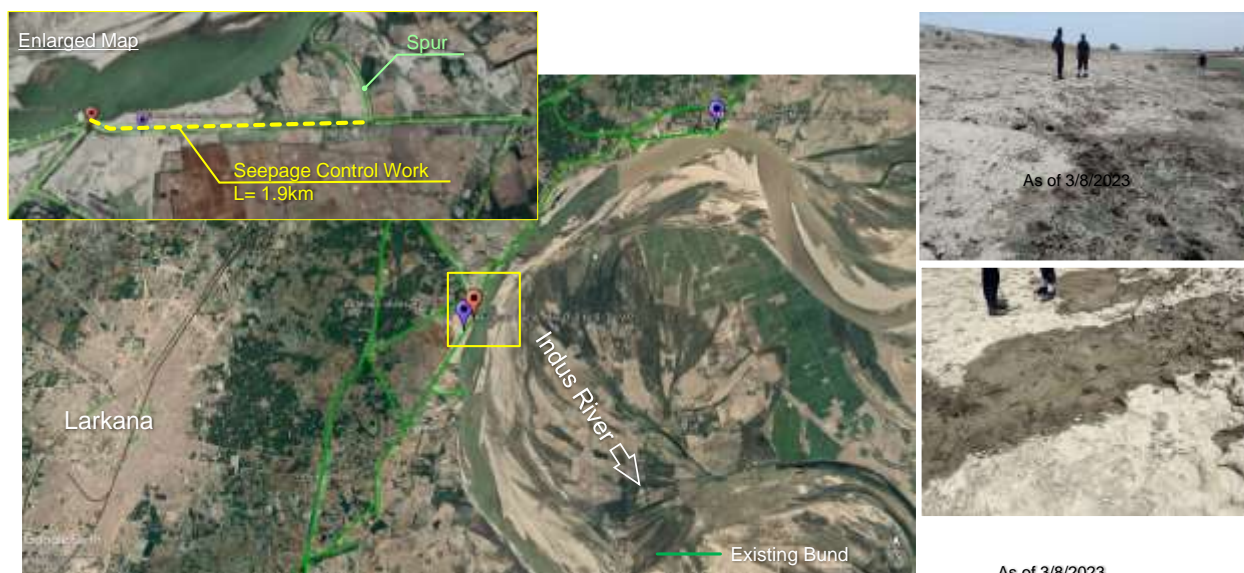
In Akil Link Bund, seepages are observed at the land side slope of bund.

Figure 1.1.8 Condition around Akil Link Bund

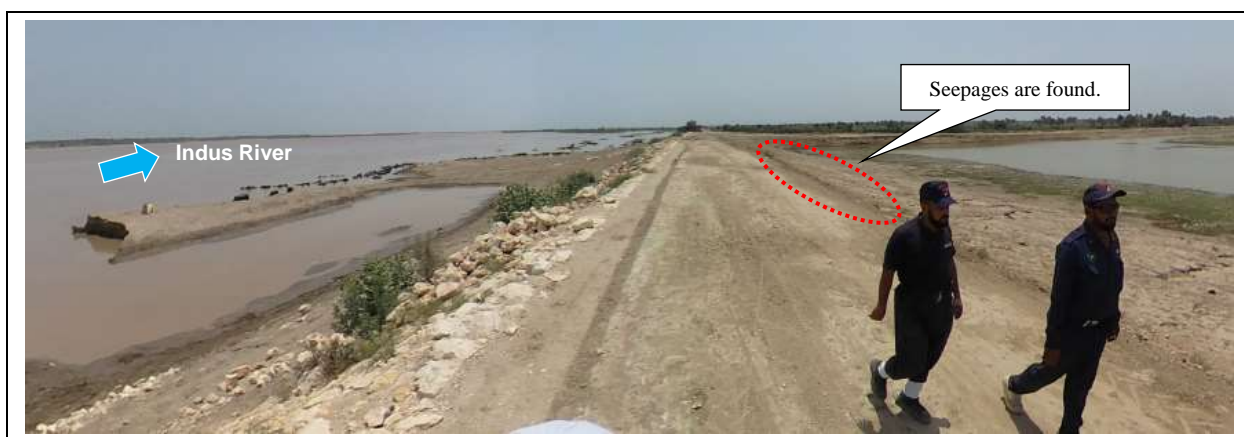
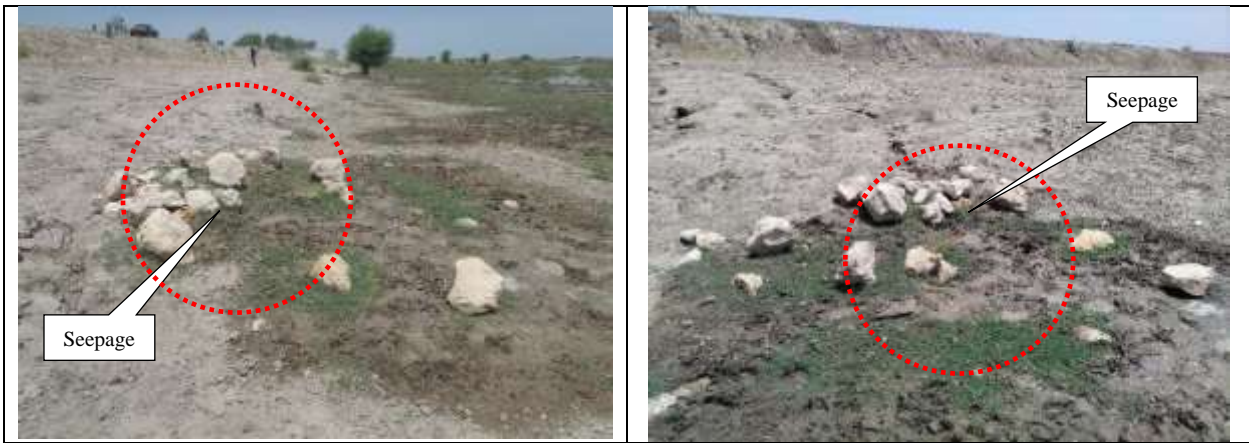
Photo 1.1.6 Akil Link Bund, August 3, 2023

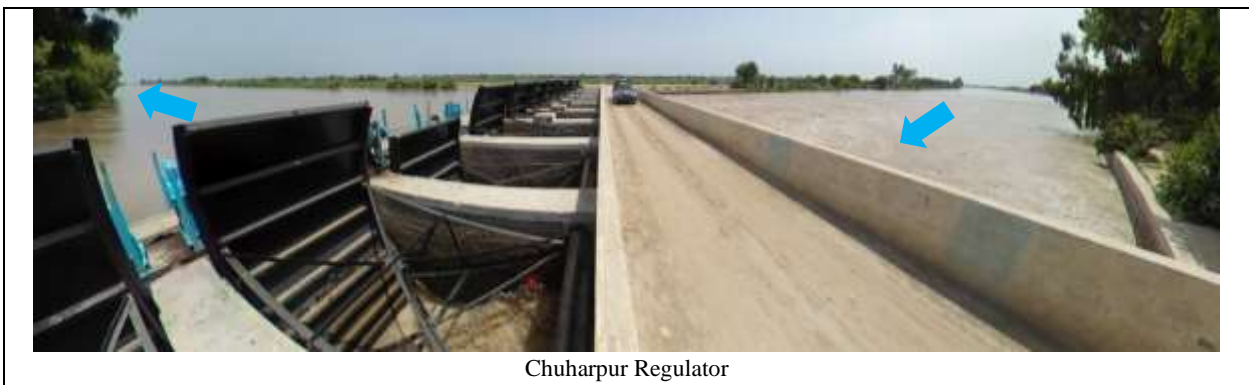
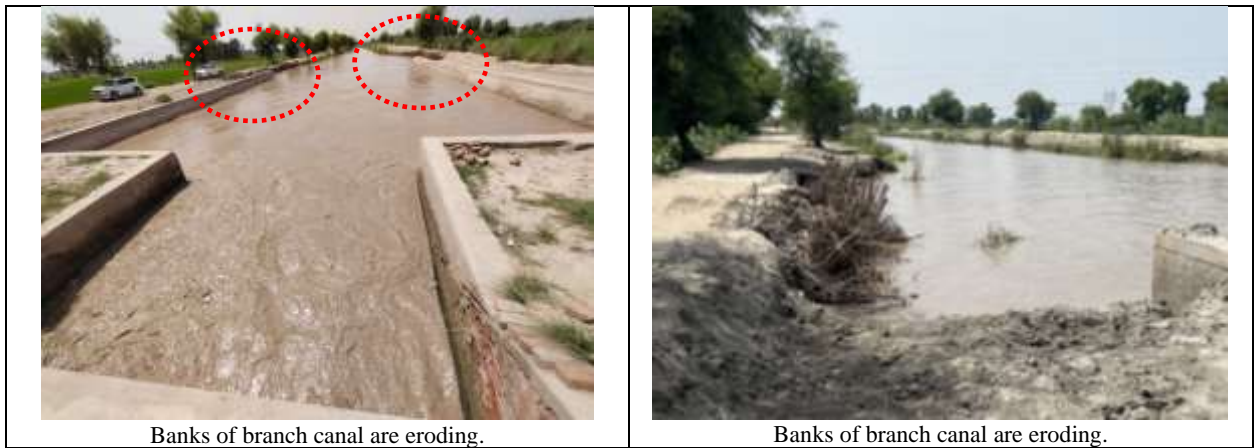
Chuharpur Regulator

Banks of branch canal are eroding.

Photo 1.1.7 Rice Canal, Chuharpur Regulator, August 3, 2023

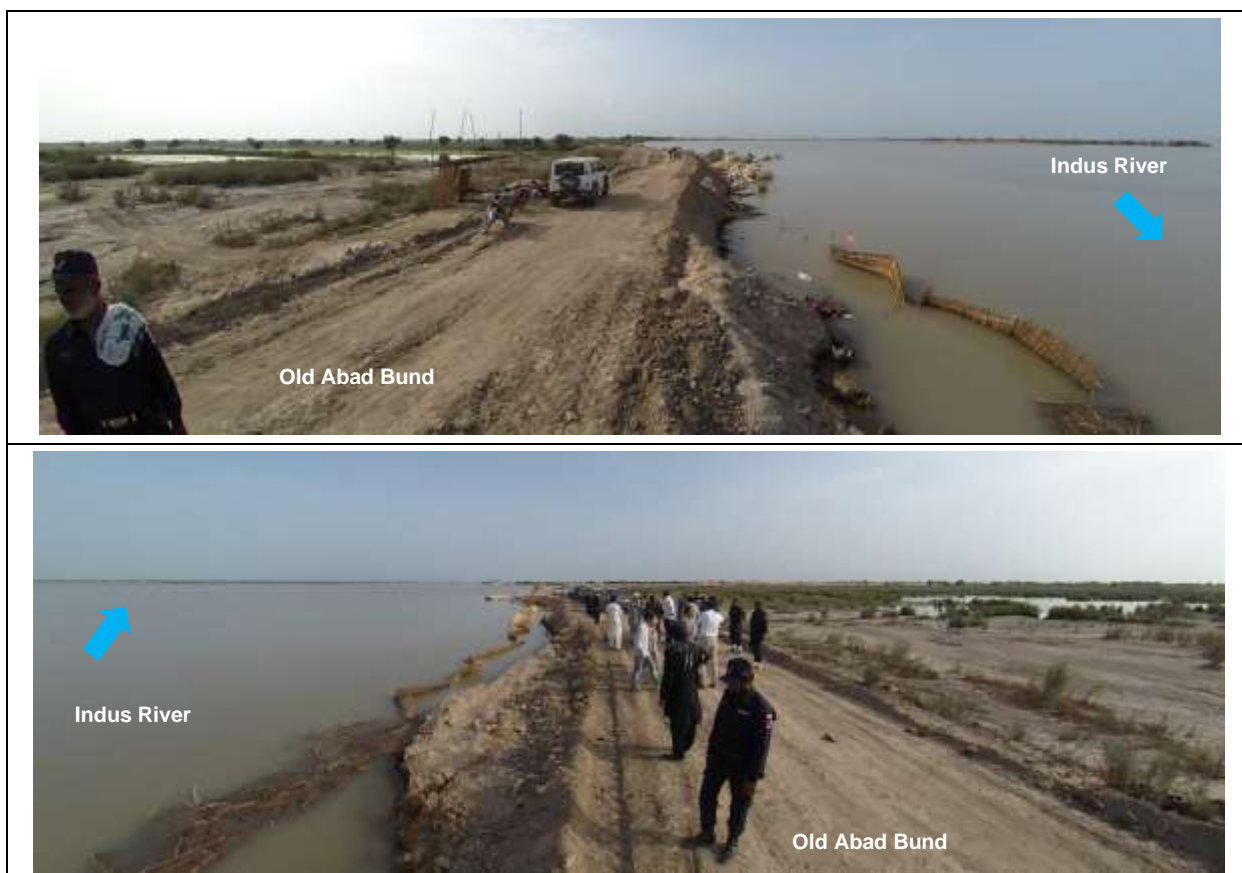
Old Abad Bund is experiencing scour and erosion due to water flow of Indus River.

Photo 1.1.10 Old Abad Bund, August 3, 2023

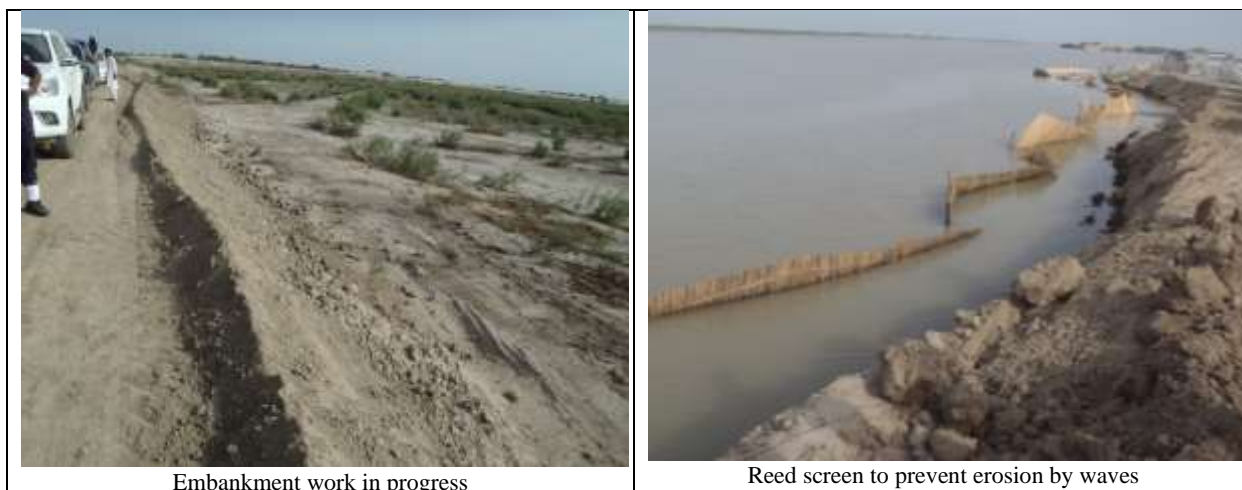
Photo 1.1.11 Construction Works at Old Abad Bund, August 3, 2023

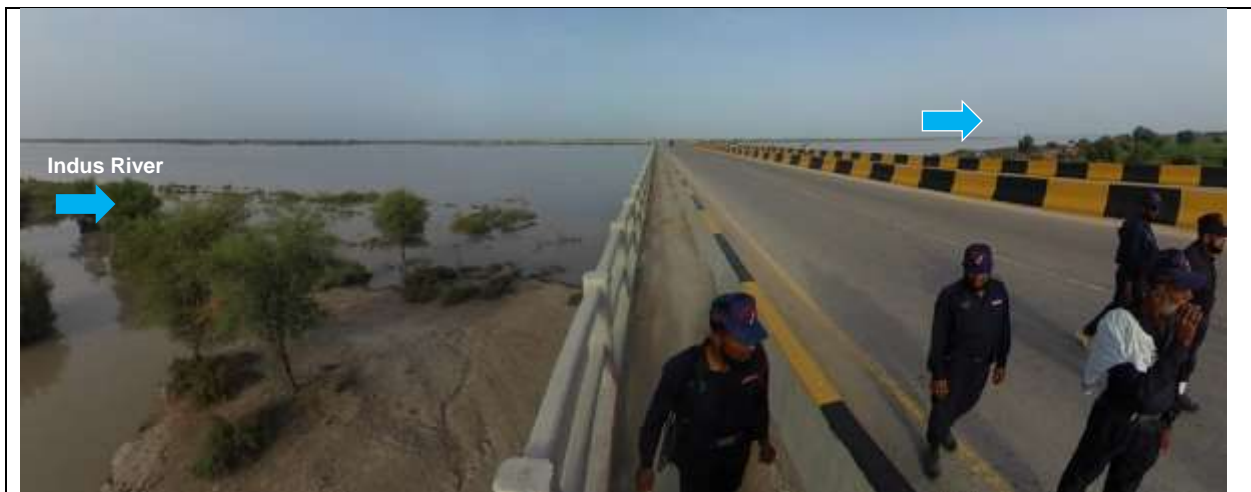
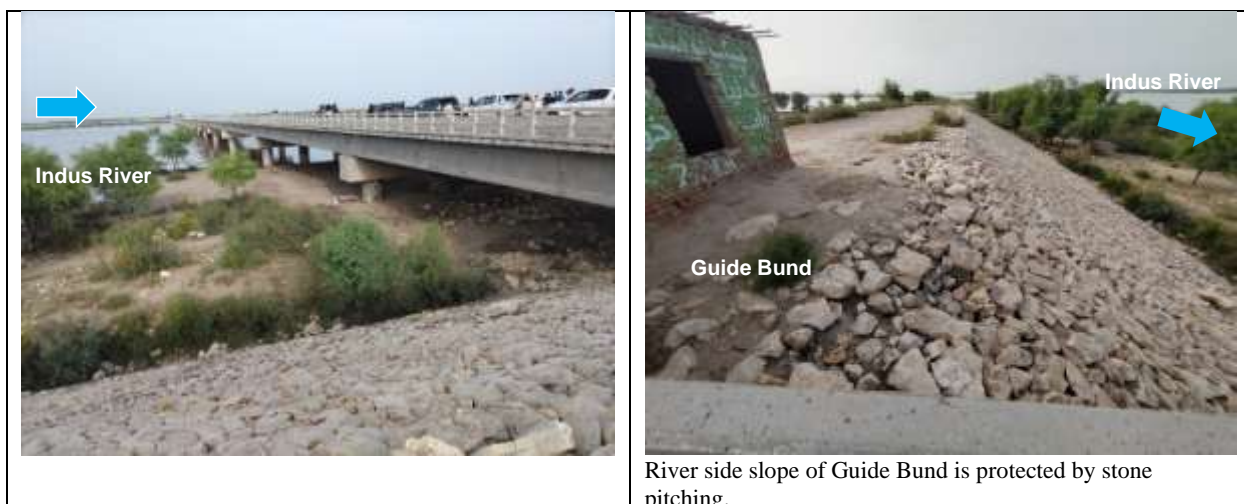
Larkana-Khairpur Bridge was opened for public in 2009. Prior to that, there were no transportation facilities across Indus River in the approximately 150 km section between Sukkur Barrage and Dadu Moro Bridge.

Photo 1.1.12 Larkana Khairpur Bridge and Guide Bund, August 3, 2023

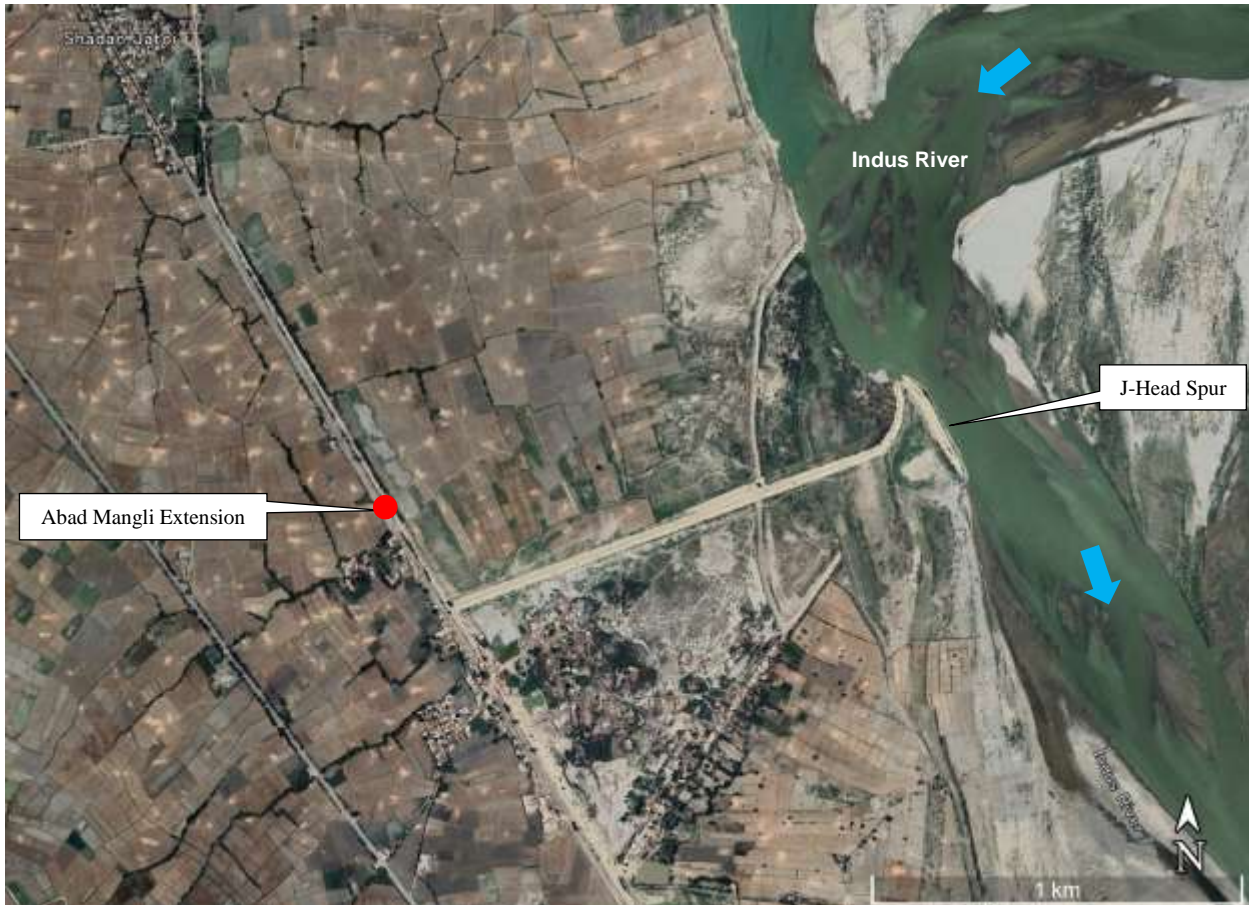
According to PID Sindh, restoration of stone pitching and stone aprons on dike slopes are required, but due to the effect of J-Head Spur located downstream of Abad Mangli Extension, the risk of erosion caused by river flow was not so high and the restoration work was not considered to be urgent.

Figure 1.1.15 Location of Abad Mangli Extension, August 4, 2023

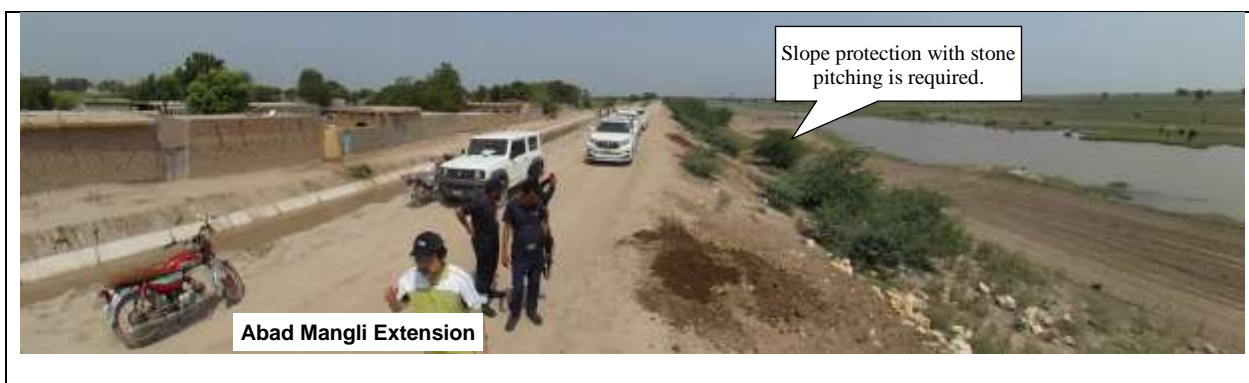
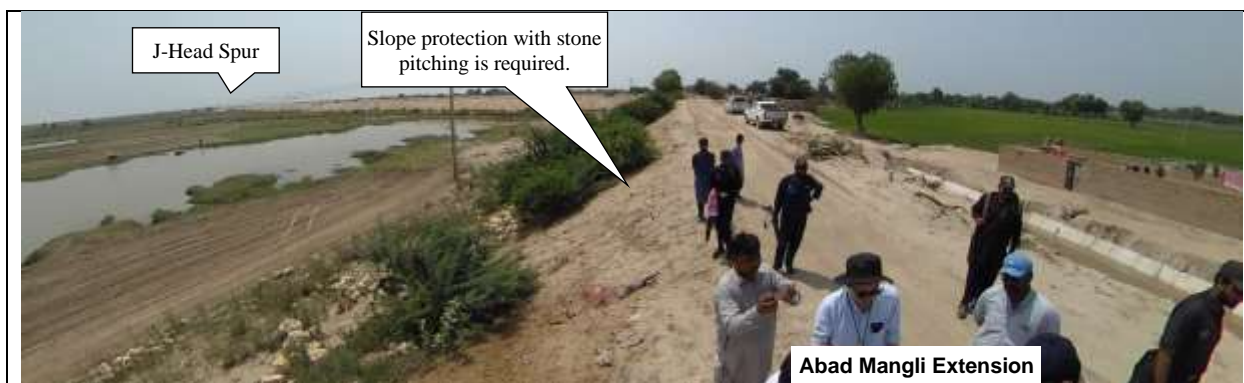
Photo 1.1.13 Abad Mangli Extension, August 4, 2023

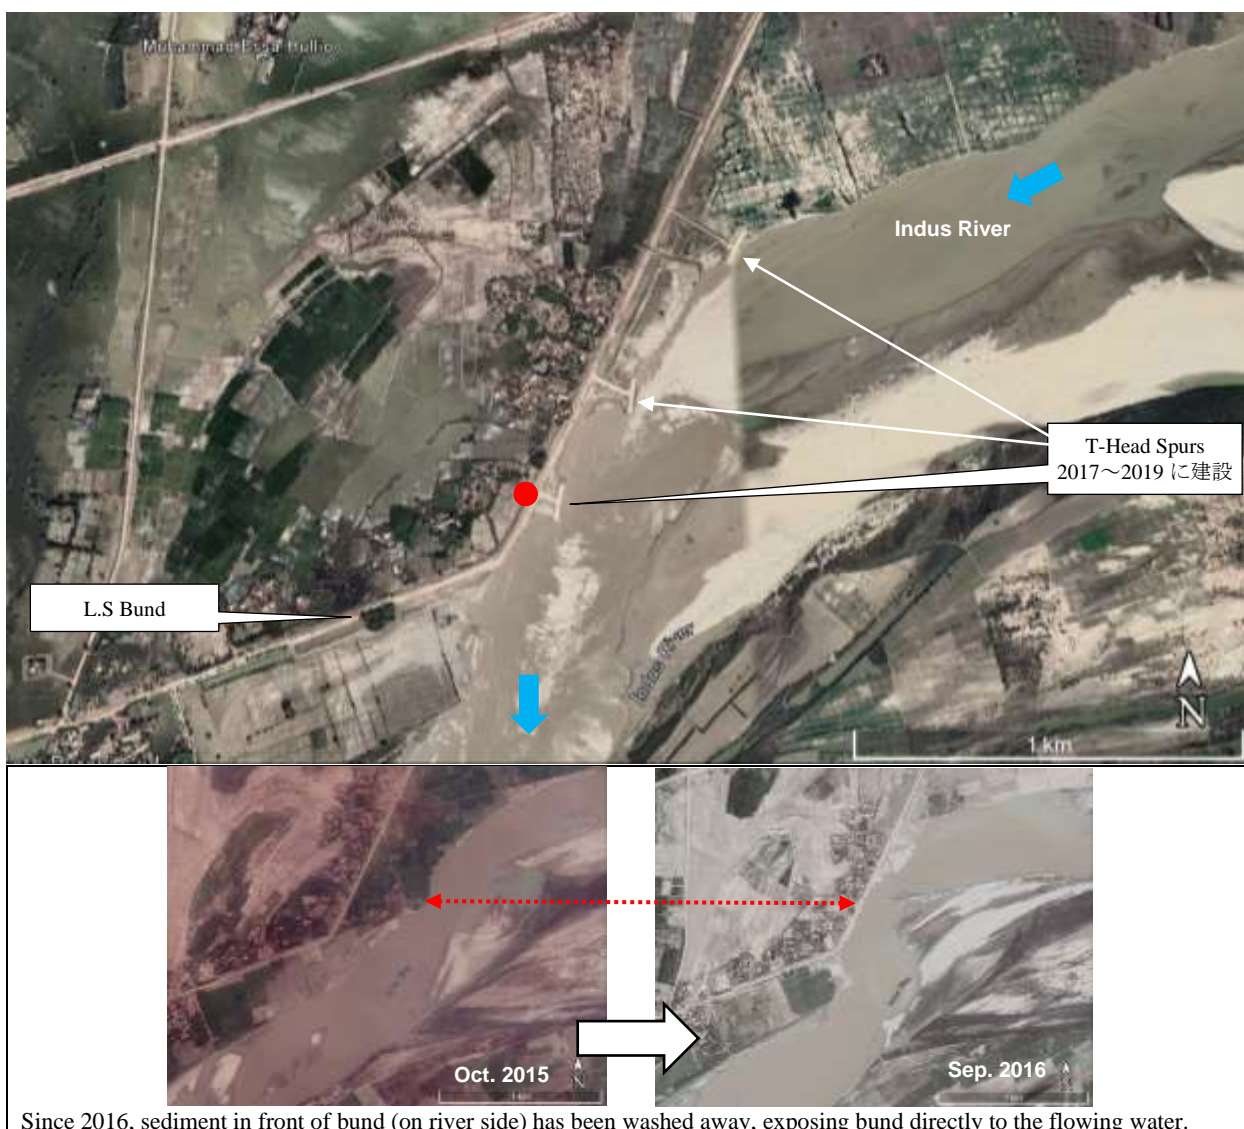
Around 2016, Indus River flow started hitting this location of bund directly, and several T-Head Spurs have been constructed to protect bund. Spur Dikes have been properly maintained.

Since 2016, sediment in front of bund (on river side) has been washed away, exposing bund directly to the flowing water.

Figure 1.1.16 Location of L.S. Bund, Hakra Point, August 4, 2023

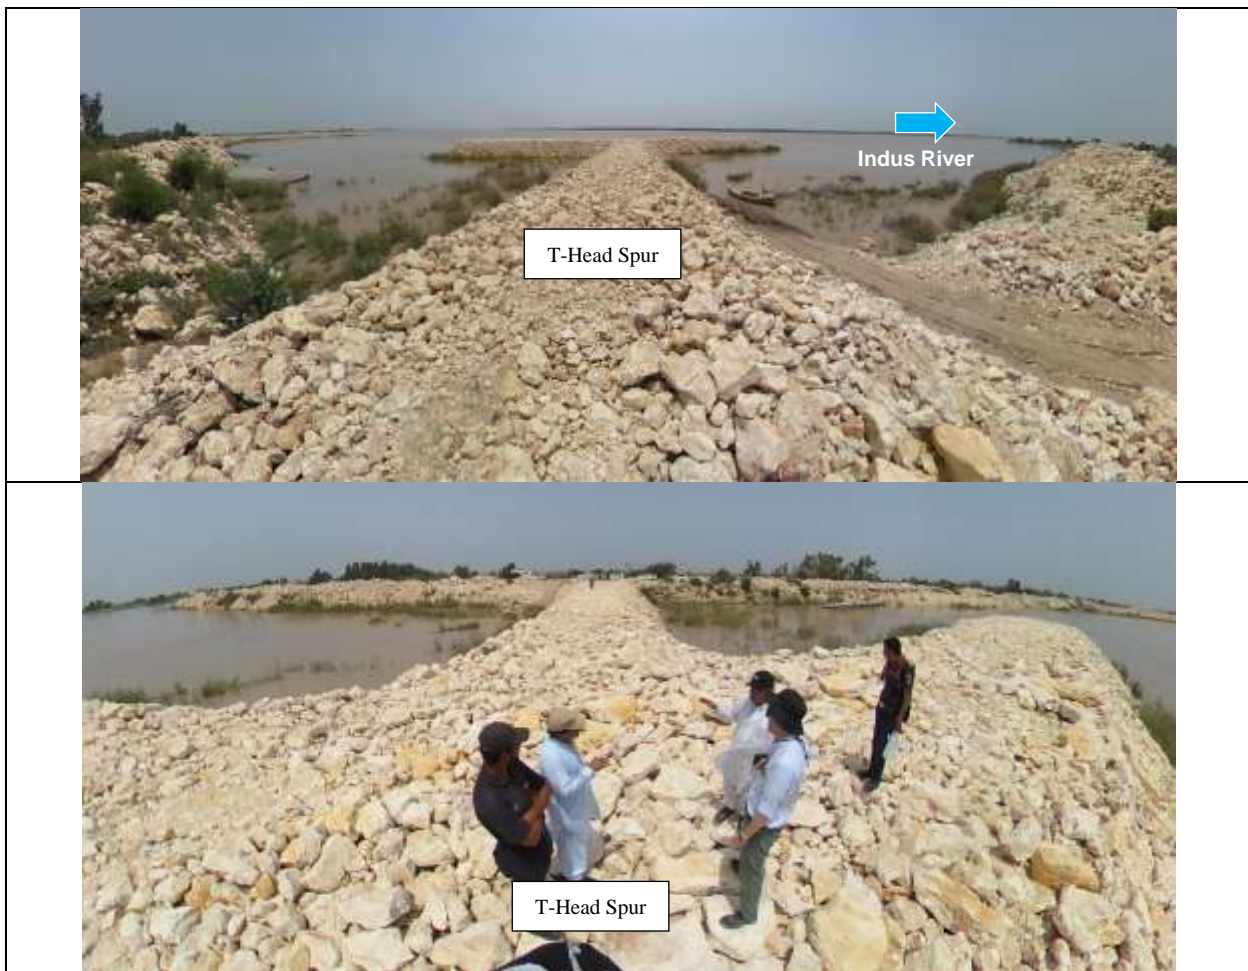
Photo 1.1.14 T-Head Spur at L.S. Bund, Hakra Point, August 4, 2023

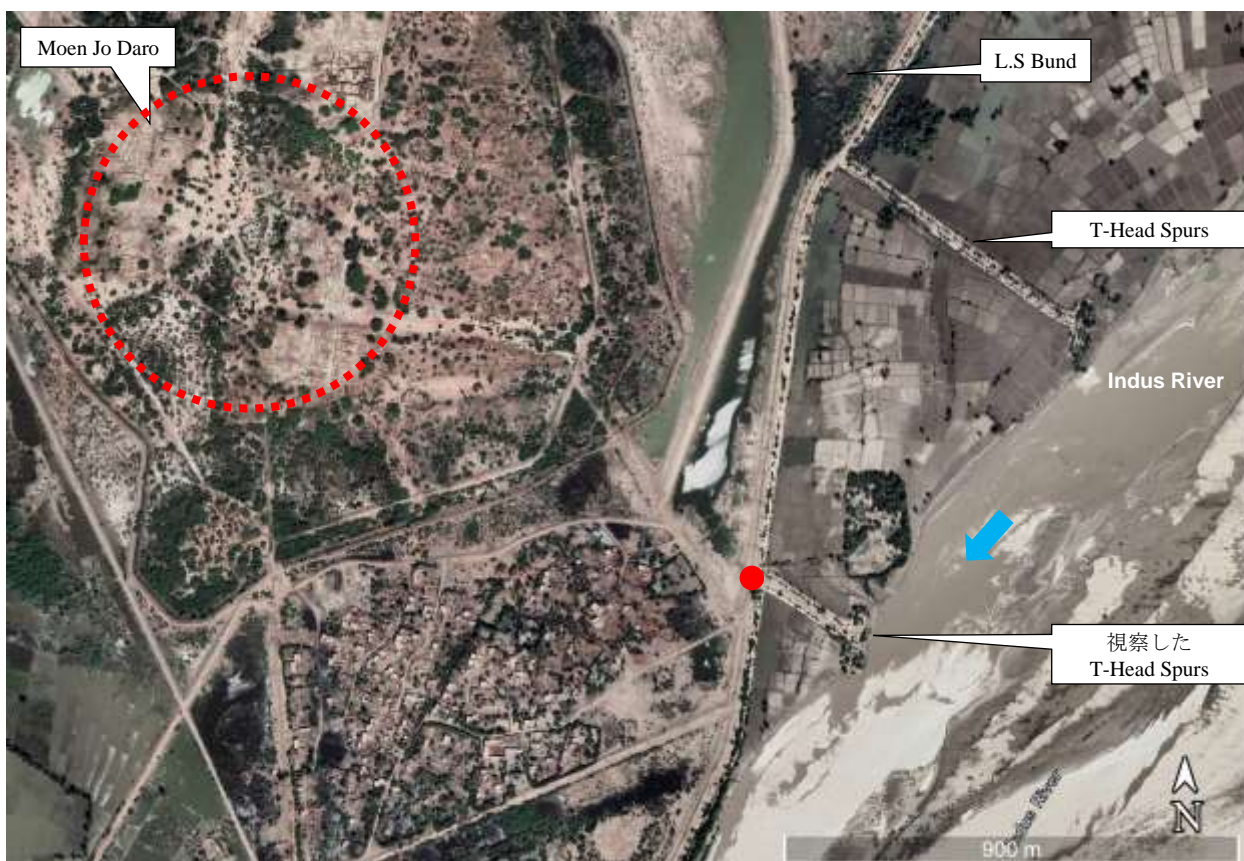
This part of L.S Bund is located a few hundred meters from the Archaeological Ruins at Moen Jo Daro, one of the largest urban ruins of Indus civilization and a World Heritage, the bund plays an important role in protecting the Moen Jo Daro and the surrounding town. The vegetation taking root on the Spur Dike indicates that it has not often suffered from washing away or erosion in recent years. The multiple Spur Dikes control the flow path of Indus River, and although the L.S Bund and Indus River are in close proximity, L.S Bund appears to be safely protected.

Figure 1.1.17 Location of L.S. Bund, Opposite Moen Jo Daro, August 4, 2023

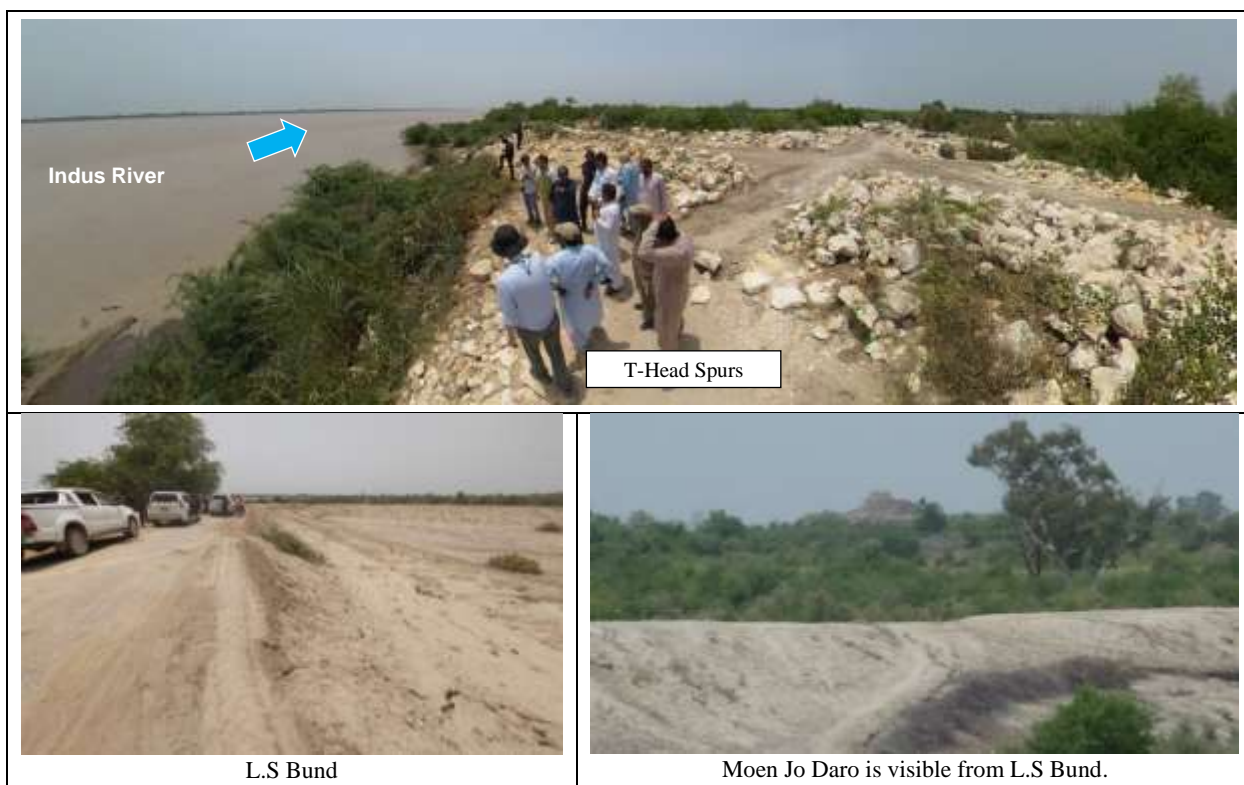
Photo 1.1.15 L.S. Bund, Opposite Moen Jo Daro, August 4, 2023
