THE STUDY ON DRAINAGE
IMPROVEMENT PLAN, DOHA CITY

MAIN REPORT

APRIL, 1987

JAPAN INTERNATIONAL COOPERATION AGENCY

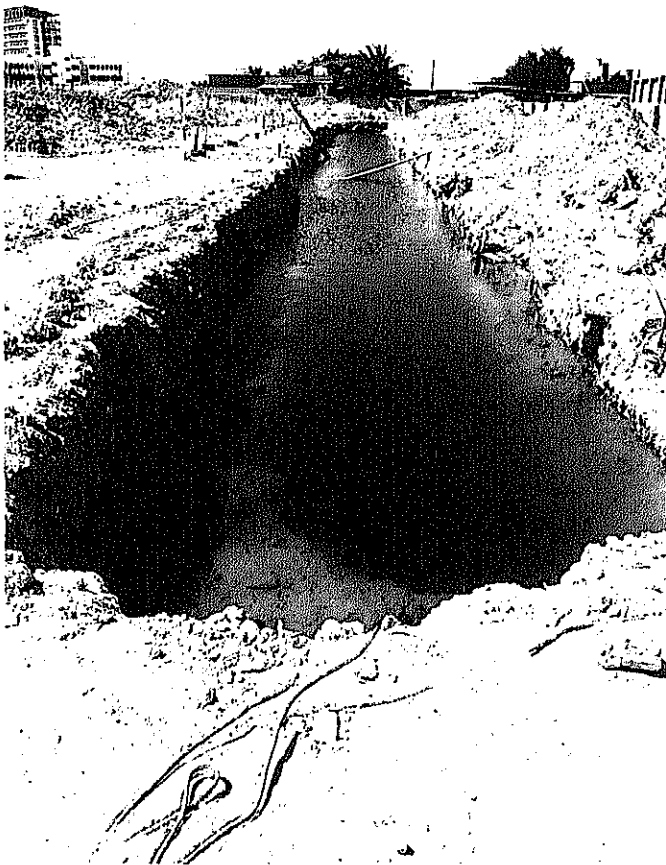
Wadi Musherib
Test Work Site

Recovery Test

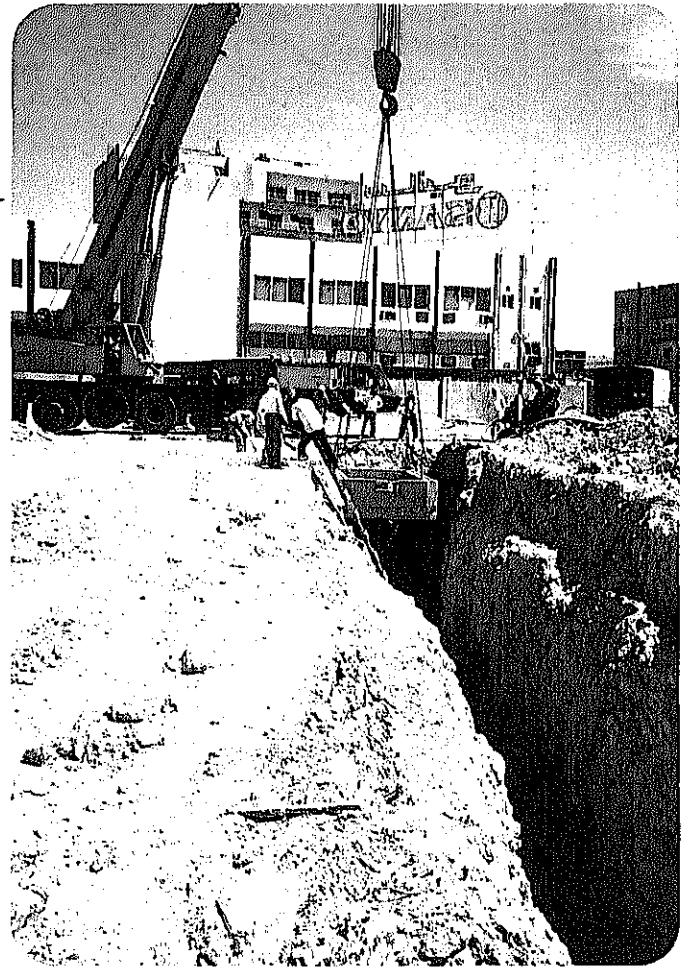
Test trench
construction

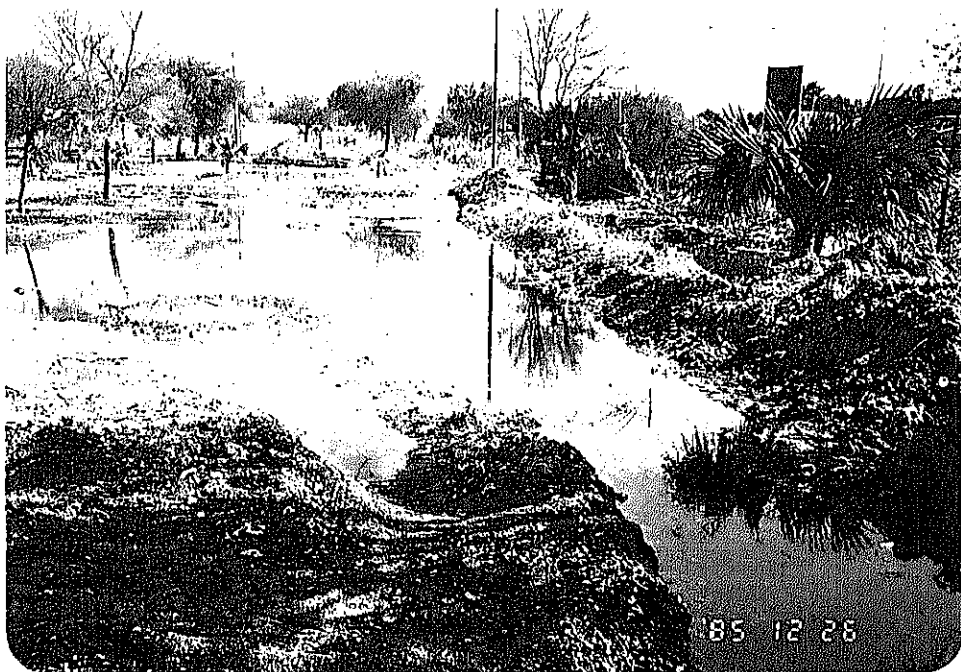
Standing Water near Musherib Dam
