CHAPTER 7

GEOLOGY AND CONSTRUCTION MATERIALS

CHAPTER 7 GEOLOGY AND CONSTRUCTION MATERIALS

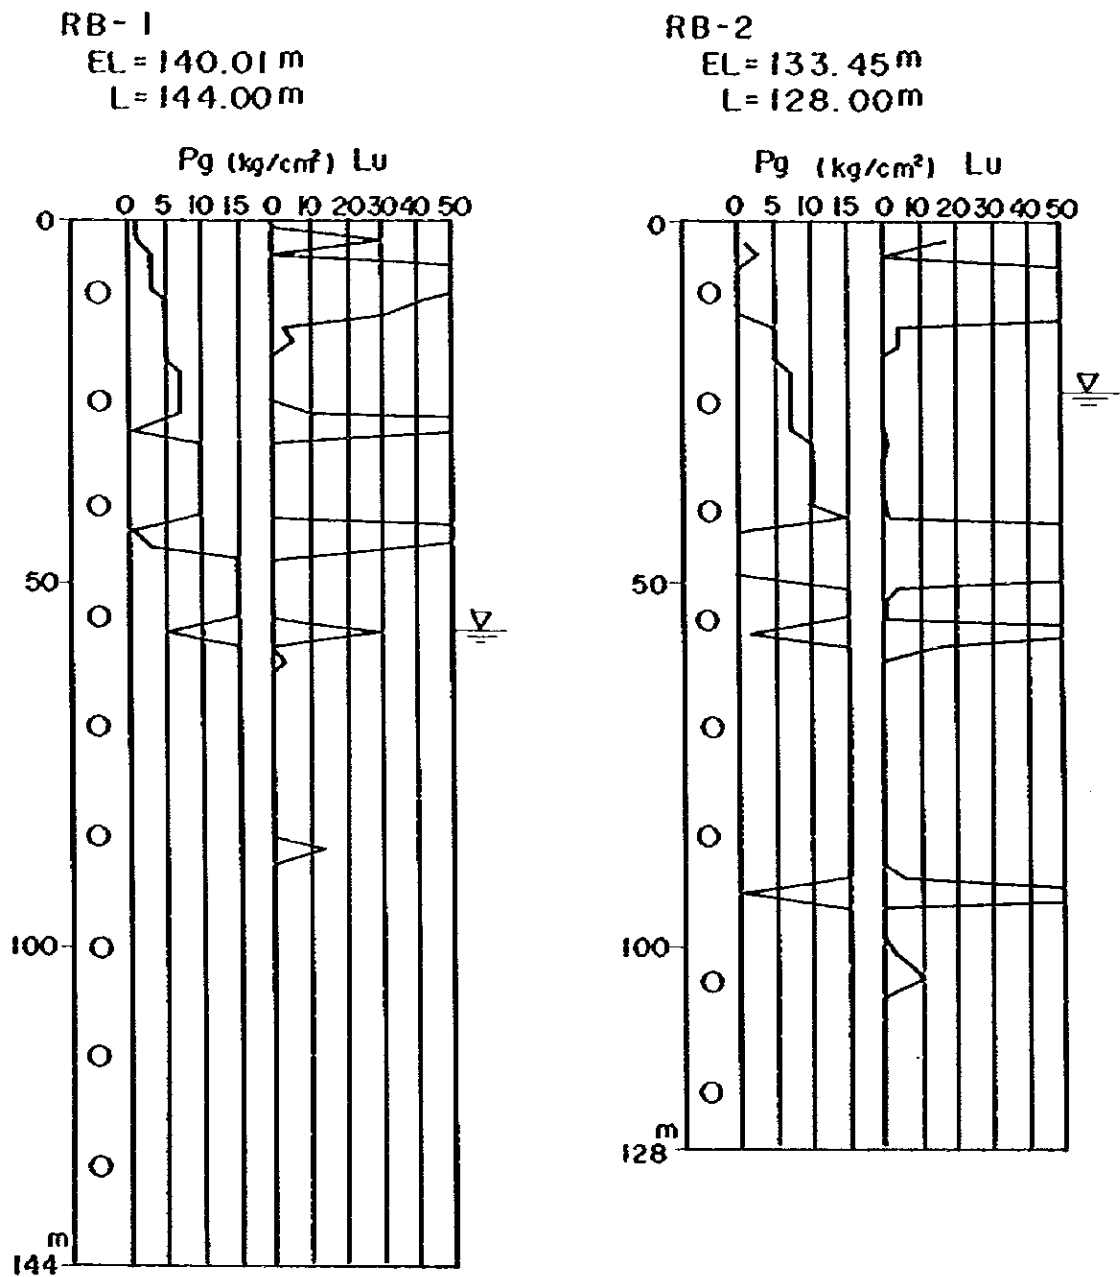
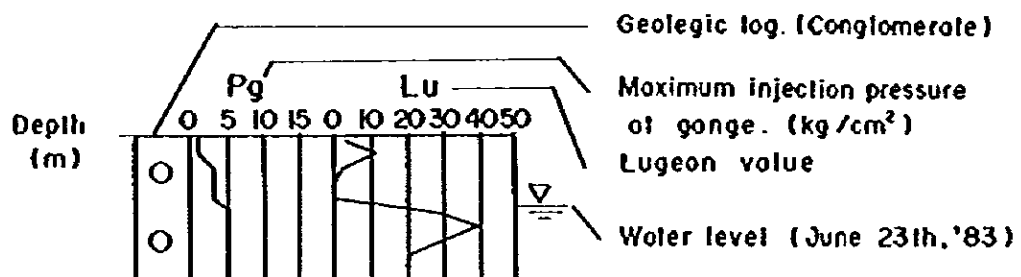
Fig.7-3 Log of Drillholes RB-1 and 2

Two drillholes named RB-1 and -2 were executed by DSI during the Feasibility Study. These drillholes were drilled in the Köprüçay Conglomerate, and measurement of water level and permeability tests were executed. The results of them are shown in Figs. 7-3 and 7-4 and the following table.

- i) Permeable surface layer is 14 m thick
- ii) Below 60 m deep (EL.70 m) permeable portion are limited and most portion (88%) are quite impermeable (0 Lu)
- iii) No intercalation of shale exists in the conglomerate
- iv) Water level in the drillholes are lower than river level.

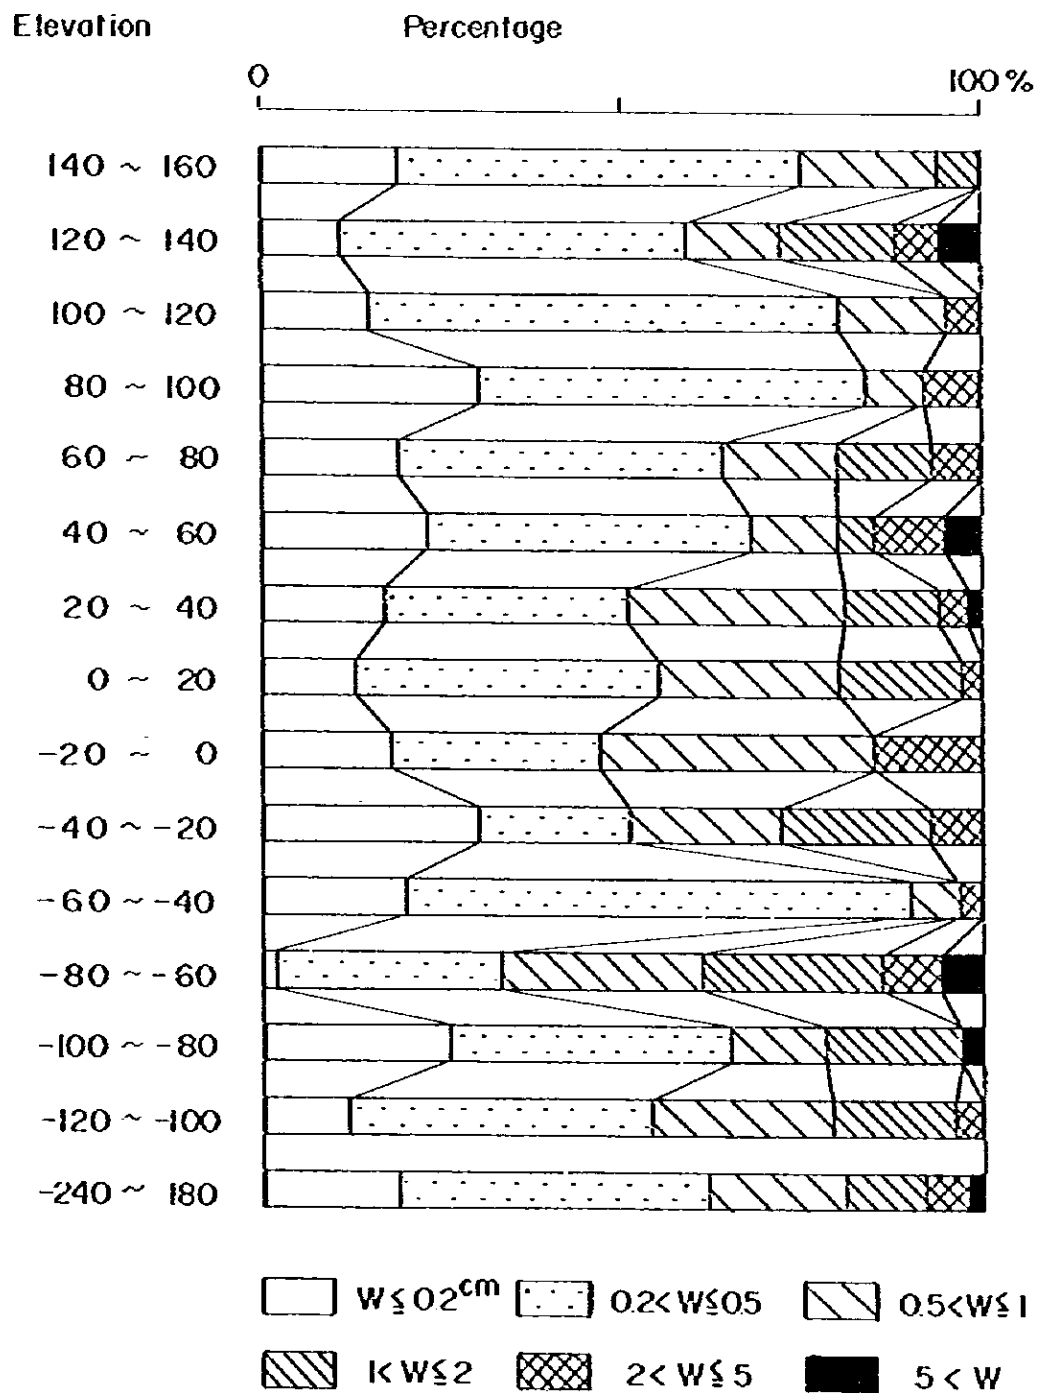
Fig. 7-8 Width of Solution in Drillhole

The widths of solution cavities in test adits average 1.1 to 3.4 cm with the largest being 80 cm at 46 m in main adit of LT-1. Solution channels of widths 2 cm or less make up 70% of the whole, and those of widths of 10 cm or more make up 7% of the whole. The diameters of solution caves average 25 to 60 cm, the maximum being 150 x 300 cm in the vicinity of 43 m in the entrance adit RT-4. Solution cavities of diameters 10 to 50 cm make up 58% of the whole, with those of diameters of 1 m or more make up about 5% (4 cavities).

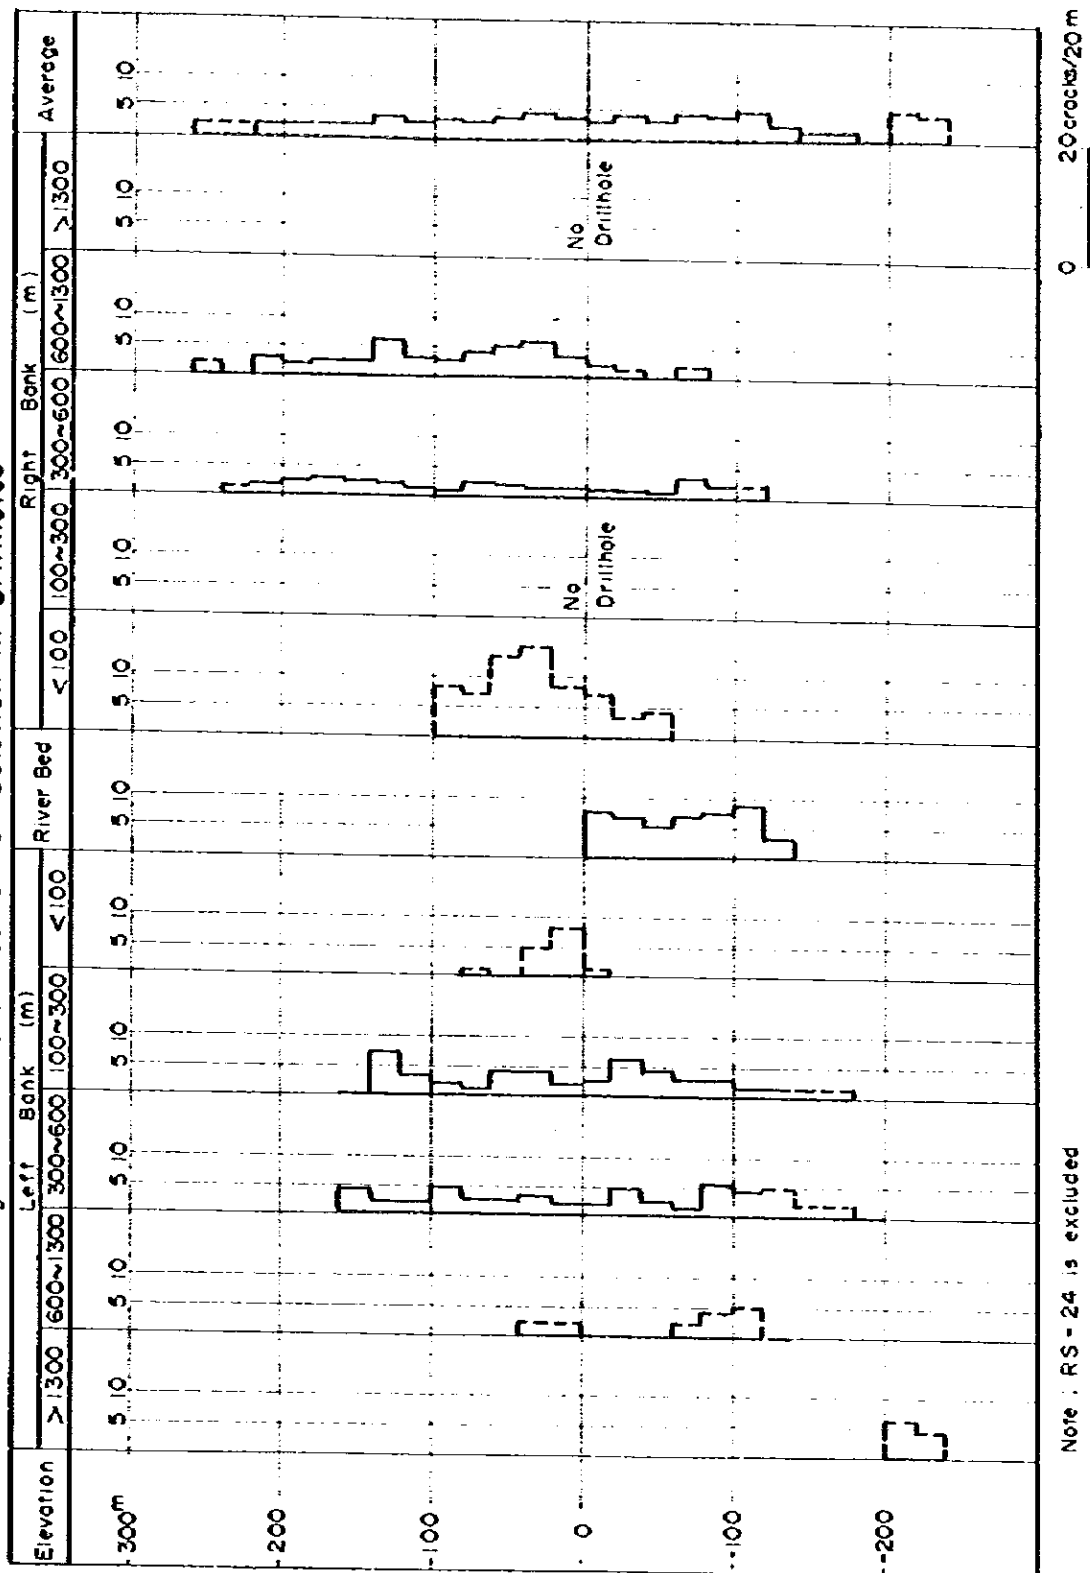
Fig. 7-9 Distribution of Solution in Drillholes

Since drillholes have the purpose of making investigations for dam construction and curtain grouting, they are located in a long, narrow area extending in the northeast-southwest direction. Fig. 7-9 shows drillholes grouped according to distance from the Köprüçay River and the distribution of solutions in the Köprüçay Conglomerate by elevation. Solutions exist even in the vicinity of the bottom (EL.-236.86 m) of a drillhole LS-19 drillhole reaching the lowest elevation. The lower limit of karstification has not yet been confirmed.

However, at the vicinity of the river bed and at the left bank, hardly any agreement can be seen between the two (see Fig. 7-9 and Fig. 7-16), that is, at individual permeability test sections, in case of existence of solutions, the Lugeon values are not necessarily high. This is thought to be due to the solutions being filled with clay or calcite seen in test adits, or certain of the solutions lacking in continuity.

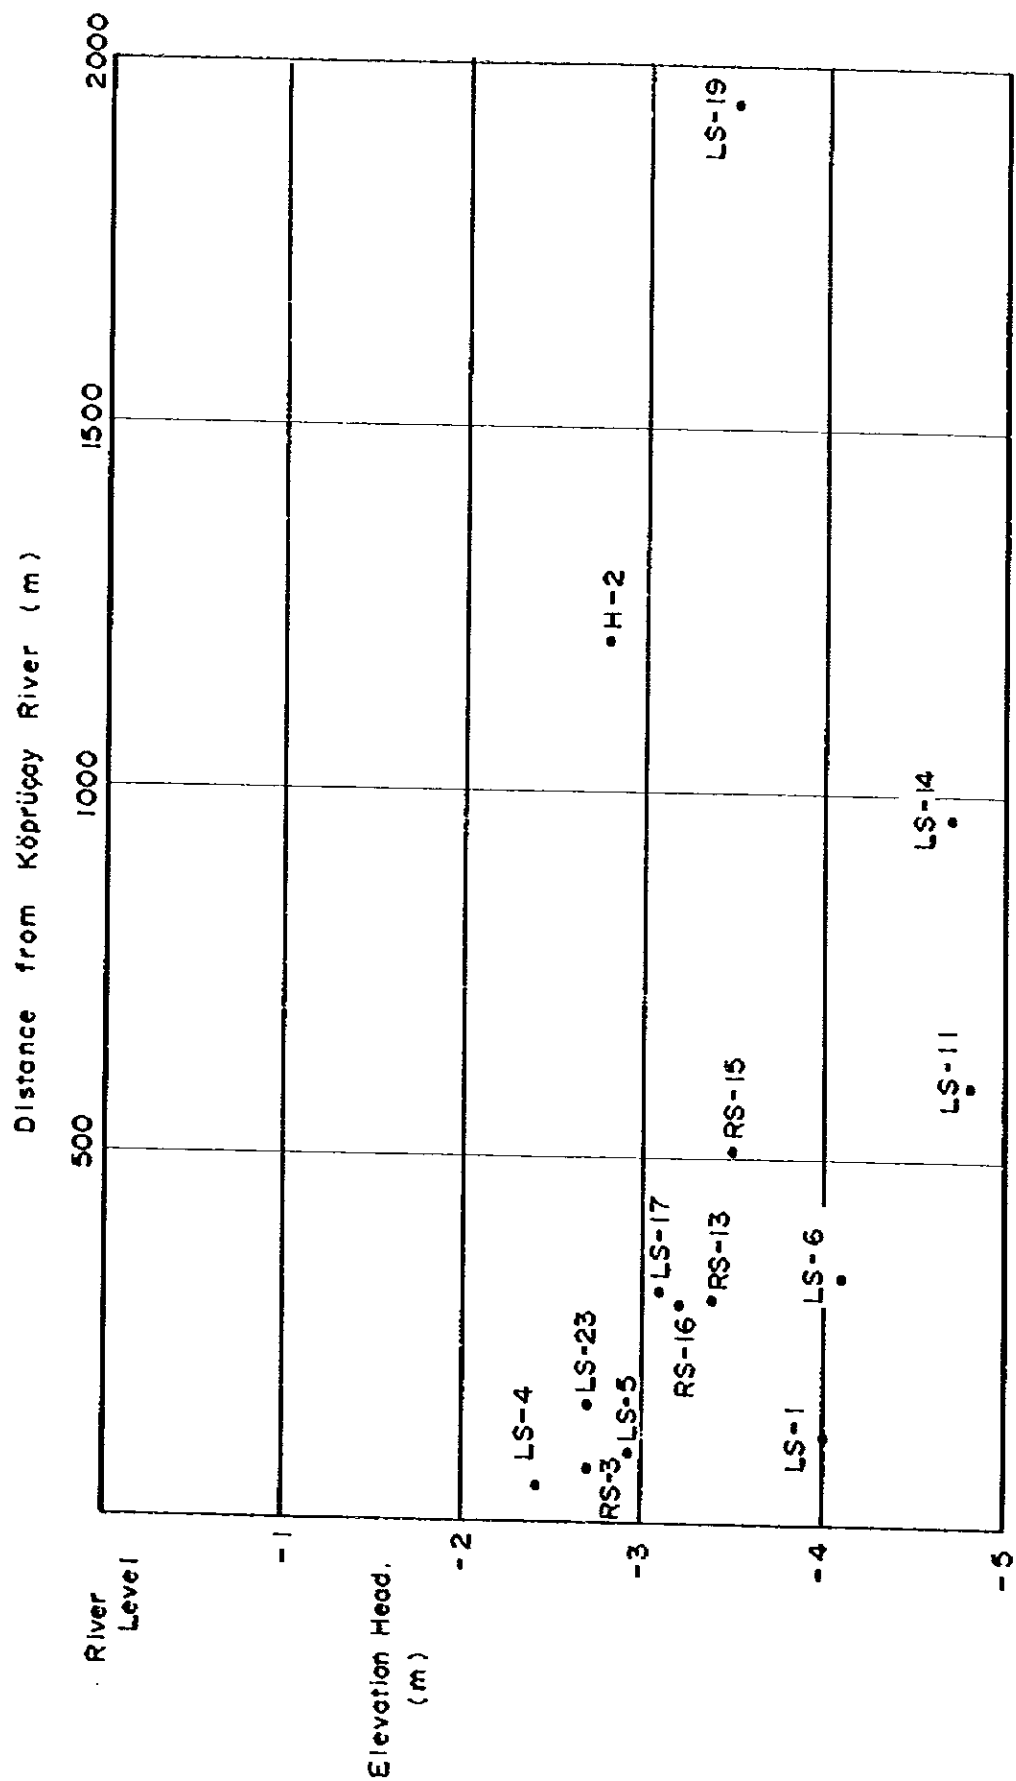
Fig. 7-12 Elevation Head Between River Level and Water Level in Drillhole

Fig. 7-12 shows the differences between river level and water levels in drillholes in the dry season. The water levels in drillholes show comparatively sharp declines (gradients 3/100

and steeper) from the Köprüçay River to about 100 m away, and as described in 7.3.4, this appears to have relations with high distribution frequency of solutions in this portion.

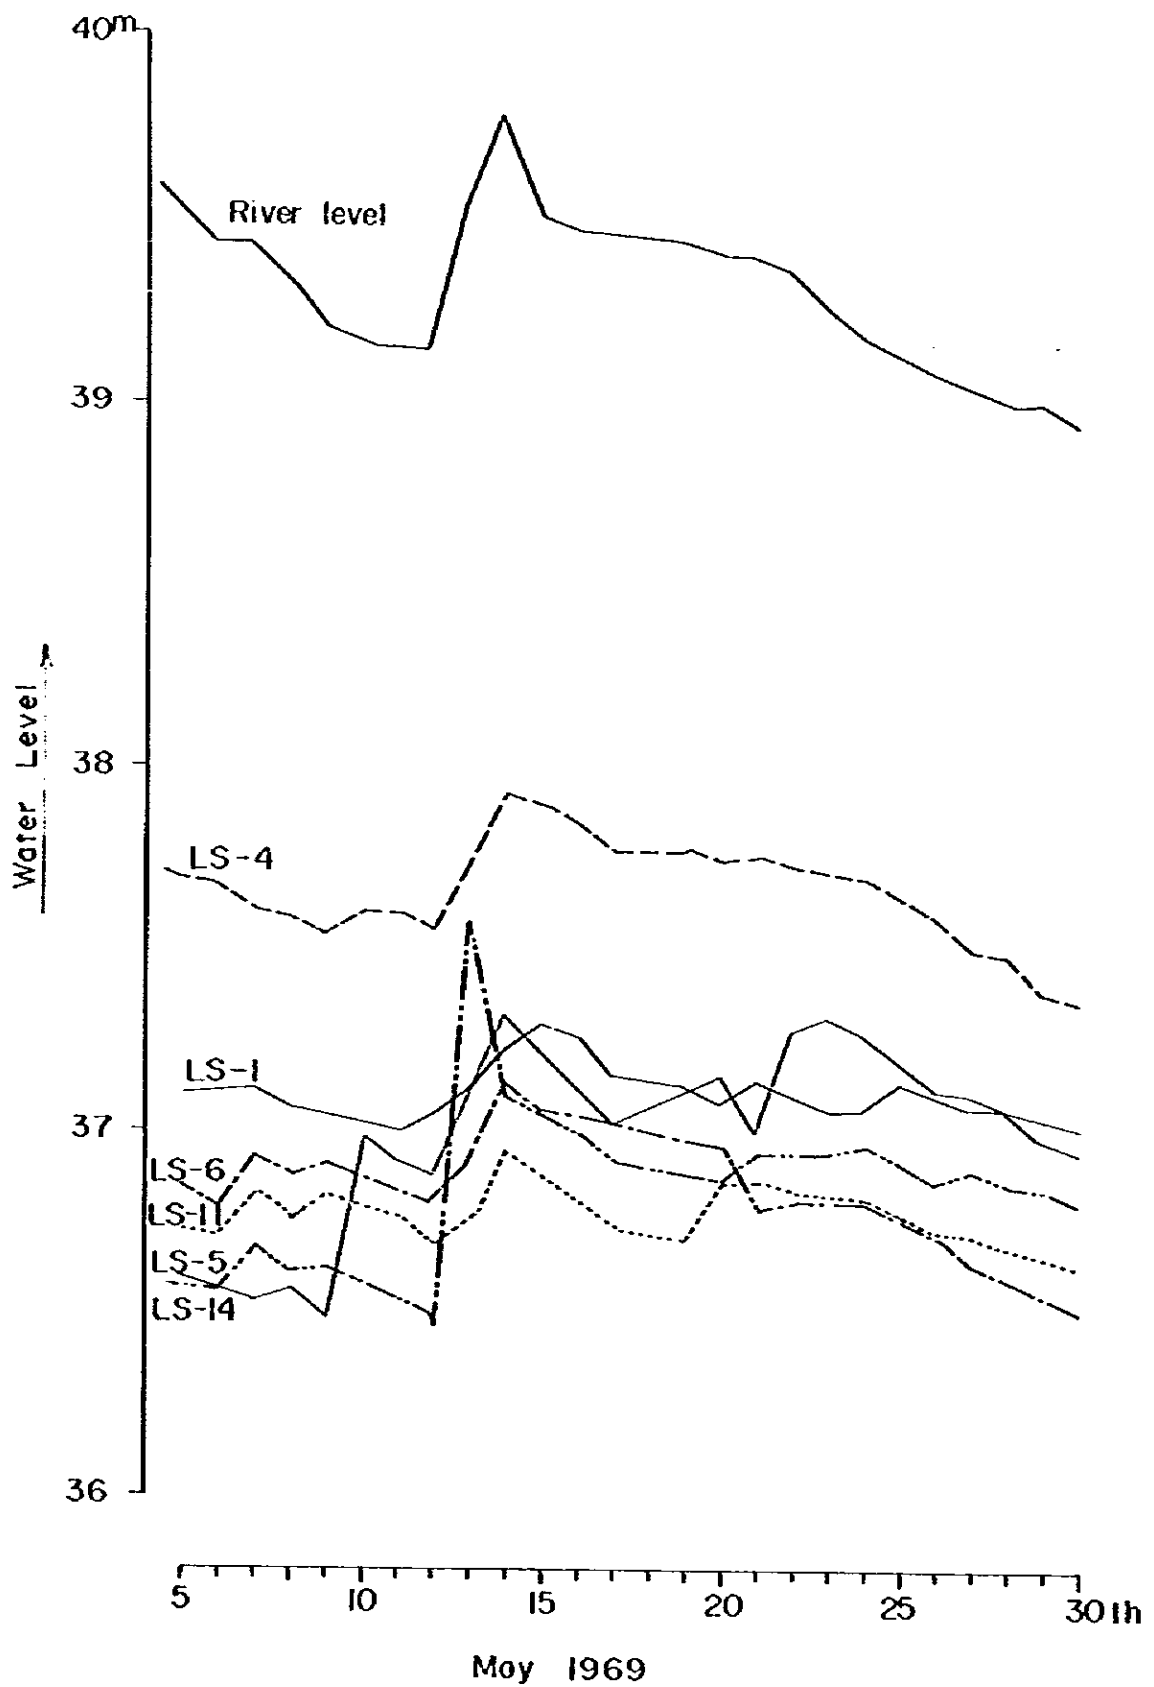
Fig. 7-13 Fluctuation of Groundwater Level
in Drillholes in the Vicinity of Dam Site

Fig. 7-13 indicates a portion of the records of measurements on river levels and drillhole water levels of Sümerman (1973). It shows that water levels in many drillholes quickly follow fluctuations in river level. This phenomenon is thought to suggest that interconnected voids are generally developed in the bedrock in the vicinity of the dam site.

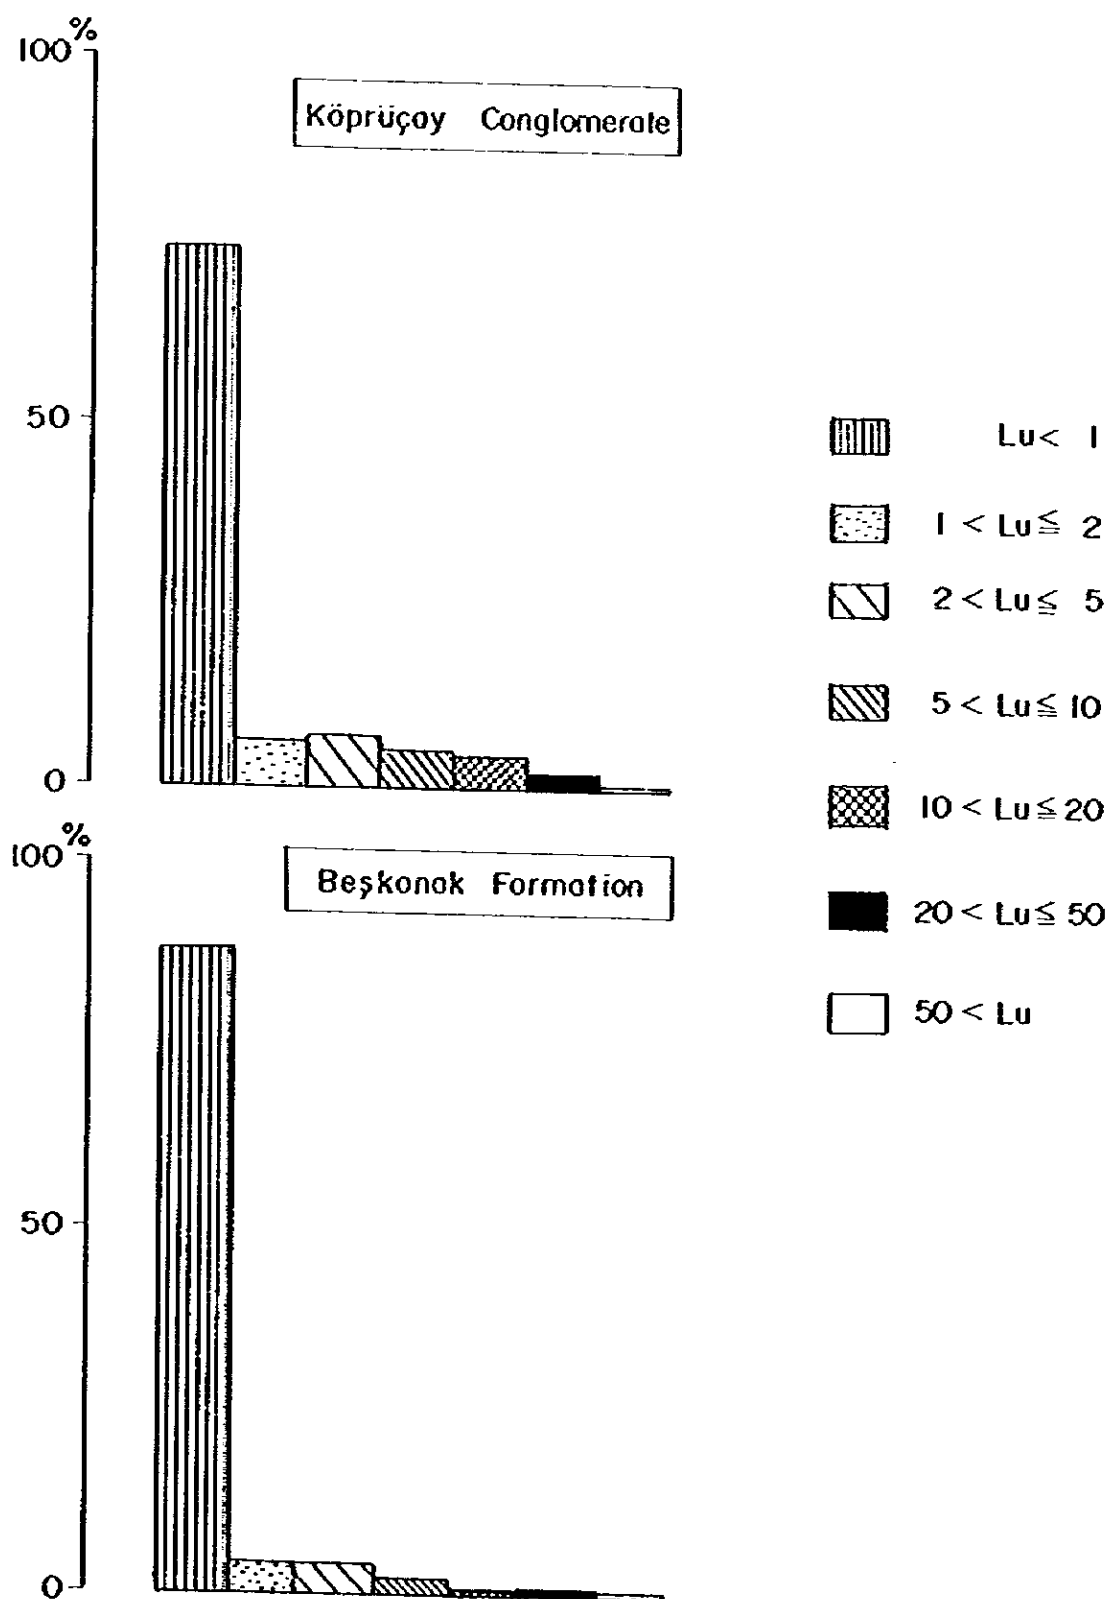
Fig.7-15 Frequency of Lugeon Value
at the depth deeper than 40m

The Köprüçay Conglomerate generally comprises surface layers which are 20 to 40 m thick with high permeability of 10 to 70 Lu. Deeper than 40 m, the permeability is an average of 5.9 Lu, with sections of 1 Lu or under making up 74% of the whole, and sections of 10 Lu and higher 7% (see Fig. 7-15).

The Beskonak Formation is generally weathered down to 40 m from the surface, but most sections have not been tested or are of less than 20 Lu. At deeper than 40 m, the mean Lugeon value is 1.6, sections of 1 Lu or under make up 88% of the whole, and sections of 10 Lu or higher 2%, so that permeability are much lower compared with the conglomerate (see Fig. 7-15). Further, with regard to the Beskonak Formation, permeable zones are not found in the vicinities of faults.

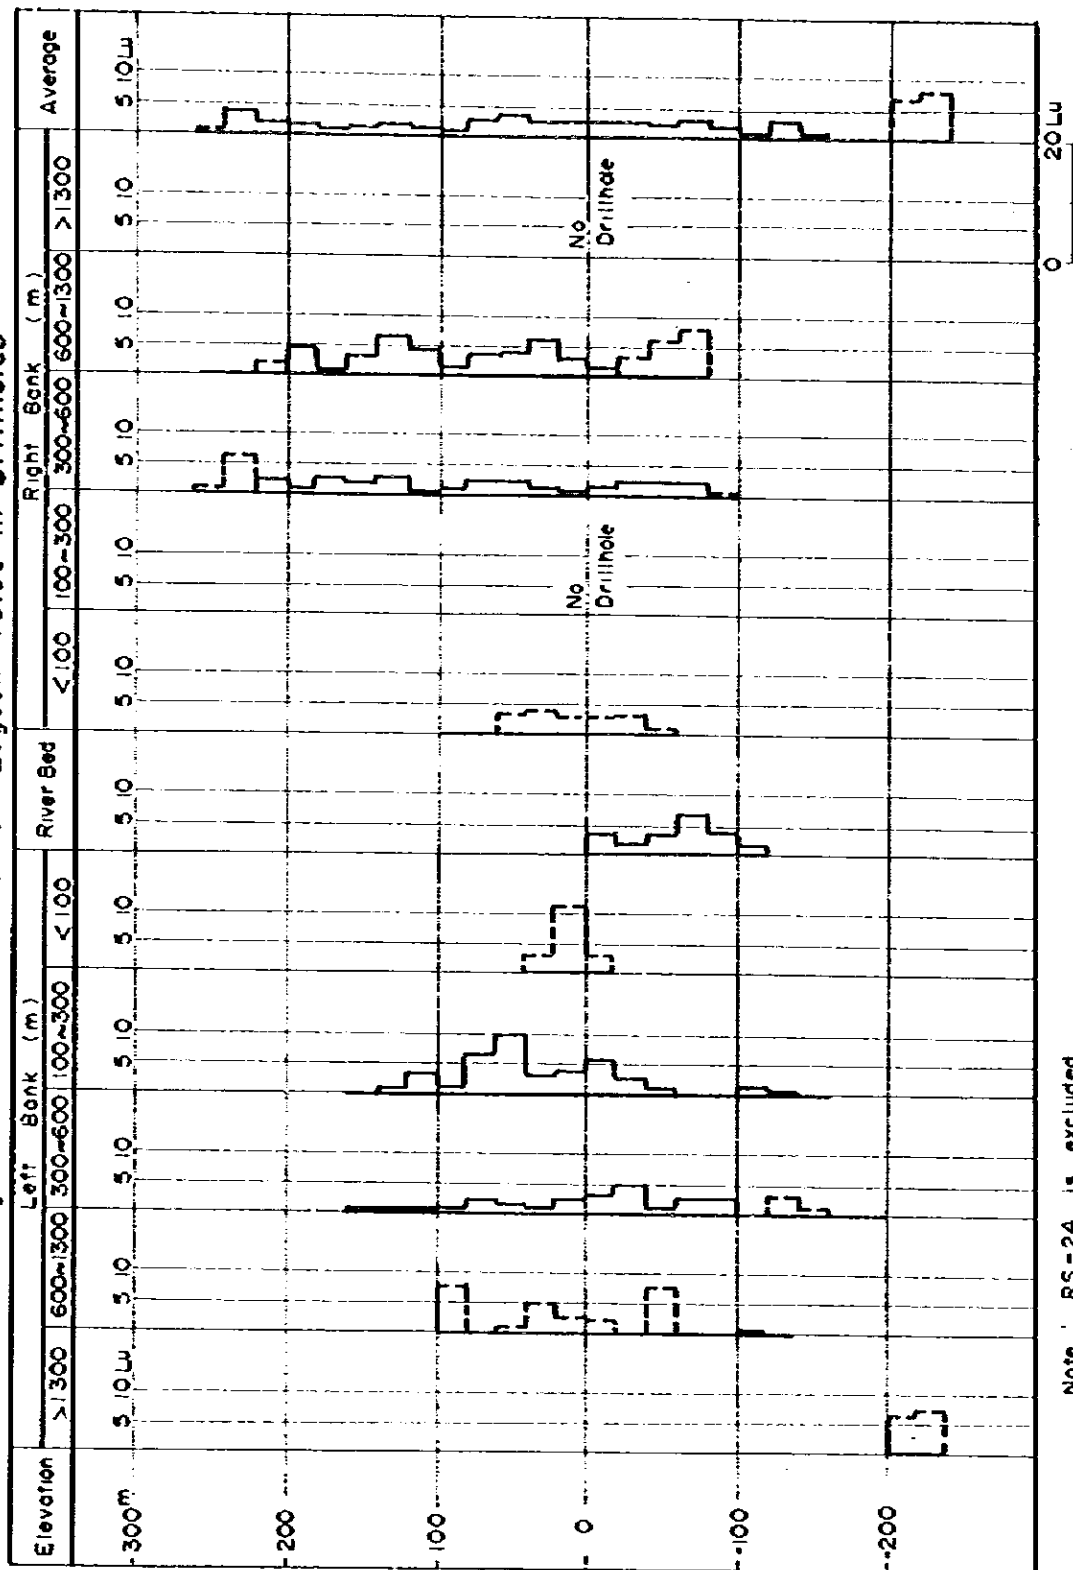
Fig. 7-16 Distribution of Lugeon Value in Drillholes

The distribution of Lugeon values of the conglomerate at depths greater than 40 m is shown in Fig. 7-16 in terms of relation between distance from the Köprüçay River and elevation. As shown in this figure, parts of especially high Lugeon values are not recognized seen from the standpoint of distance from the Köprüçay River. From the standpoint of elevation, peaks of Lugeon values are indistinct at the left bank, but from the river bed to the right bank, peaks are seen fairly clearly at elevations of 120 to 140 m, 20 to 60 m, and -60 to -80 m. As a whole, at elevations of 40 to 60 m and -60 to -80 m, there are indistinct peaks. At

- (1) The correlations between Lugeon values obtained by permeability tests at the various drillholes and elevations, were estimated with distances from the river as a parameter. The results are shown in Fig. 7-16.
- (2) The correlations between the distribution of solution cracks and elevations, were estimated with distances from the river as a parameter. The results are shown in Figs. 7-17 and 7-18.
- (3) The results of permeability tests near the ground surface and in the vicinities of faults were arranged separately from (1) and (2).

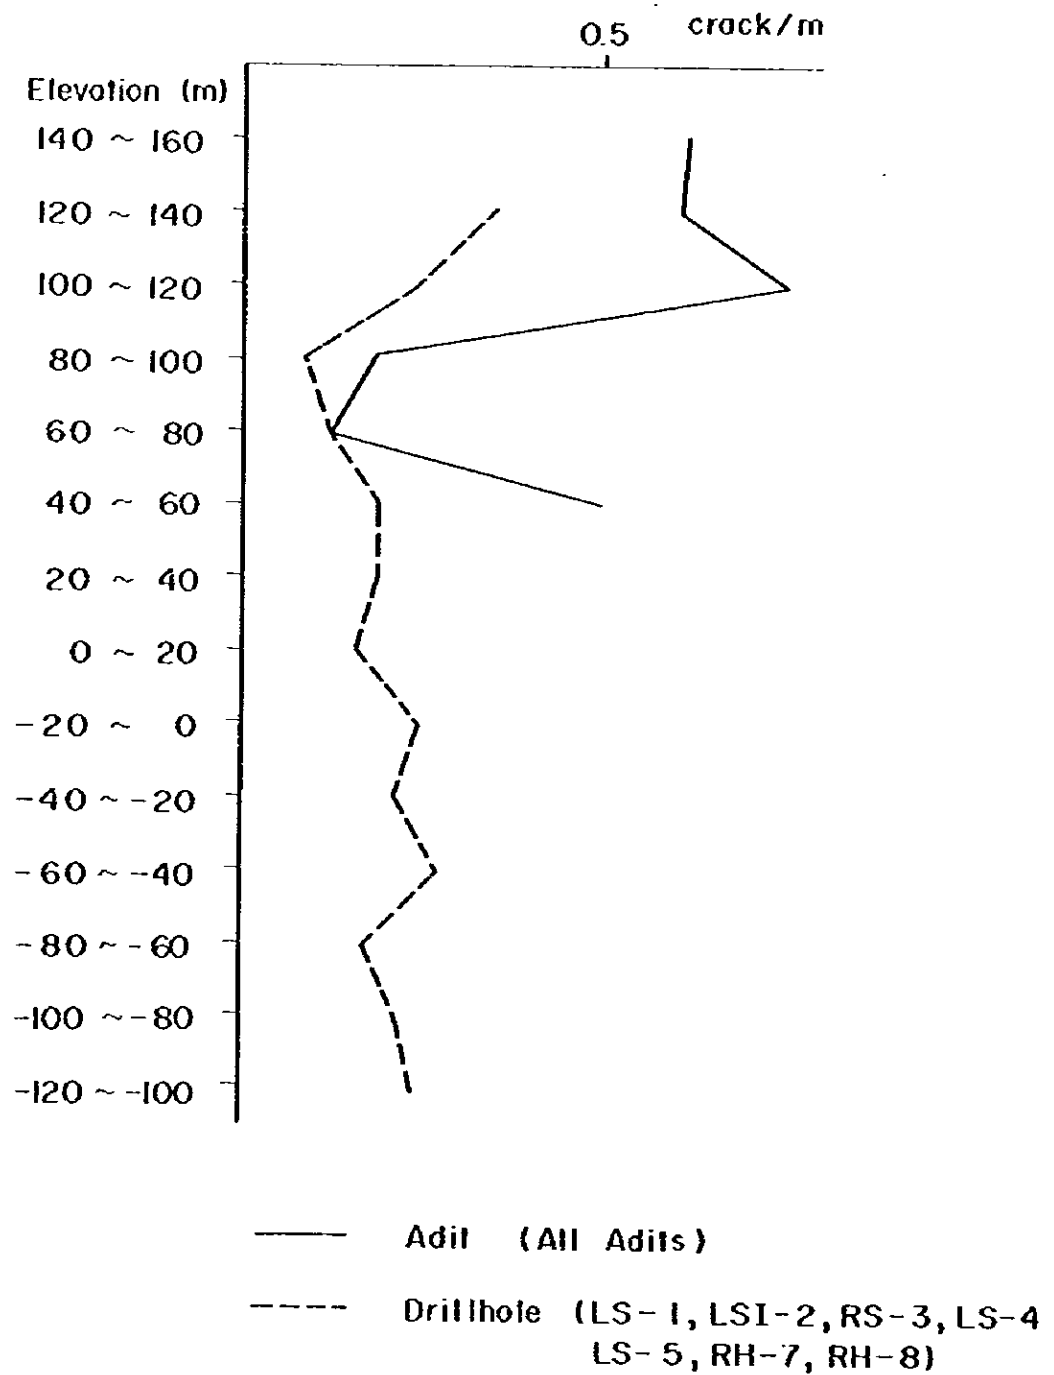
Fig. 7-17 Distribution of Solution at Dam Site

i) Regarding the distribution frequency of solutions, it has been found to be high at the river bed and the right bank by drillholes RH-7, RH-8 and RS-3. The distribution frequency is high above elevation of 100 m, while a trend of decrease is not indicated above EL. -120 m (see Fig. 7-17).

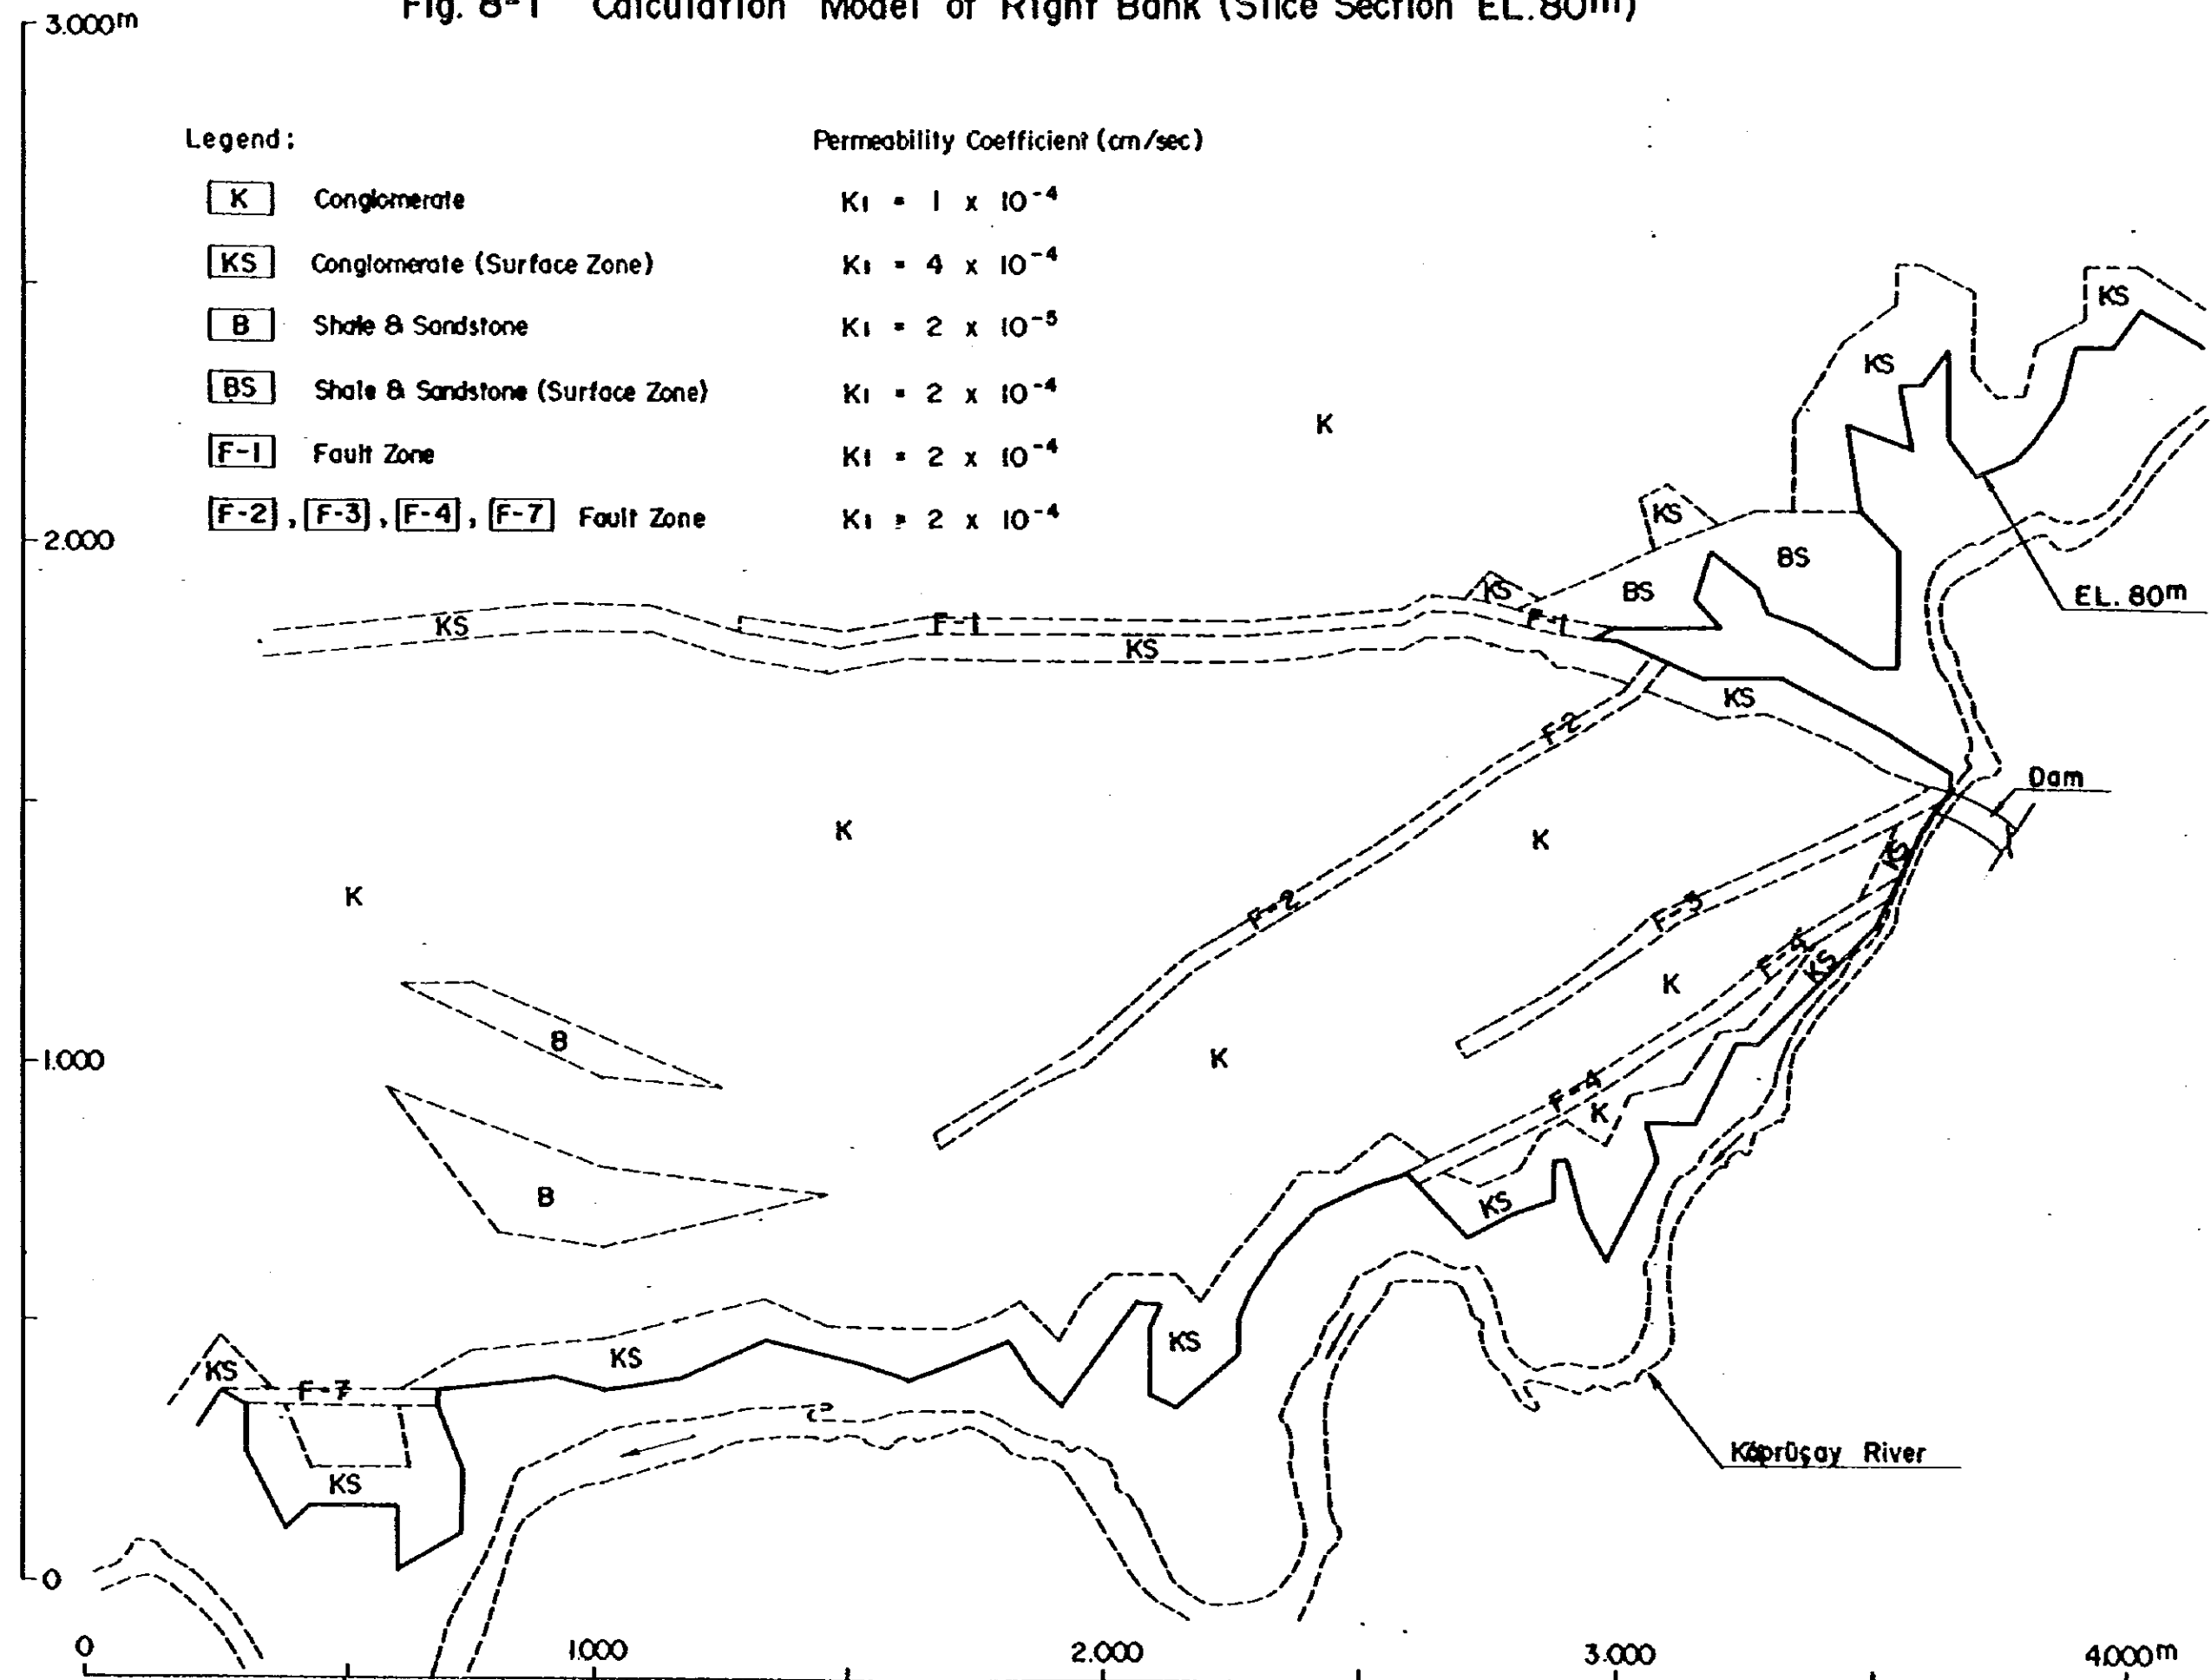
Fig. 8-1 Calculation Model of Right Bank (Slice Section EL.80m)

The analysis was made for a plane at EL. 80 m, an intermediate water level of the reservoir, with the purpose of finding behaviors such as seepage path and stream line direction of seepage flow, and plane distribution of leakage volume, thereupon to decide the calculation cross sections. Calculation models are given in Figs. 8-1 and 8-2, and the calculation results in Figs. 8-3 to 8-5. Figs. 8-3 and 8-4 indicate the flow nets of the left and right banks when grout curtains are not provided, while Fig. 8-5(a) shows the plane distribution of seepage flow at the upstream face inflow portion. The greater part of the leakage from the reservoir occurs in the vicinity of the dam site, and approximately 90% of the total amount flows out in the range of 800 m from the dam on the right bank side and 400 m on the left bank side. More or less the same trend is seen regardless of whether or not there is grout. Further, the seepage flow is governed by the path length, and there is little influence of faults and geological boundaries.
