6.6 Probable Maximum Flood

- Fig. 7-1 Regional Geology
- Fig. 7-2 Yusufeli Project, Geology, Dam Plan
- Fig. 7-3 Yusufeli Project, Geology, Dam Section A-A'
- Fig. 7-4 Yusufeli Project, Geology, Dam Section B-B'

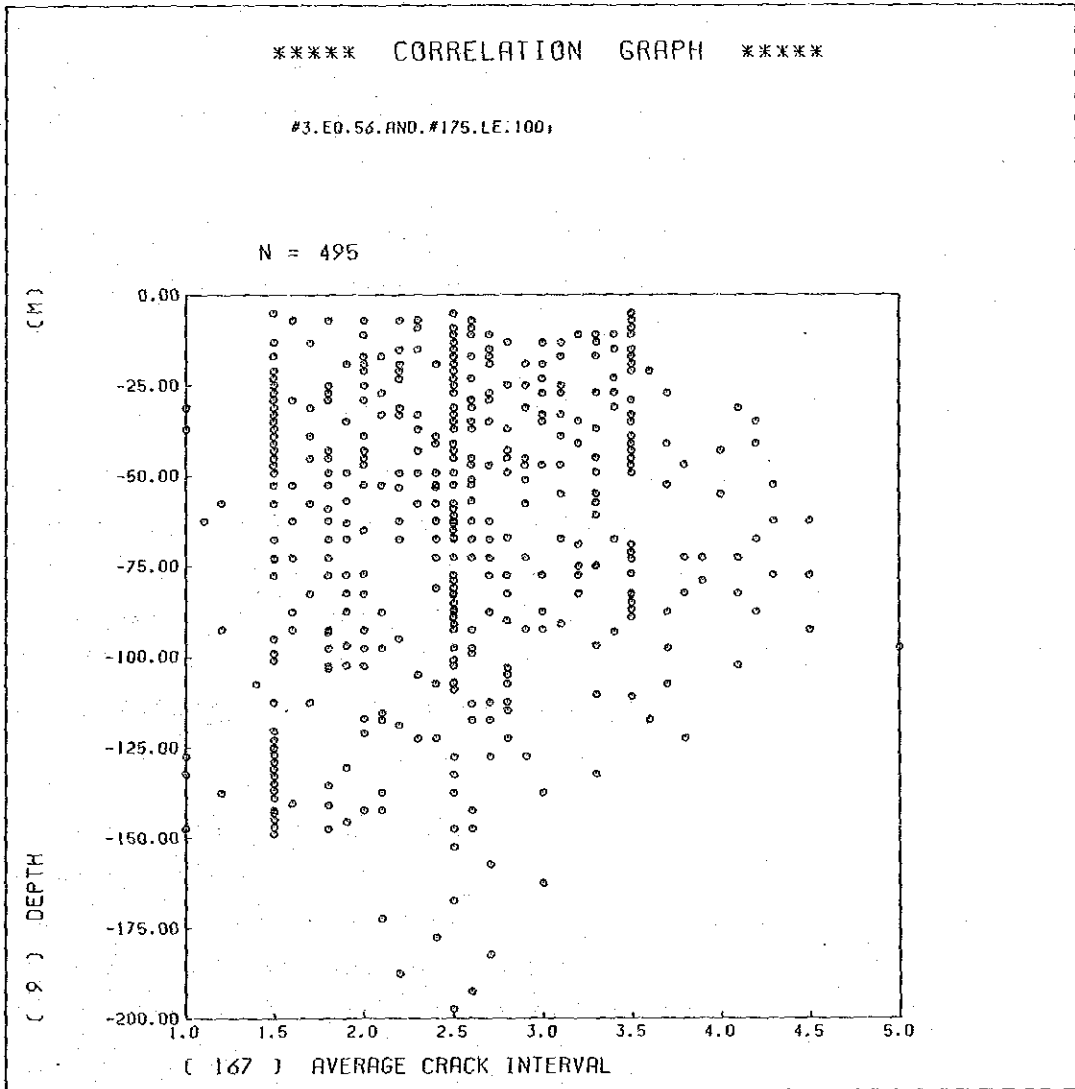
Fig. 7-10 Correlation graph, Depth — Crack Interval

- . The joints and cracks are discolored to brown in weathered parts and are separable relatively, but are well tightened in other parts.
- . Attitudes of 2,910 joints were measured by EIE's investigations and the results are summarized in Fig.7-9. According to this, although relative concentration is observed in attitude of NS with steep dip to east at 60 - 80 degrees, general distribution is scattered in all quadrants to indicate that joints are developing in all directions. Thus, it can be safely said that foundation rocks in the dam site are overall isotropic so far as joints are concerned.
- . The graph of Fig. 7-10 shows the correlation between the depth from the top of each hole and the intervals of cracks (degrees of crack intervals are shown in Table 7-9, 10).

The following tendency can be read from this graph.

- * The degree of crack interval is generally less than 3.5.
- * The remarkable tendency can not be seen in between the depth of 0 m (ground surface) and the depth of 100 m. However, below 100 m, the crack intervals decrease in accordance with the depth.
