PART III. ANALYSIS OF ACCIDENTS

PART III ANALYSIS OF ACCIDENTS

PART IV. EVALUATION OF CANAL CONDITIONS

PART IV EVALUATION OF CANAL CONDITIONS

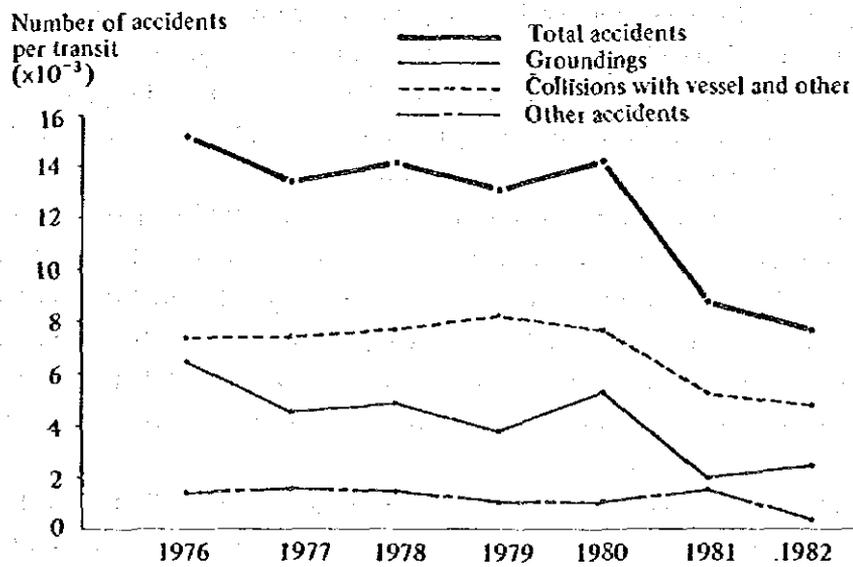
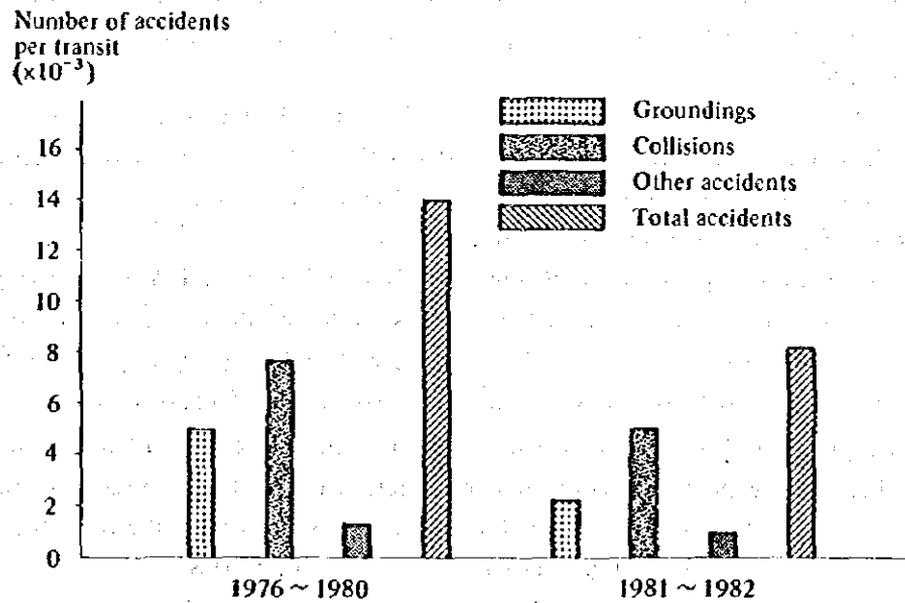
Fig. IV-1-(1)-1 Risk Level by Year

Fig. IV-1-(1)-1 shows the annual changes in risk level per transiting vessel in the period from 1976 to 1982 according to the accident records of the SCA, and compares the mean risk levels in the pre-widening/deepening period from 1976 to 1980 and the post-widening/deepening period from 1980 to 1981.

It is clear that the risk level of transiting vessels decreased from the widening/deepening of the Canal as shown in Table IV-1-(1)-1. Thus, the widening/deepening has definitely contributed to the enhancement of the safety of transiting vessels in the case of the Suez Canal.

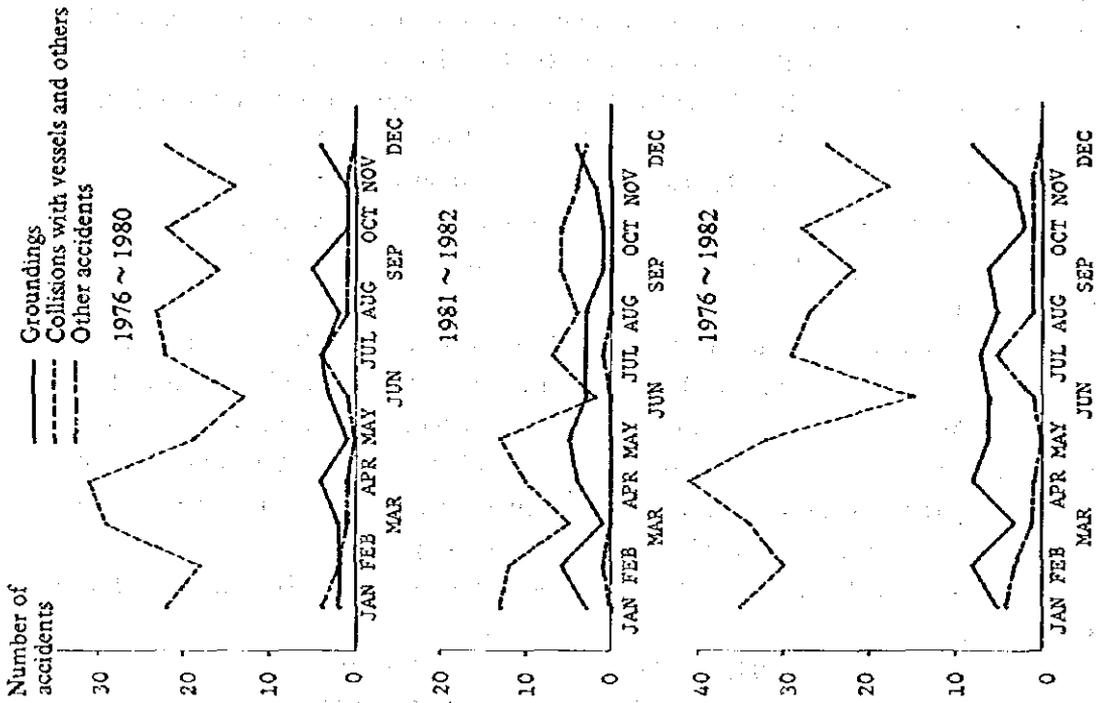
Fig. IV-1-(1)-3 Number of Accidents at Port Said by Month

Despite the fact that decreasing of the number of vessels of the northbound convoy pass through the port due to the new completion of the Port Said Bypass, the overall risk level in Port Said has not come down much as may be seen from the records as given below:

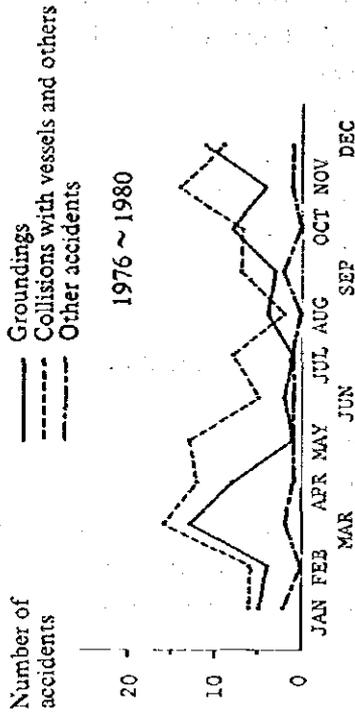
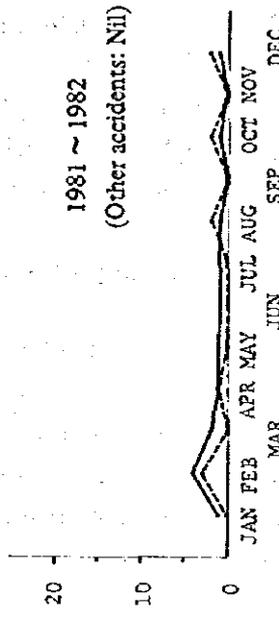
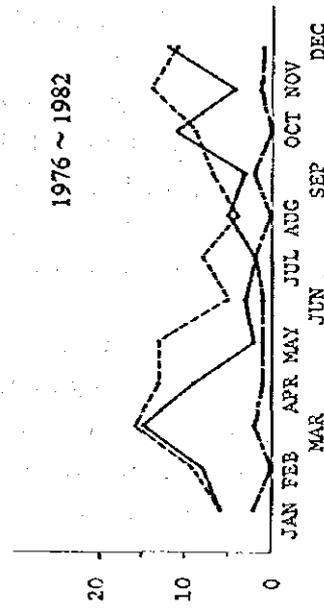
Fig. IV-1-(1)-7 Number of Accidents at El Kabrit and Little Bitter Lake by Month

The overall risk levels in waters in the vicinity of El Kabrit and the Little Bitter Lake have come down remarkably as shown below:

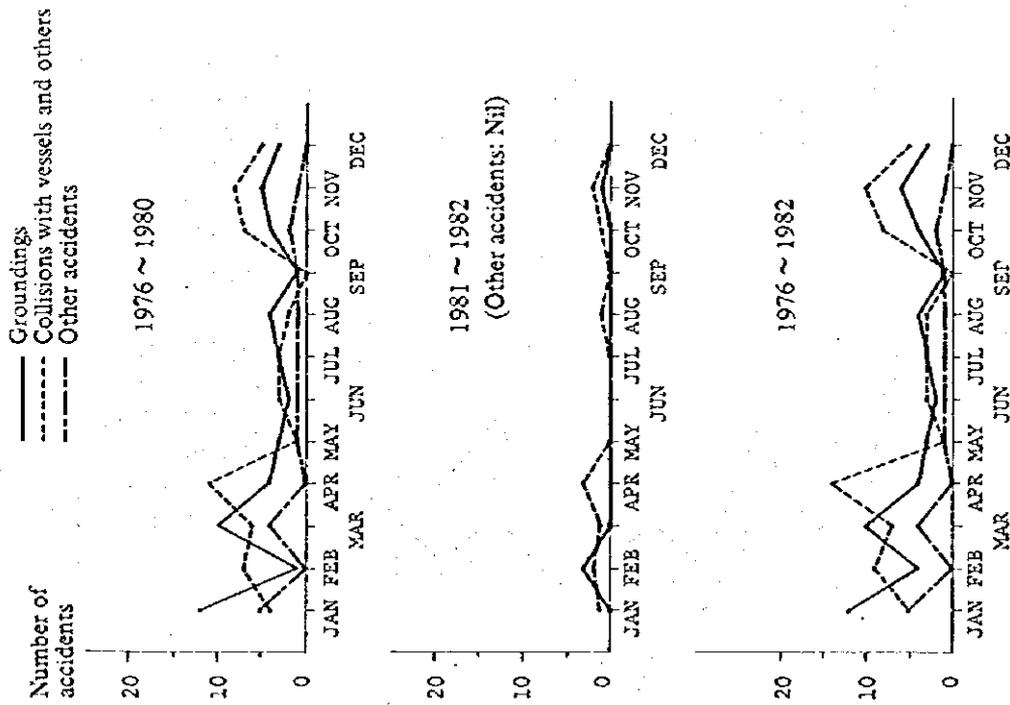
Fig. IV-1-(1)-8 Number of Accidents at Km 135 ~ 161 by Month

The results of the above discussions on the monthly changes in risk level clearly show that establishment of effective safety measures to counter seasonal fluctuations in all waters of the Canal, Lakes and Ports is necessary where particular efforts must be made in establishing effective measures against sandstorms.

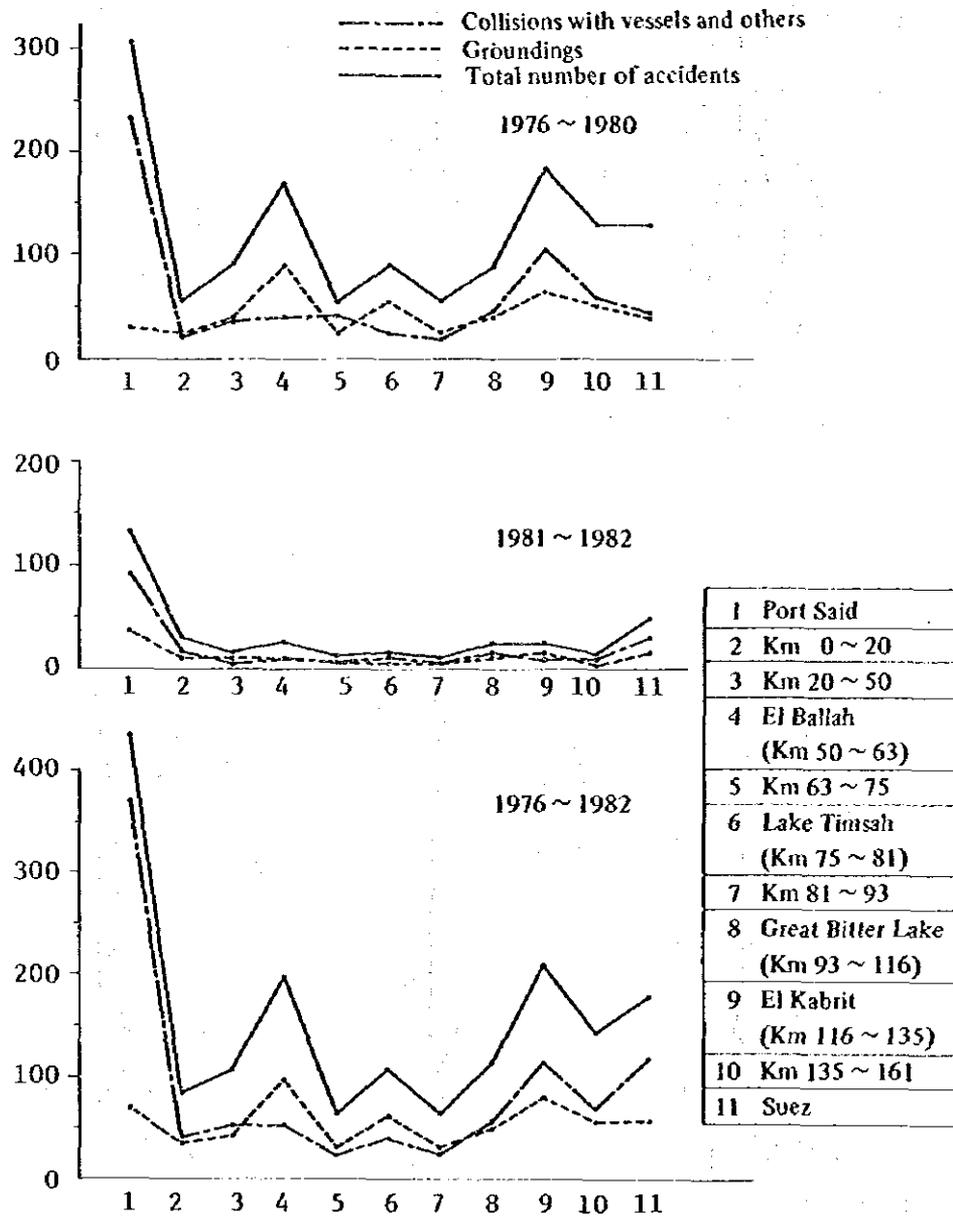
Fig. IV-1-(1)-10 Number of Accidents by Position

Fig. IV-1-(1)-10 shows the locational changes in risk level in the three periods, i.e., the period from 1976 to 1980, from 1981 to 1982 and the total period from 1976 to 1982, and Table IV-1-(1)-2 compares the risk levels in the period from 1976 to 1980 and the period from 1981 to 1982 by location.

It may be seen that the collision cases in the period from 1976 to 1980 are highly concentrated in Port Said with a much smaller peak in El Kabrit, but those in other areas are more or less on the same level. Grounding cases have three peaks in El Ballah, Lake Timsah and El Kabrit.

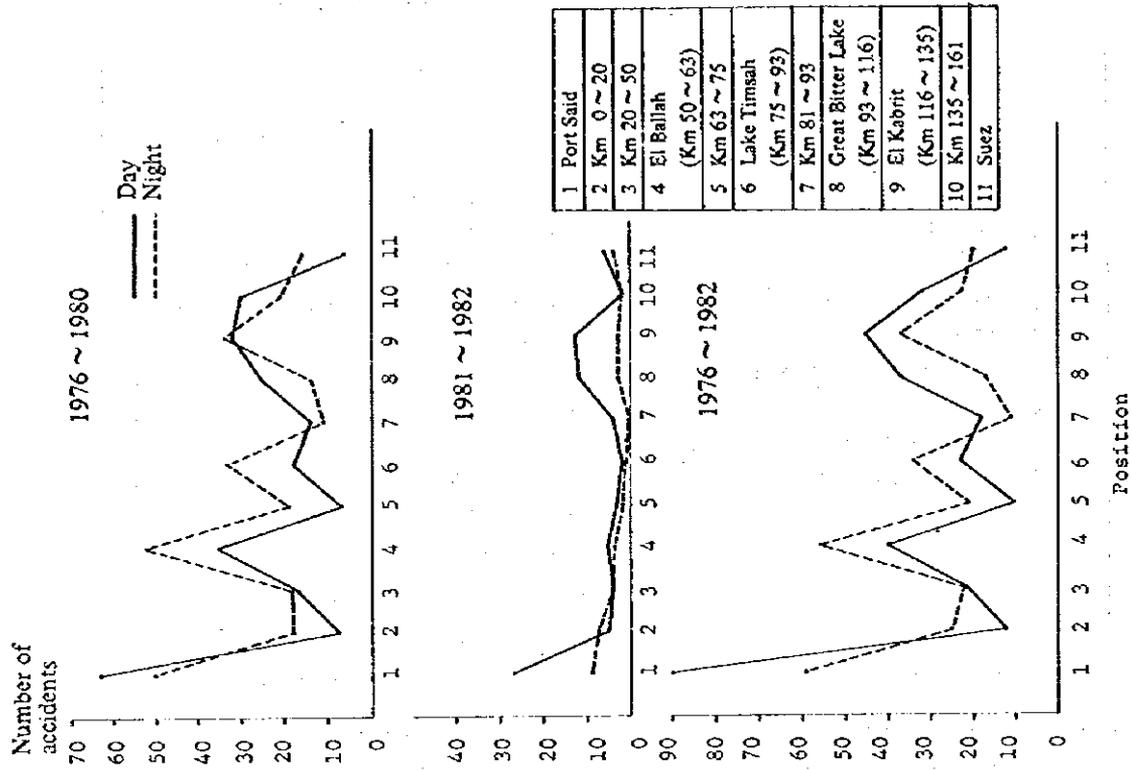
Fig. IV-1-(1)-12 Number of Accidents by Day/Night and Position

Fig. IV-1-(1)-12 shows the risk levels in the three periods classified by daytime and nighttime.

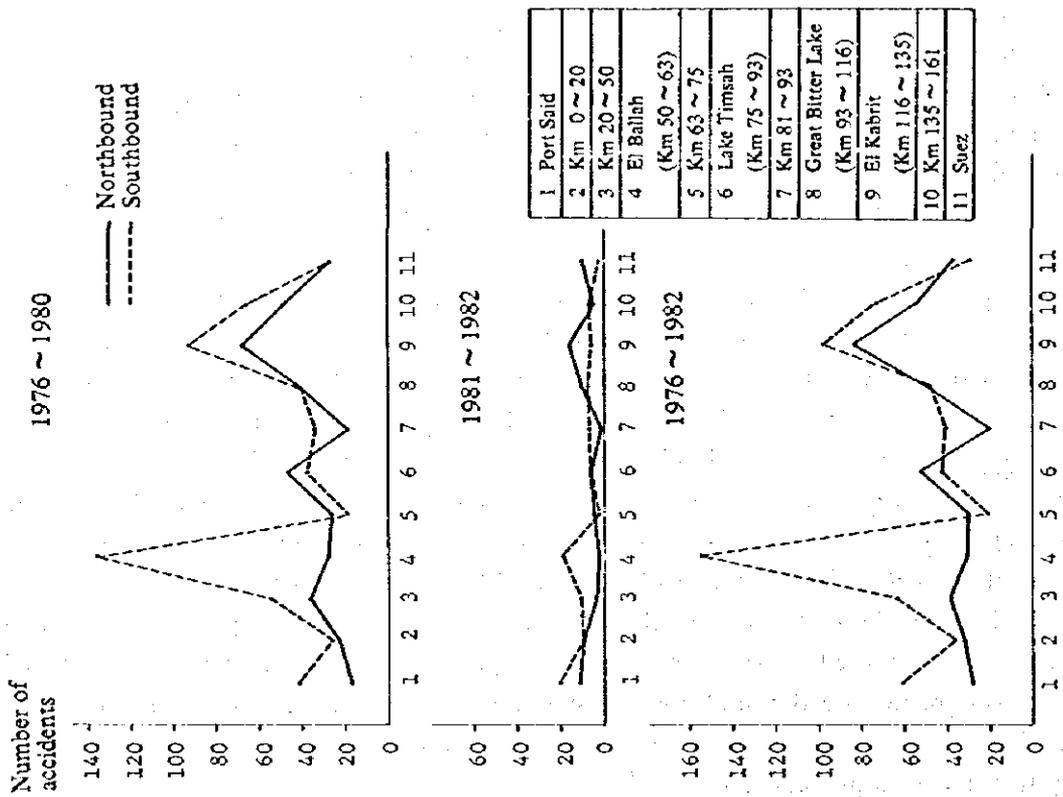
Fig. IV-1-(1)-11 Number of Accidents by Direction of Transit and Position

Fig. IV-1-(1)-11 shows the risk levels in the three periods, i.e., the period from 1976 to 1980, the period from 1981 to 1982 and the overall period from 1976 to 1982 as classified by transiting direction, i.e., northbound and southbound. (In this figure, those with direction of transit unidentifiable are not included. The apparent low risk levels in Port Said and Suez are caused by this statistical procedure.)

In our investigation on the risk levels by transiting direction, it was found in the period before the widening/deepening that those accidents caused by vessels of the southbound convoy in the vicinity of El Ballah are particularly significant followed by those caused by vessels of the southbound convoy in El Kabrit. In the case of vessels of the northbound convoy, a peak is seen in El Kabrit though it is not so remarkable as in the case of vessels in the southbound convoy.

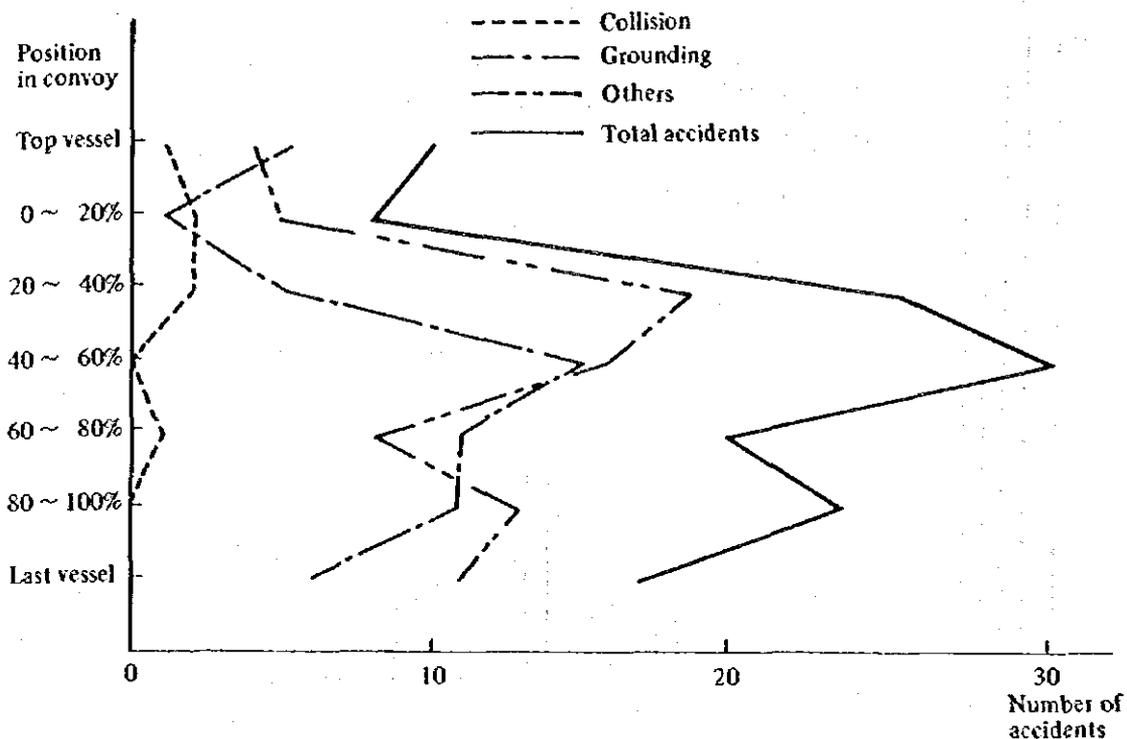
Fig. IV-1-(2)-1 Number of Accidents by Vessel's Position in Convoy

In collision cases, risk levels are high for the first 40% of vessels in a convoy, whereas those in the rear 60% of the convoy suffer most from grounding accidents.

When the total accidents are considered, those vessels in the middle part of the convoy from 20 to 60% comprise a majority, but the frequency of accidents is lower in vessels in the foremost part of the convoy. This may be attributable to the fact that those vessels in the forward part of the convoy can readily increase their speed when required for their manoeuvres, whereas vessels running in the middle have no such freedom in manoeuvres due to the obligation to observe the established ship-to-ship distance and other restrictions. In this connection, it is believed essential to have controls over transit vessels to observe their assigned ship-to-ship distance in a better way and to encourage better formation of the convoy in motion.

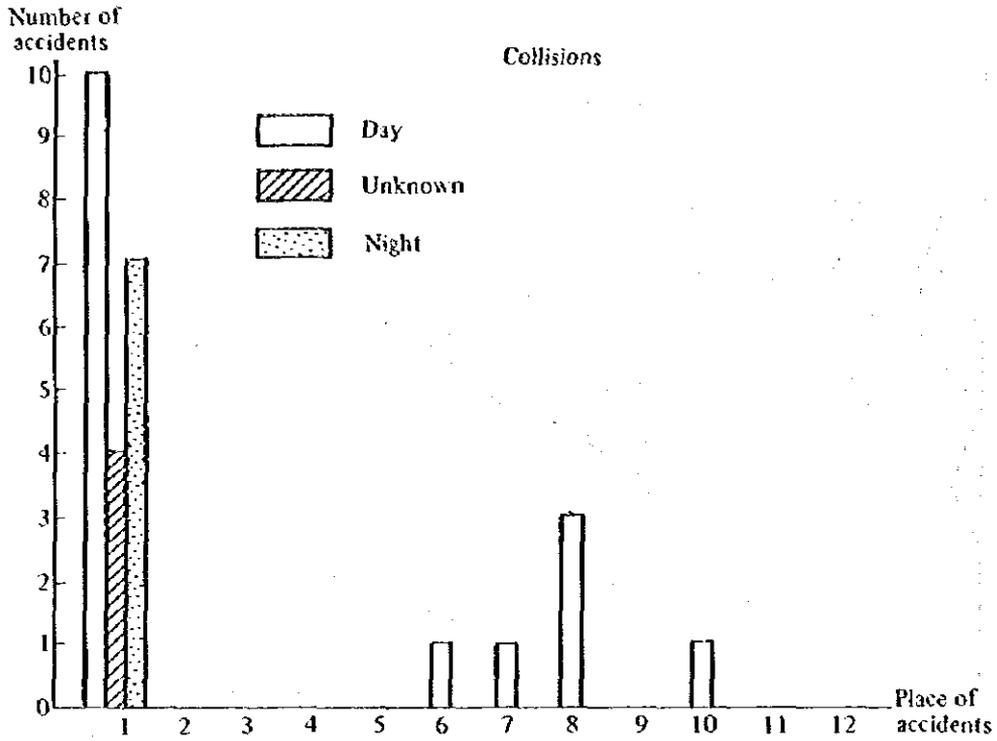
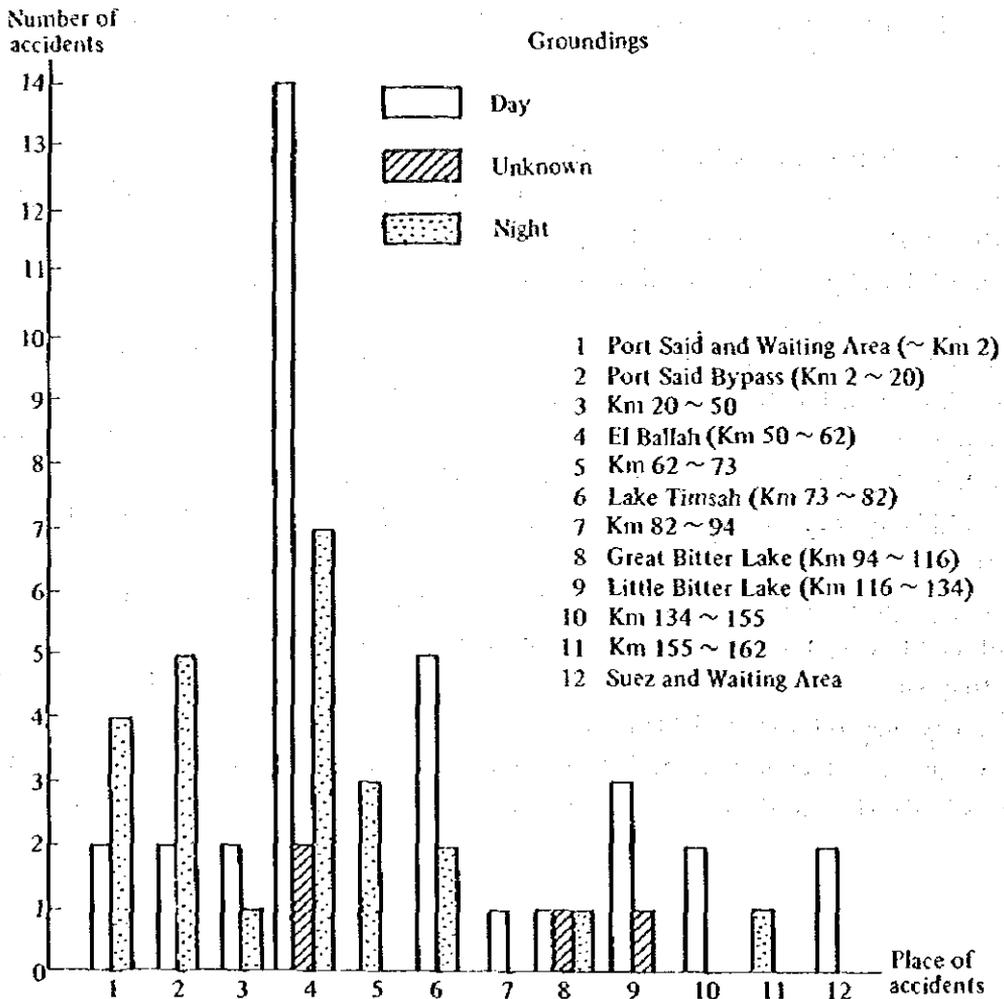
Fig. IV-1-(2)-2 Number of Accidents by Day/Night and Position

The frequency of collision accidents is highest in Port Said where the frequency ratio of accidents in daytime to those in nighttime is 10:7.

The frequency of grounding accidents is highest in El Ballah where the frequency ratio of accidents in daytime to those in nighttime is 14:7. The same ratio of the total grounding cases is 33:24.

Generally, the frequency of grounding accidents is higher in daytime than in nighttime, but in the cases of Port Said and its waiting area, and Port Said Bypass, the frequency in nighttime assumes twice or more of that in daytime, and this is considered to be one of the features inherent to this region of the Canal. In this connection, the improvement and reinforcement of aids to navigation covering the water of this region is strongly impressed.

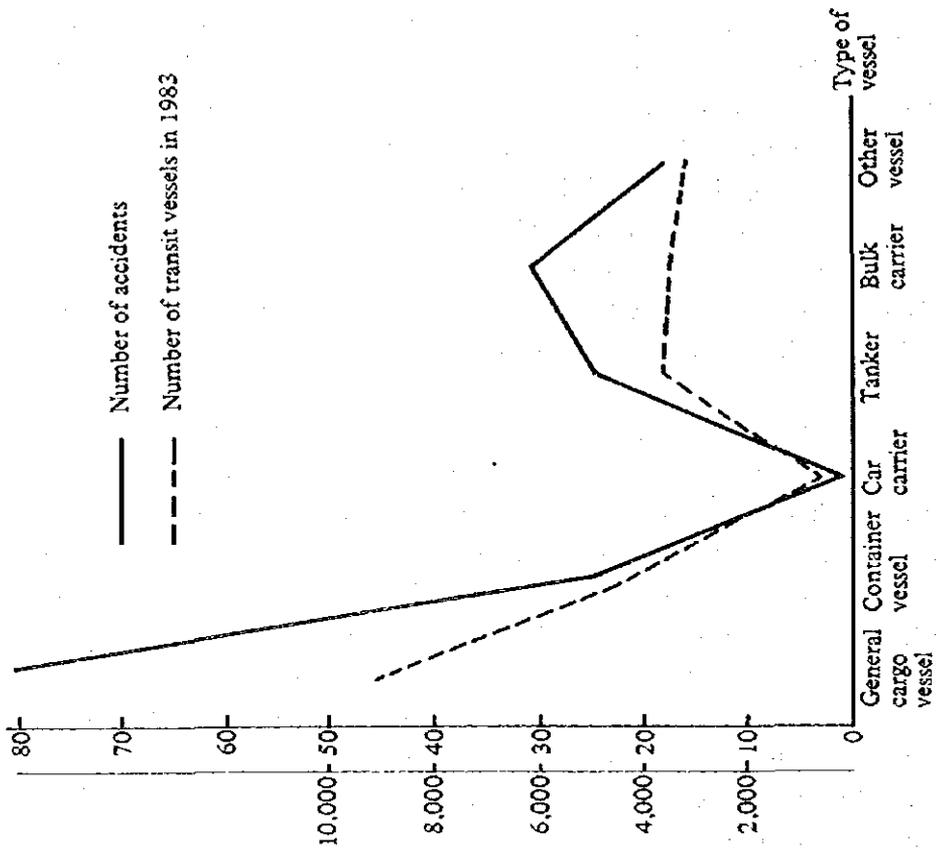
Fig. IV-1-(2)-4 Number of Accidents and Transit Vessels by Kind of Vessel

These curves are in extremely good agreement with each other suggesting that there is no appreciable difference in risk levels by ship type.

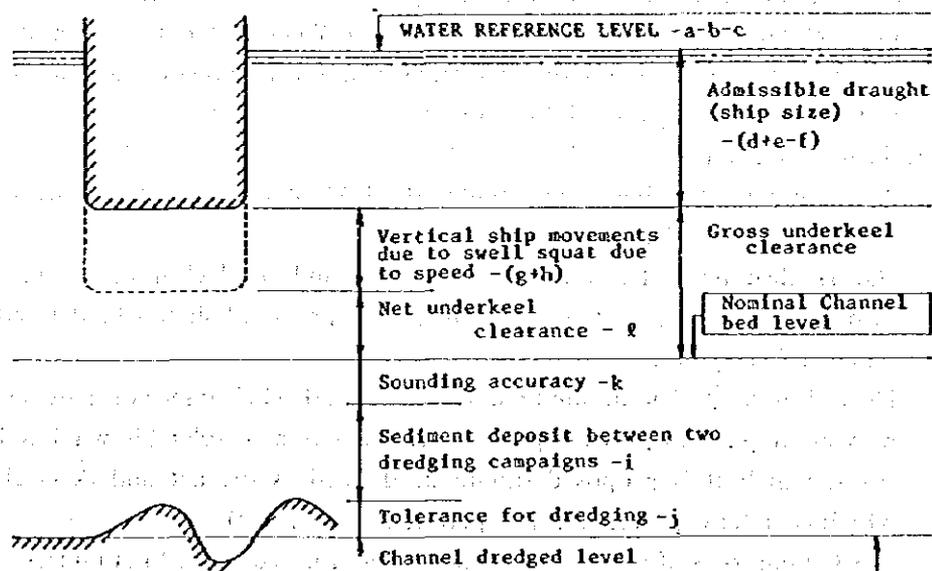
Fig. IV-2-(1)-1 Model of Depth Compositions

The design depth of the Canal is calculated as follows: (Refer to Fig. IV-2-(1)-1).

Here, if CDL (datum level) is taken as the water reference level, $-a-b-c = 0$ because CDL is almost equal to LWL (mean spring low water level) and the probability of the water level dropping below this level is very small.

Then for ship size, if $d = 16.2$ m, as assumed before, and e and f are taken as zero, $d + e - f = 16.2$ m. Vertical ship movement depends on the speeds of navigating ships and the characteristics of swell (period, amplitude, etc.). In the case of the Suez Canal it is also necessary to consider the influences of the so-called Area Ratio (the ratio of a ship's below waterline sectional area to the sectional area under sea level of the canal) and h/d (ratio of depth of the canal to the draught of a ship). The relation between squatting and ship speed is as shown in Figs. IV-2-(1)-2(1) and IV-2-(1)-2(2).

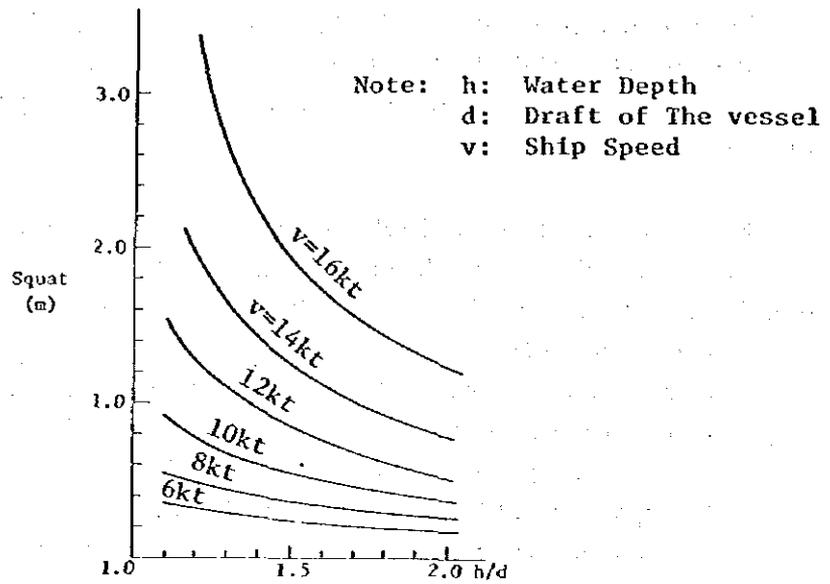
Fig. IV-2-(1)-2(1) Squat and Ship Speed (150,000 DWT Tanker)

Ship speed is limited to $14 \text{ km/h} = 7.56 \text{ Knots}$ according to the Navigation Rules, so a squat g of about 0.5 m is expected for an h/d (ratio of depth to draught) of about 1.2 and the squat g can be about 0.7 m if the Area Ratio is about 5.0 , depending on navigation speeds. Concerning the navigation waterway in the Canal, excluding both ends (Port Said and Suez), it is not necessary to consider swell because swell can be assumed to be zero, $h = 0$. Then $g + h = 0.5$ to 0.7 m .

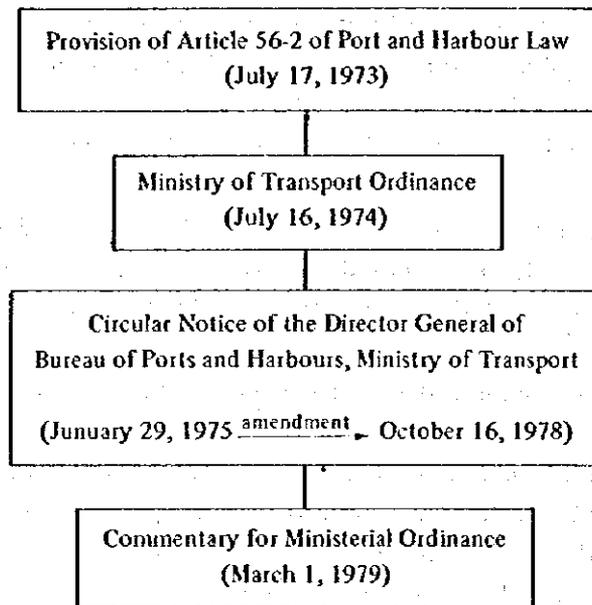
Fig. IV-2-(1)-3 Enactment of Technical Standards for Port and Harbour Facilities in Japan.

The Ministry of Transport laid down the circular notice of the Director General of Bureau of Ports and Harbours, Ministry of Transport, which provides concrete interpretation and application of the ministerial ordinance, for proper enforcement of the ordinance. The enforcement of the technical standards for port and harbour facilities in Japan is as shown in Fig. IV-2-(1)-3

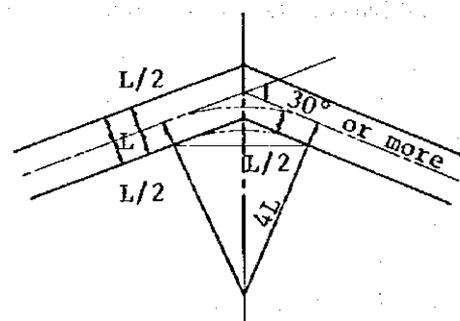
Fig. IV-2-(1)-4 Layout of Waterway at Curves

The intersection angle of center lines of a waterway at a curve should not exceed 30 degrees. When it does exceed 30 degrees, the center line at a curve of a waterway shall be a circular arc with the radius of curvature about 4 times or more of the overall length of the ship, and width of the waterway shall be wide enough for the navigation of the ship (see Fig. IV-2-(1)-4).

L: Overall length of the ship

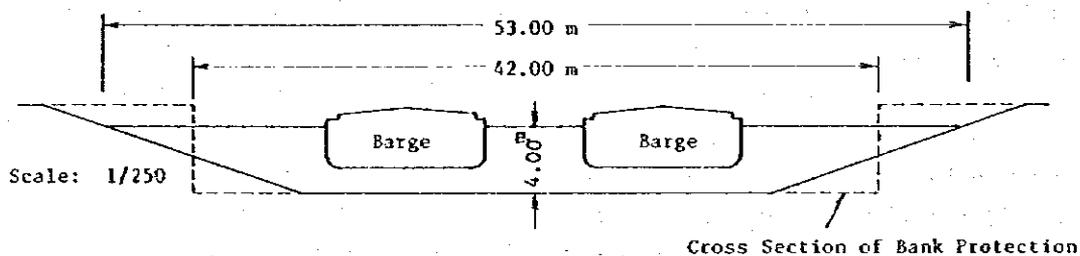
Fig. IV-2-(1)-6 New Profile of the Essen Canal

The Essen Canal (officially known as the Rhine-Herve Canal) is a lockgate type inland canal and serves as the core of transportation in the Ruhr industrial area. This canal is used mainly for traffic of so-called barges as well as of small ships, and has a depth of -4.0 m and width of 42 m at the bottom (portions of the canal are currently being expanded). It is a small sized canal (refer to Fig. IV-2-(1)-6). The design area ratio of the Essen Canal is 7.0 .

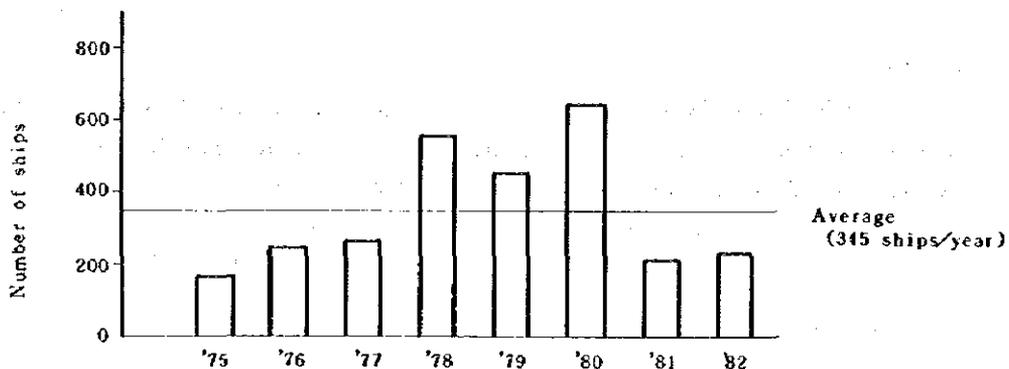
Fig. IV-2-(1)-7 Average Number of Ships Suffering Compulsory Stoppage in the Canal owing to Bad Weather (1975 ~ 1982)

Fig. IV-2-(1)-7 shows the number of ships which were forced to stop in the Canal owing to bad weather from 1975 to 1982. In this figure, bad weather means mostly poor visibility.

The average number of ships is 345/year.

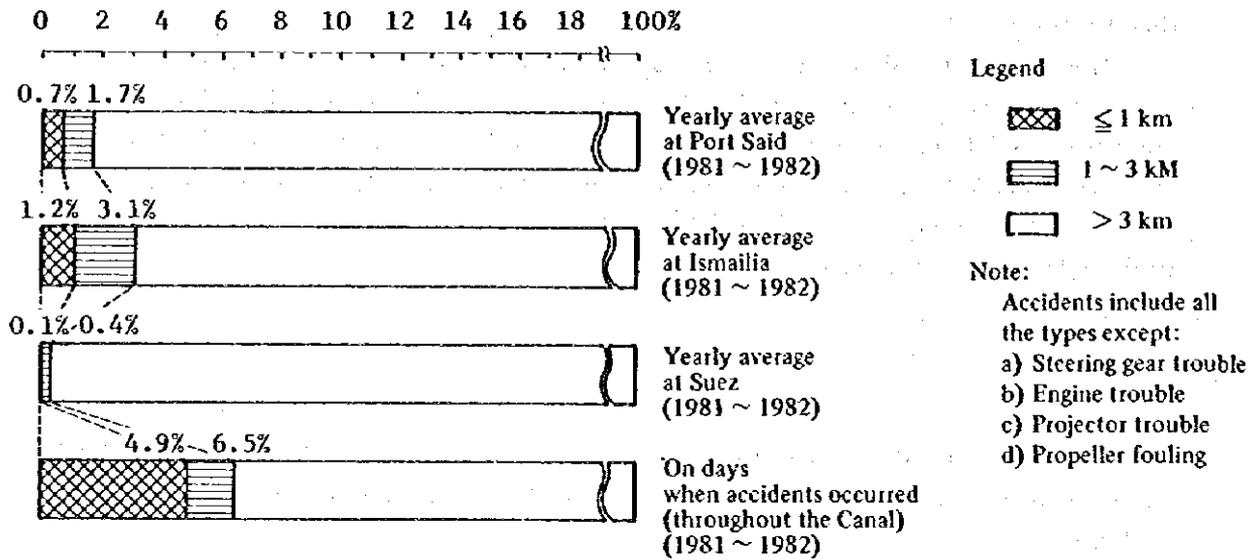
Fig. IV-2-(1)-8 Comparison of Visibility

Fig. IV-2-(1)-8 shows visibility conditions on the days when the ship accidents actually occurred and yearly average visibility conditions. This figure indicates that visibility under one kilometer clearly affects the number of accidents. Visibility is one of the most important factors affecting navigation.

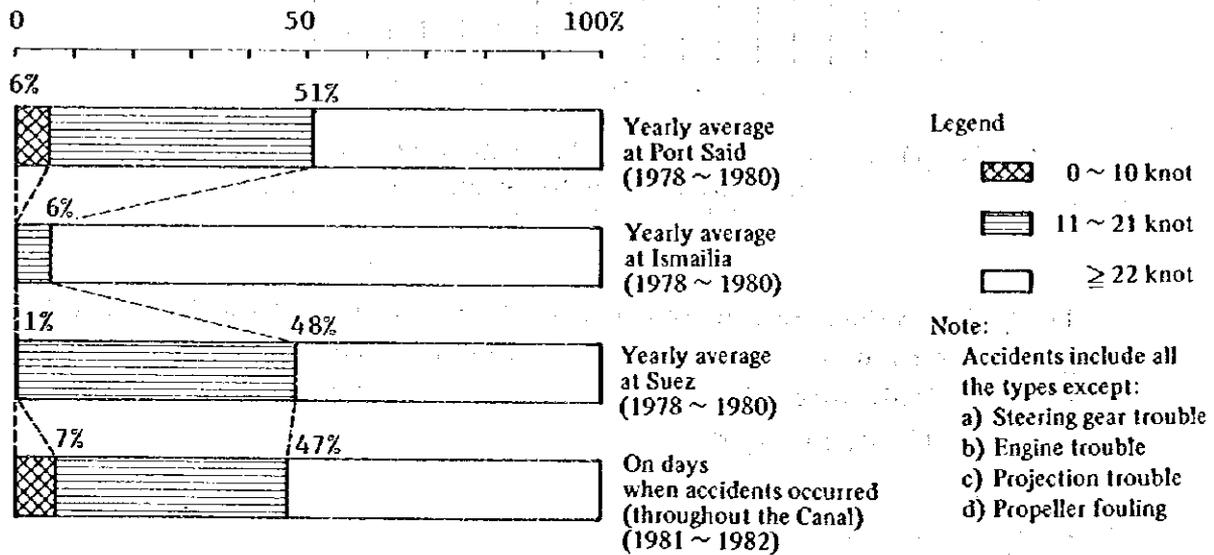
Fig. IV-2-(1)-9 Comparison of Wind Velocity

Fig. IV-2-(1)-9 shows the occurrence frequency of velocity on the days when ship accidents actually occurred and the yearly average velocities. This figure indicates that wind velocities over 22 knots are related to ship accidents.

The most frequent wind direction of strong winds in northwest to north in this region (See II-2-(5)). This means that the occurrence frequency of strong winds which run across the waterway in high near El Kabrit. In fact, many ship accidents have occurred in the El Kabrit area.

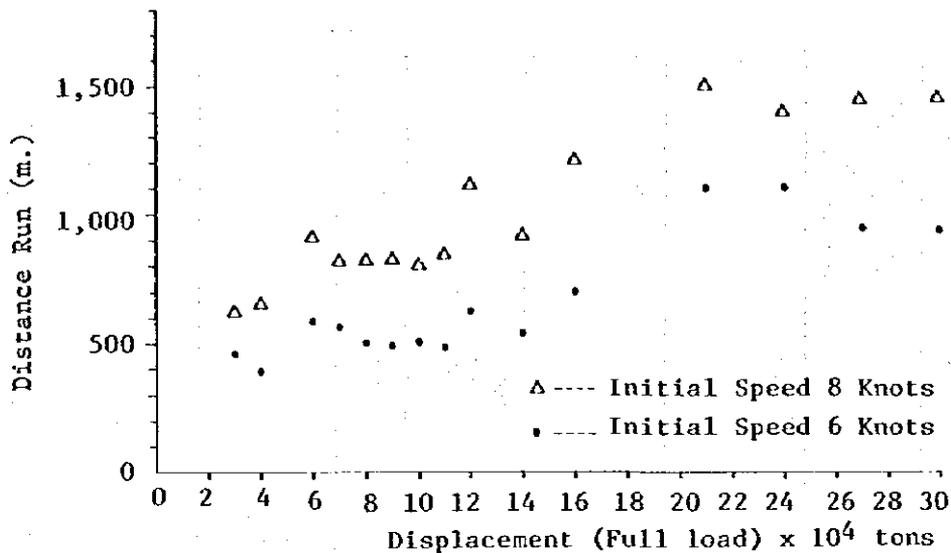
Fig. IV-2-(2)-1 Reverse Stopping Distance
(Source: Japan Dockmasters' Association)

If we consider the emergency stopping distance of a vessel actually proceeding through the Canal, more distance than the trials results may possibly be required; and further, if we take some degree of safety allowance into account, a stopping distance 1.5 times as much as that in the trials may be necessary. If such is the case, the following ship-to-ship distances of three times the values given in Fig. IV-2-(2)-1 are considered necessary for safe operation.

These values are in pretty good agreement with the ship-to-ship distance established by the SCA as the reference values, and thus the SCA's standards are considered to be reasonable.

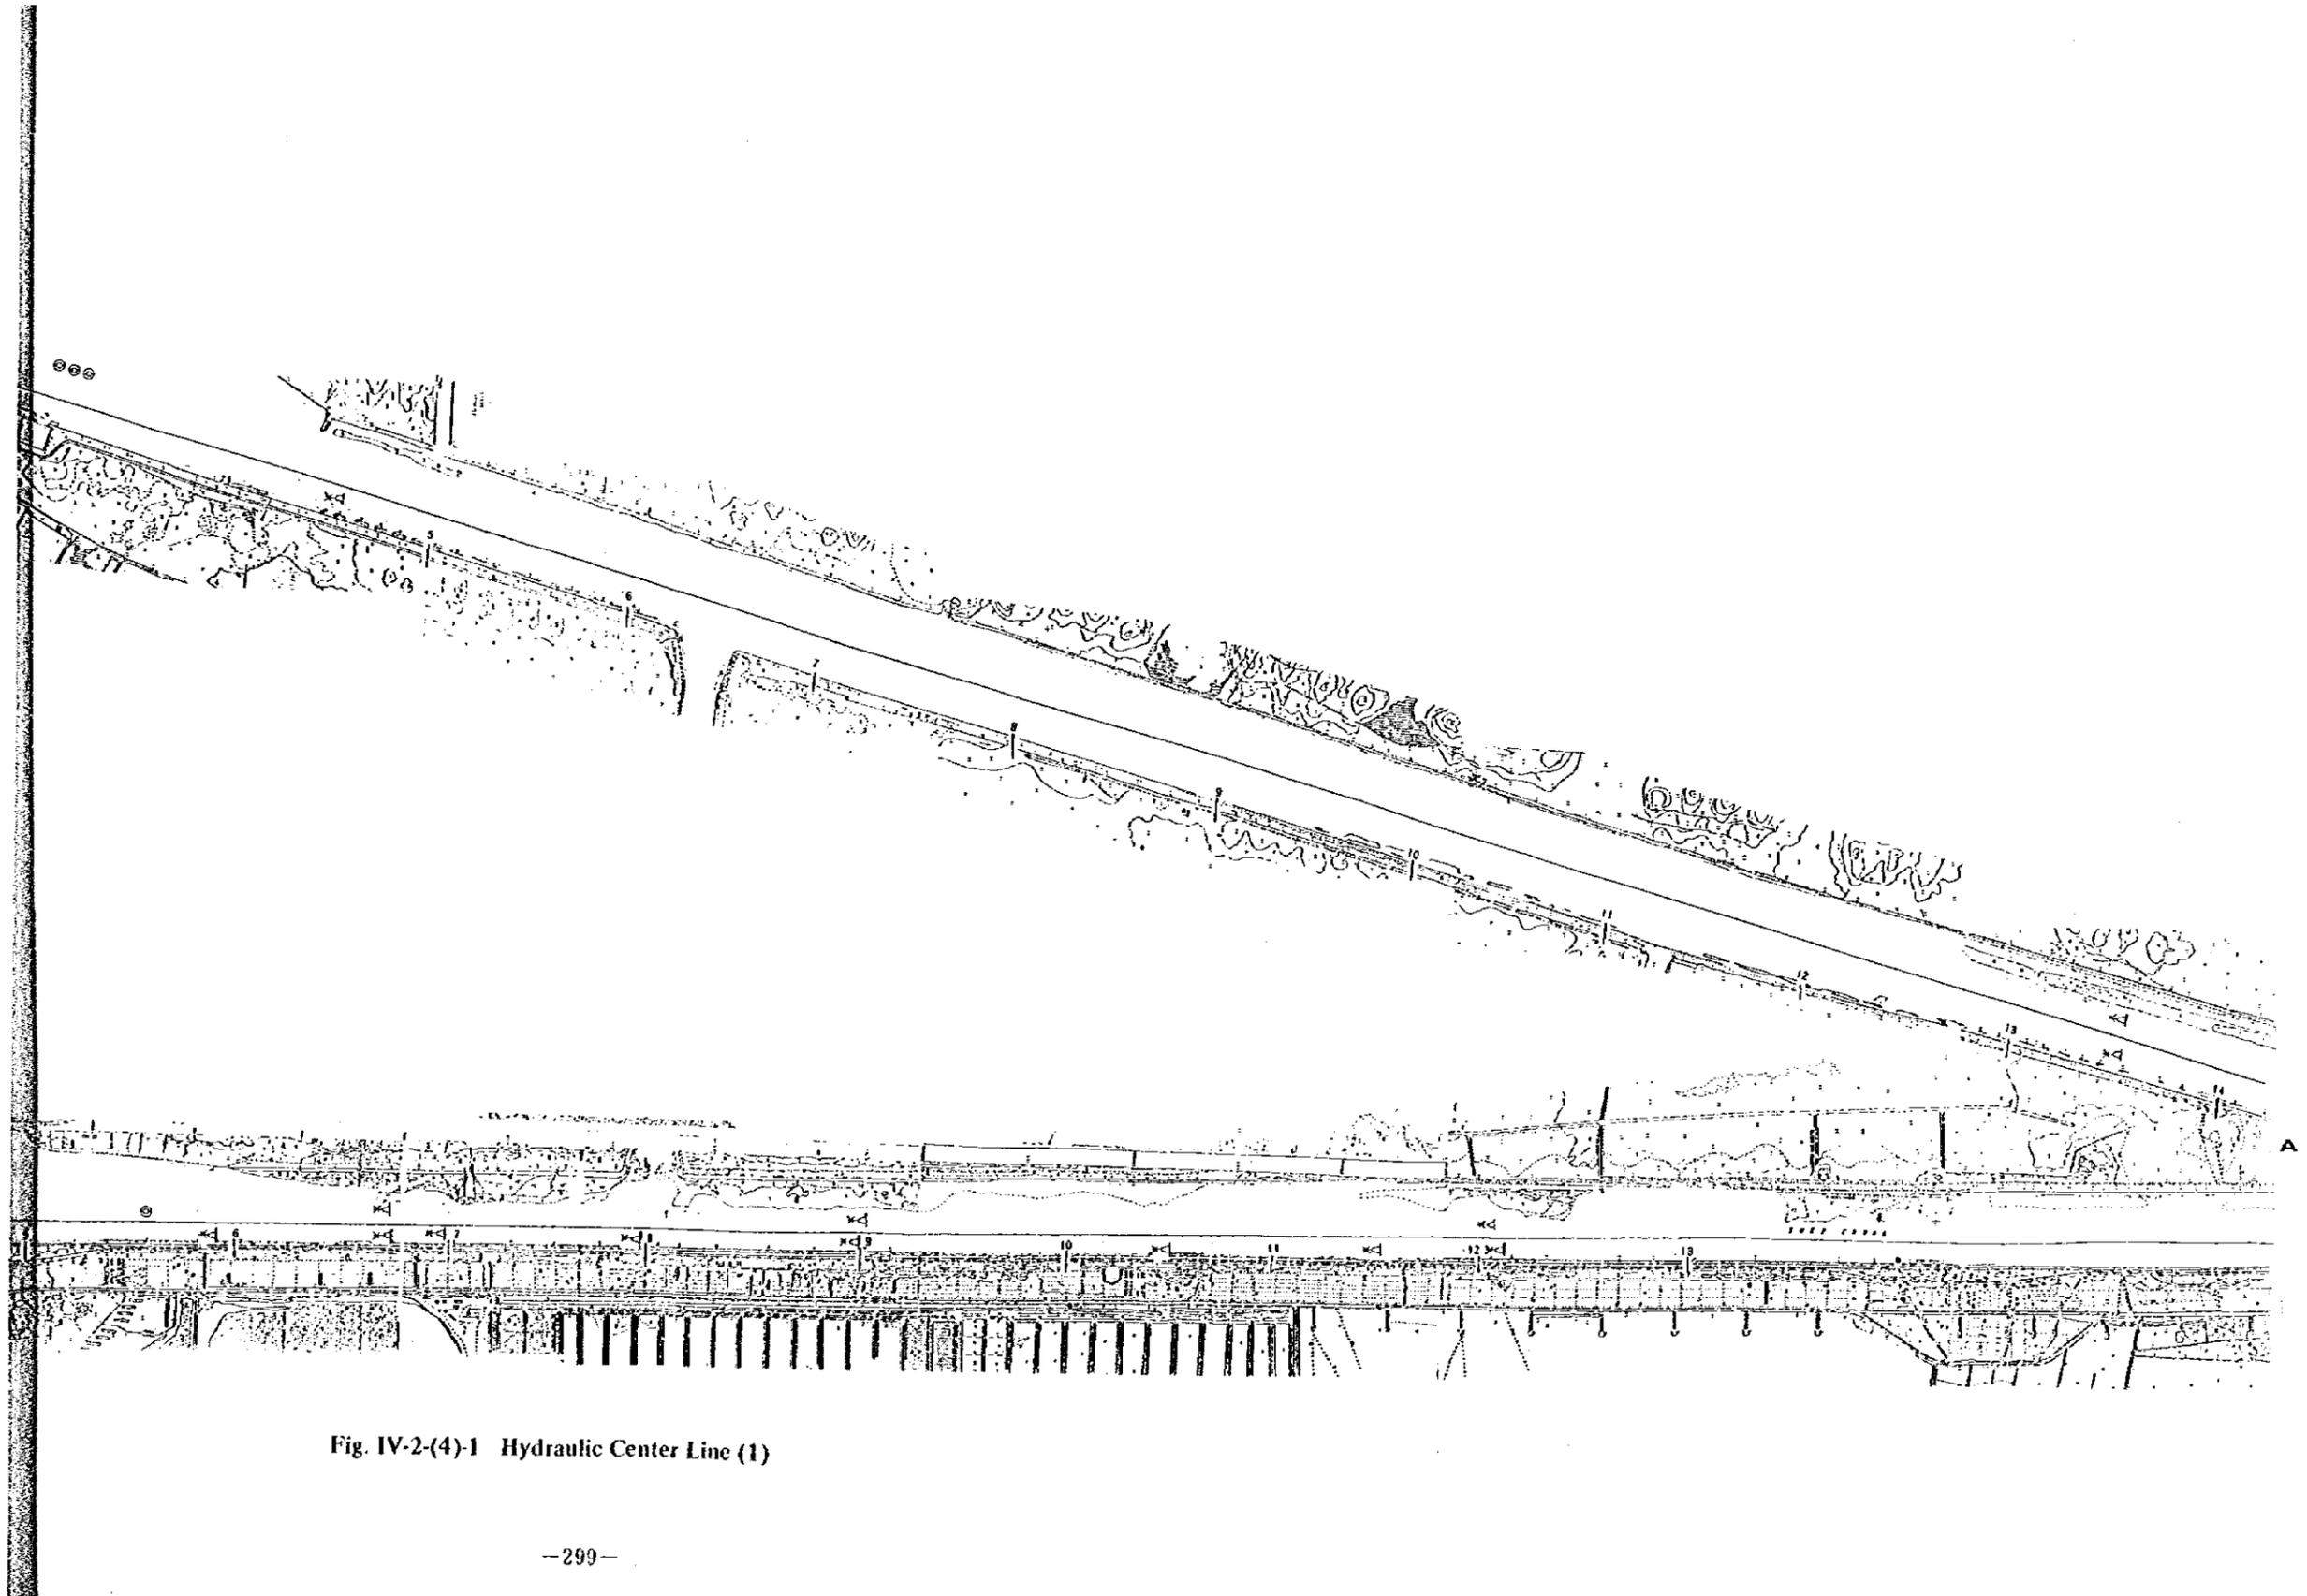
Fig. IV-2-(4)-1 Hydraulic Center Line (1)

Figs. IV-2-(4)-1~6 are maps noted with the hydraulic centreline which were drawn based on microfilm photos of the maps marked with the data of hydraulic centreline that were forwarded from the SCA in July, 1984.

The system of coordinates used in position fixing by Loran-C, namely the system of coordinates of the hydraulic centreline and that used in this map have been left uncorrelated.
