PART III. ANALYSIS OF ACCIDENTS

PART III ANALYSIS OF ACCIDENTS

PART IV. EVALUATION OF CANAL CONDITIONS

PART IV EVALUATION OF CANAL CONDITIONS

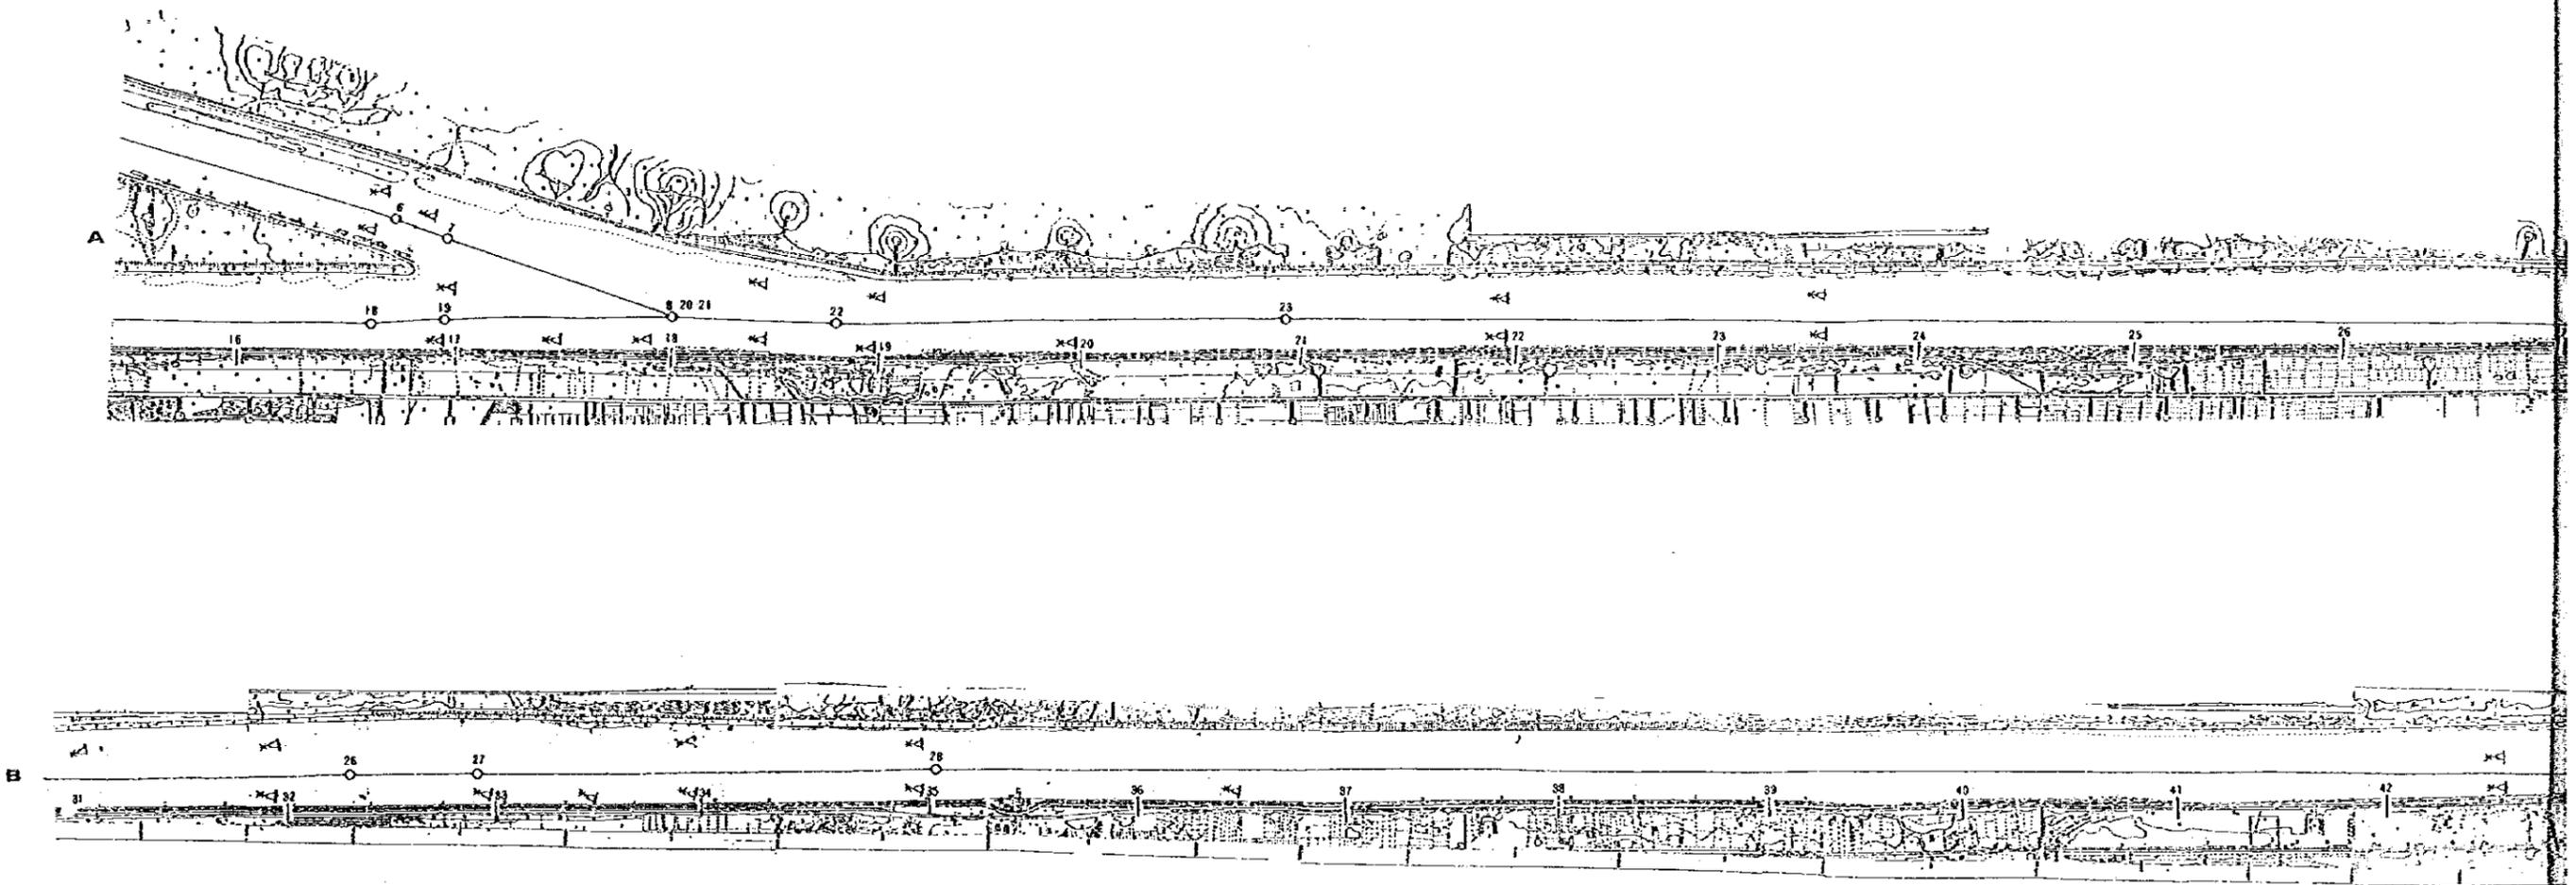
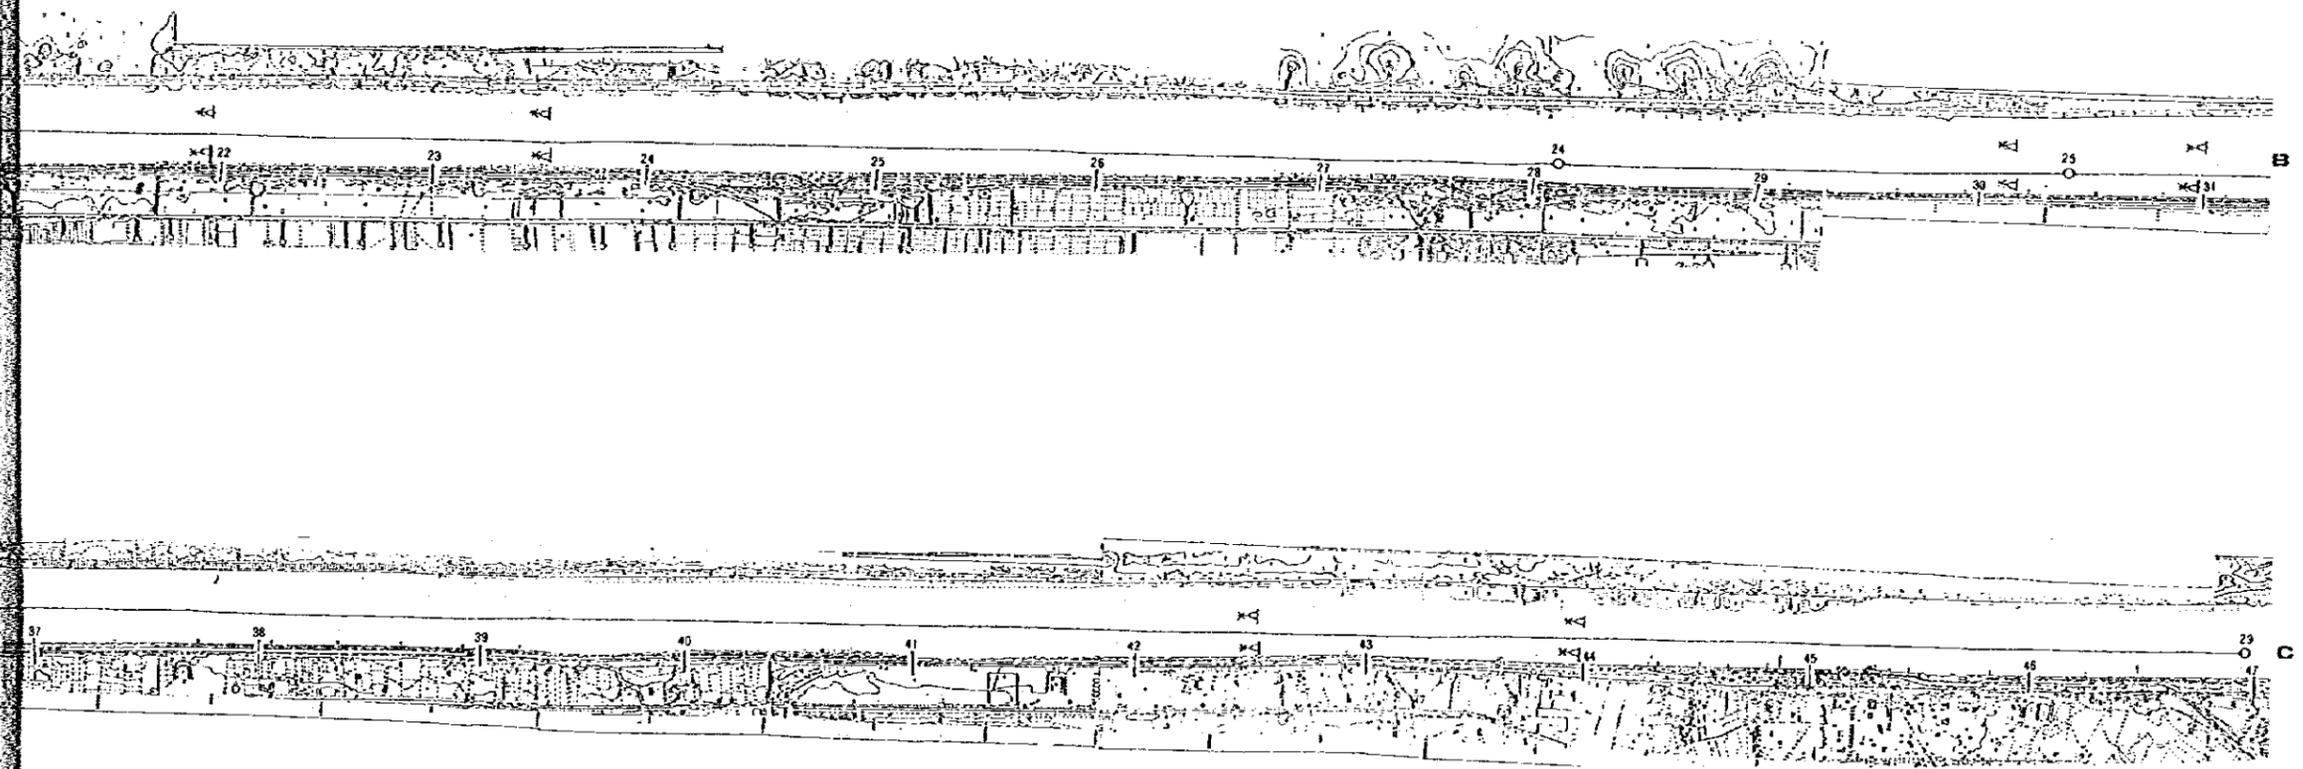
Fig. IV-2-(4)-2 Hydraulic Center Line (2)

Fig. IV-2(4)-2 Hydraulic Center Line (2)

Figs. IV-2-(4)-1~6 are maps noted with the hydraulic centreline which were drawn based on microfilm photos of the maps marked with the data of hydraulic centreline that were forwarded from the SCA in July, 1984.

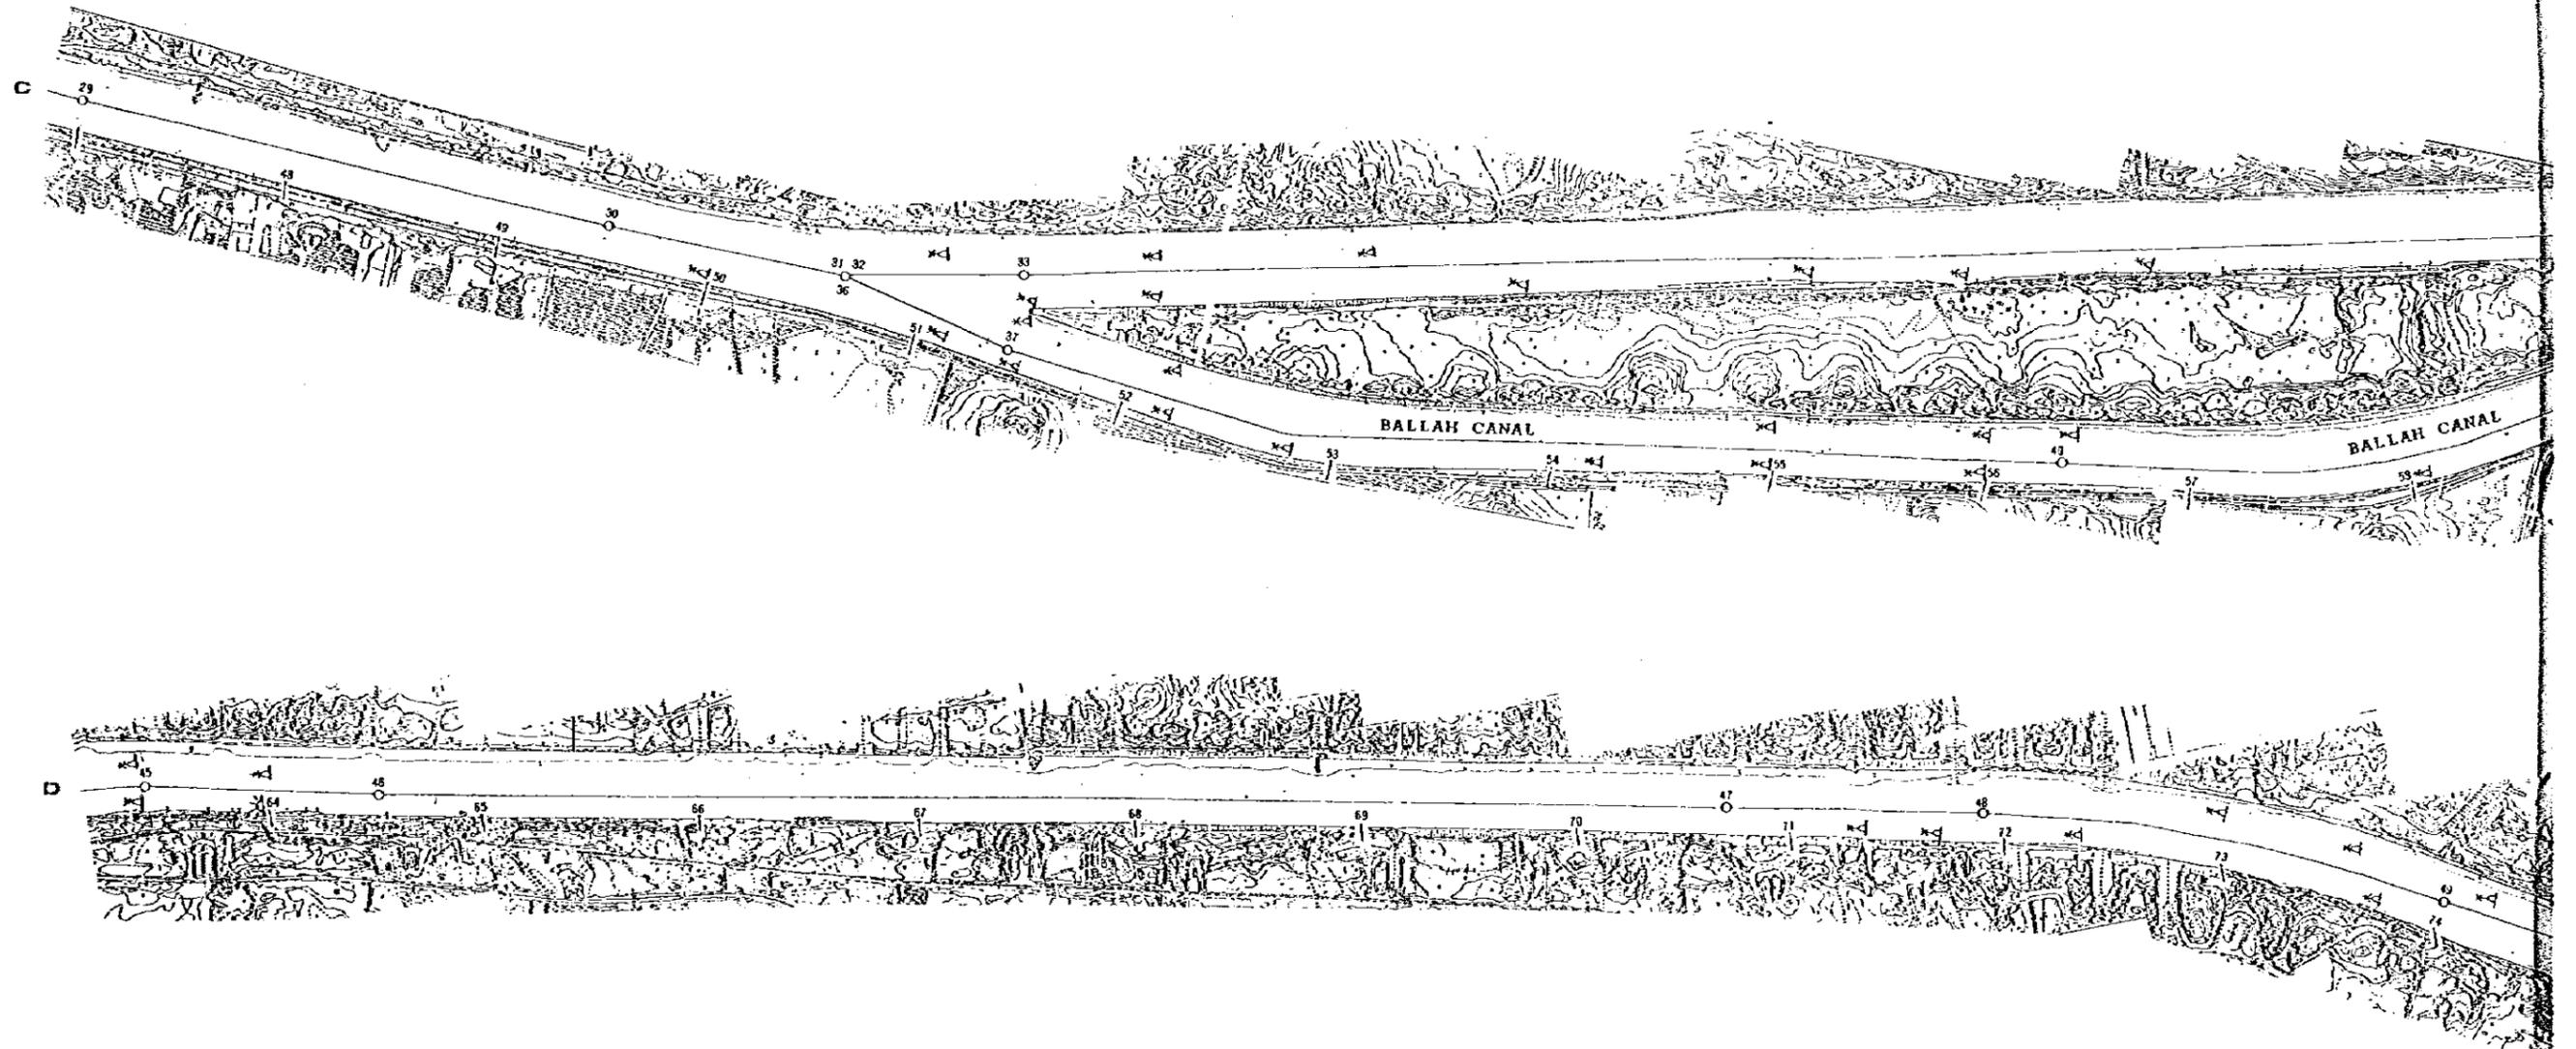
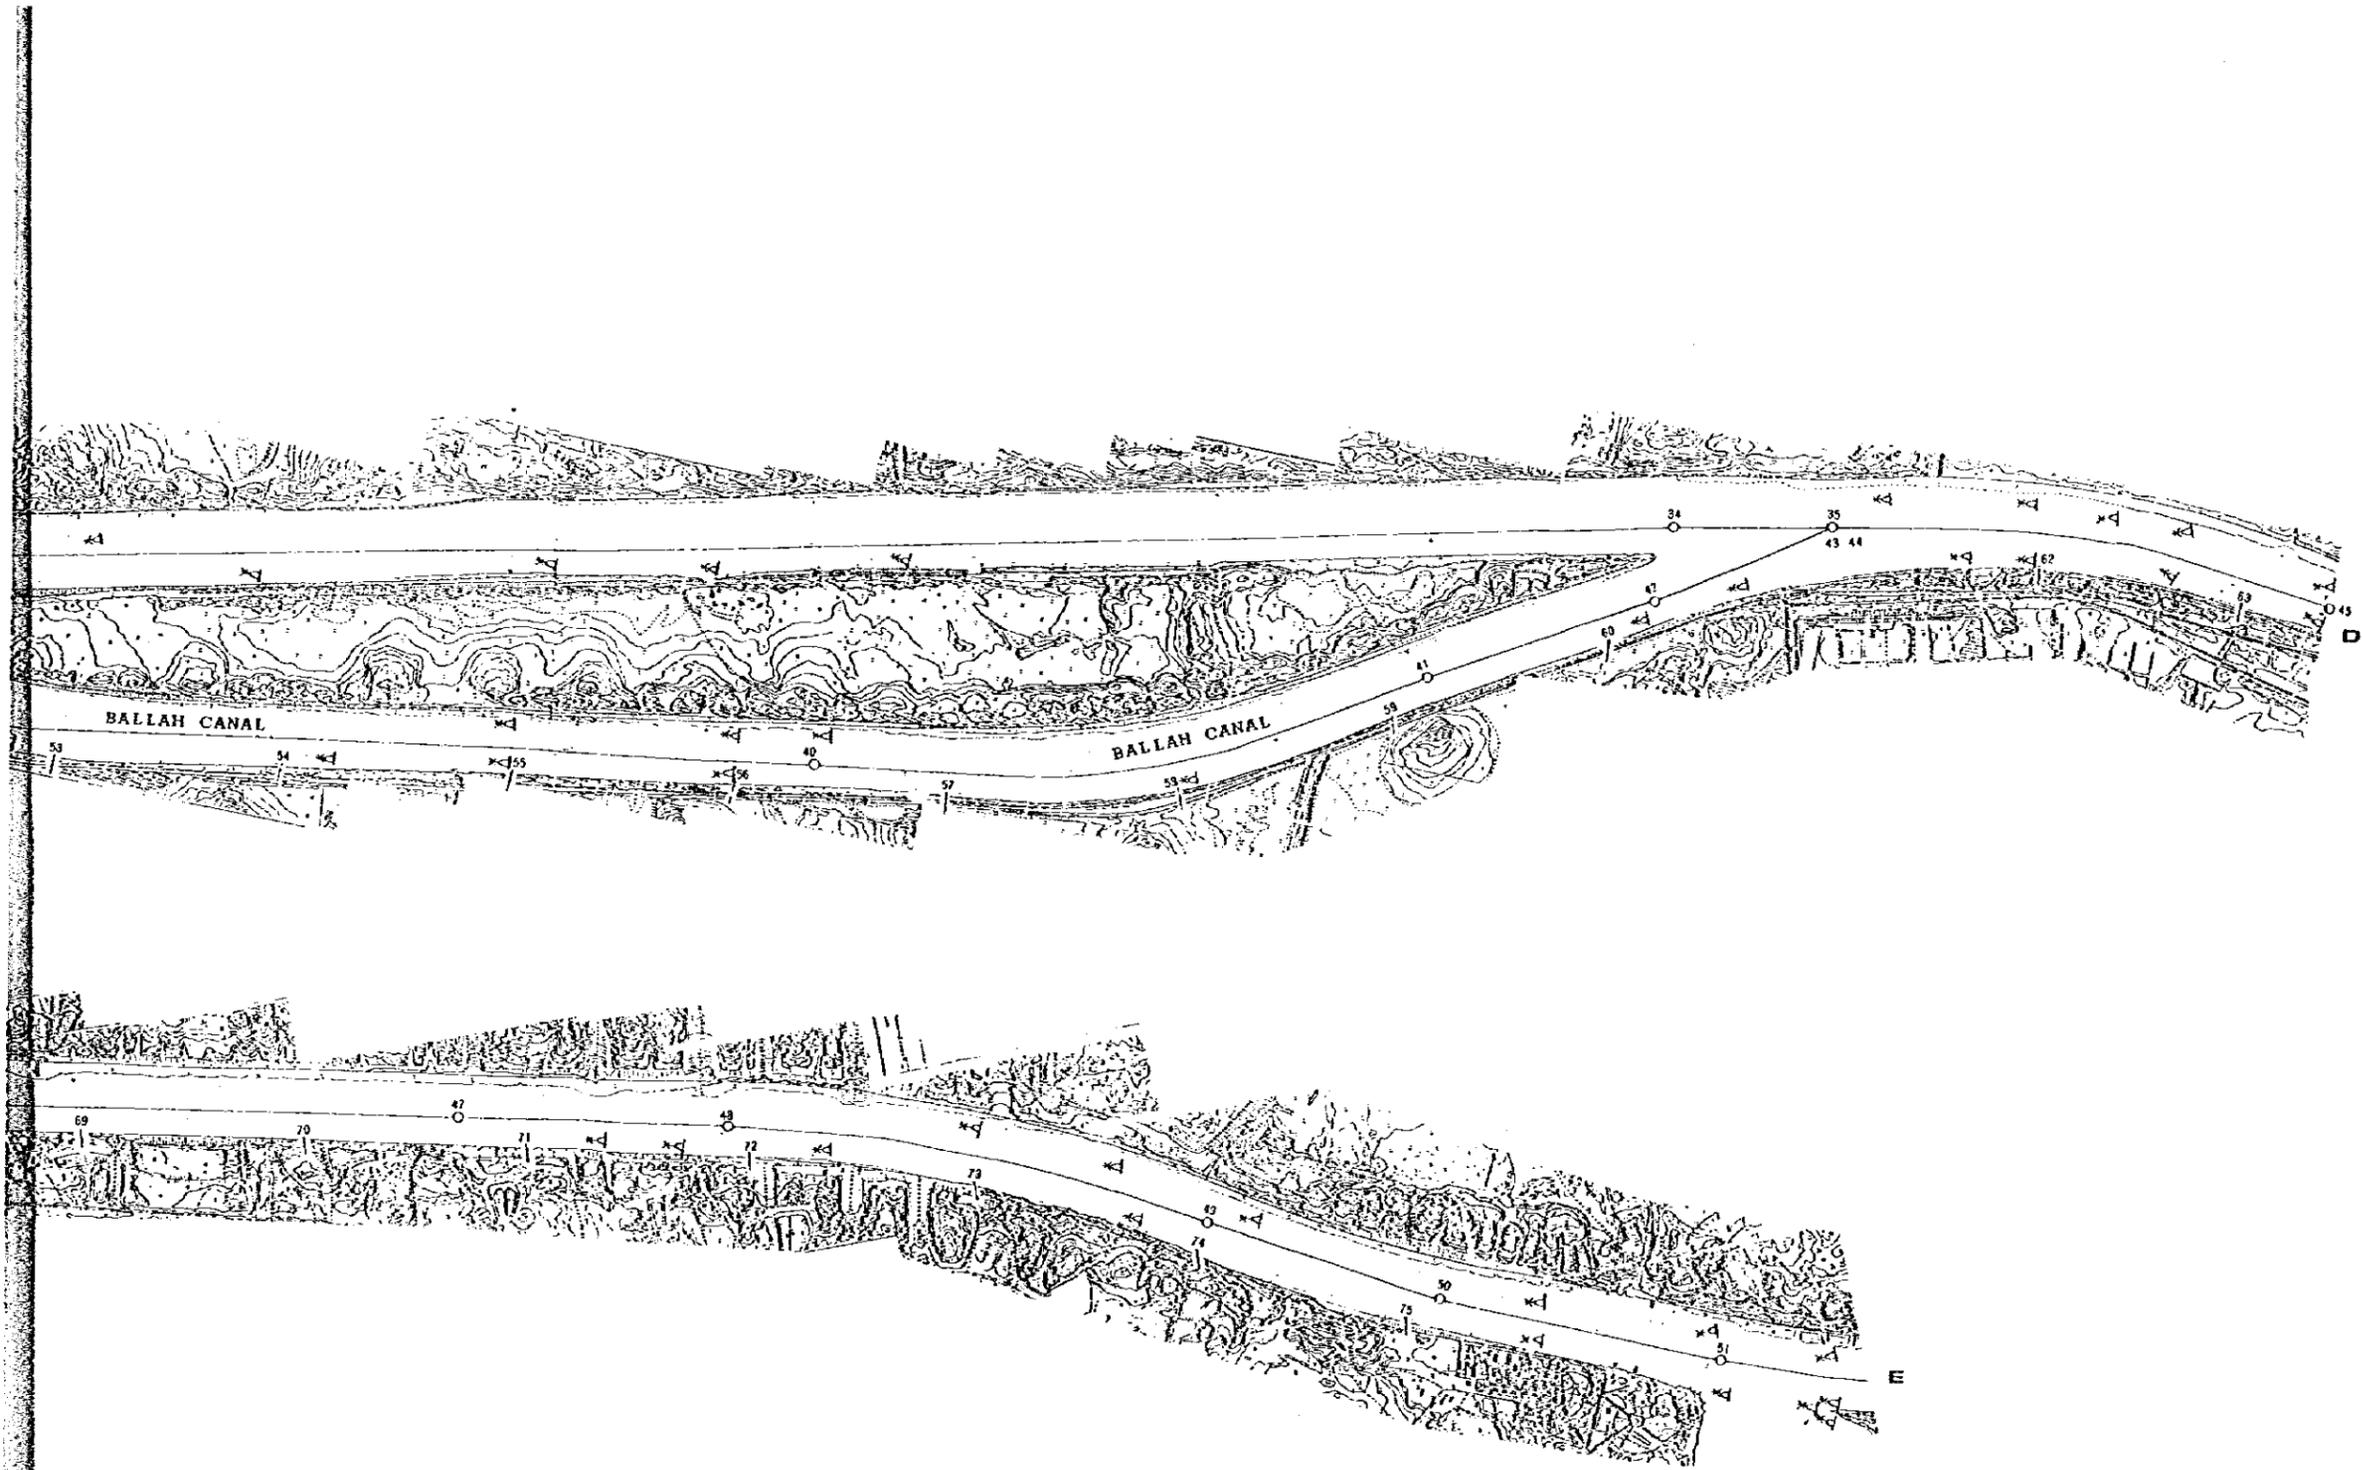
Fig. IV-2-(4)-3 Hydraulic Center Line (3)

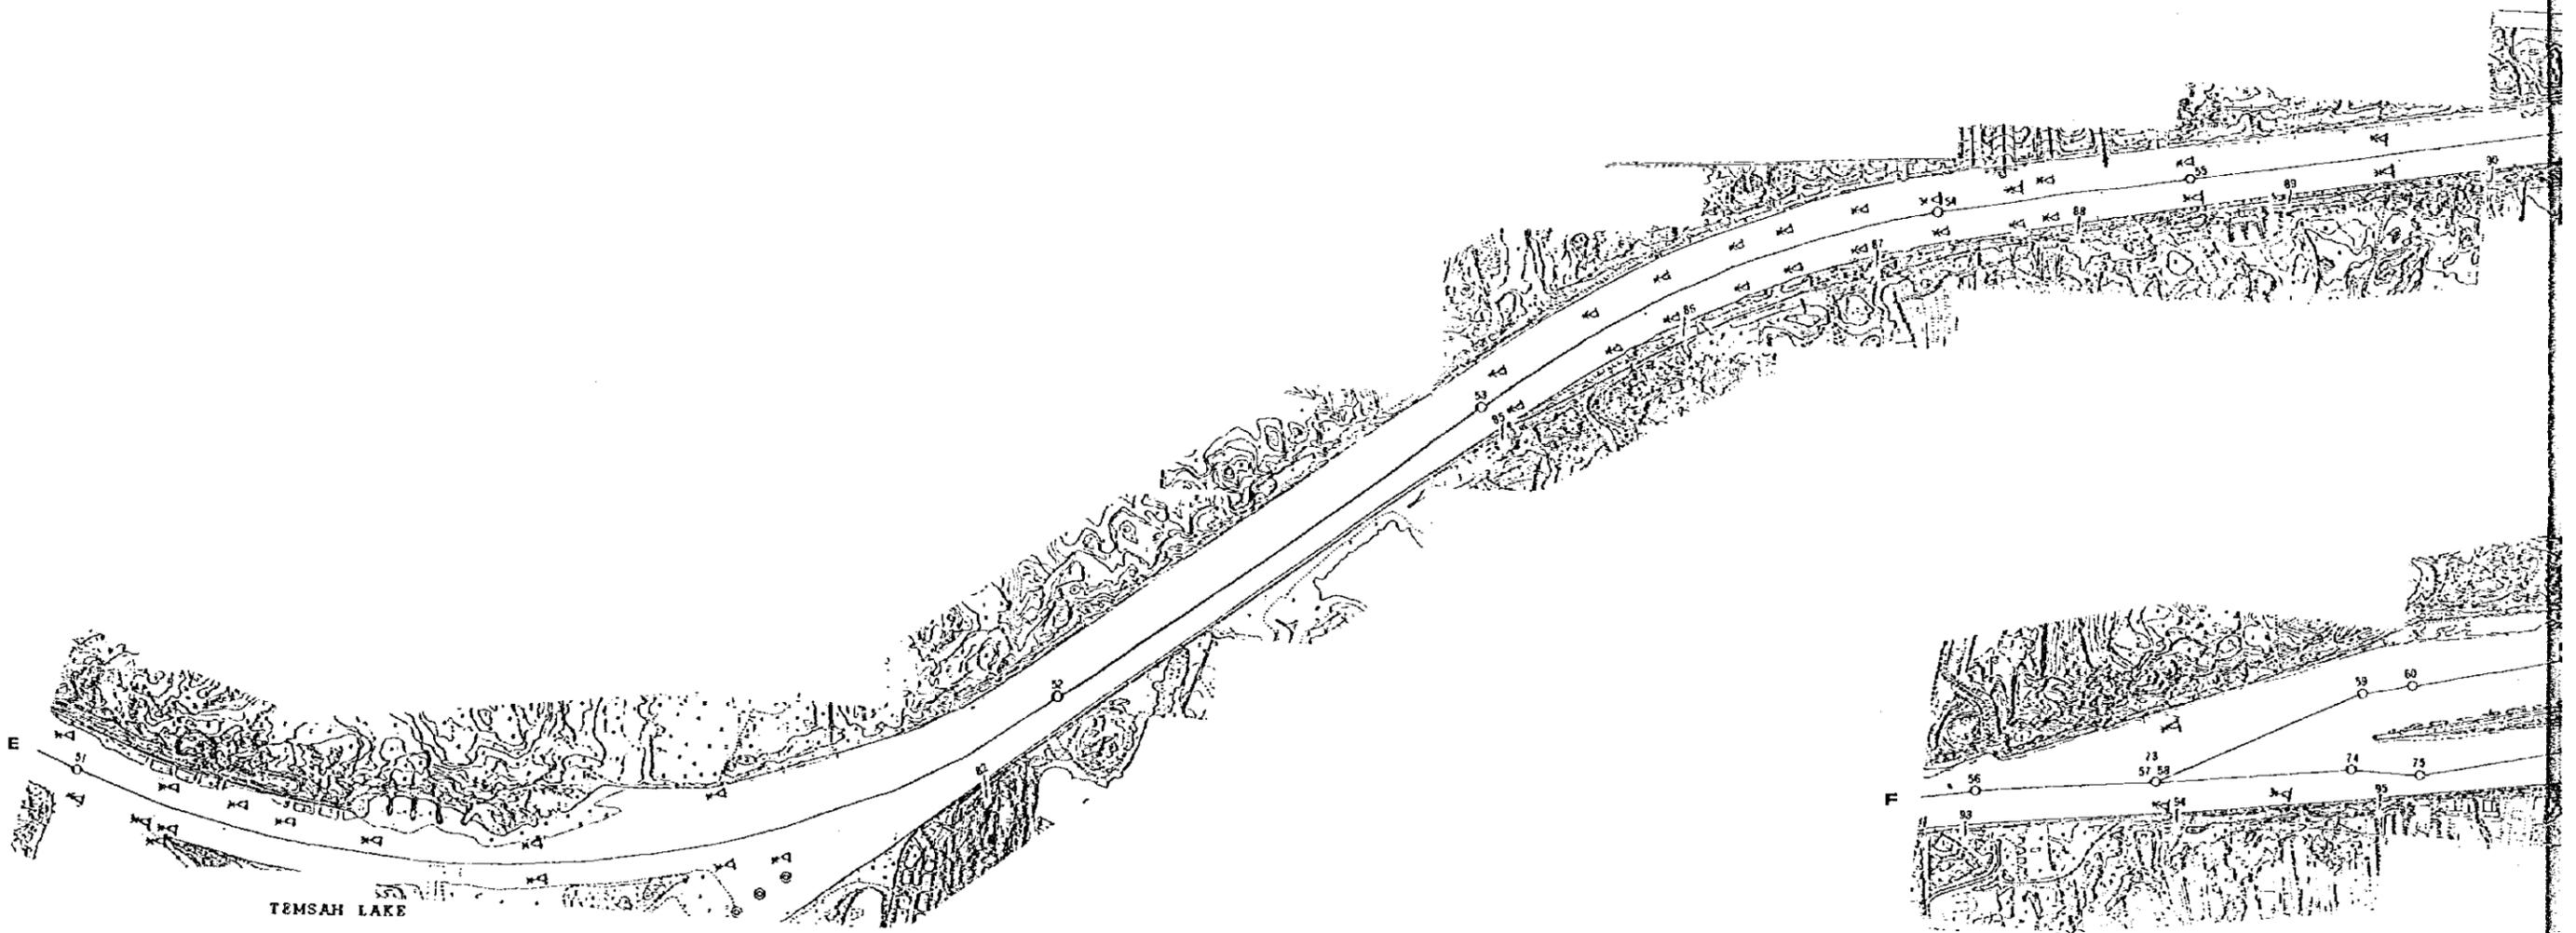
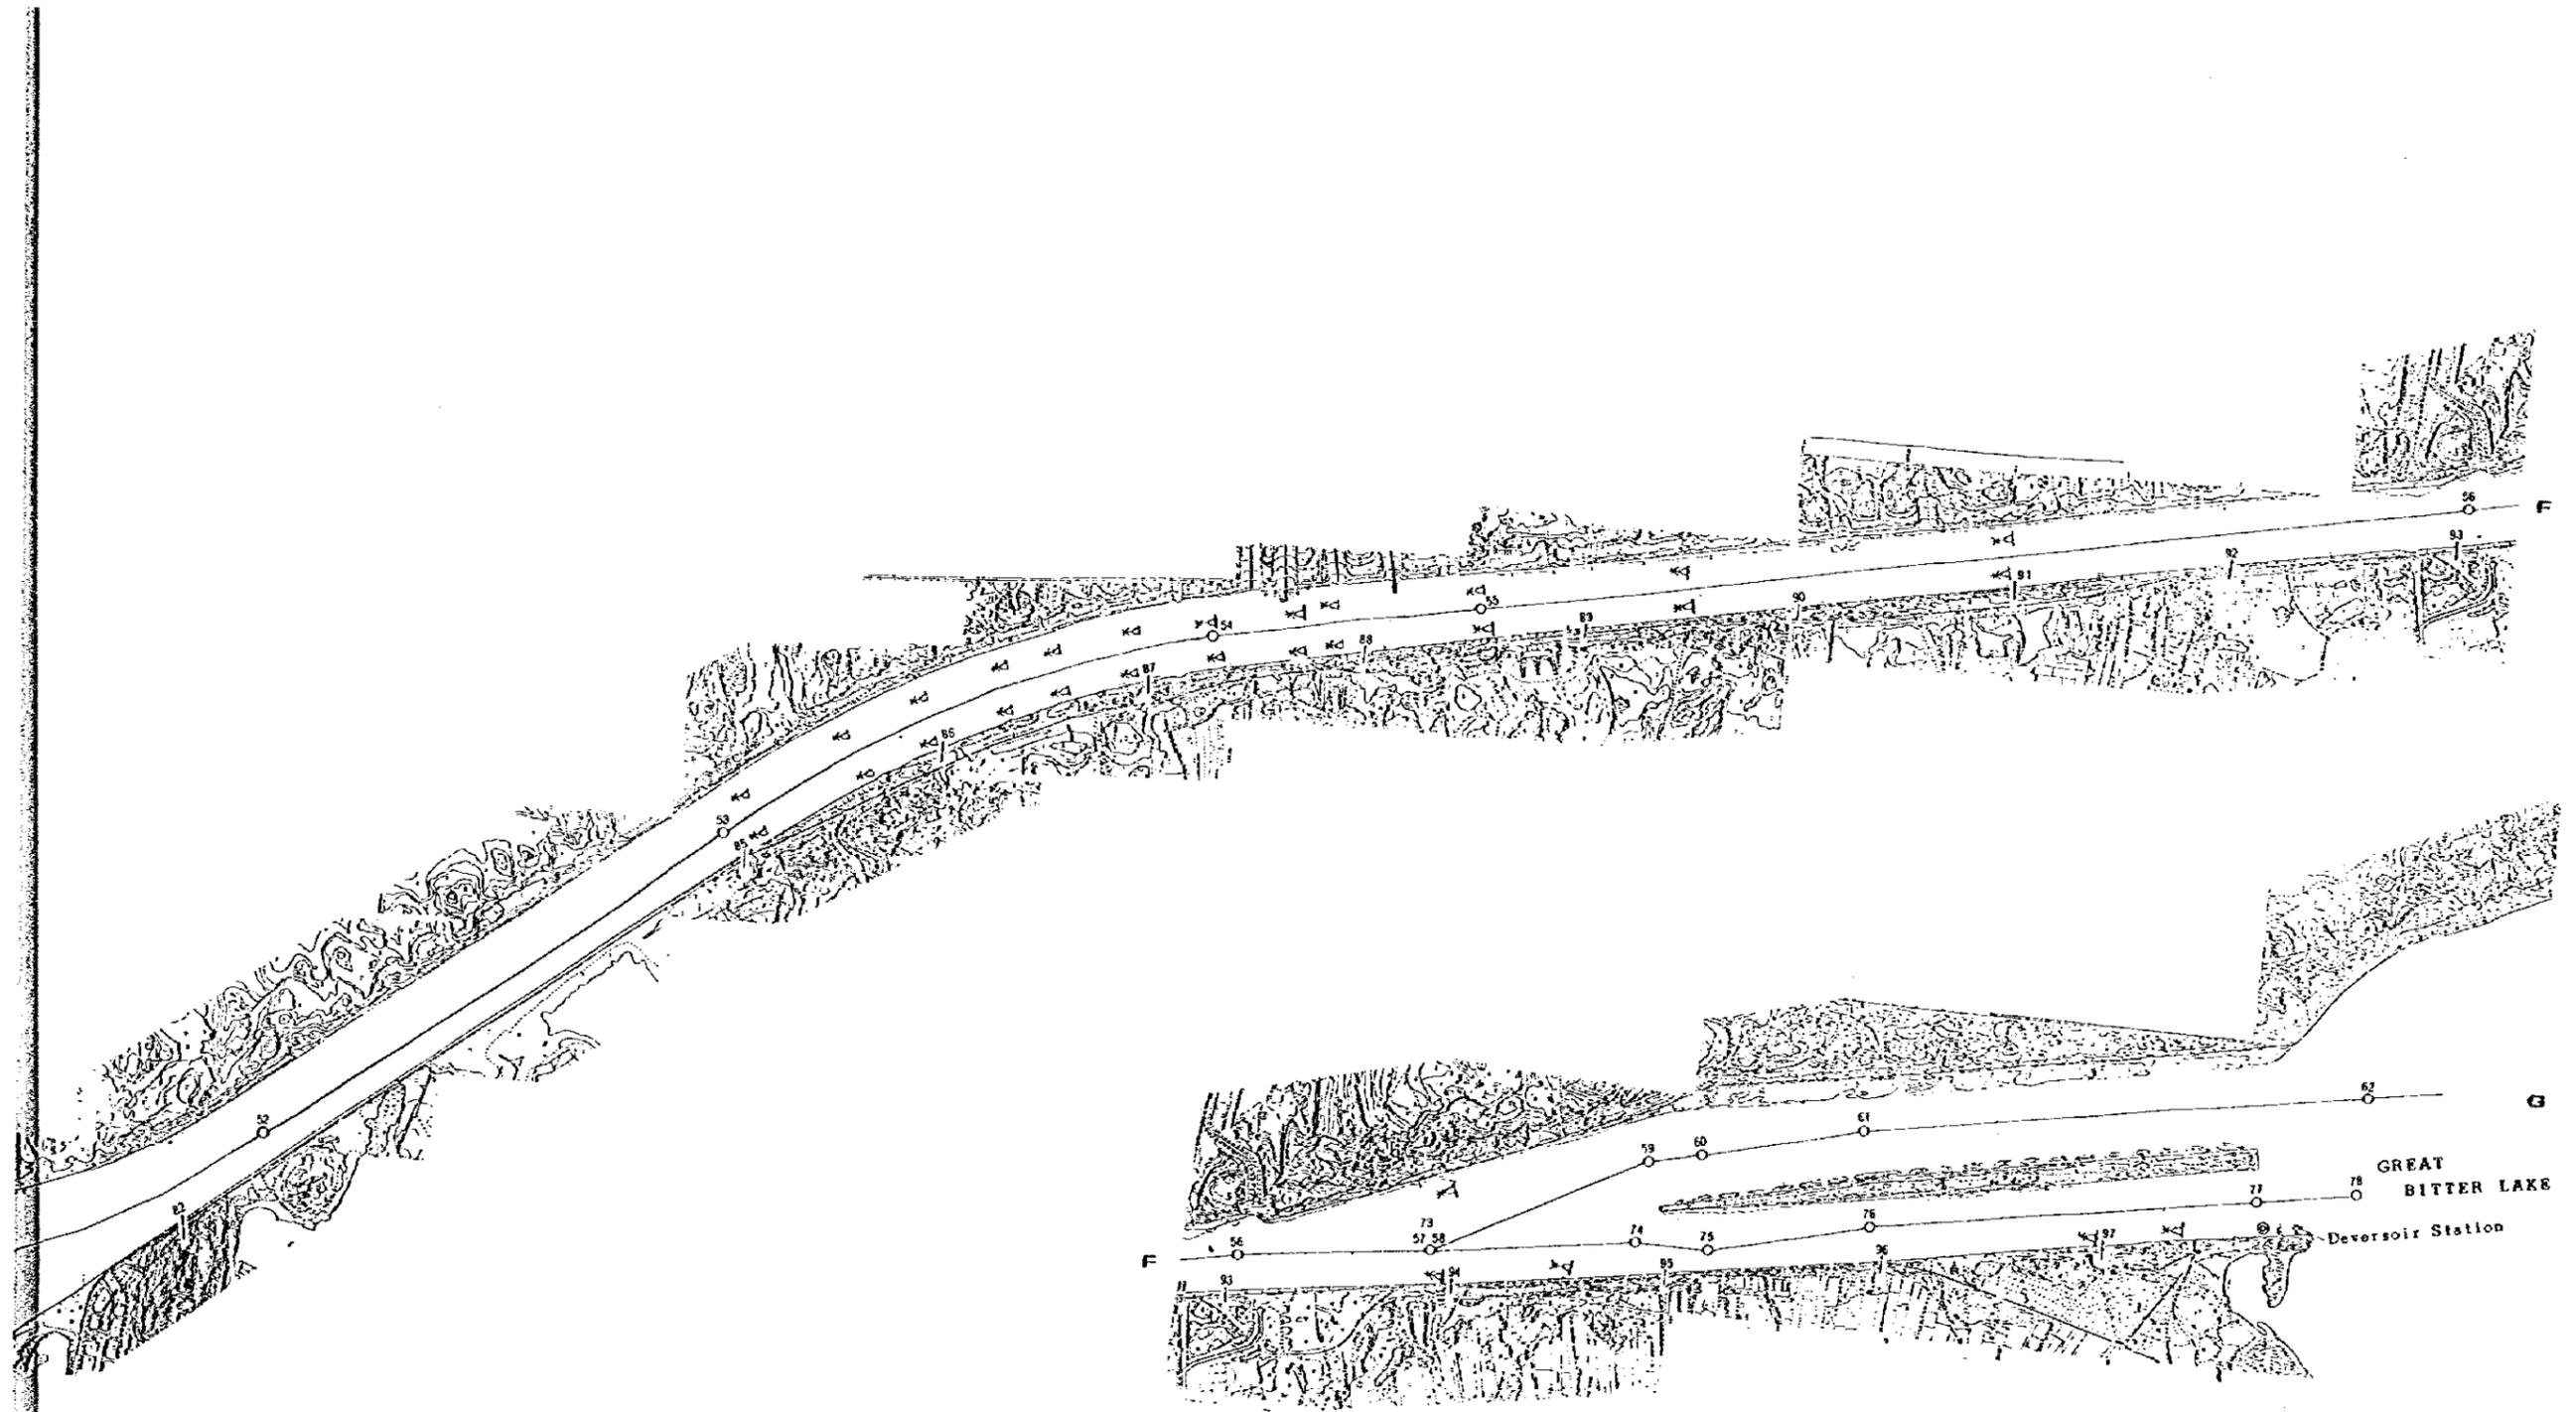
Fig. IV-2-(4)-4 Hydraulic Center Line (4)

Fig. IV-2(4)-4 Hydraulic Center Line (4)

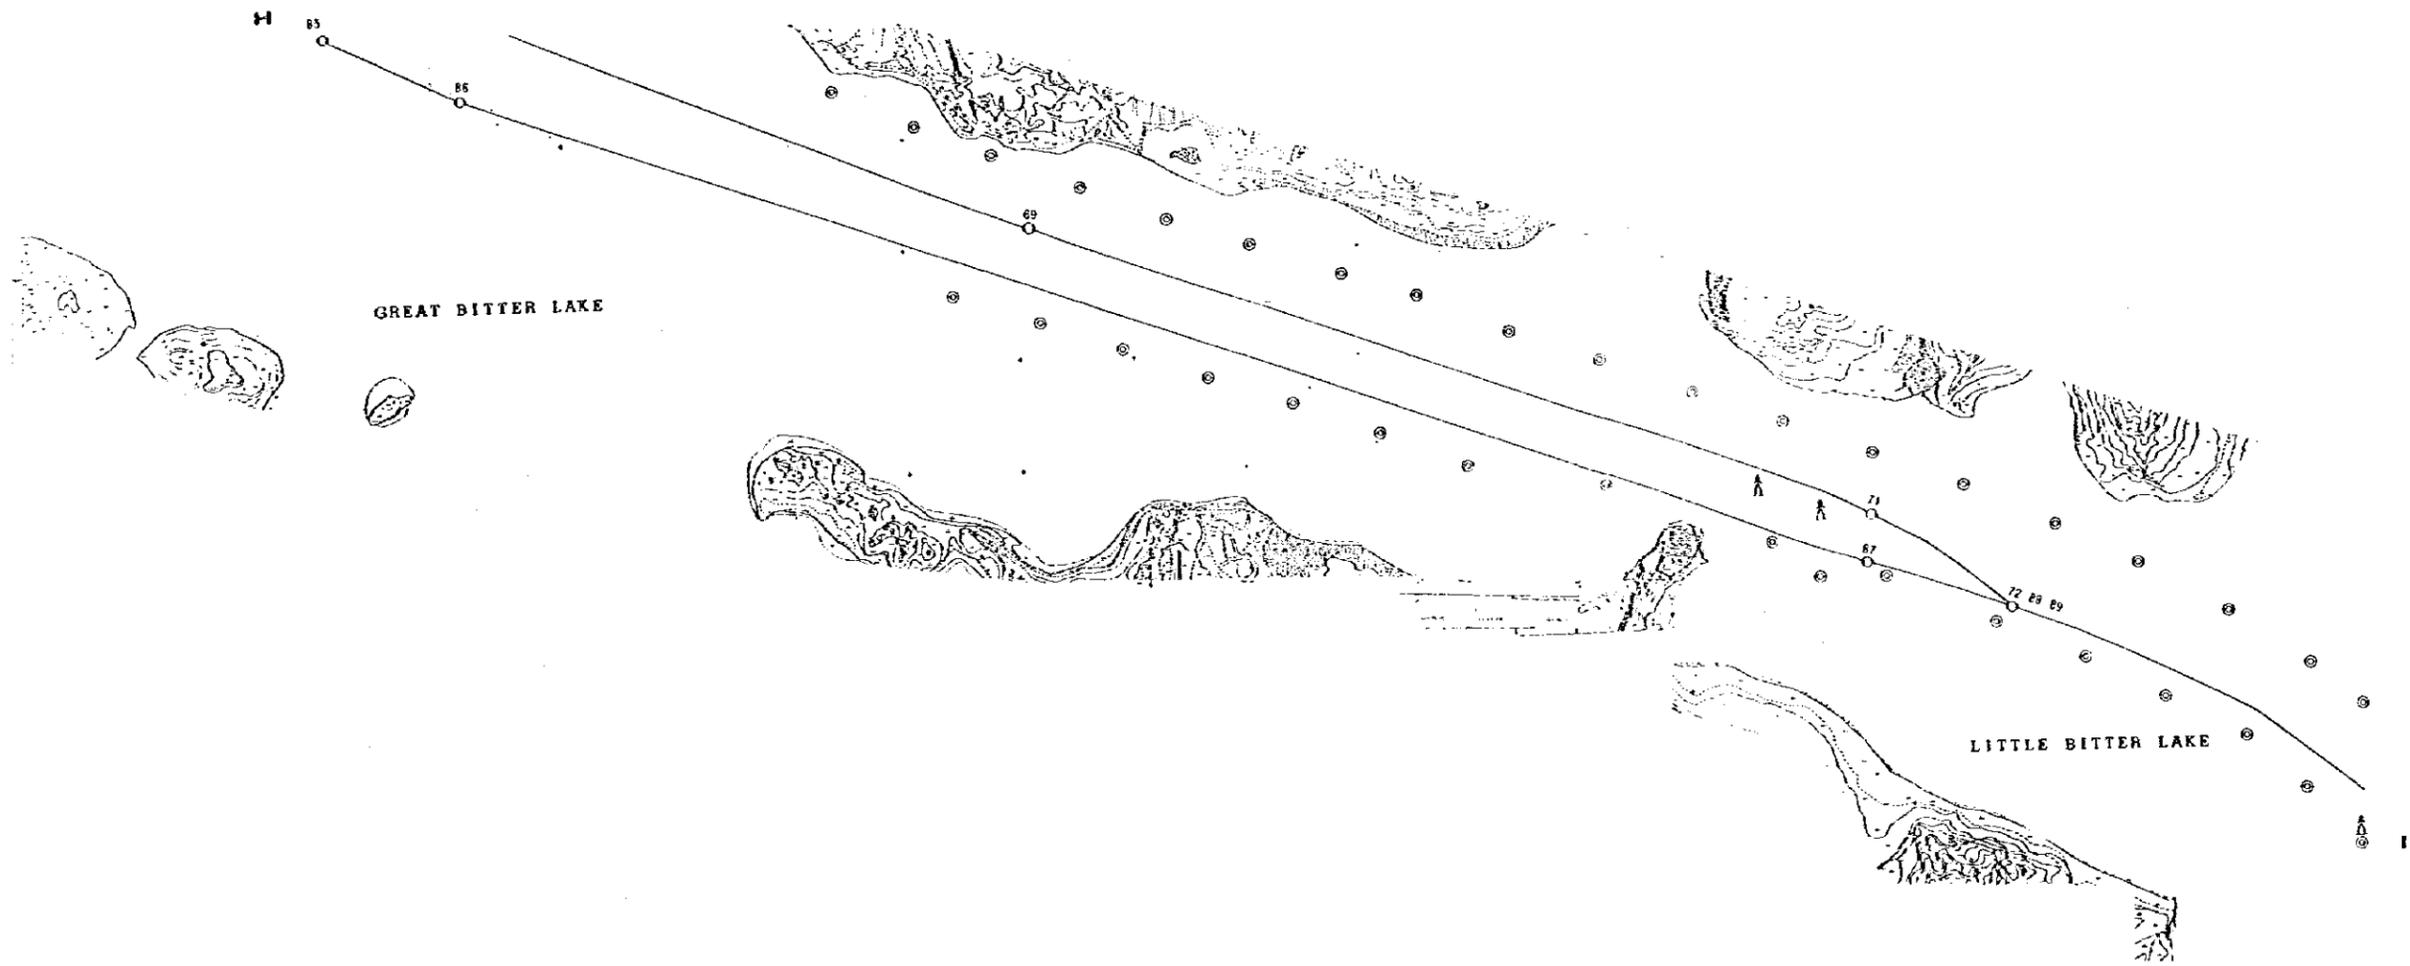
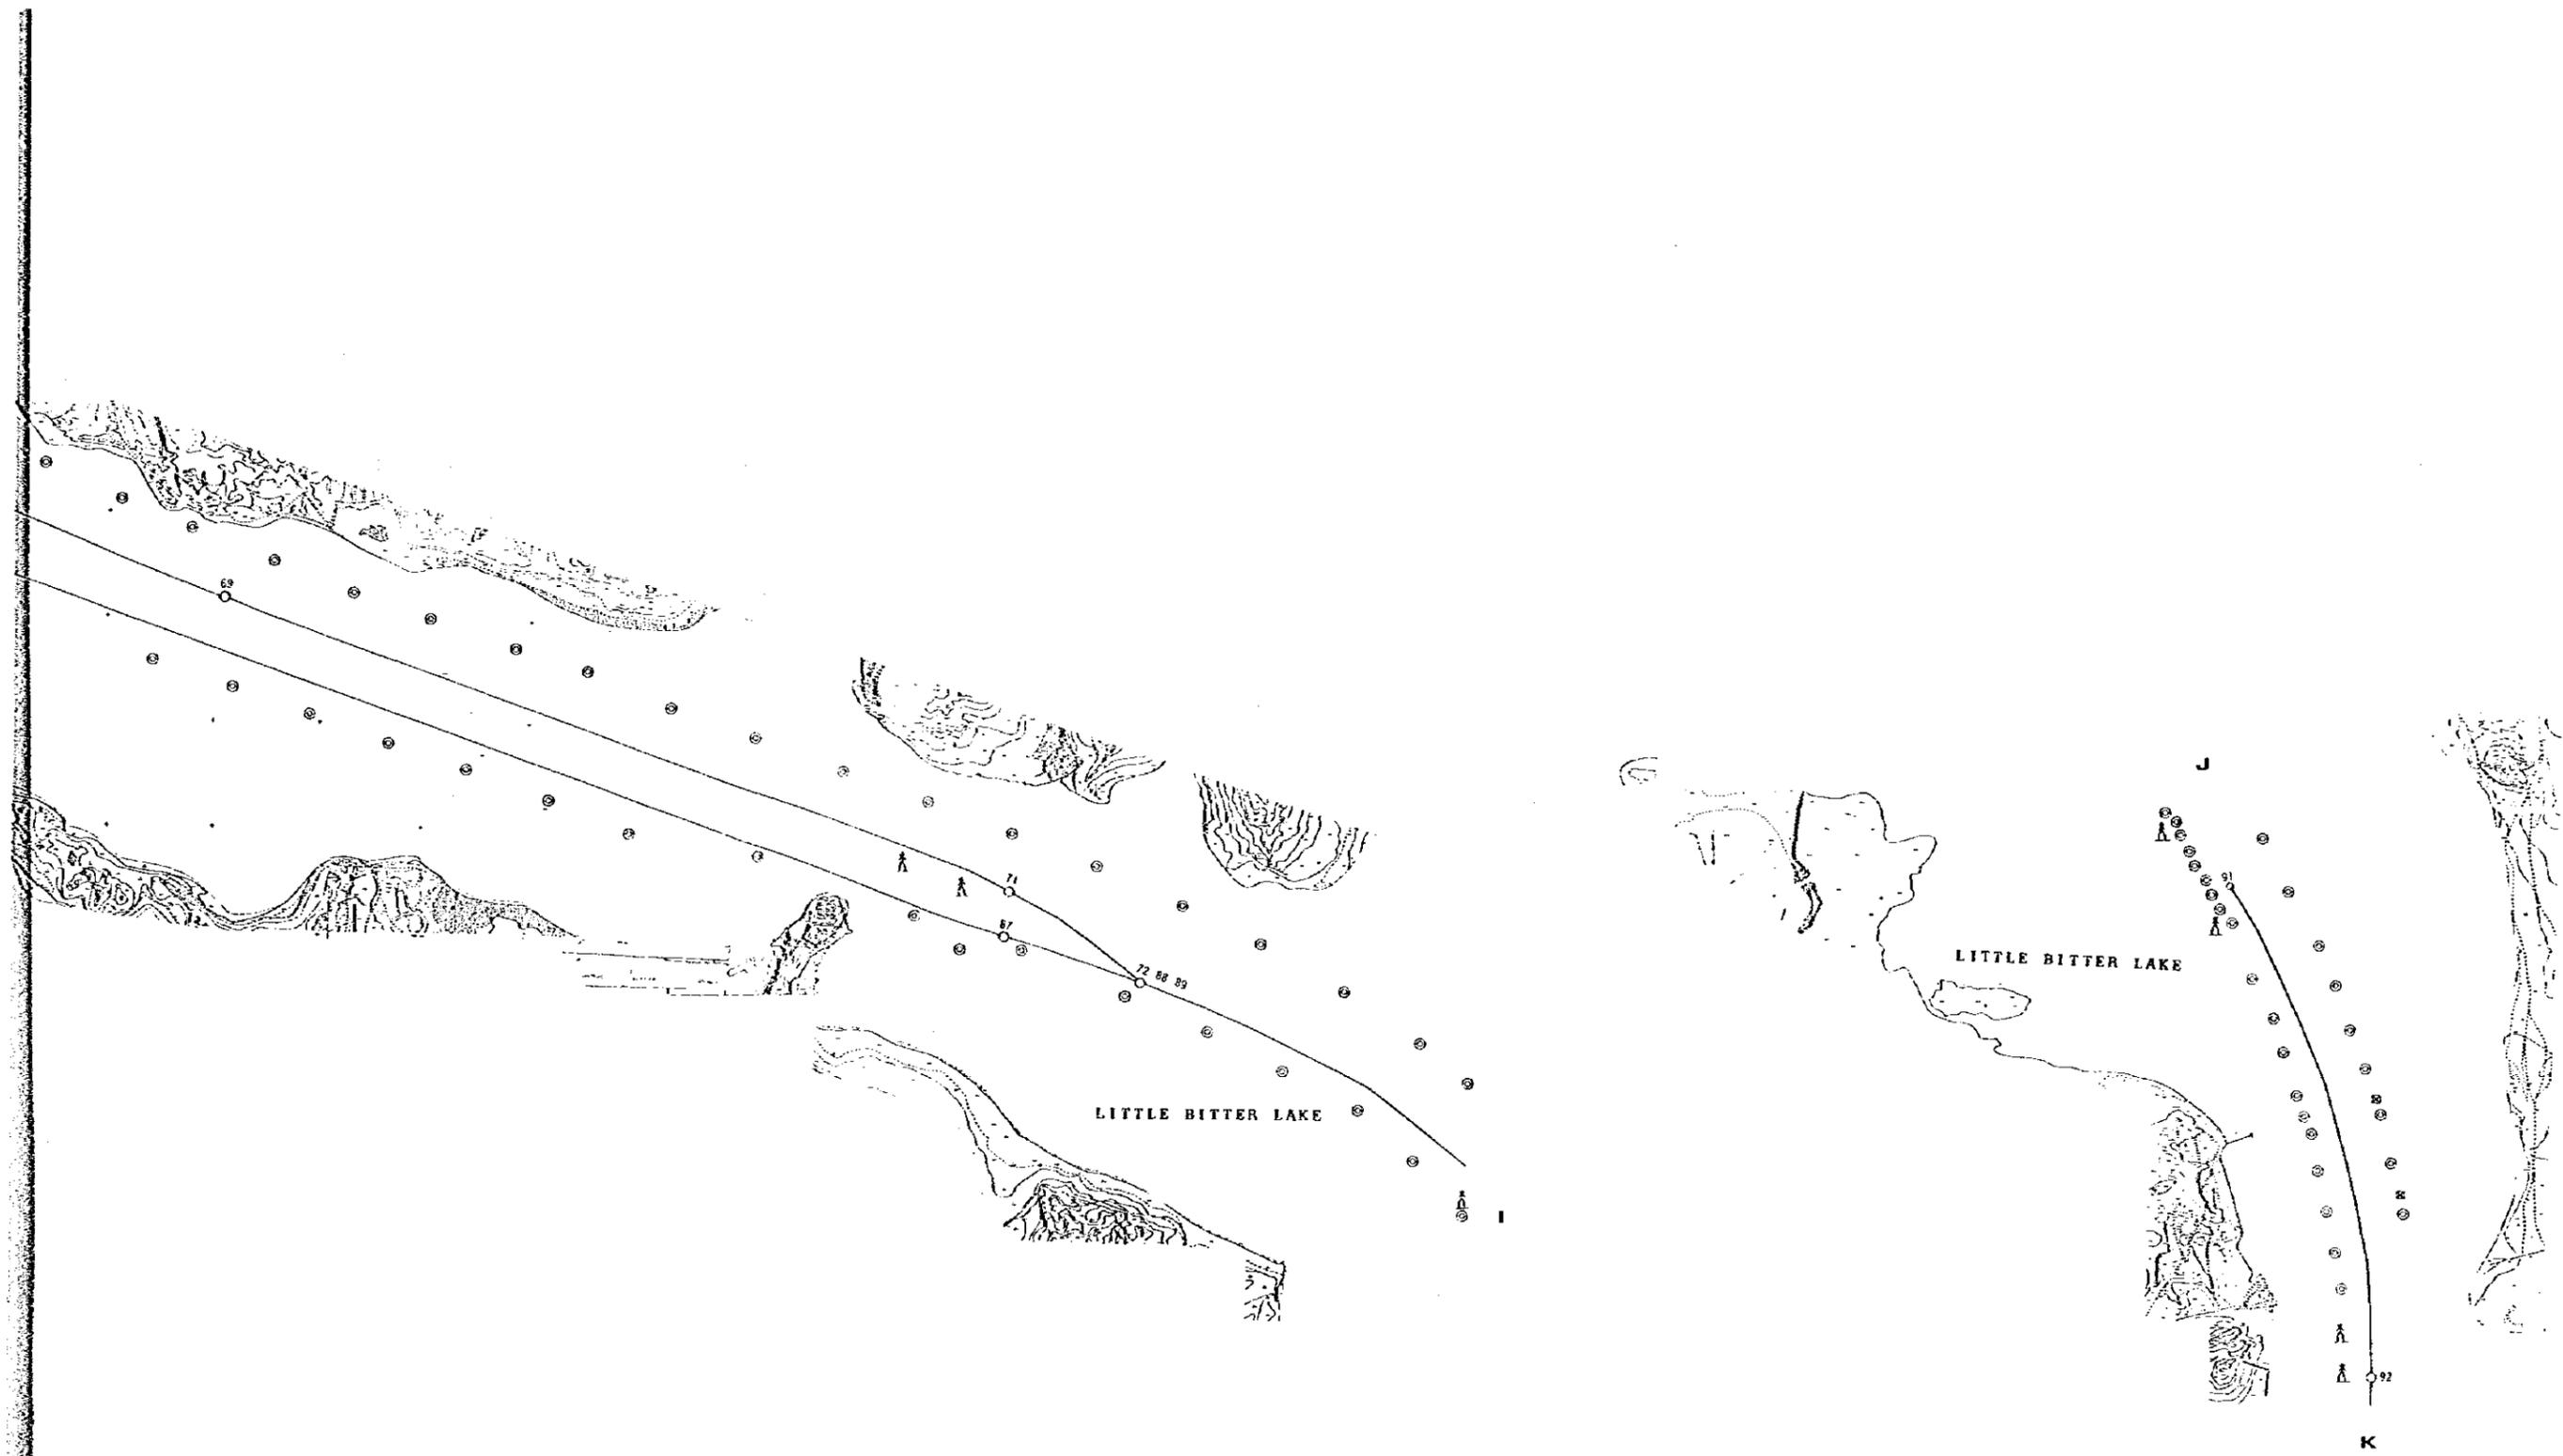
Fig. IV-2-(4)-5 Hydraulic Center Line (5)
