PART III. ANALYSIS OF ACCIDENTS

PART III ANALYSIS OF ACCIDENTS

PART IV. EVALUATION OF CANAL CONDITIONS

PART IV EVALUATION OF CANAL CONDITIONS

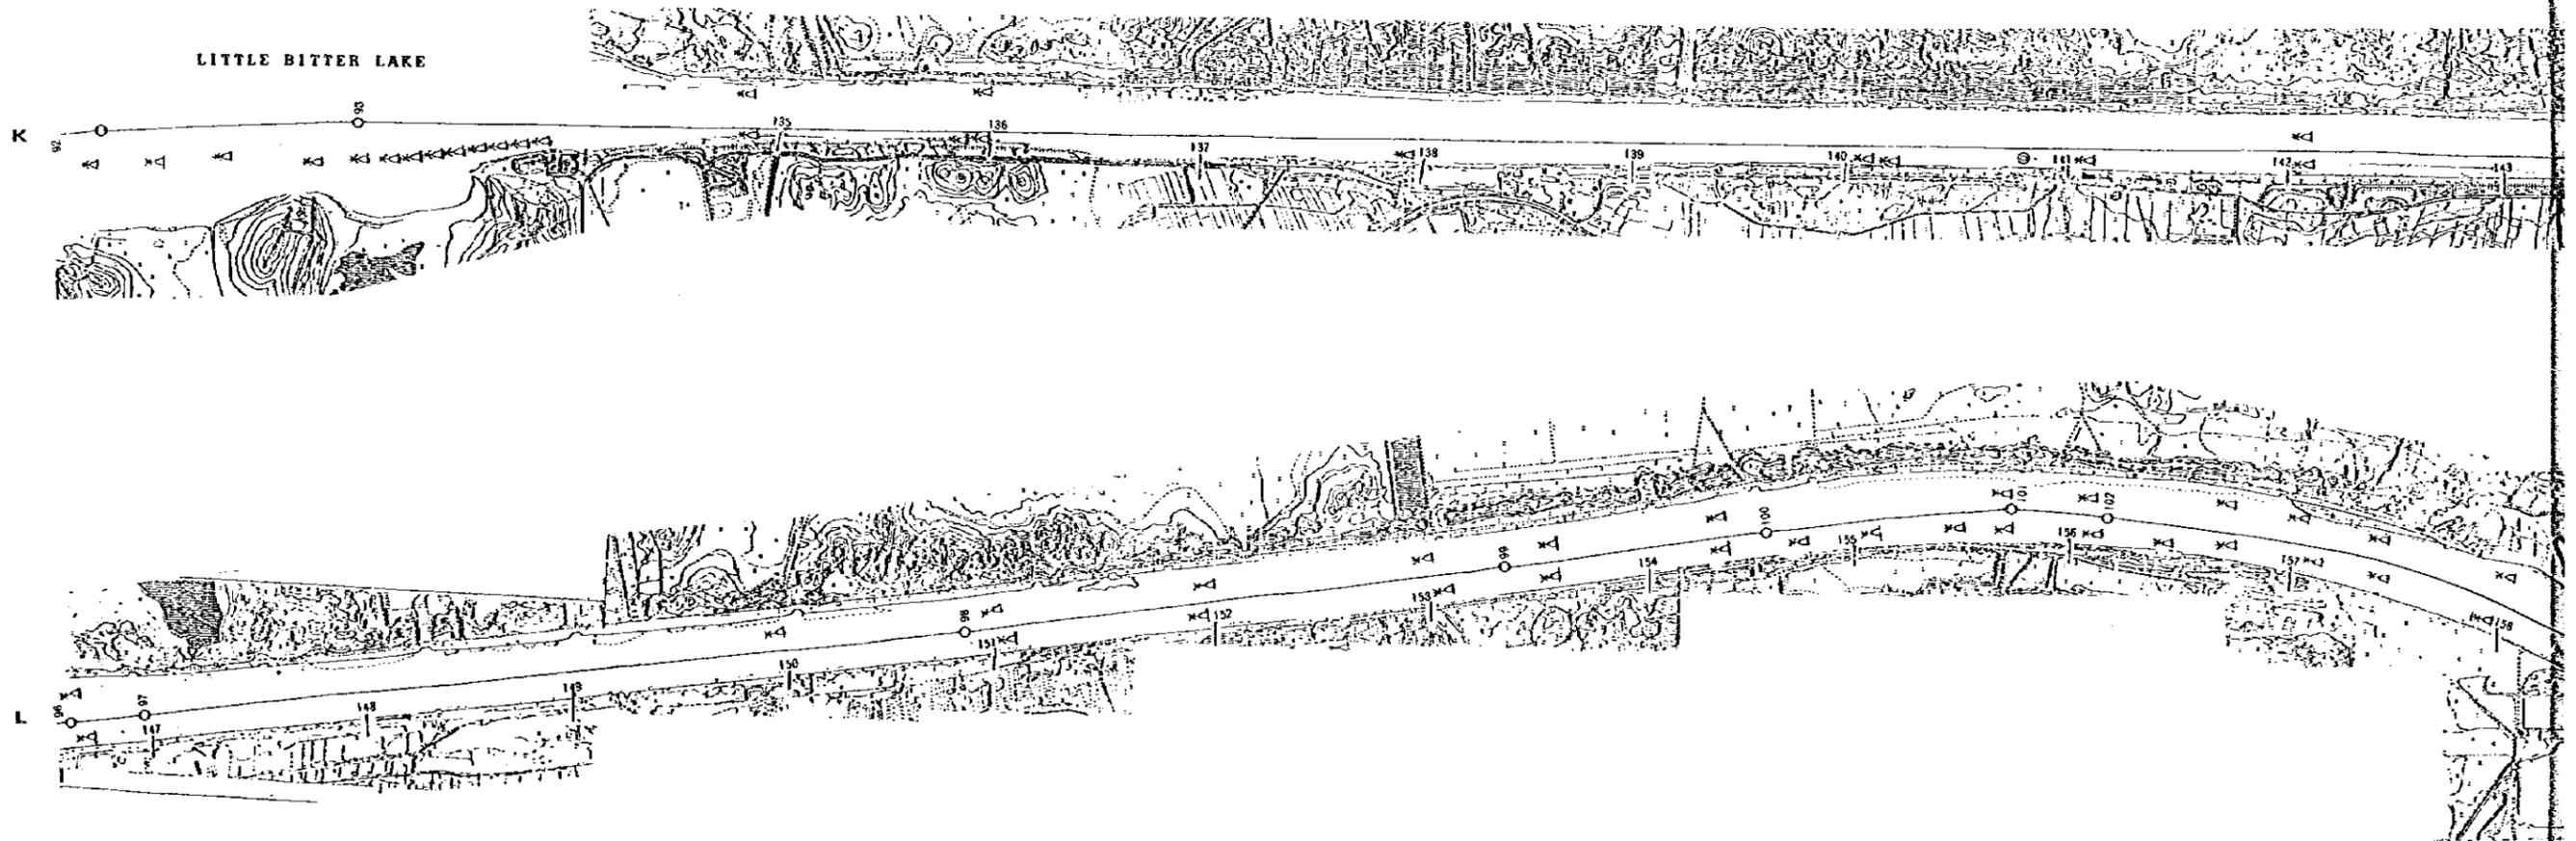
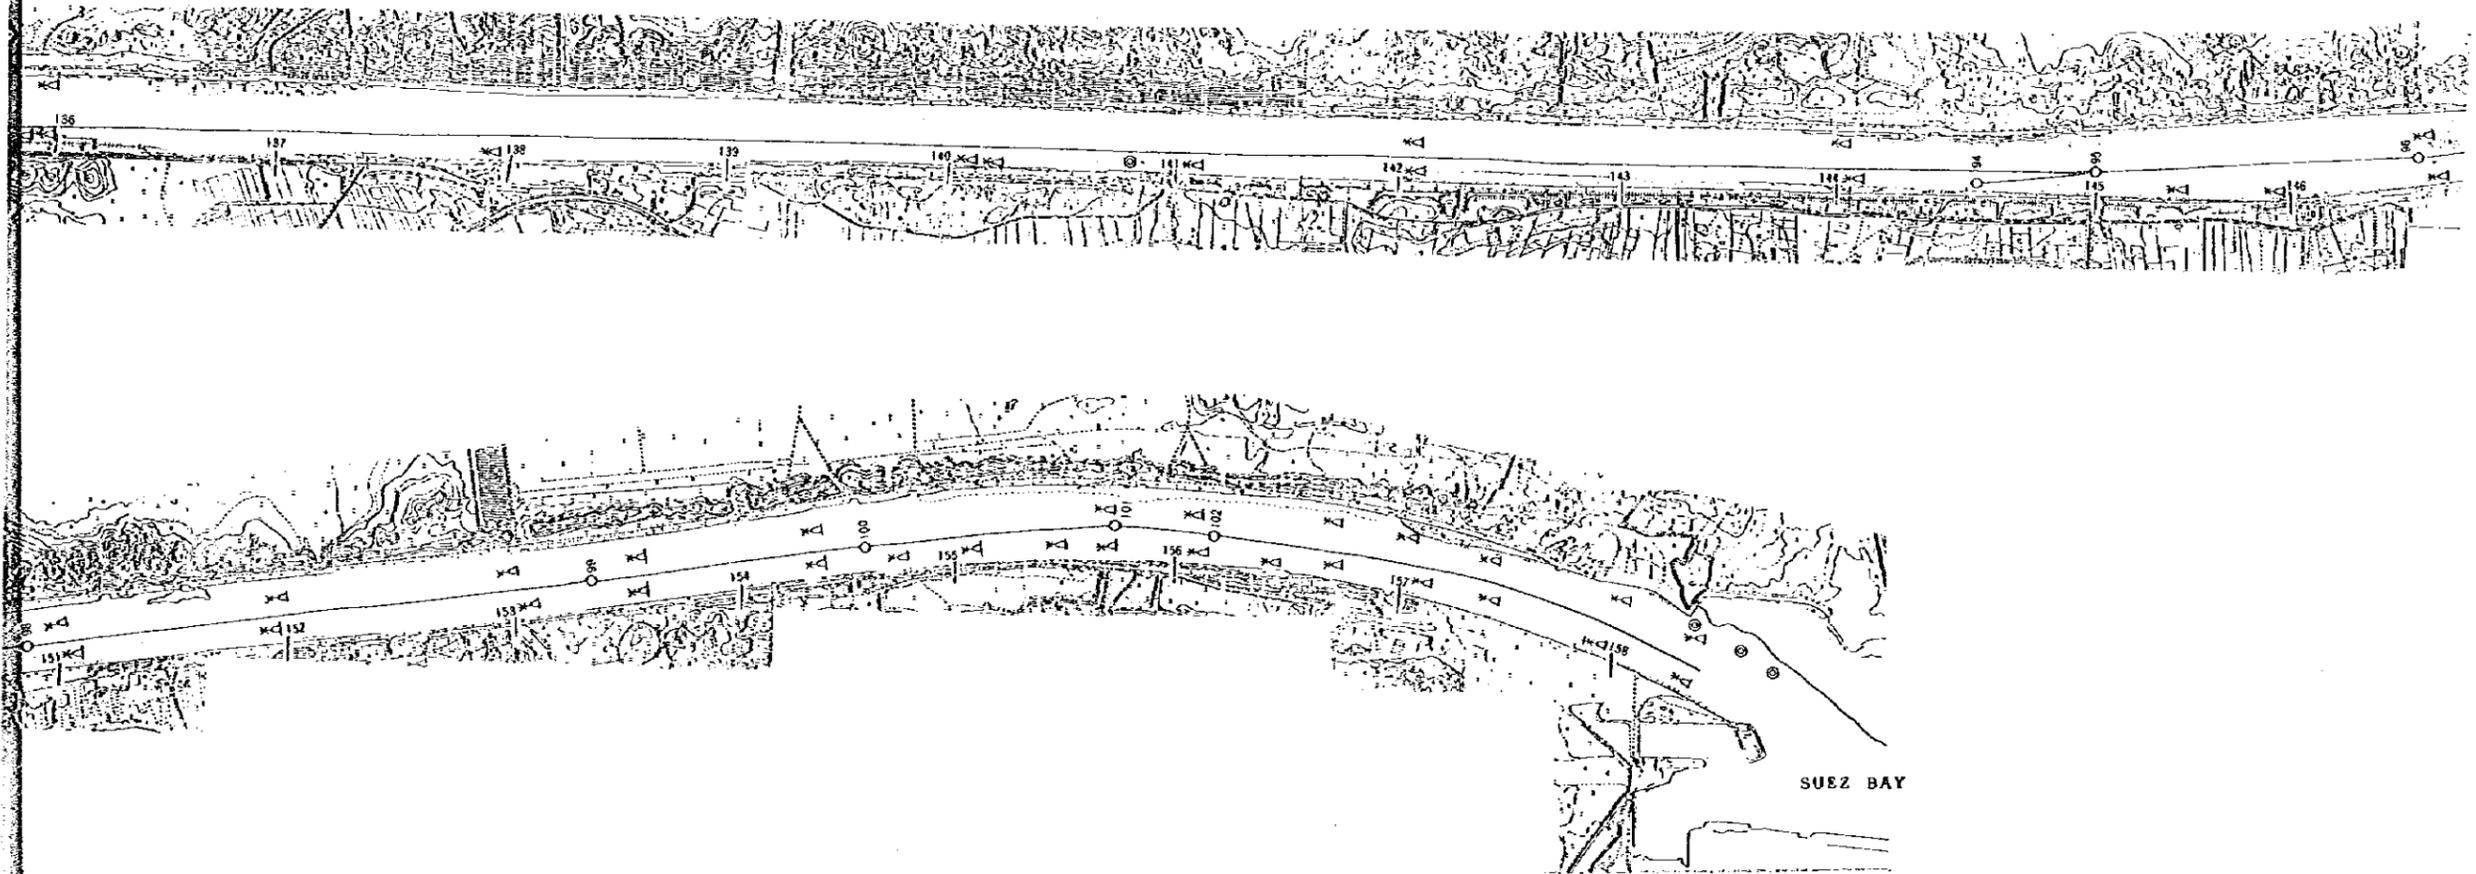
Fig. IV-2-(4)-6 Hydraulic Center Line (6)

Figs. IV-2-(4)-1~6 are maps noted with the hydraulic centreline which were drawn based on microfilm photos of the maps marked with the data of hydraulic centreline that were forwarded from the SCA in July, 1984.

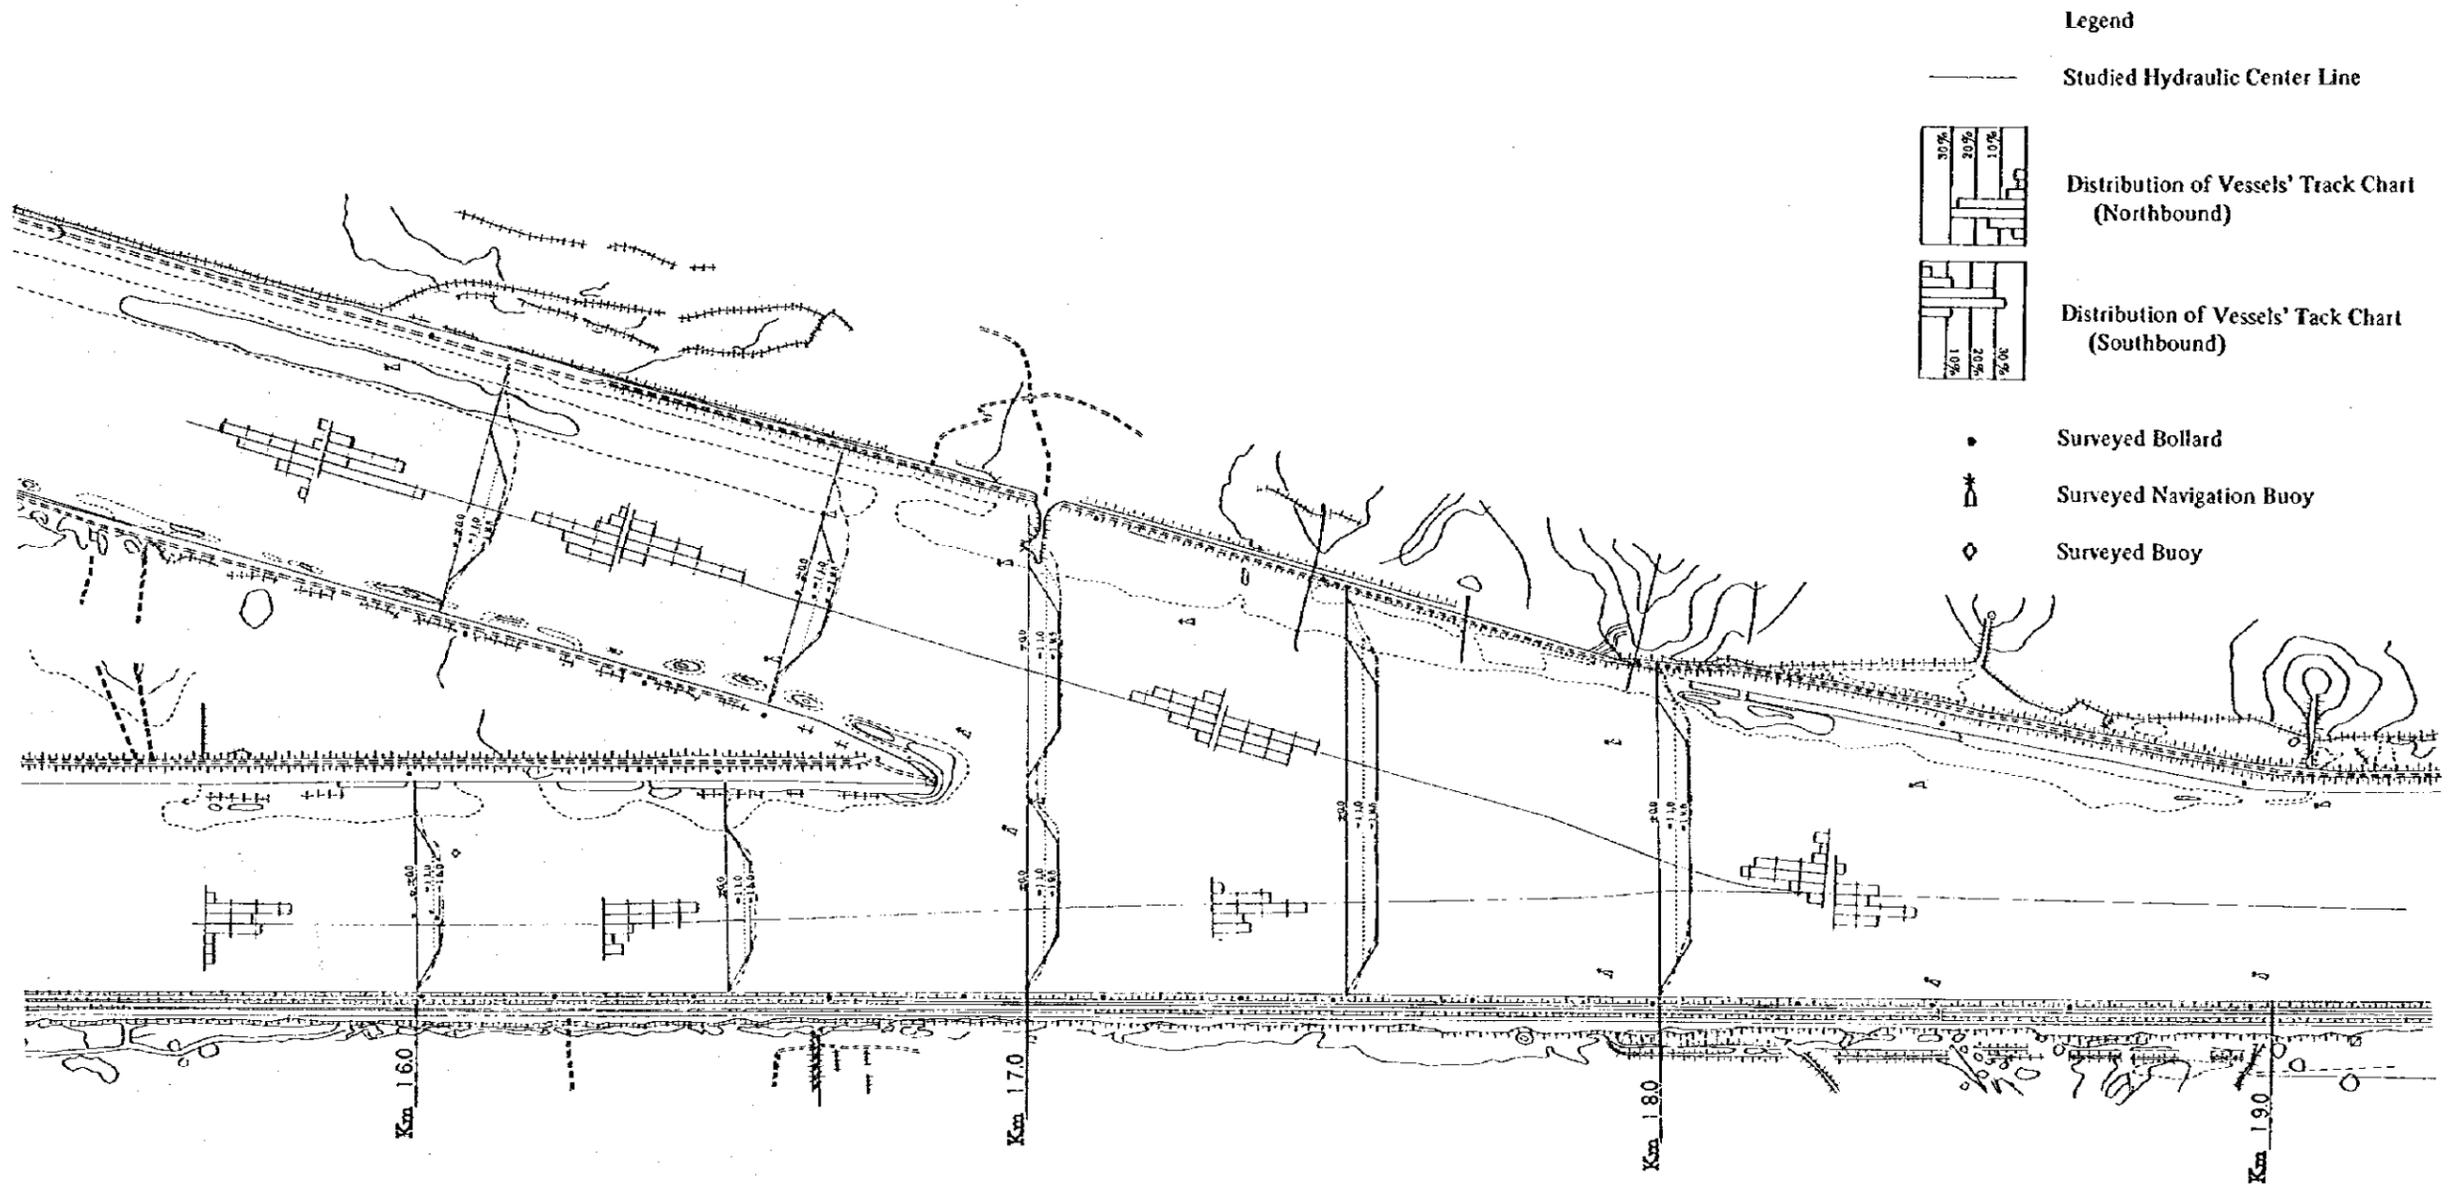
Fig. IV-2-(4)-7 Correlation between the Canal Cross-sections, the Hydraulic Center Lines and the Distributions of Vessels' Track Chart (Km 14.5 ~ 19)

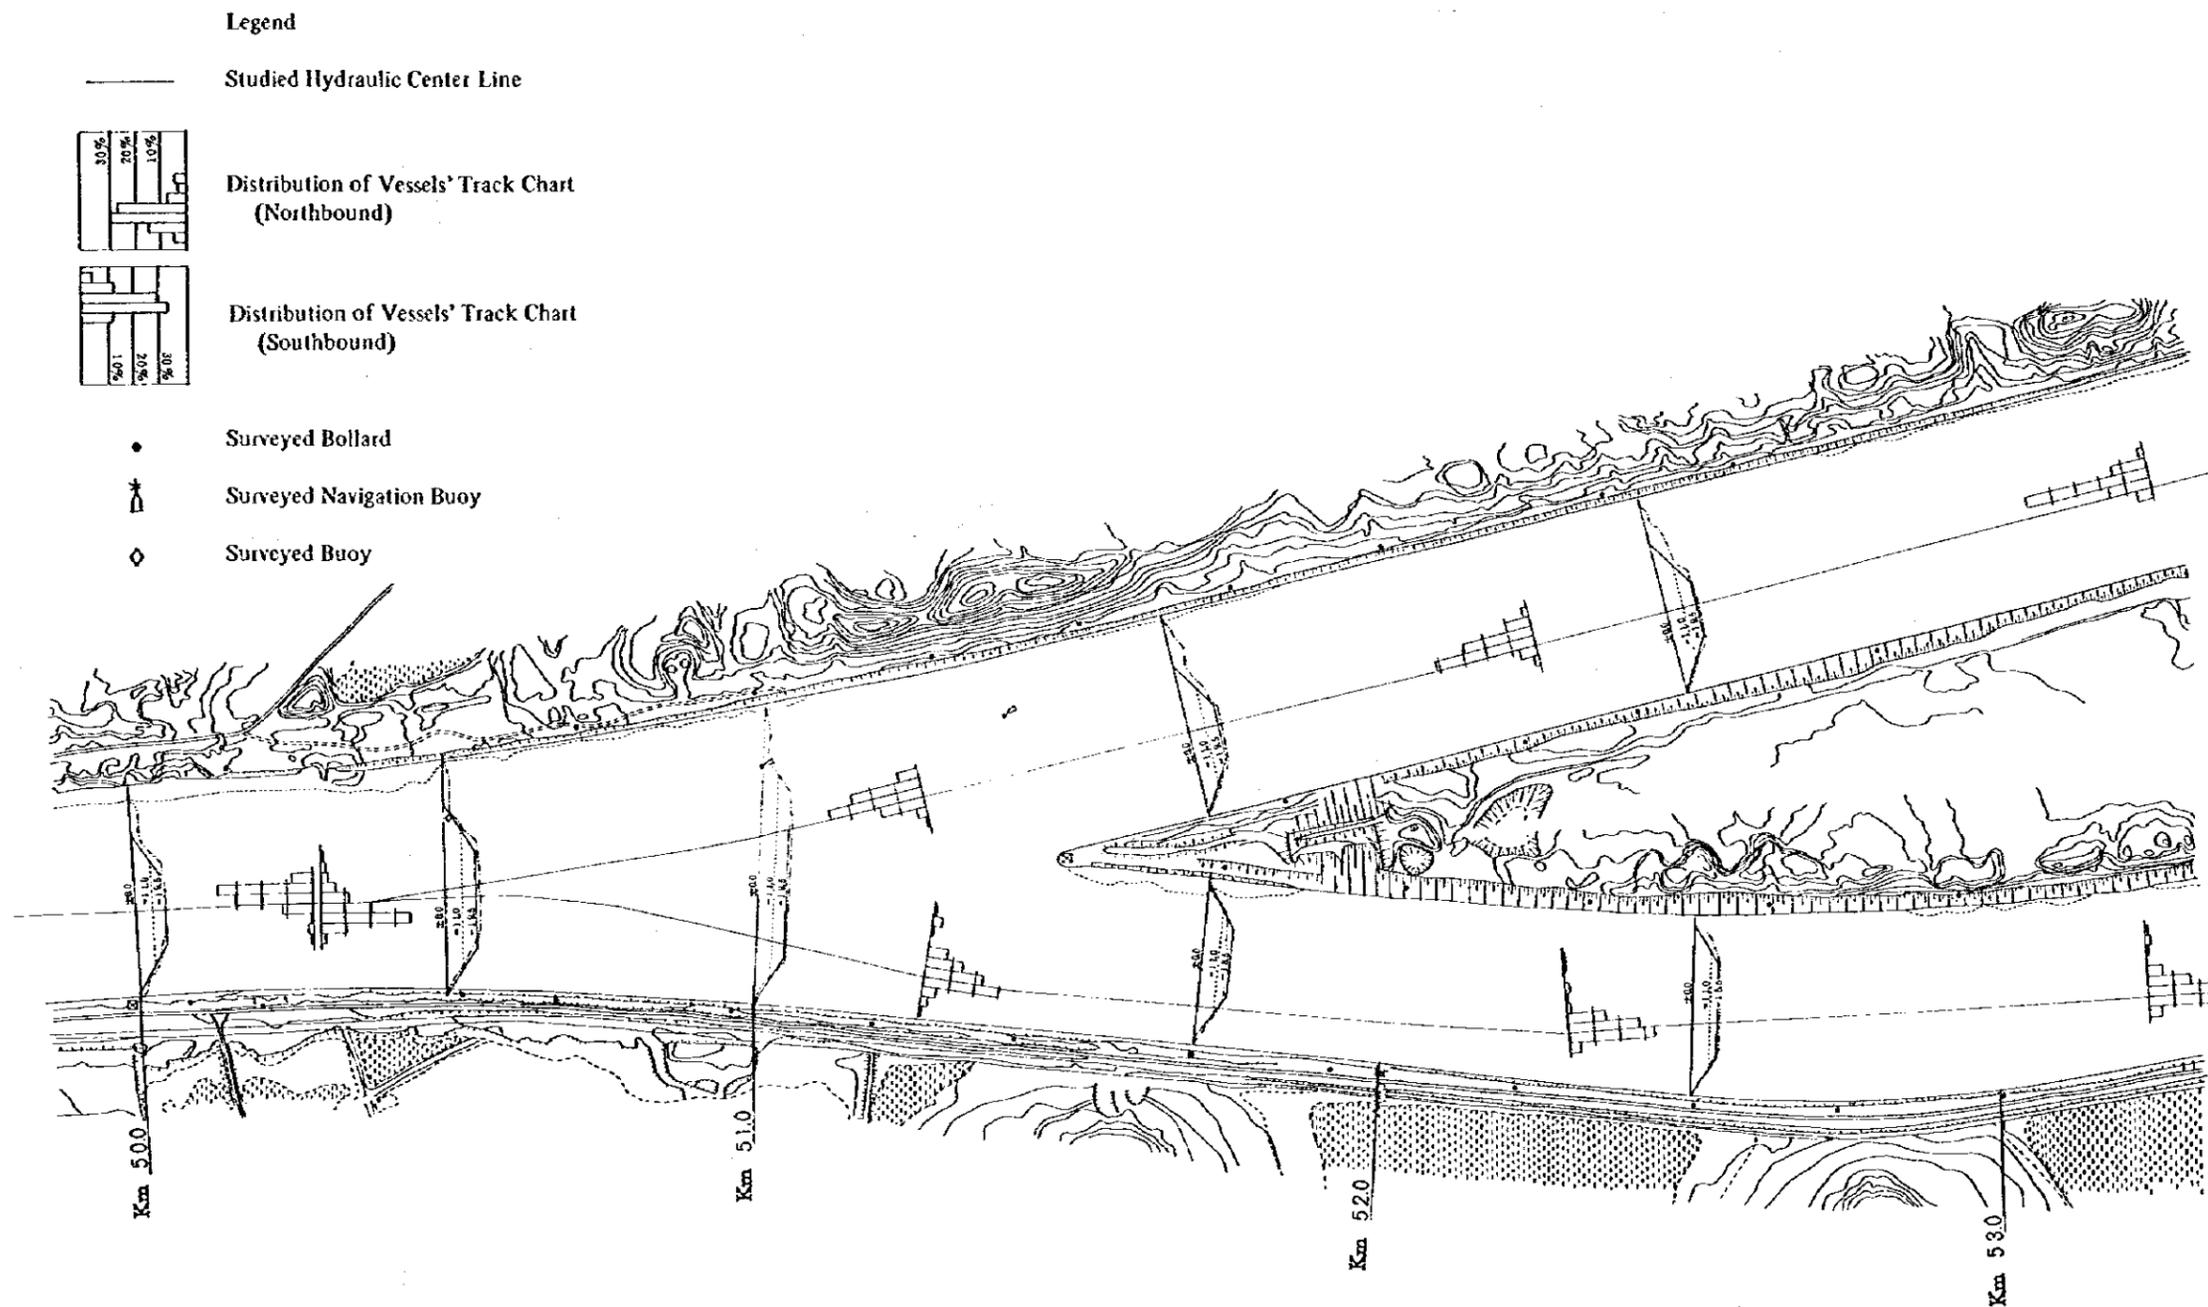
Fig. IV-2-(4)-8 Correlation between the Canal Cross-sections, the Hydraulic Center Lines and the Distributions of Vessels' Track Chart (Km 50 ~ 53)

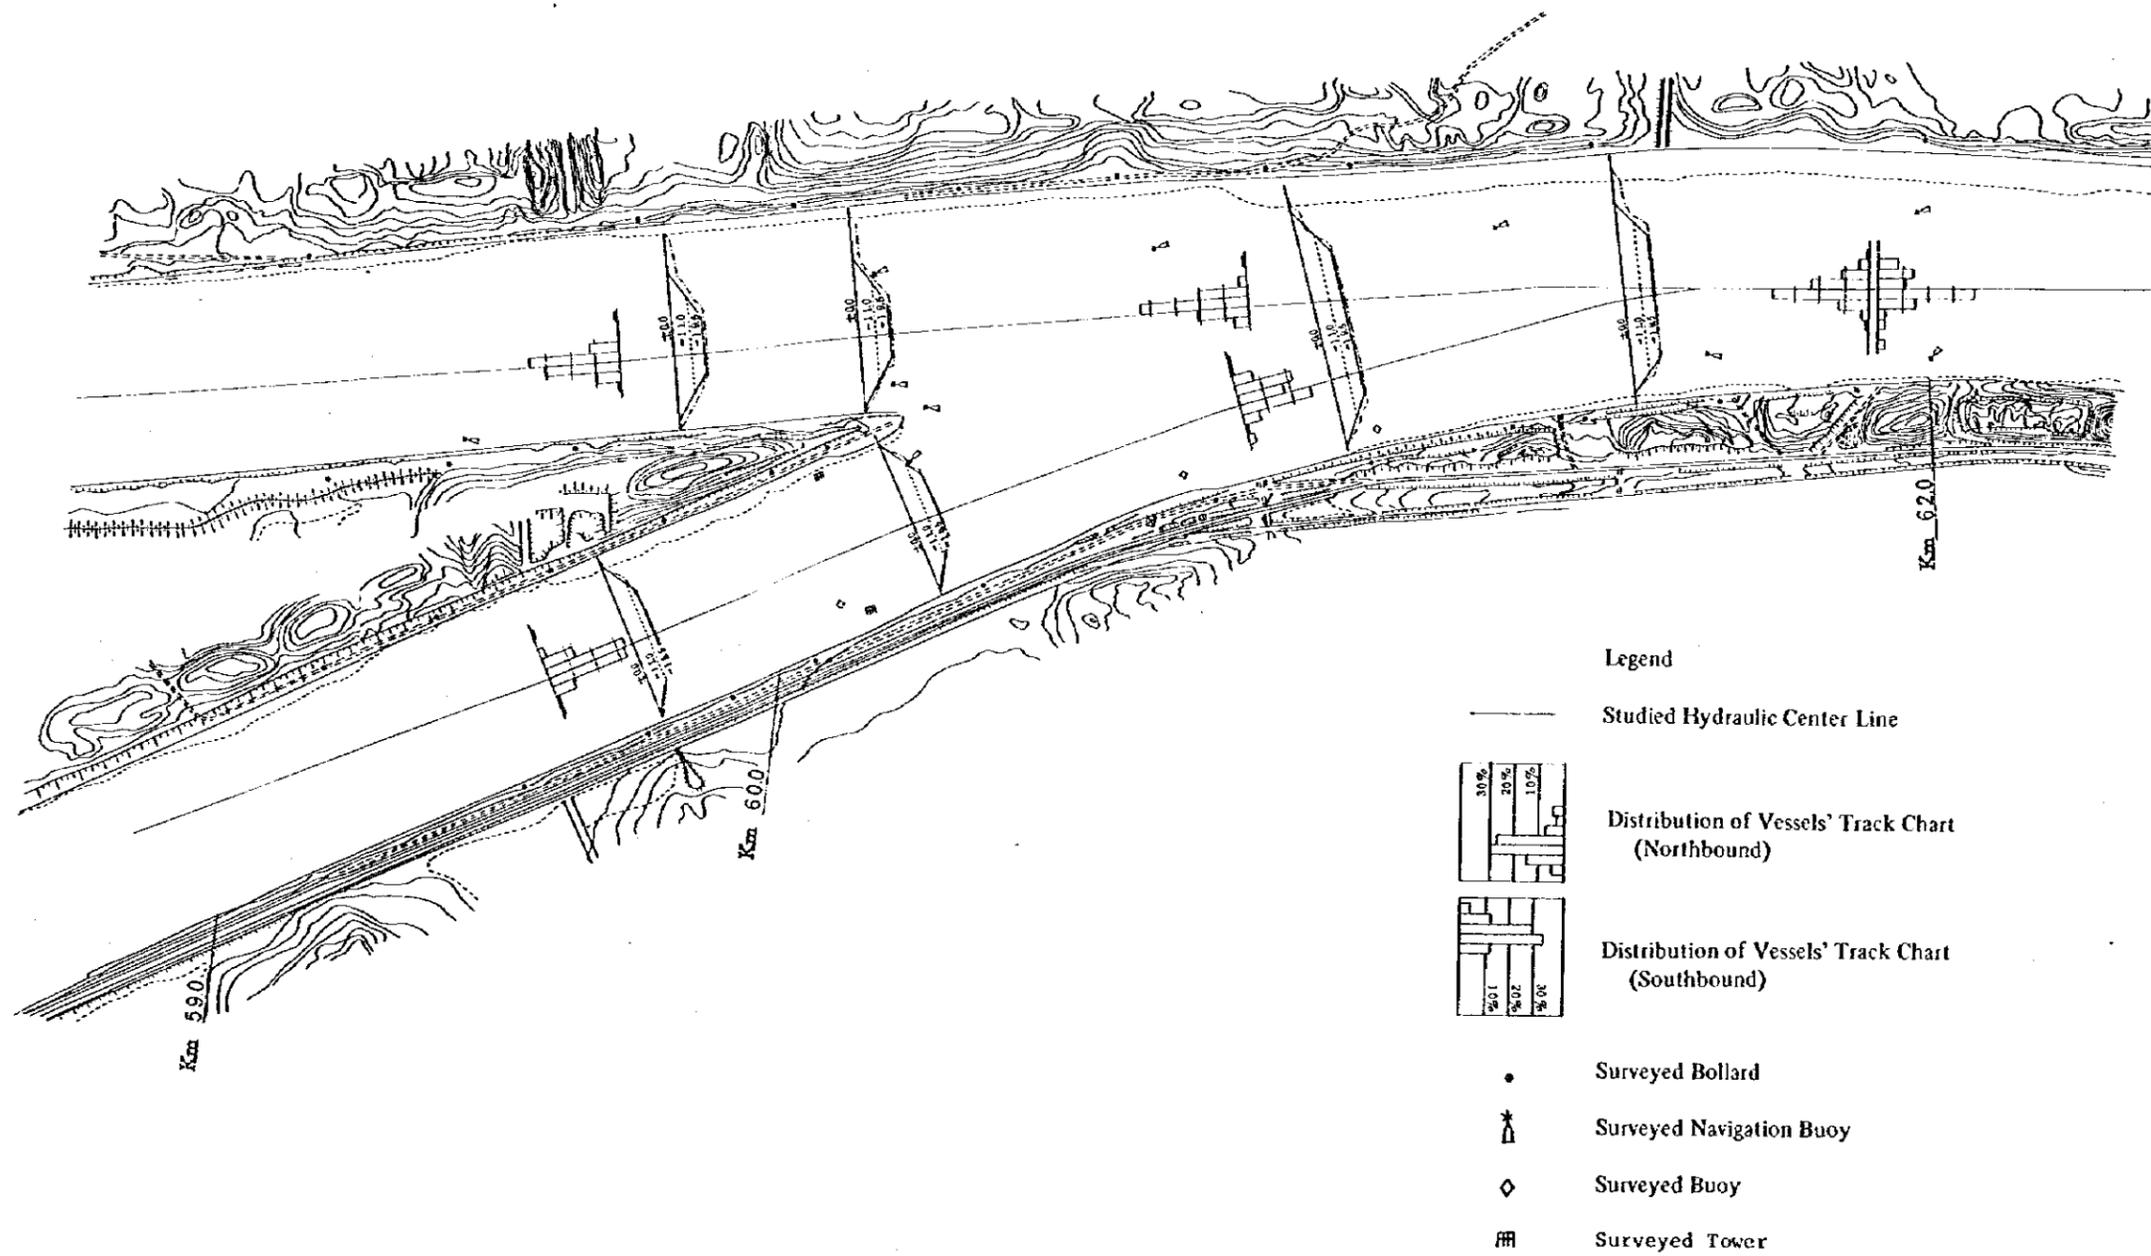
Fig. IV-2(4)-9 Correlation between the Canal Cross-sections, the Hydraulic Center Lines and the Distributions of Vessels' Track Chart (Km 59 ~ 62)

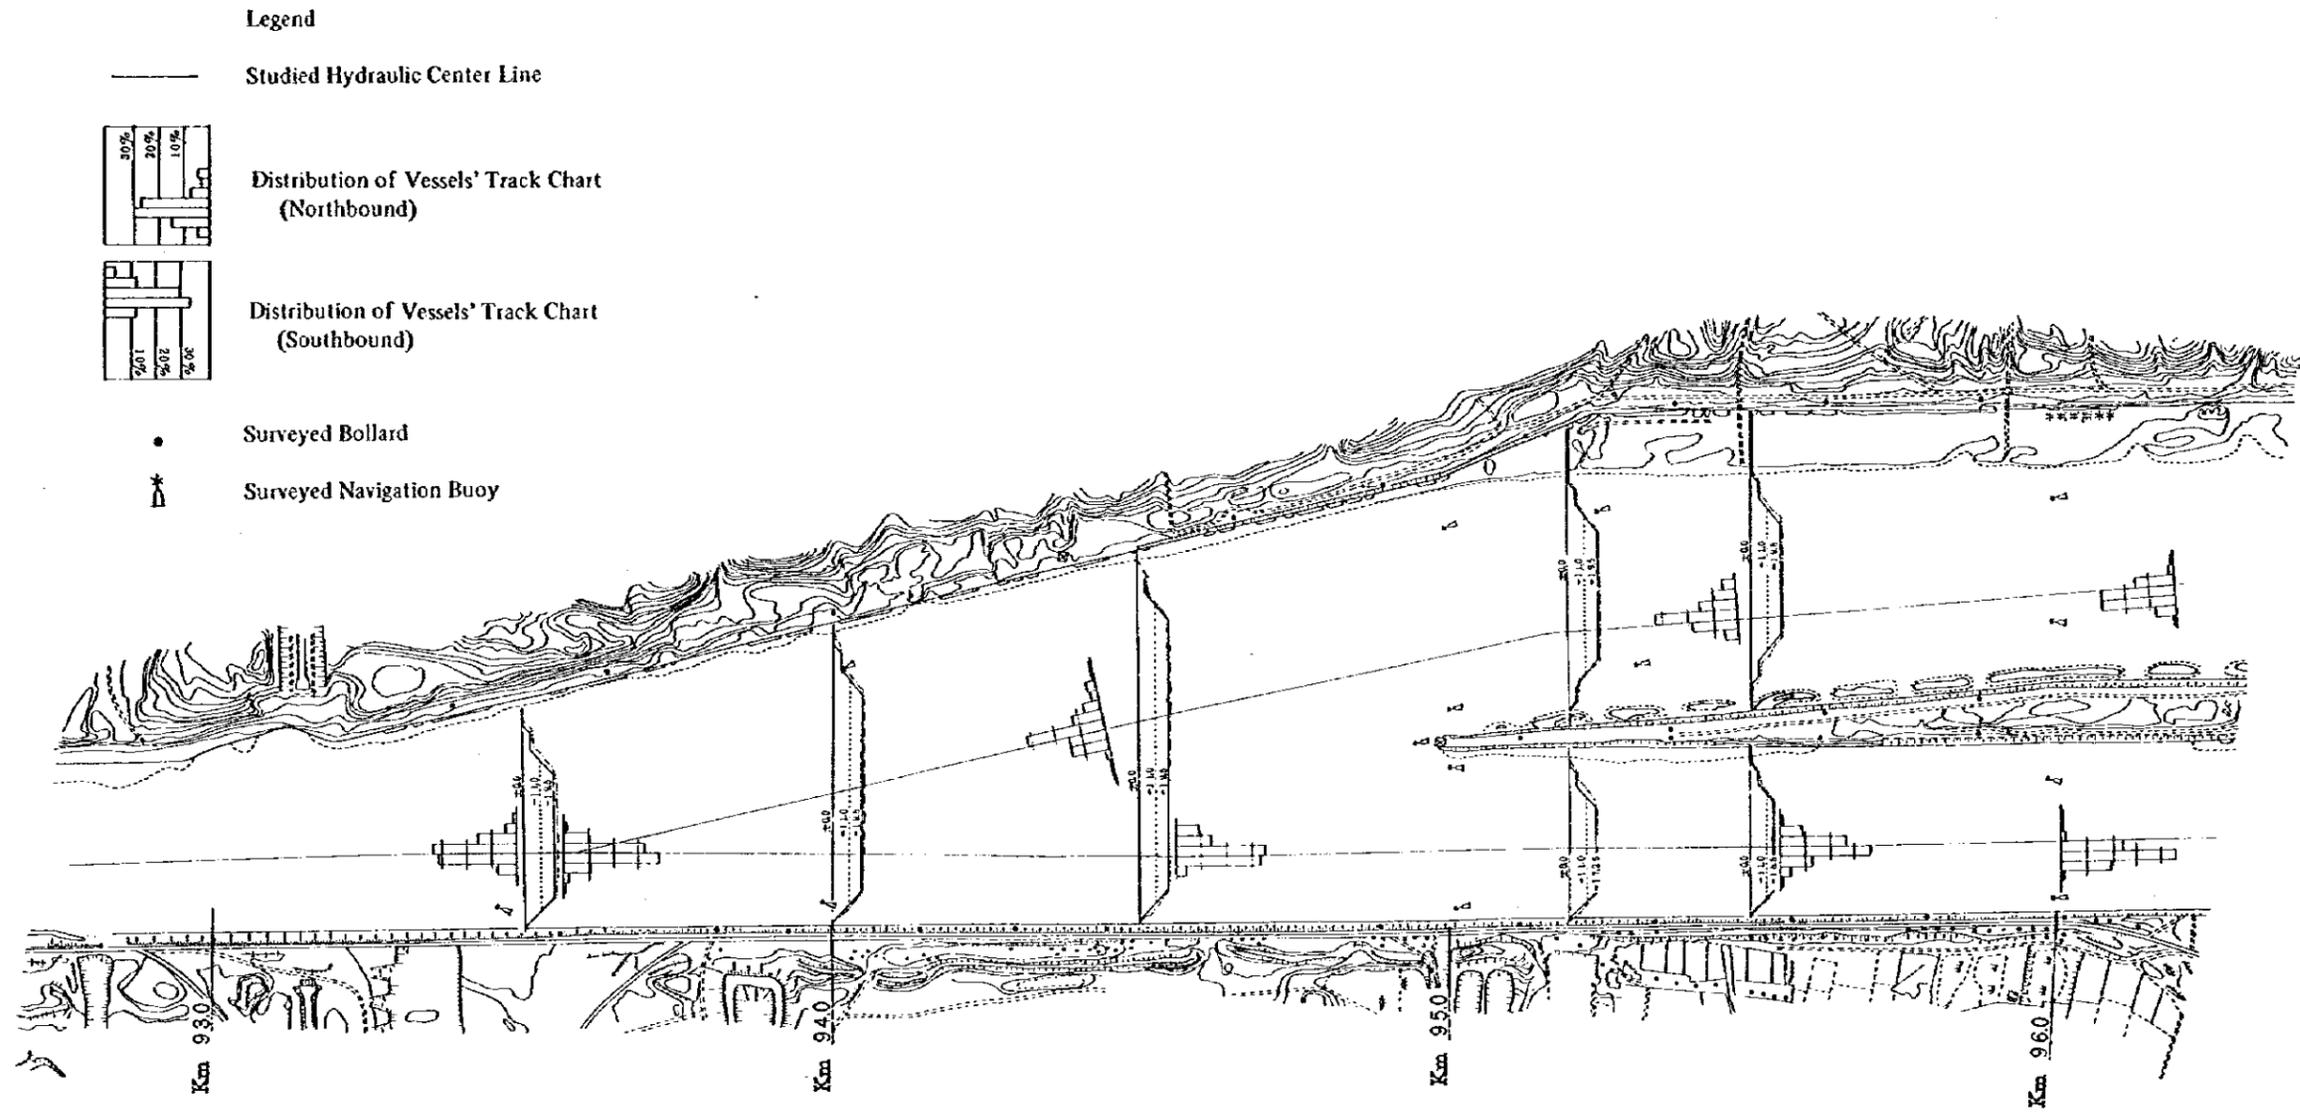
Fig. IV-2-(4)-10 Correlation between the Canal Cross-sections, the Hydraulic Center Lines and the Distributions of Vessels' Track Chart (Km 93 ~ 96)

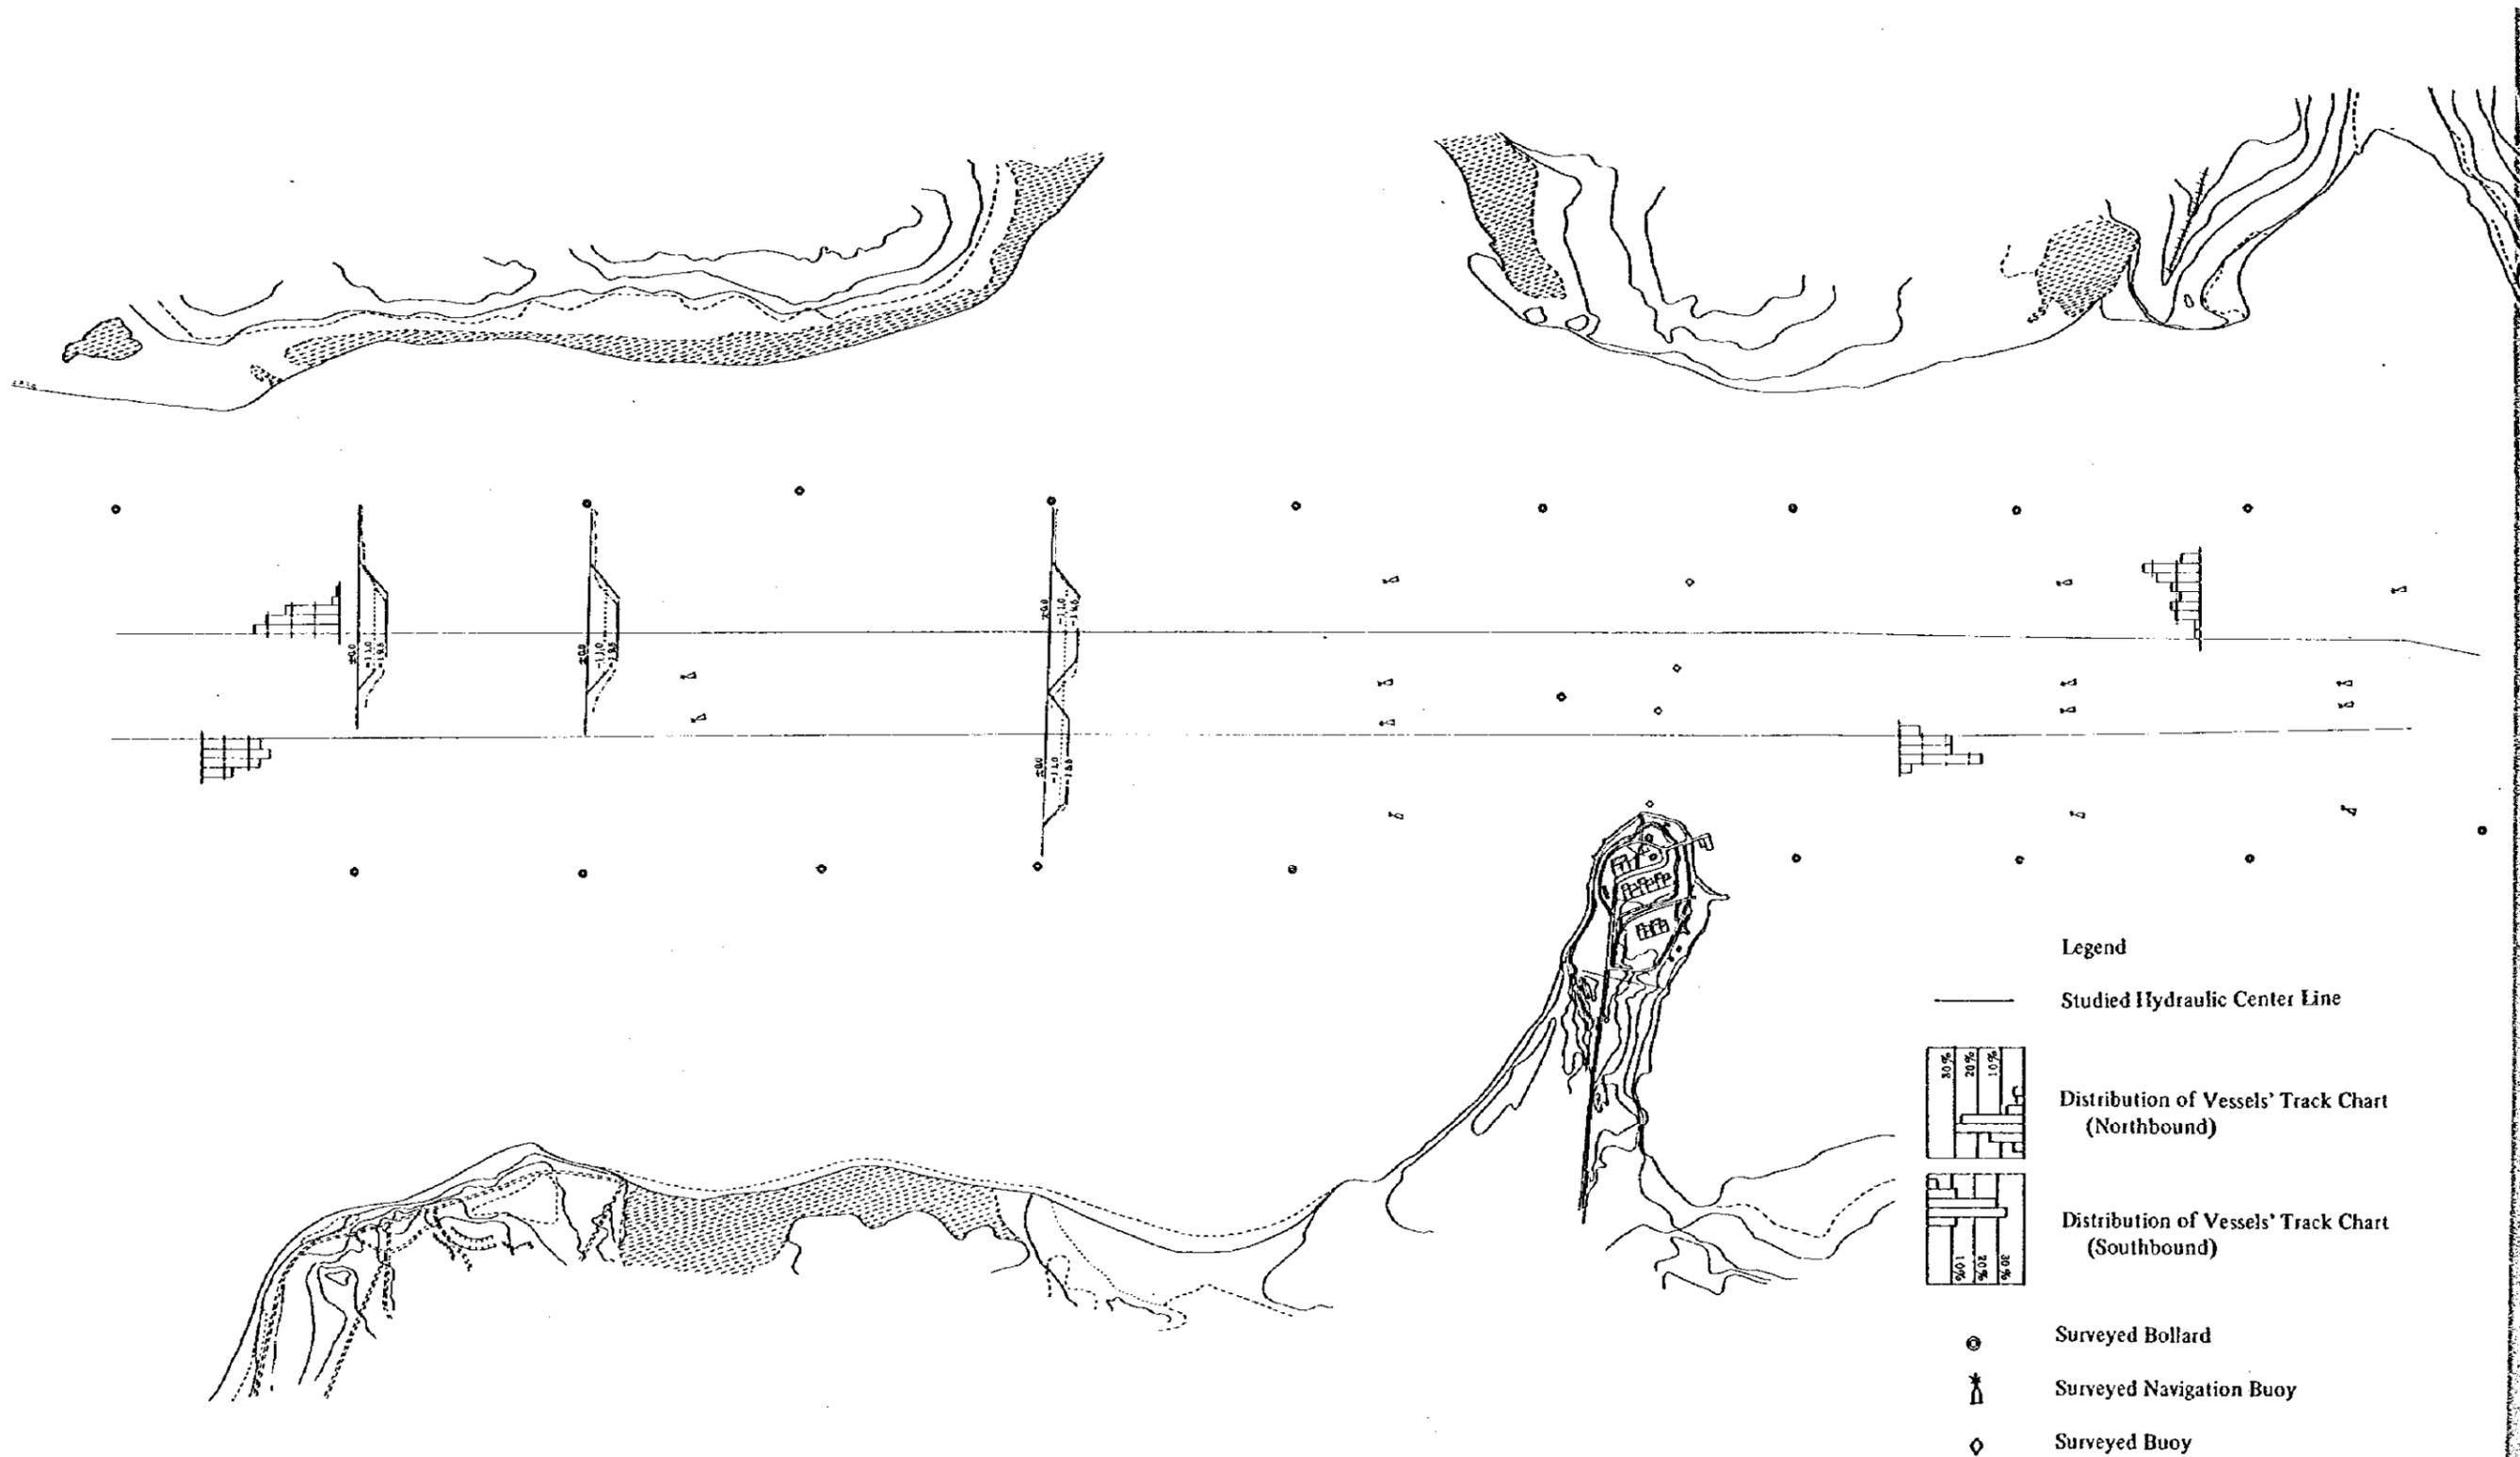
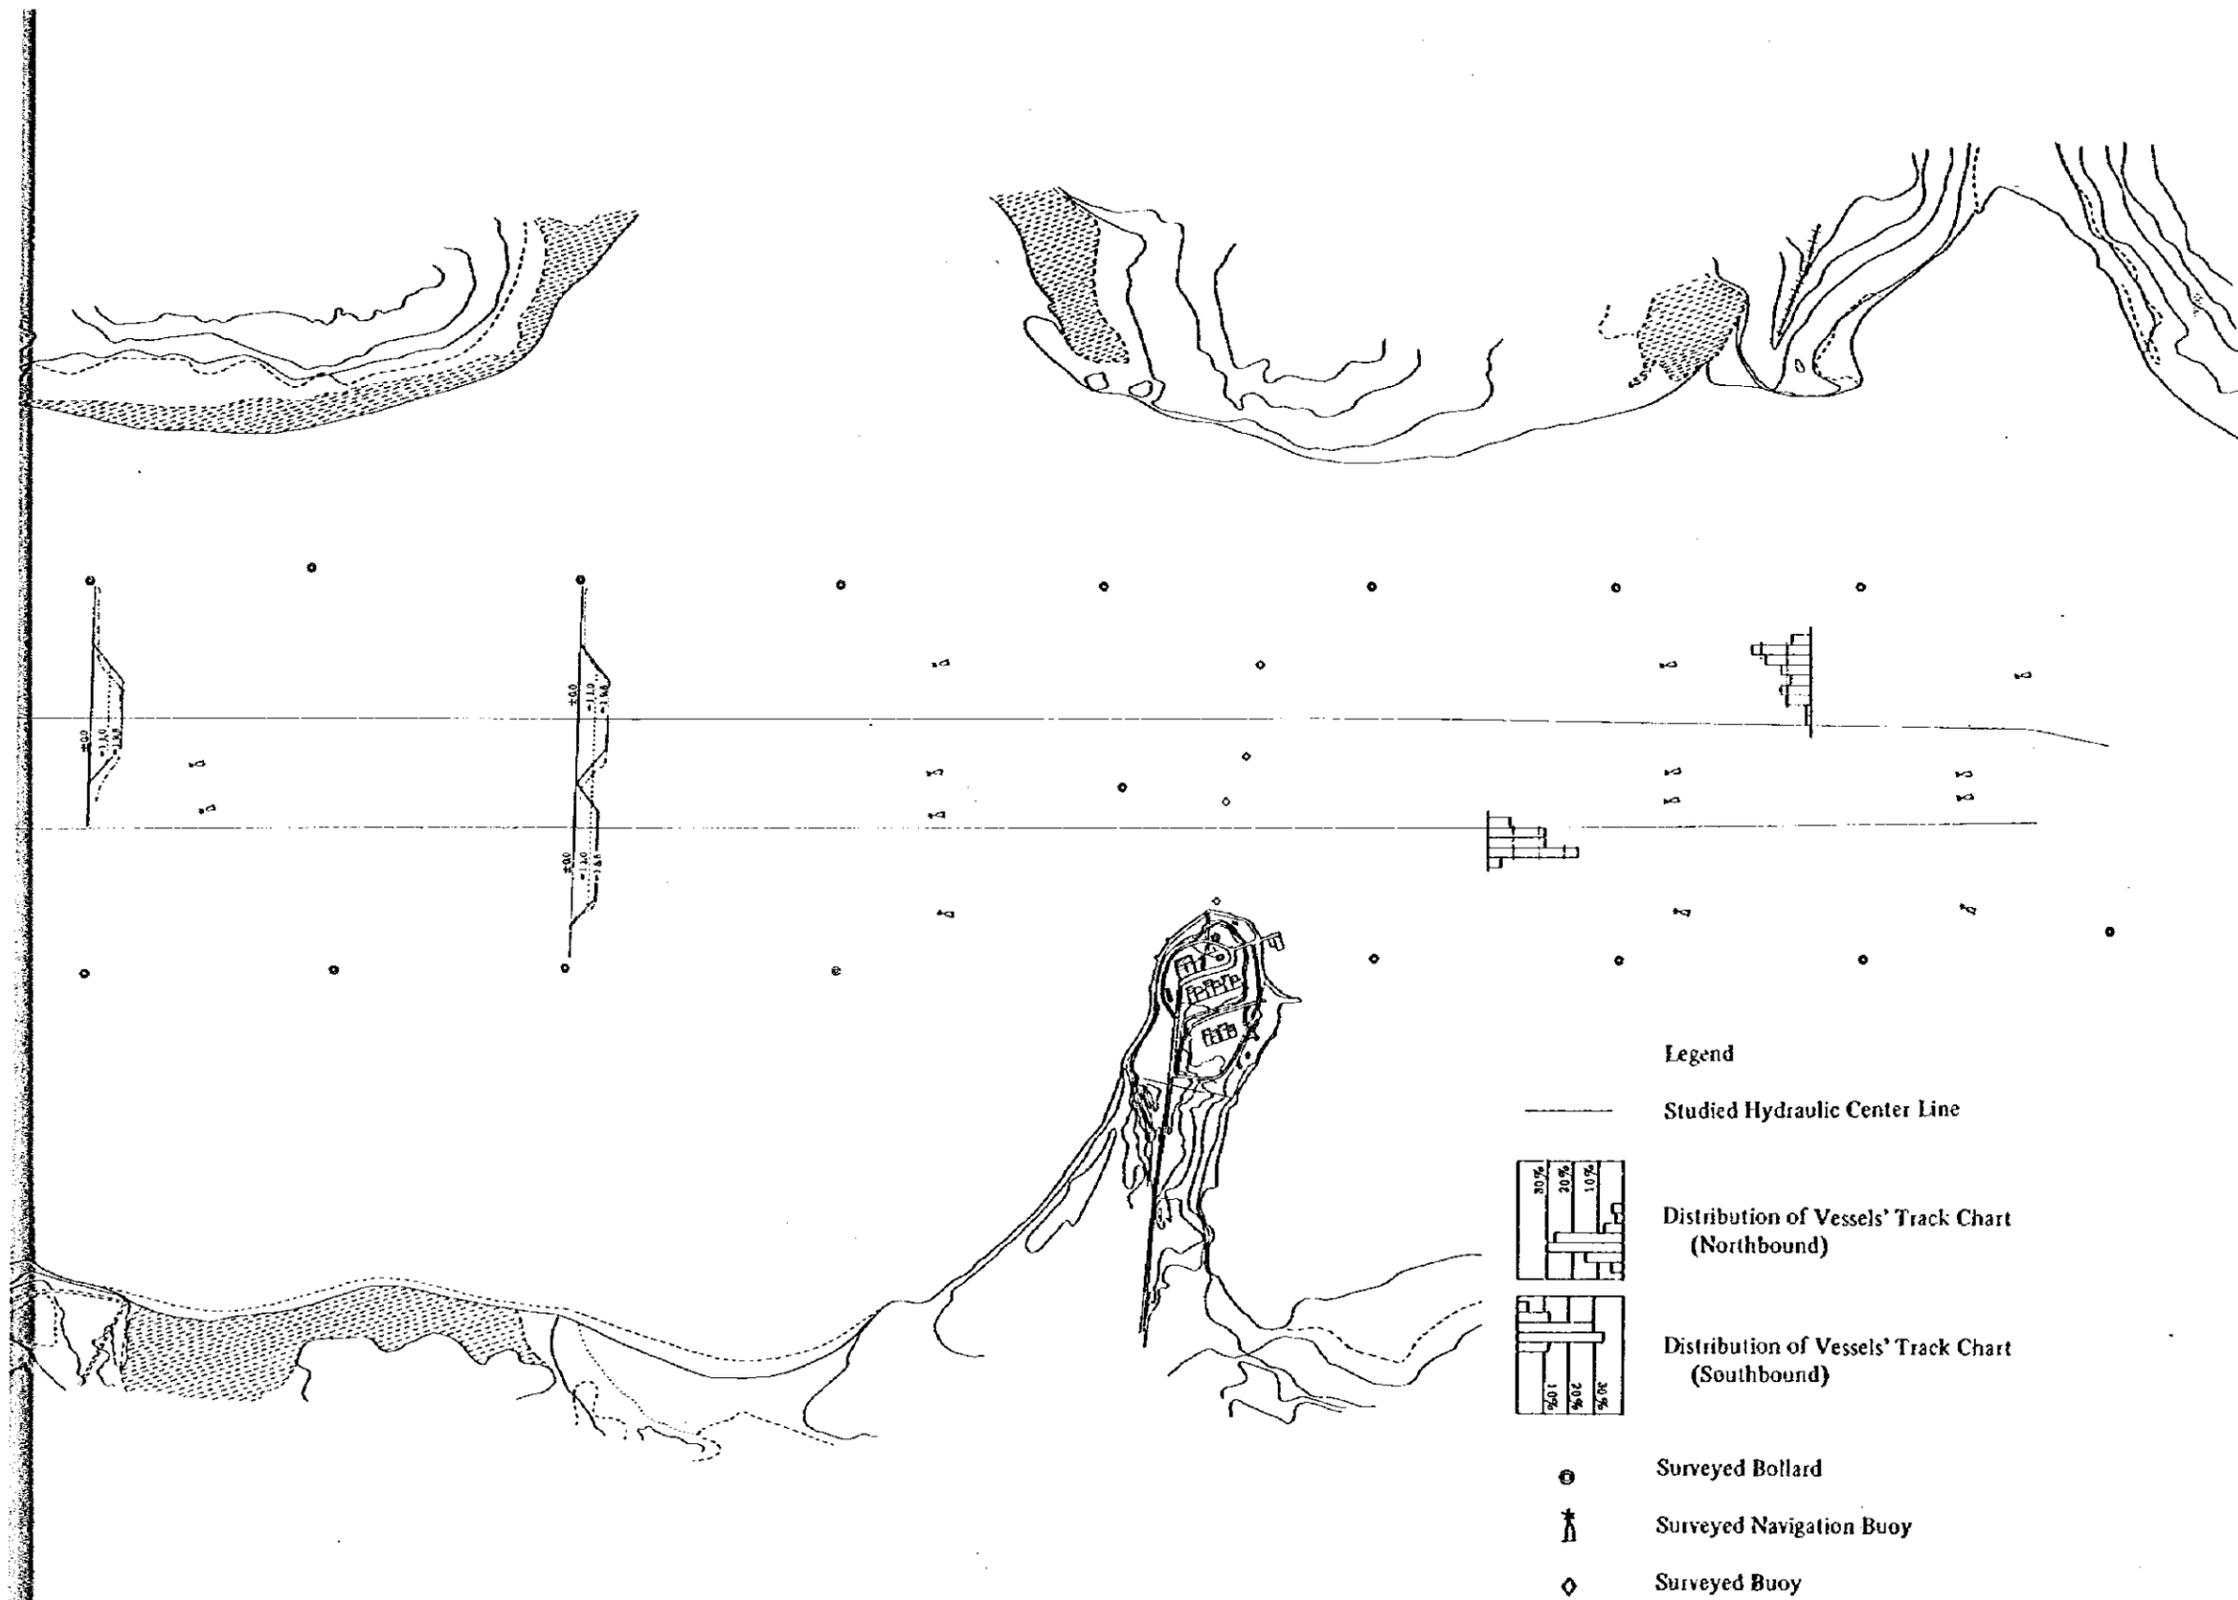
Fig. IV-2(4)-11 Correlation between the Canal Cross-sections, the Hydraulic Center Lines and the Distributions of Vessels' Track Chart (Km 118 ~ 122)
