PART III. ANALYSIS OF ACCIDENTS

PART III ANALYSIS OF ACCIDENTS

PART IV. EVALUATION OF CANAL CONDITIONS

PART IV EVALUATION OF CANAL CONDITIONS

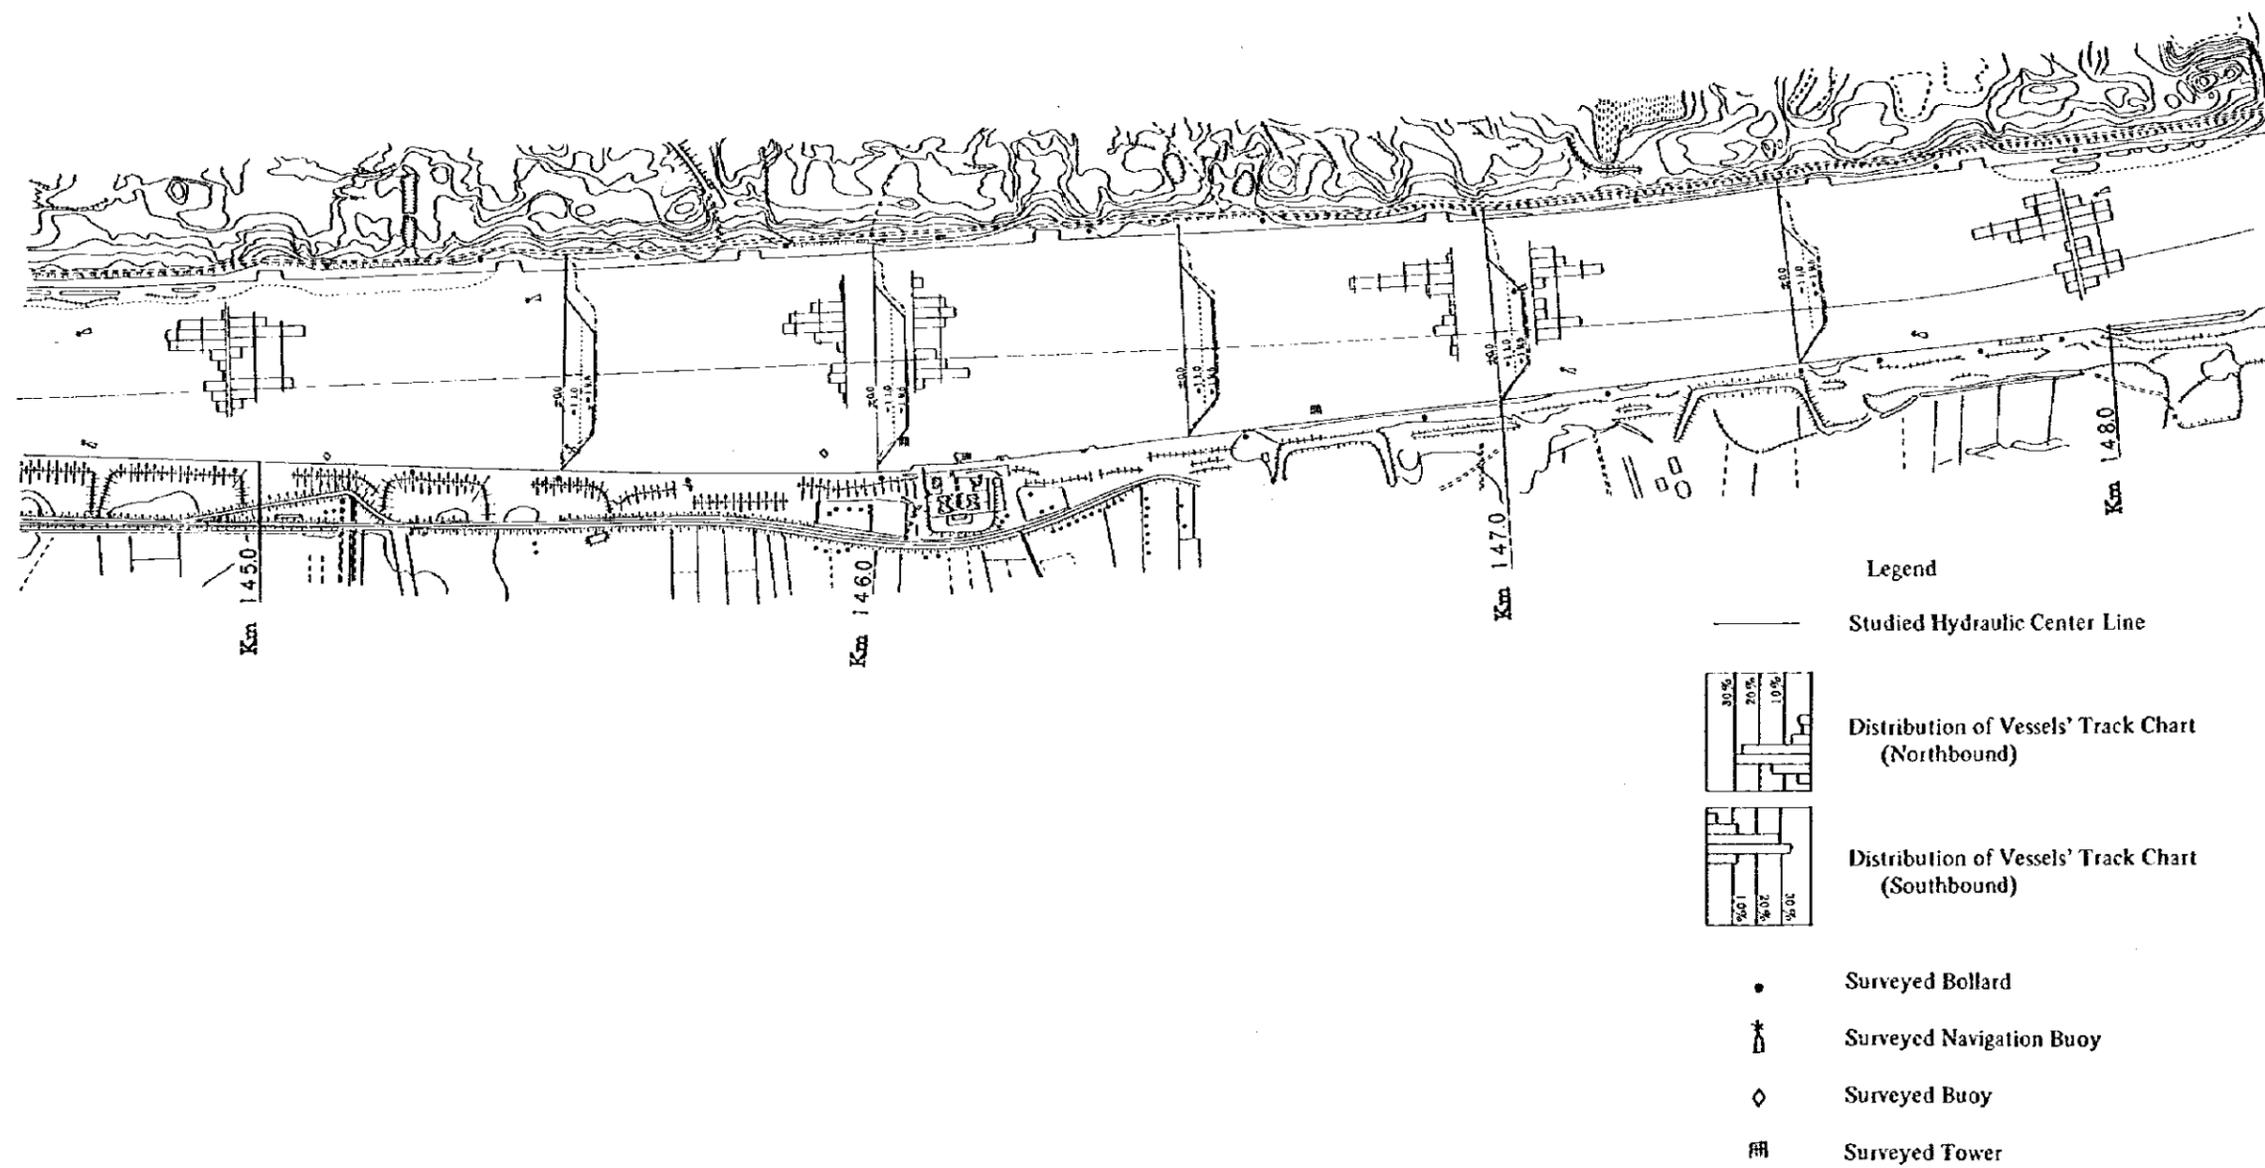
Fig. IV-2-(4)-12 Correlation between the Canal Cross-sections, the Hydraulic Center Lines and the Distributions of Vessels' Track Chart (Km 145 ~ 148)

The correlation between the canal cross-sections and the hydraulic center line is almost all reasonable except around Km 147.5. Near this point, the line is too close to the west bank.

The distribution of vessels track chart is not always reasonable, because the distribution is too extensive on the east side.
