1.4. Preliminary Design and Construction Cost

1.4.1. Design Conditions

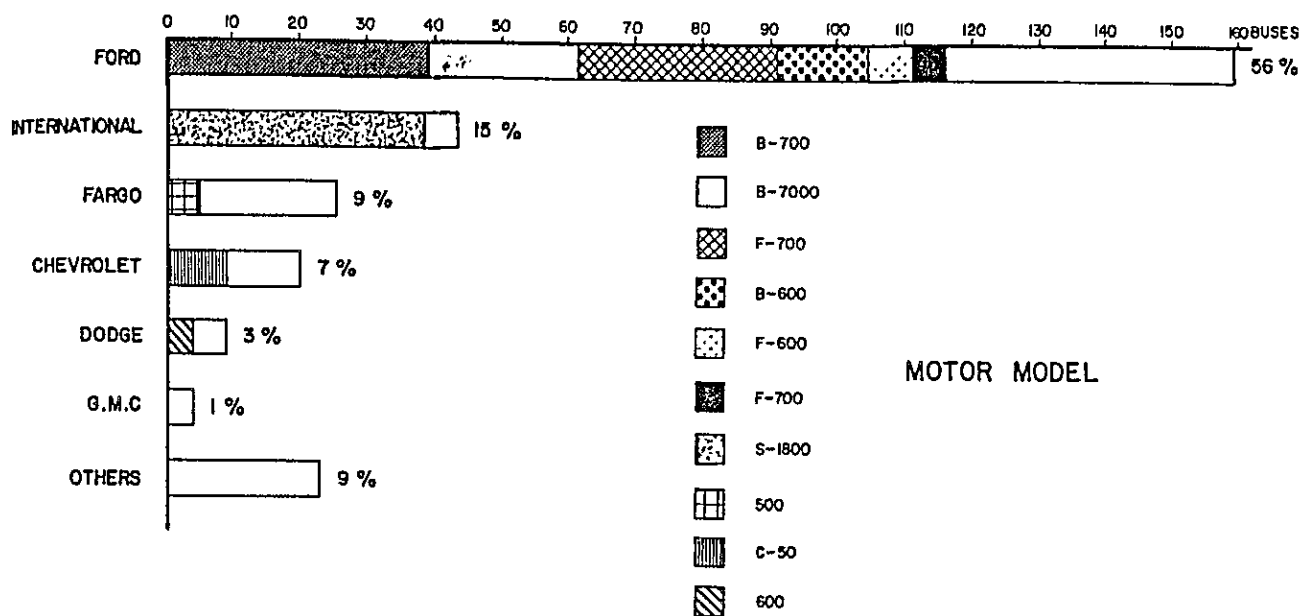
Fig. IV-2-2 NUMBER OF BUSES BY MAKER

Existing buses are of diverse models. A 30% sampling survey by ESTAMPA II resulted in the observation of 29 kinds of buses. More than 90% of all buses are made in the United States, and about half of the 90% are made by Ford Motors (see Fig. IV-2-2 and Table IV-2-4). More than 90% are of bonnet type (with protruding engine space under hood), and one-box type buses are few.
