6-4 Preliminary Design

MINUTES OF MEETINGS
ON
PROGRESS REPORT
OF
THE FEASIBILITY STUDY AND PRELIMINARY DESIGN
FOR
THE AMPLIFICATION OF AN INSPECTION AND
REPAIRING WORKSHOP FOR ELECTRIC ROLLING STOCK

APPENDIX 3 RESULTS OF THE SURVEY OF ROLLING STOCK INSPECTION/REPAIRING WORKSHOPS

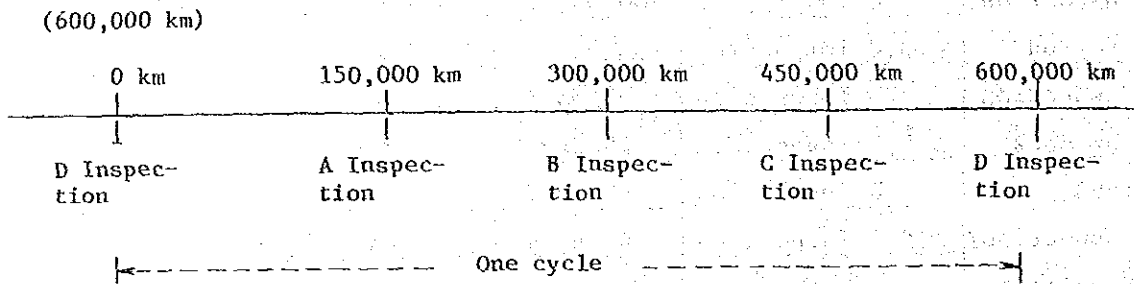
The electric railcar inspection periodicity is as follows.

Traction motors and compressors are removed. Bogies are demounted. The car-body is cleaned and minor repairs are made. This inspection is the work of about 1,000 man hours (MH).

This is an overhaul. The B Inspection, complete car-body inspection and car-body painting are carried out. Since rolling stock in use at present has been in service for more than 20 years, there is much corrosion of floors and the lower part of side panels, and repairs take a great deal of time. This inspection is the work of about 4,000 MH.

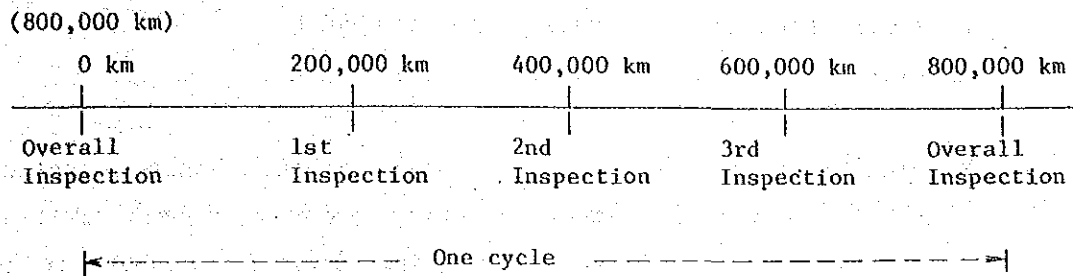
The above is the inspection/repairing periodicity for Guber Besser, GE, ALCO and FIAT railcars. The following cycle is used for GM locomotives.

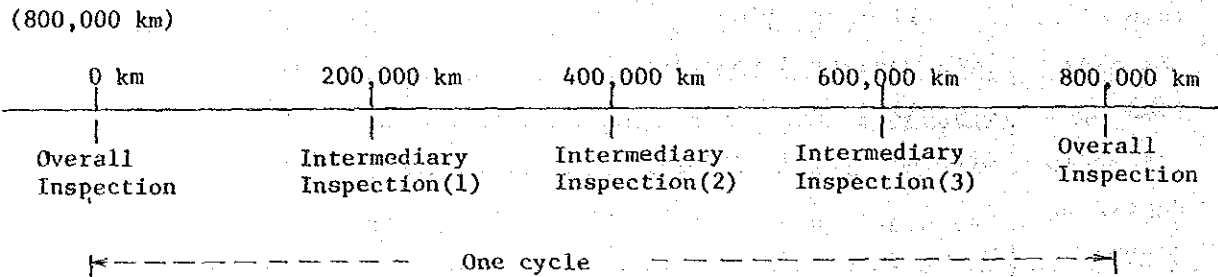
The diesel electric locomotive inspection periodicity is as follows.

The number of days needed for each of these inspections is overall inspections 38 days, Intermediary Inspection (2) 30 days, and Intermediary Inspections (1) and (3) 26-28 days. However, these are the standard numbers of days when all of the spare parts are available. In fact, there are many instances in which the shortage of spare parts is causing delays in the process.

The man-hours needed for each inspection are in the case of ALCO (1980 p.s.) planned at 7,800 MH (actual 8,500) for Overall Inspections and 7,200 MH (actual 7,200) for Intermediary Inspections (the average of (1) and (2)).

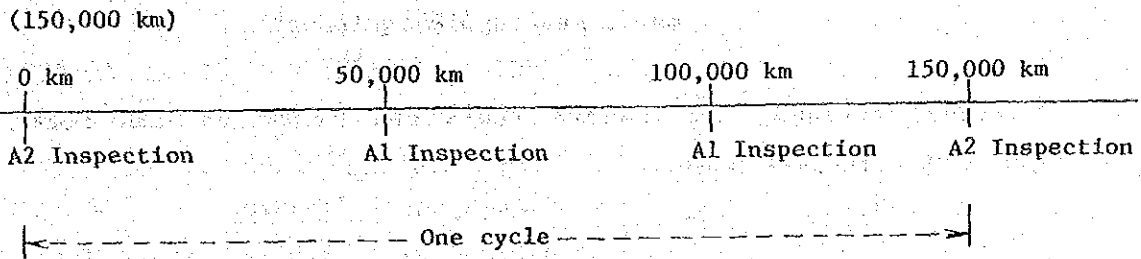
The workshop's inspection/repairing periodicity is as follows.

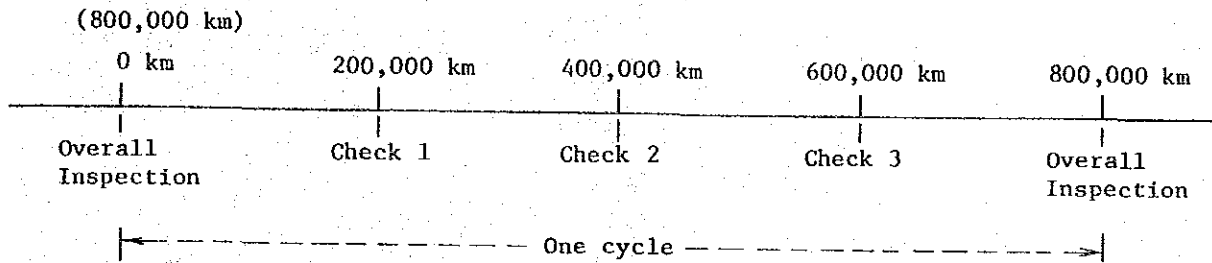
Diesel Electric Locomotive Inspection/Repairing Periodicity

The workshop's diesel electric locomotive and passenger car inspection/repairing periodicities are as follows.
