**ANNEX H**

**INFRASTRUCTURE**

The majority of infrastructures planned for use in the project will be rehabilitation of the existing structures. The Project area is already under cultivation. Accordingly, infrastructures including irrigation facilities have been established. However, these facilities are insufficient in number and the majority are too old to fulfill their function. Deterioration is particularly evident in the existing facilities such as intakes and certain portions of the canals. For effective use of water resources, reduced maintenance cost and increased adaptable productivity, rehabilitation of existing facilities is planned along with construction of new structures.

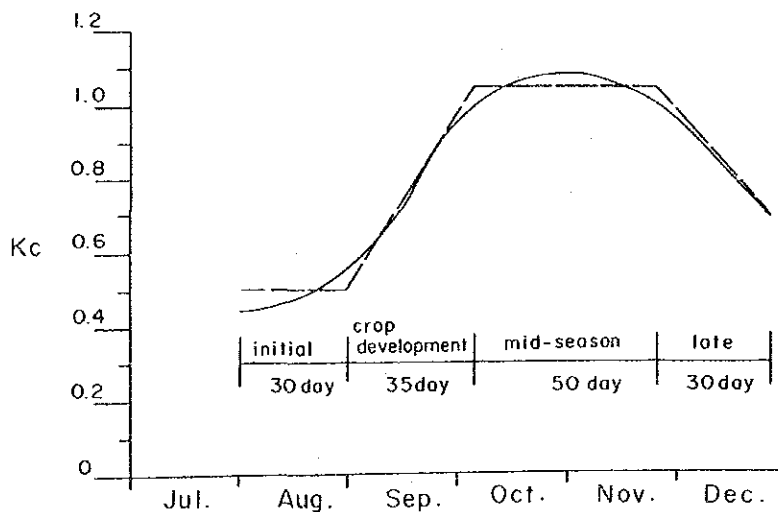
Kc : Potato

Kc		0.50	0.75	1.05	1.03	0.85
----	--	------	------	------	------	------

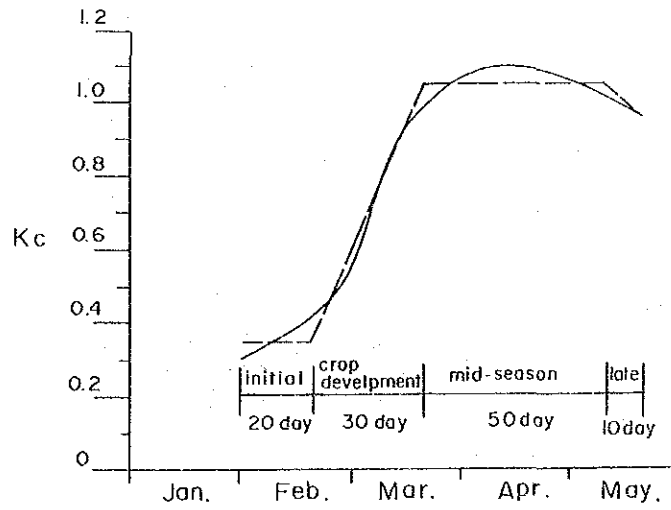
Kc : Choclo

Figure G-5-1 (3) Kc Value

Kc		0.40	0.90	1.07	1.00
----	--	------	------	------	------

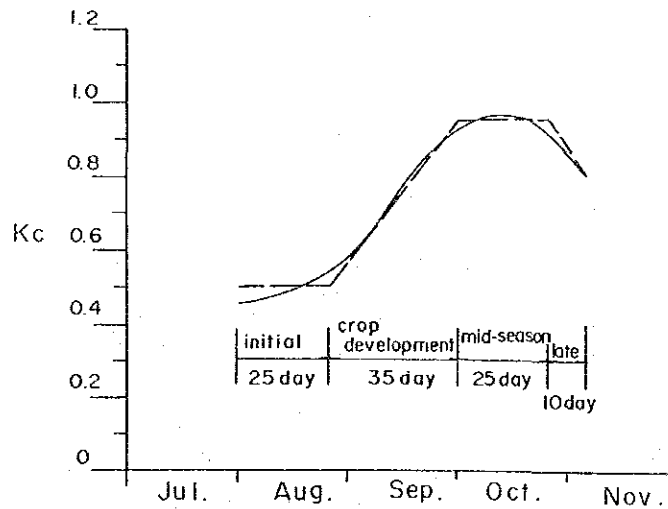
Kc : Green Manure

Kc		0.50	0.75	0.95	0.80
----	--	------	------	------	------

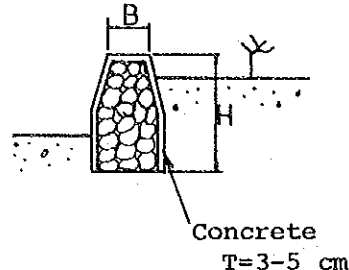
Table H-2-18 Summary of Existing Levee(1)

Location	Structure (m)	Length (km)	Remarks
<b>Right Bank</b>			
-Upstream of Esperanza Intake	Concrete (B=0.5, H=2.0 - 3.0)	0.50	(Constructed in 1925)
-Downstream of Puente Palpa	Concrete (B=0.8, H=2.0)	0.06
