**NAM MAE YUAM HYDROELECTRIC  
DEVELOPMENT PROJECT  
FEASIBILITY REPORT**

**VOLUME I  
(Main Report)**

**MARCH, 1984**

**JAPAN INTERNATIONAL COOPERATION AGENCY**

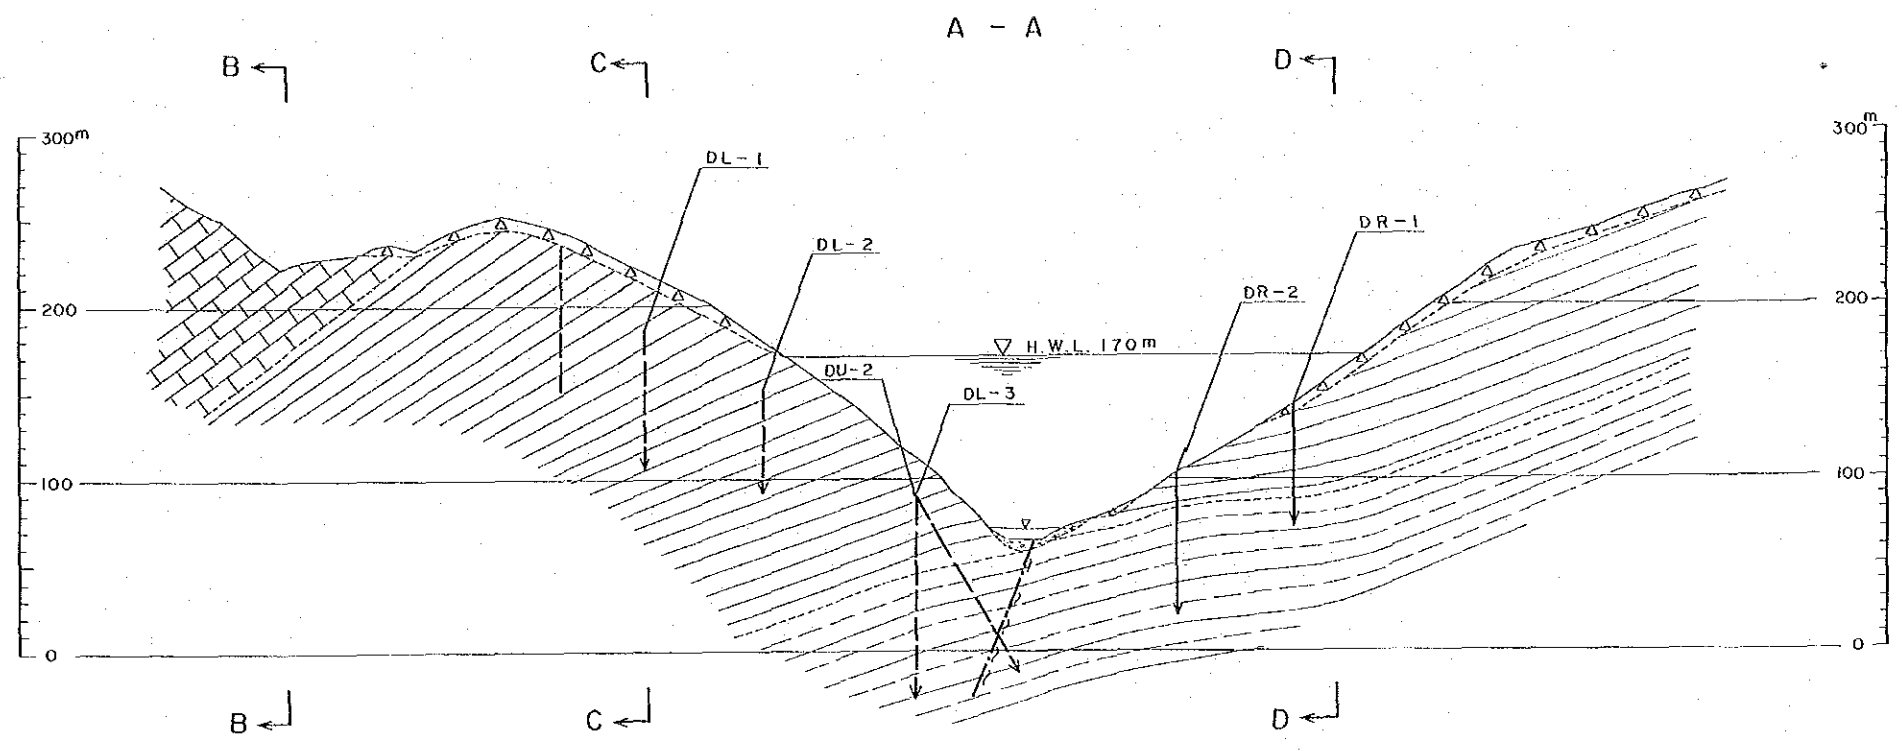
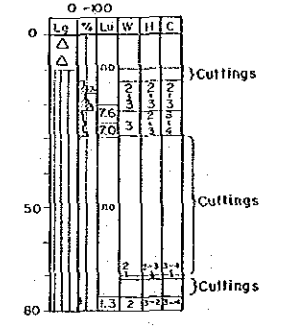
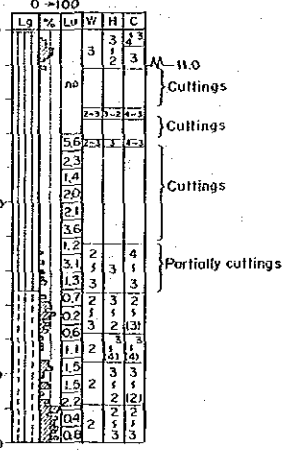
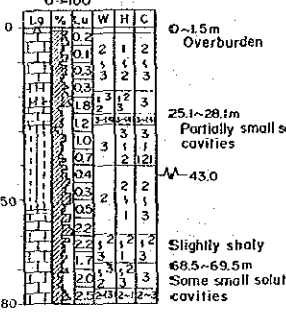
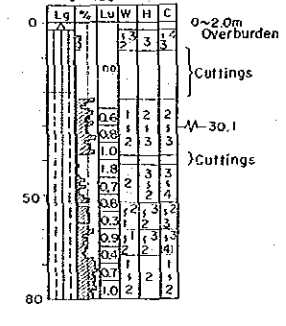
Fig. 2-5 , 1983

- Topsoil, Tulus deposit
- Recent river deposit
- Limestone
- Calcareous sandstone, Calcareous shale, Sandy limestone, Shaly limestone
- Shale
- Geologic boundary
- Fault
- Assumed fault
- Drill hole
- Drill hole (Projection)

- Log. R.Q.D. Lugeon value Core evaluation
- 0-100  
Log % Lu W H C
- W : Weathering  
 1 : Fresh  
 5 : Decomposed
- H : Hardness  
 1 : Hard  
 5 : Soft
- C : Core cutting  
 1 : Stick  
 5 : Grain
- Talus deposit  
 Recent river deposit  
 Terrace deposit  
 Shale  
 Sandstone  
 Calcareous shale, Calcareous sandstone  
 Sandy limestone, Shaly limestone  
 Limestone  
 Fault
