CHAPTER 6

GEOLOGY AND CONSTRUCTION MATERIALS

JAPAN INTERNATIONAL COOPERATION AGENCY
 INSTITUTO COLOMBIANO DE ENERGIA ELECTRICA
 JULUMITO HYDRO-ELECTRIC POWER PROJECT
**GEOLOGY
 GENERAL PLAN**

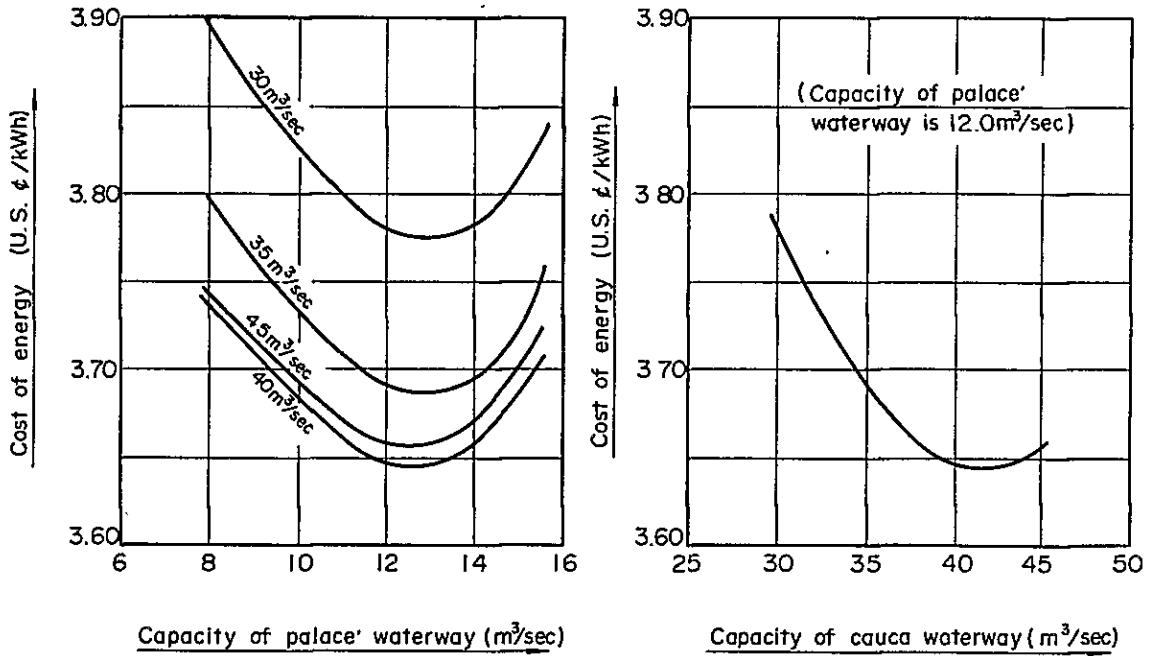
Fig. 7-2 Result of Study on Optimum Capacity of Cauca and Palace Diversion Waterway (Cost of Energy)

The results of studies according to the above are shown in Table 7-1, Fig. 7-2 and Fig. 7.3. As is clearly seen in the table and figures, the most economical scale is when the intake from Rio Cauca Diversion Dam is 40.0 m³/sec and that from Rio Palace Diversion Dam 12.0 m³/sec. Consequently, the maximum capacities of the waterways are to be the following:
