**PLANNING REPORT
ON THE PASIG-POTRERO RIVER
FLOOD CONTROL AND SABO PROJECT**

APPENDIX II

**GEOLOGY AND DEBRIS PRODUCTION
SABO PLAN**

SEPTEMBER 1978

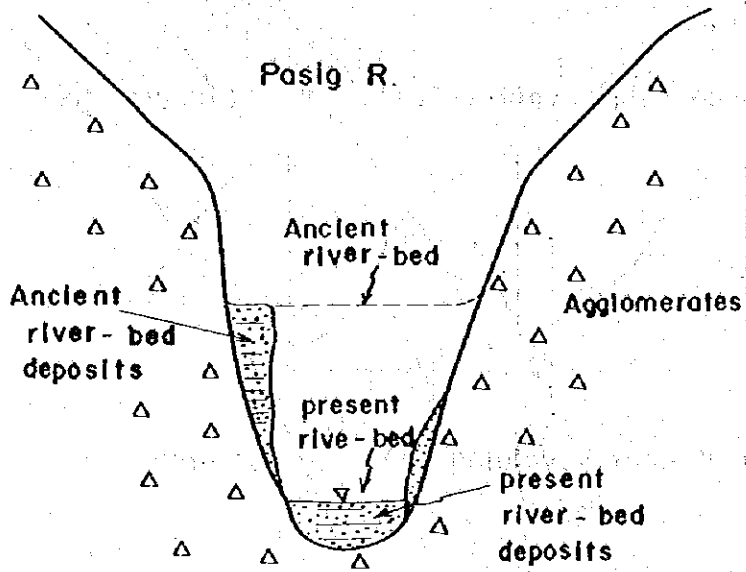
FIGURE I - 3 ANCIENT RIVER-BED DEPOSITS REMAINED ON THE RIVER-COAST ALONG THE PASIG RIVER.

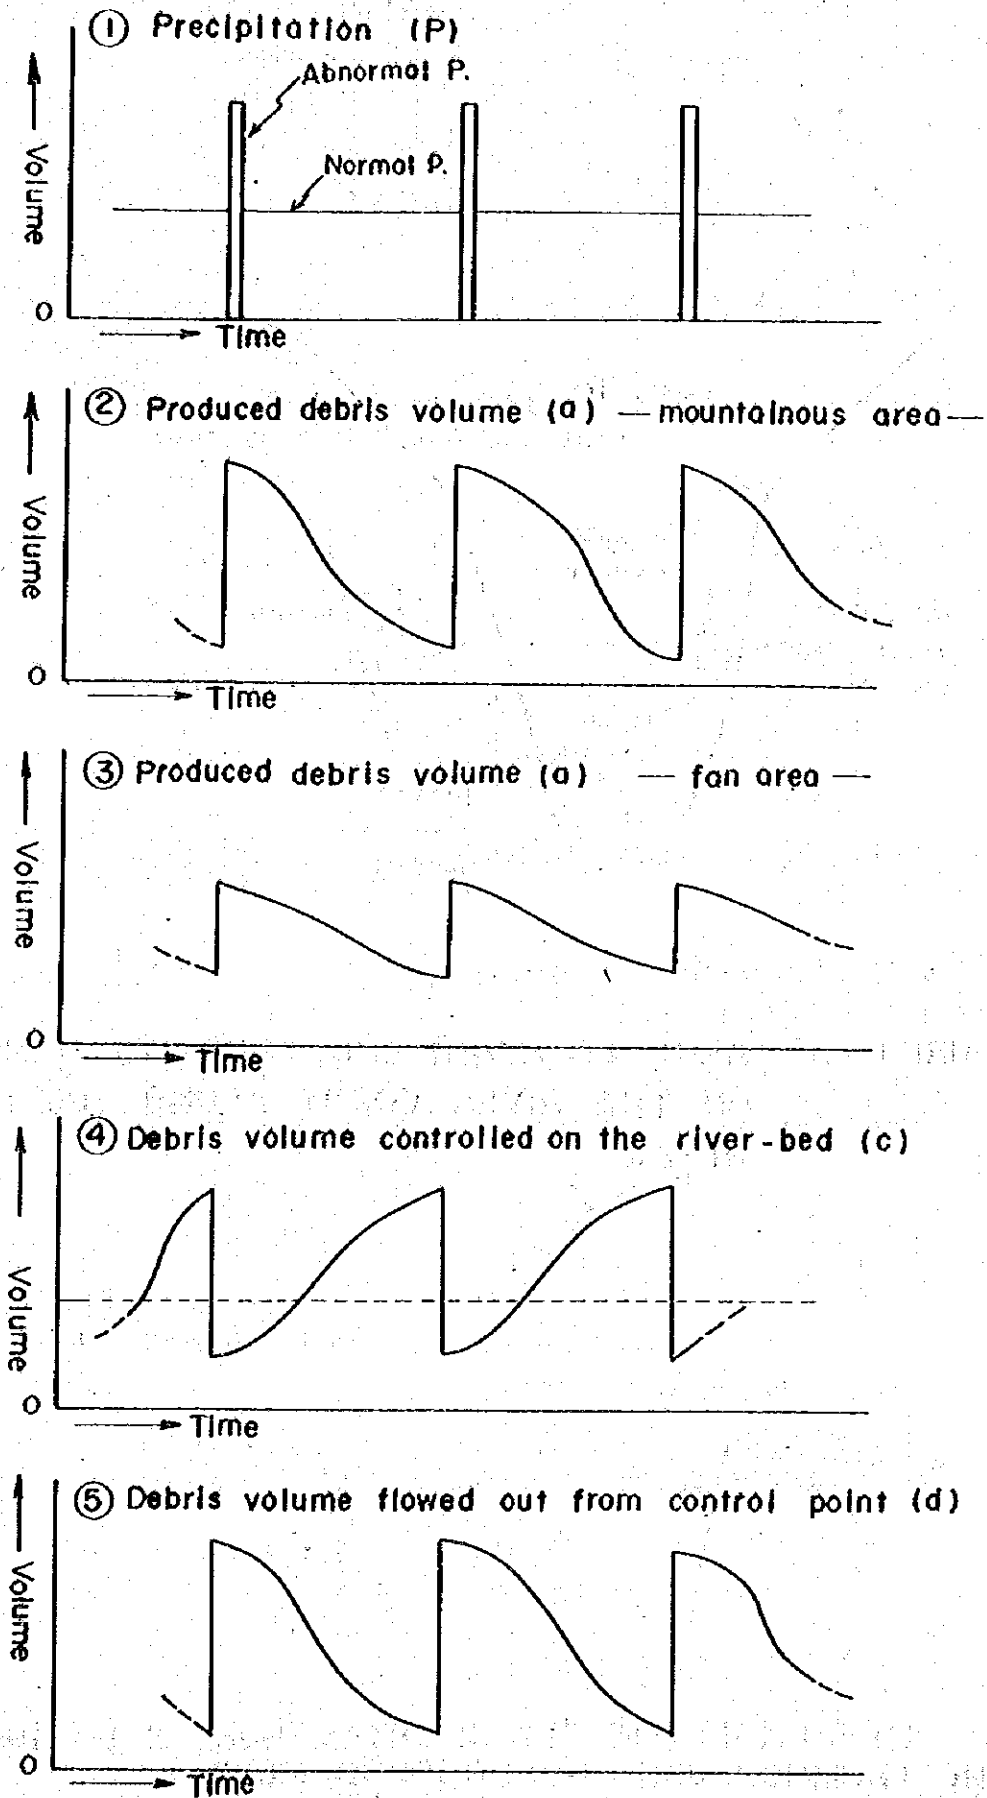
FIGURE I - 4 CONCEPTUAL REPRESENTATION SHOWING THE QUANTITATIVE DEBRIS VARIATION.

In the sedimentation period of the fan deposits (I), the debris supplied upstream was more than that discharged downstream. However, other fan units display terrace liked landforms and this suggest that the debris volume discharged downstream is more than that supplied upstream. Namely, the river-bed has a tendency to sink annually after sedimentation of the fan deposits and also in the present conditions has been laid on its extentions. But, such tendencies come from only a conclusion taking into account the long time scale.
