**UPPER QUAE YAI HYDROELECTRIC  
DEVELOPMENT PROJECT  
FEASIBILITY REPORT**

**Volume 3  
(APPENDIX 2 and 3)**

# CHAPTER 1 GEOLOGY

## APPENDIX 2 GEOLOGY AND MATERIAL

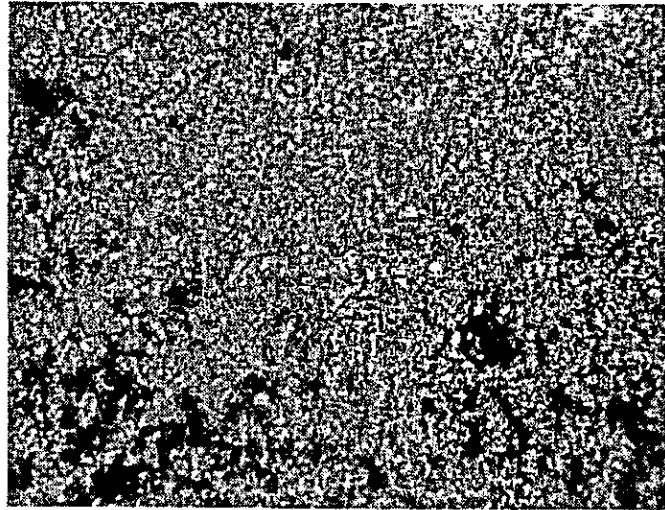
Rock name:

Dolomitic limestone  
Formation D

(open nicols)

Micrograph and Petrographic Description of Rock (Plate 1 of 7)

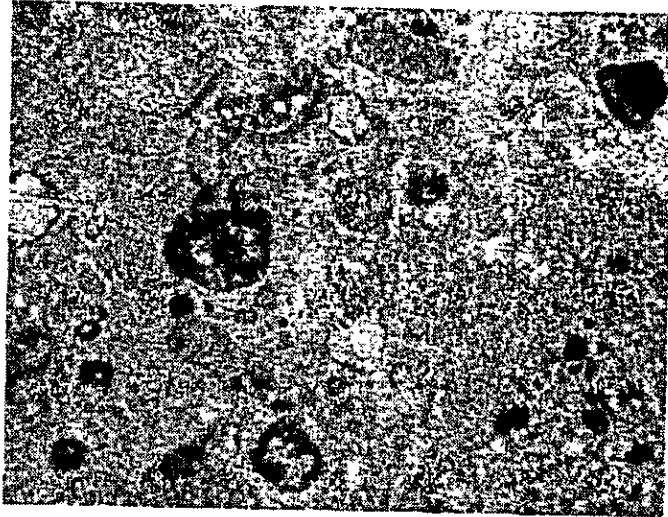
Rock name:

Limestone  
Formation D

(open nicols)

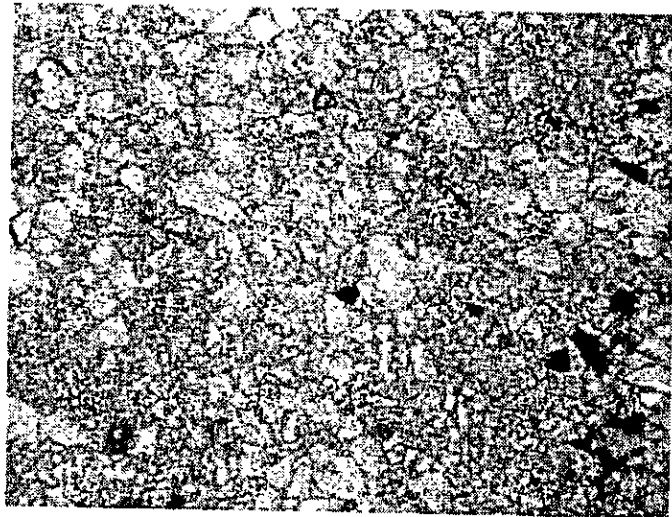
Rock name:

Calcareous sandstone  
Formation C

(open nicols)

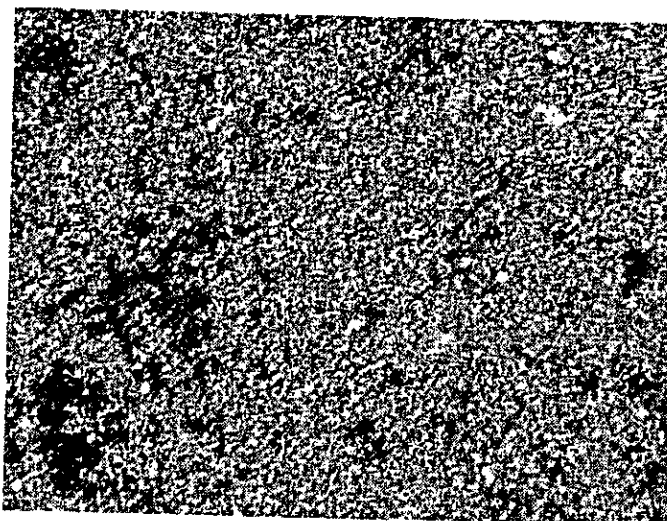
Calcareous shale

Formation C

(open nicols)

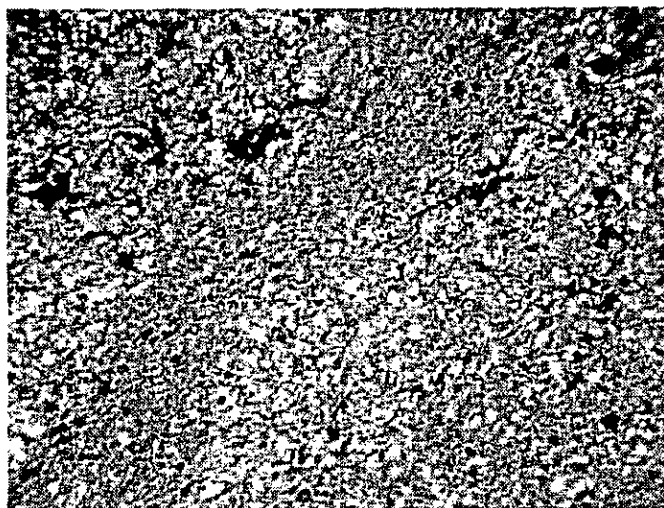
Rock name:

Phyllite  
Formation B

0 1.0mm (open nicols)

Original rock is alternation of sandstone and shale. Alternated phyllite composed of greenish grey slate (carbonate, chlorite, quartz  $\gg$  graphite, sericite) and pinkish grey slate (carbonate  $>$  quartz  $\gg$  sericite, hematite). Foliation is observed from upper right to lower left in microphoto.

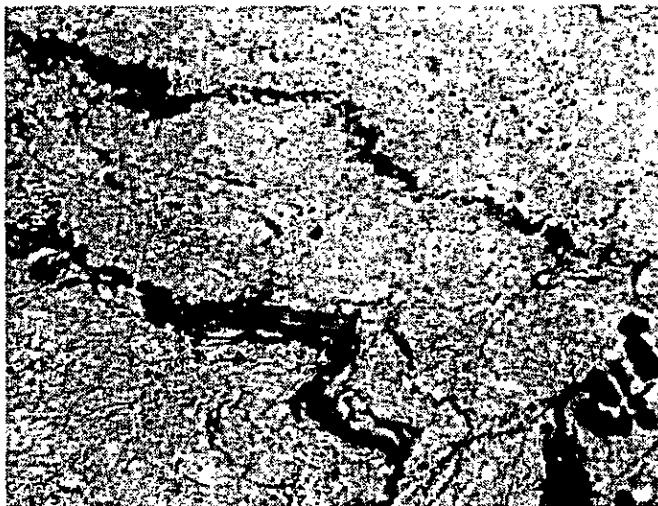
Slate

Formation A

Grey slate chiefly consisting of fine-grained quartz and sericite with small amounts of graphite, chlorite and plagioclase. No carbonate is observed.

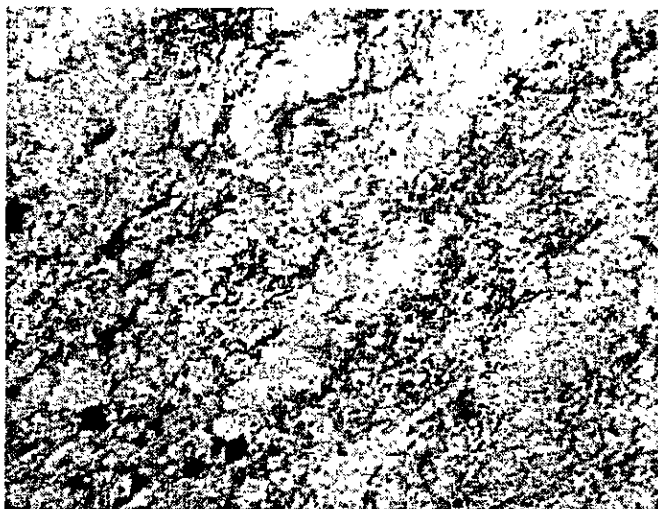
Schist (River gravel)

Metamorphic rock

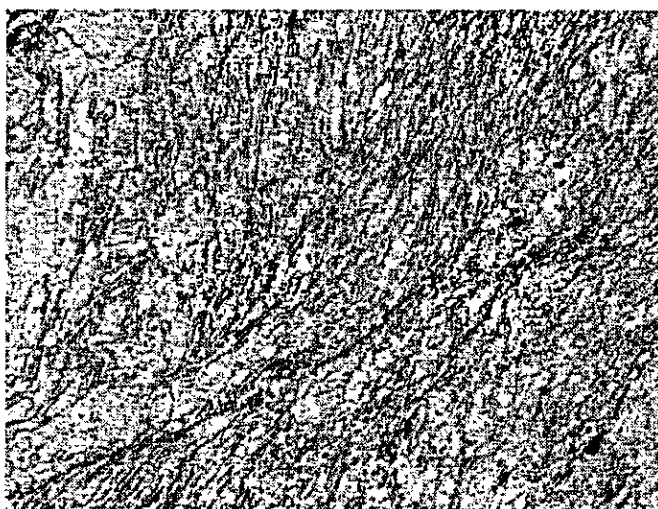
Phyllite

Metamorphic rock

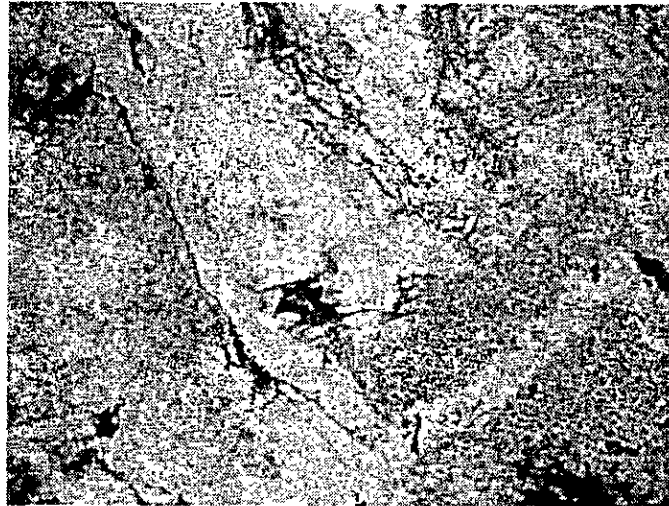
Rock name:

Biotite granite

0 1.0mm (open nicols)

Brownish hydrothermally altered biotite granitic rock. Wholly sheared and altered at hydrothermal conditions with the following results; chloritization of biotite, sericitization of K-feldspar, albitization of plagioclase, deformation and recrystallization of quartz.

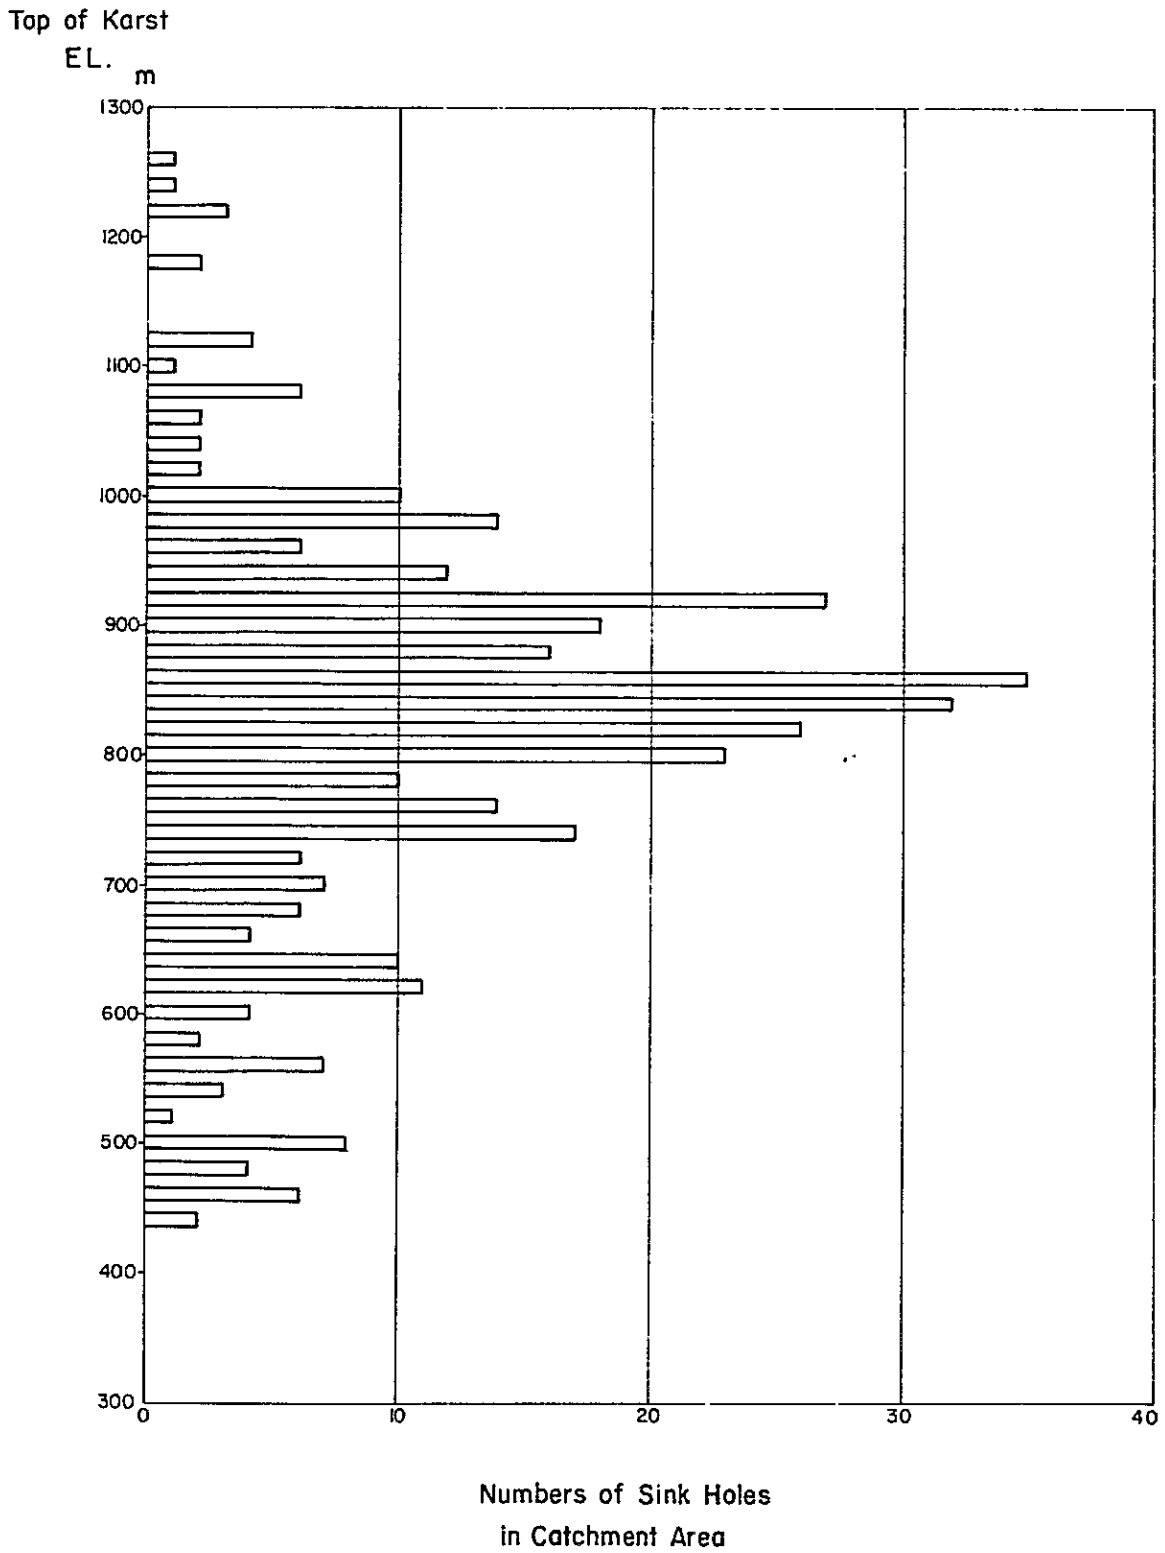
Fig.1-5 Numbers of Sink Holes

Group III Area - Elevations from 700 to 1,000 m, contour line spacings mostly around 2 cm and 3 to 7 cm. Areas of this classification are so-called peneplain areas, and the greatest number of dolines in the Upper Quae Yai Project area is distributed in these areas. The distribution frequency is higher than 75% as indicated in Fig. 1-5.
