### 3-1 Survey on Design and Construction Environment

#### 3-1-1 Country and Natural Features of the City of La Paz

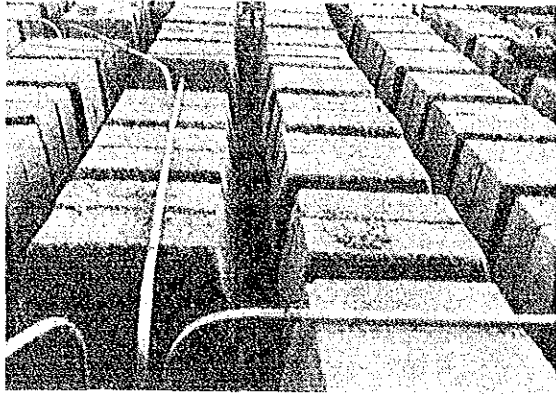
Joist slab method using floor blocks

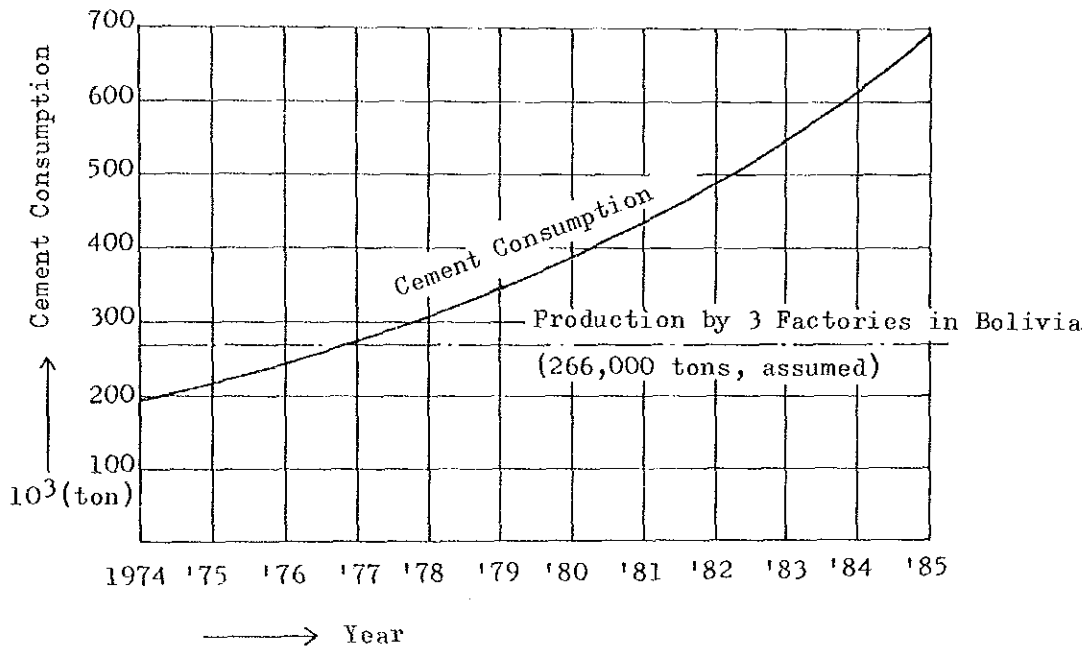
Graph for Forecasting Cement Consumption in Bolivia

Since cement consumption is proportional to the investment in construction, shortage in construction materials in the future should be taken into consideration. Hence, effective measures should be taken in advance for the construction of the Research Center.

Under the leadership of a stable government, Bolivia is now promoting its social and economic development under a new 5-year program from 1976 to 1980. As one of the projects under this 5-year program, construction work using programmed construction investment funds is actively under way and, accordingly, the consumption of construction materials is increasing each year. To prove this tendency by actual data, changes in cement consumption are shown in the graph below.

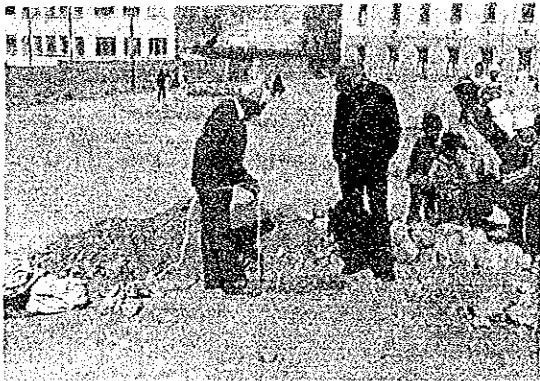
Boring for Soil Test of the Site

The soil condition was investigated by boring at two places in the site. Boring hole No.1 was 5.5 meters deep and No.2 was 4.5 meters deep, and soil was sampled for each 1-meter for each hole and a standard penetration test was also conducted. (Reference Material-I)
