FEASIBILITY STUDY REPORT

LEBIR DAM PROJECT

VOLUME 2

JAPAN INTERNATIONAL COOPERATION AGENCY  
(JICA)

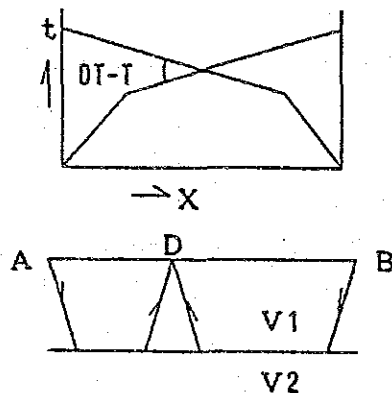
(a) Mean-Minus T Method

A time difference between the arrival time of blastings at Point A and Point B to the measuring Point D can be written as;

$$DT = TB - TA$$

where,  $TB$  is the arrival time from Point B to Point D

$TA$  is the arrival time from Point A to Point D

The first arrival time of each blasting to the measuring point was taken from the data on the field tests, and plotted on a figure with distance on the abscissas and time on the coordinates, from which a travel time curve was prepared on each traverse line. In analyzing the travel time curve, the Mean-Minus T method and the ABC method were used.

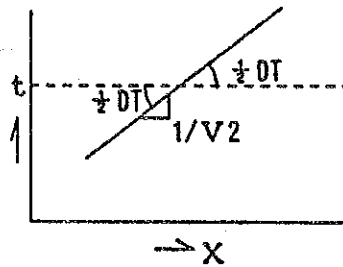
The velocity of the refraction layer can be expressed as the inverse number of the inclination obtained by plotting  $1/2 DT$  on each measuring point, as shown below:

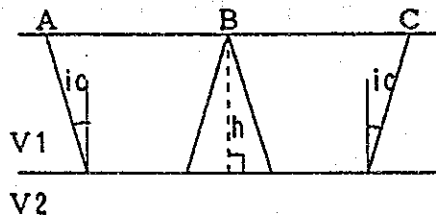
(b) ABC Method

The depth to the lower layer ( $V_2$  layer) from the measuring point B to check the travel time from the blasting points A and C can be expressed as:

$$h = \frac{1}{2} \frac{(T_{AB} + T_{CB} - T_{AC}) V_1}{\sin i_c}$$
