GOVERNMENT OF MAURITIUS
PORT LOUIS WATER SUPPLY PROJECT

**ANALYSIS ON GROUNDWATER
LEVEL AND LEAKAGE**

JUSTIFICATION FOR DEPTH OF FOUNDATION
EXCAVATION FOR SPILLWAY AND EARTH DAM
AT MO4 AND TR9

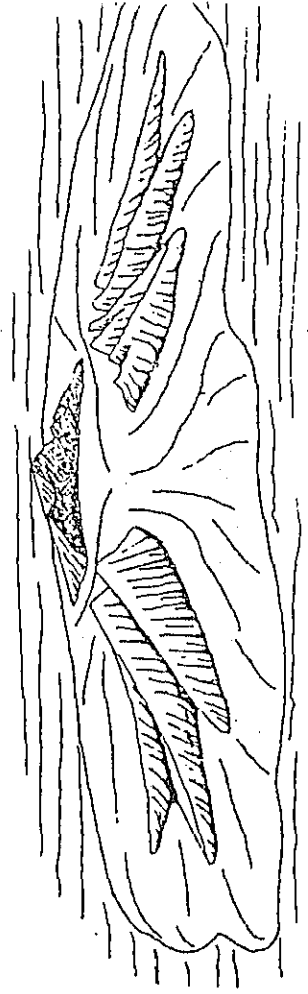
Fig. B.2.17

1. Eruption of Older Volcanic Series as a shield volcano

2. Erosion of the shield, leading to spurs & deeply incised valleys

3. Caldera collapse, or preferential erosion of the centre of the shield

4. Eruption of Younger Volcanic Series, isolating the eroded remnants of the Older Volcanic Series shield

GEOLOGICAL FORMATION OF MAURITIUS

After this long period of erosion, renewed volcanism produced the Younger Volcanic Series. These lavas infilled much of the rugged topography, covering colluvial and residual soil development and leaving gently undulating plains with only the higher mountains of the Older Volcanic Series prominently exposed.

Erosion of the Late Lavas of the Younger Volcanic Series is not well advanced, the landscapes being structural rather than erosional in origin. Where these Late Lavas are in close contact with the mountains of the Older Volcanic Series, as in the Port Louis area, further development of colluvium from the mountains has overlain the margins of the Late Lava surface.
