NAM YUAM RIVER
HYDROELECTRIC

NAM YUAM RIVER BASIN INTEGRATED
HYDROELECTRIC DEVELOPMENT PROJECT

GEOLOGY
RESERVOIR AREA OF
NAM NGAO DAM
PLAN

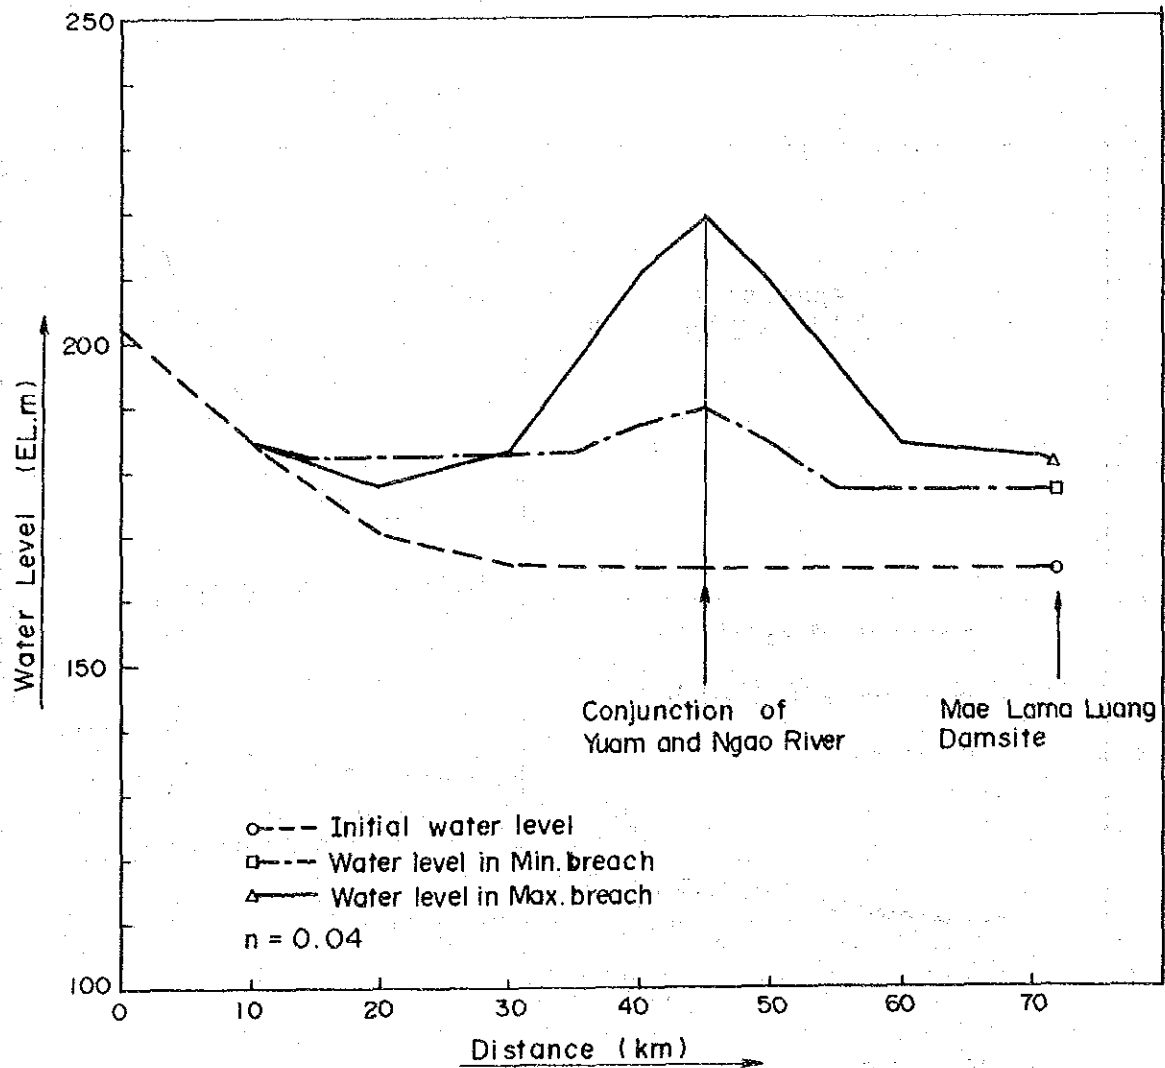
Fig. 5-35 Profile of Maximum Water Level of Ynam River Due to Breach of Nam Ngao Dam

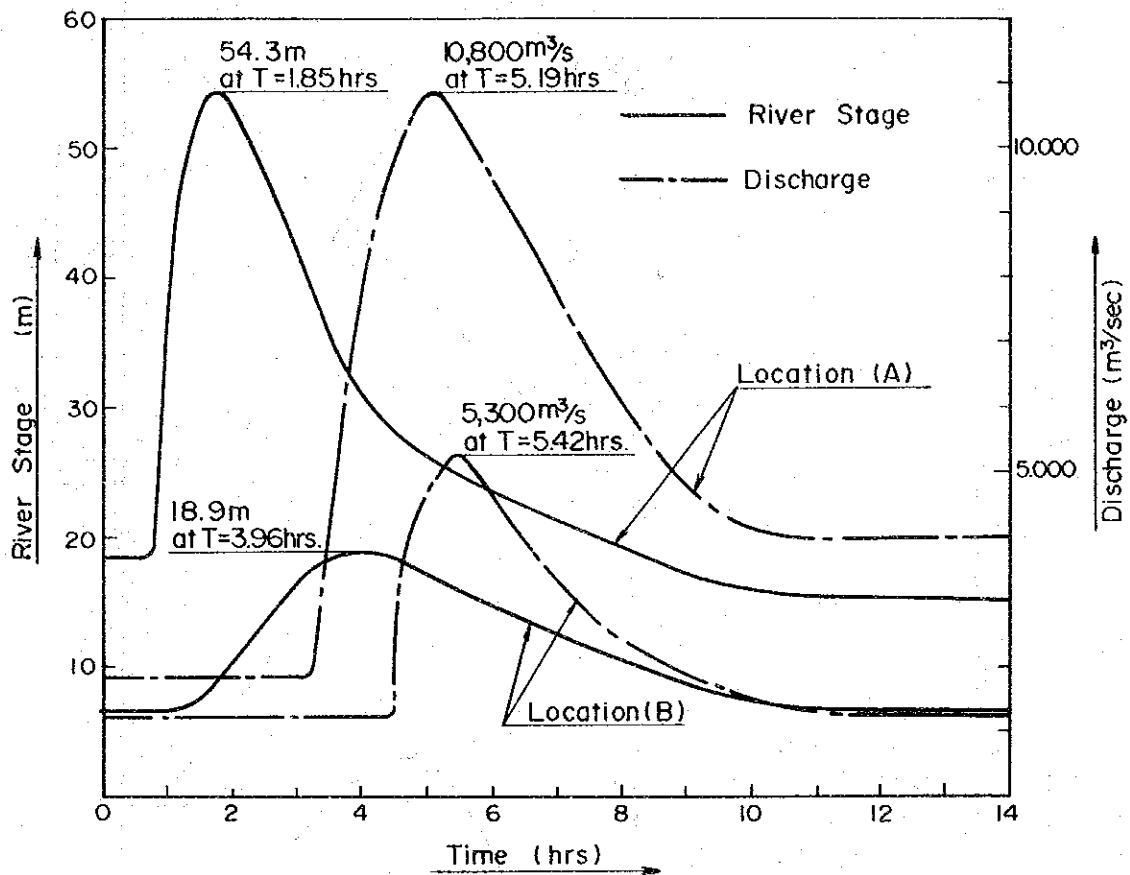
Fig. 5 - 36 Attenuation of Break Flood of Nam Ngao Dam Along Upstream of Conjunction of Yuam and Ngao River

Note : Location (A) — 8 km upstream of the conjunction
 Location (B) — 21 km upstream of the conjunction
 Maximum breach at $n=0.04$

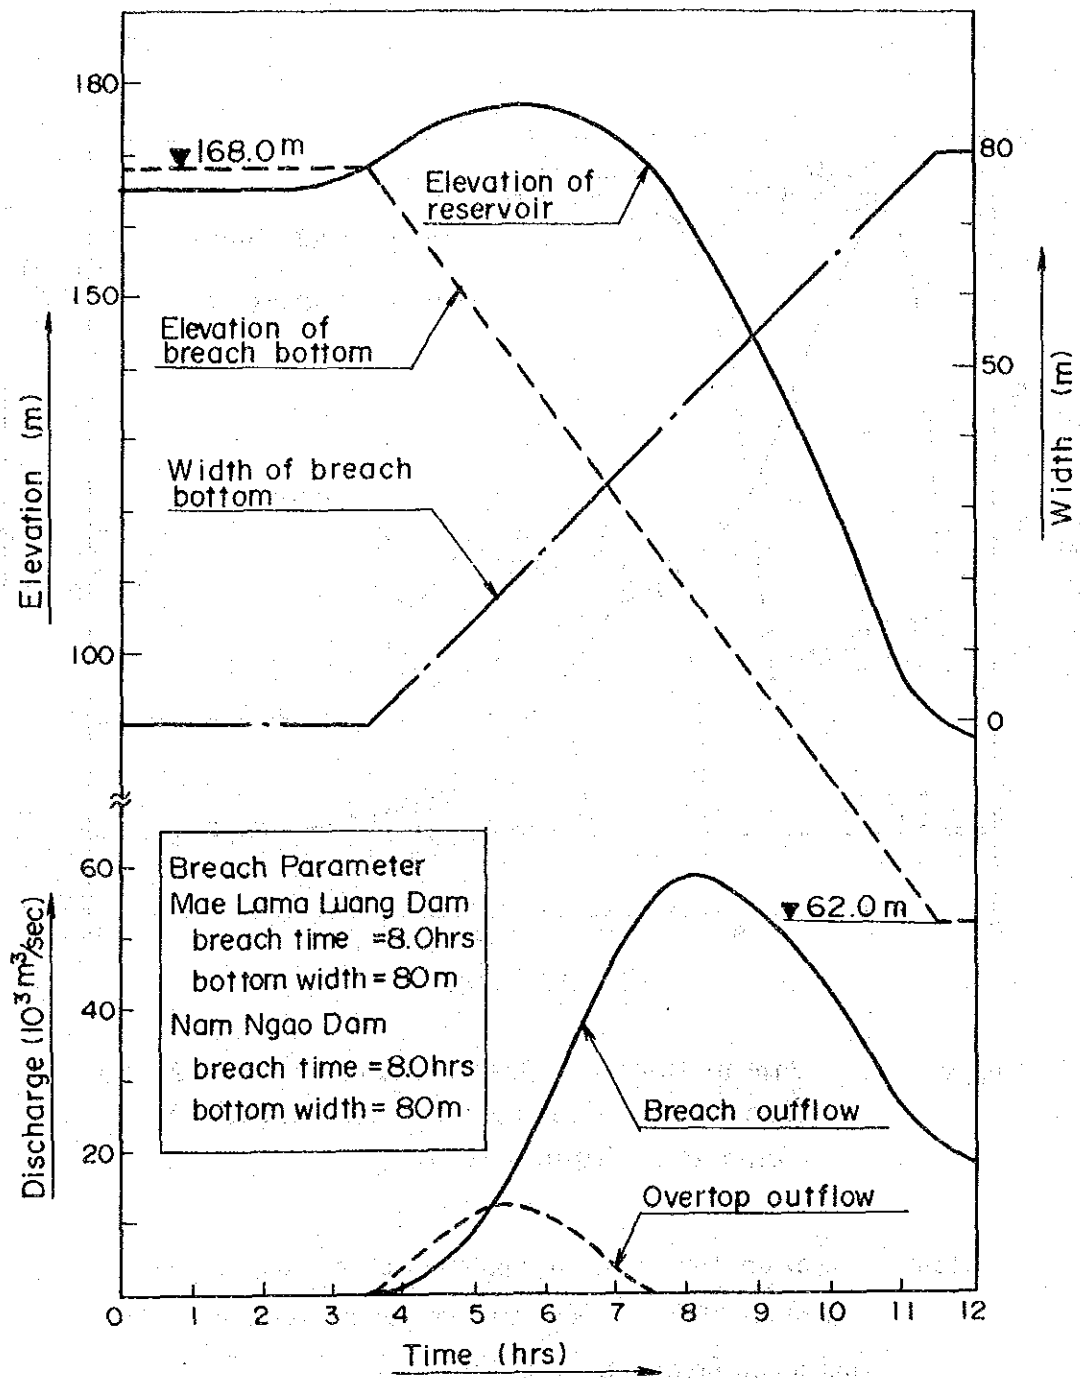
Fig.5-37 Breach Formation and Outflow of Mae Lama Luang Dam Due to Nam Ngao Dam Breach in Min. Case

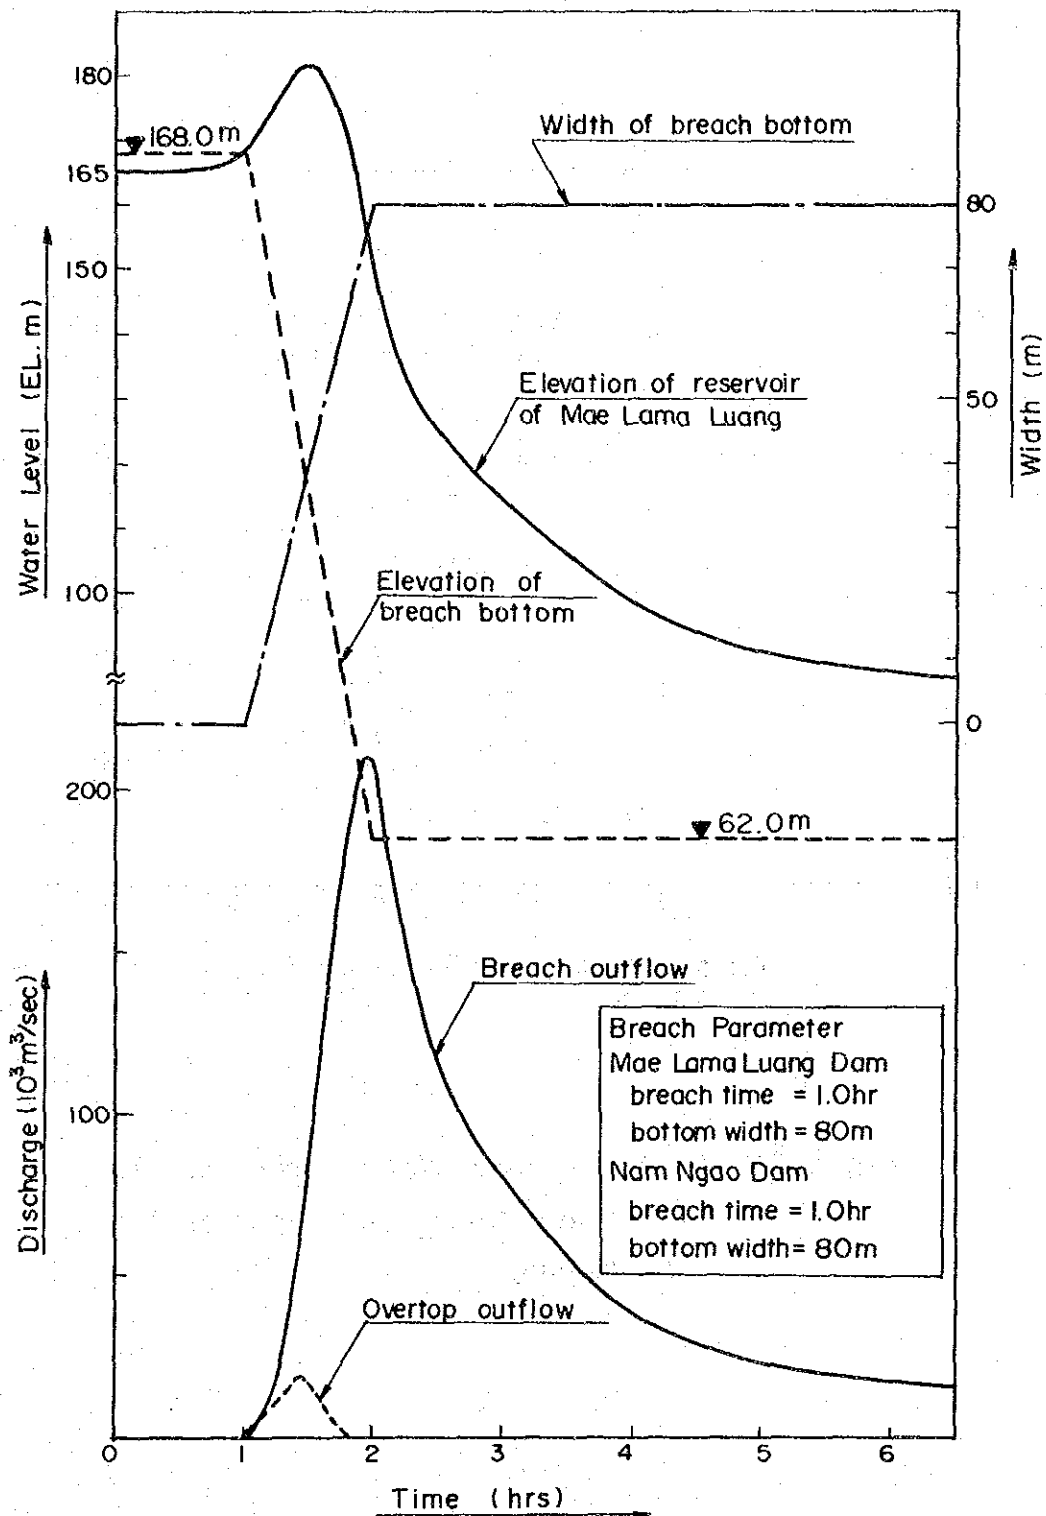
Fig.5-38 Breach Formation and Outflow of Mae Lama Luang Dam due to Nam Ngao Dam Breach in Max. Case

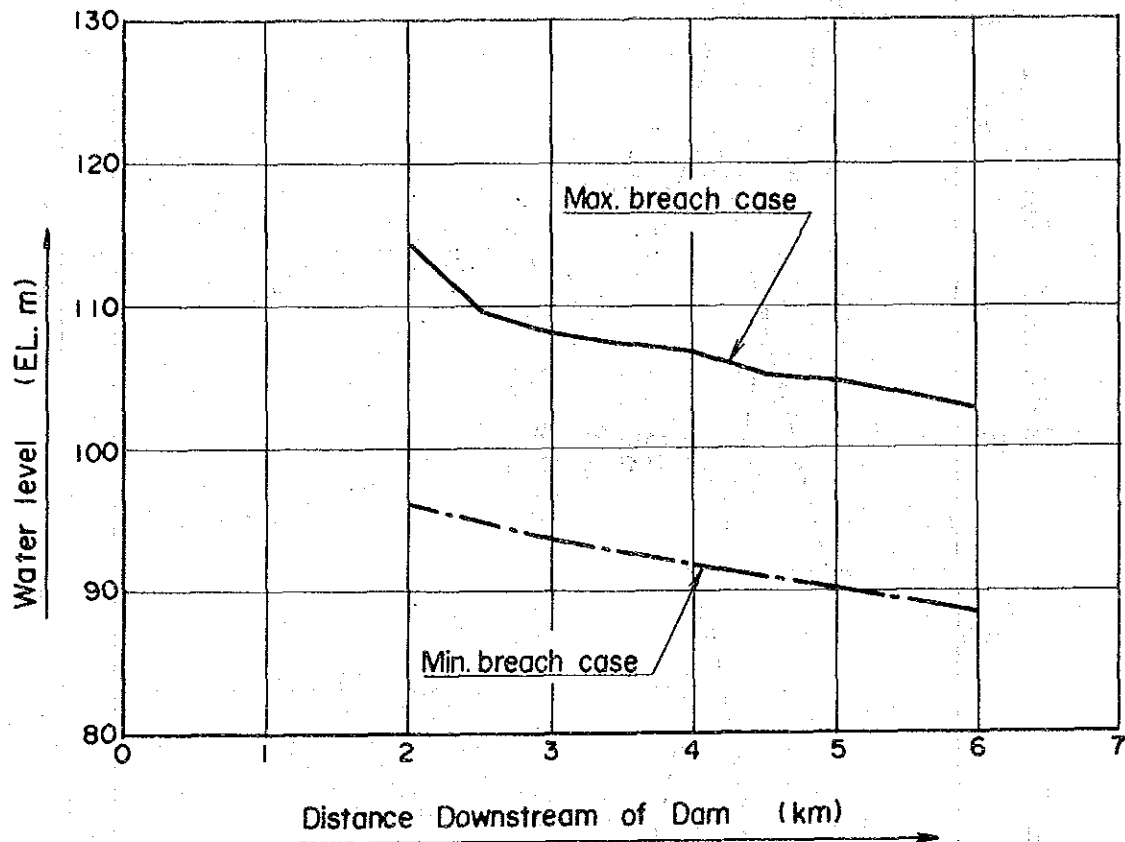
Fig. 5-39 Profile of Max. Water Level Due To Mae Lama Luang Dam Breach By Overtopping

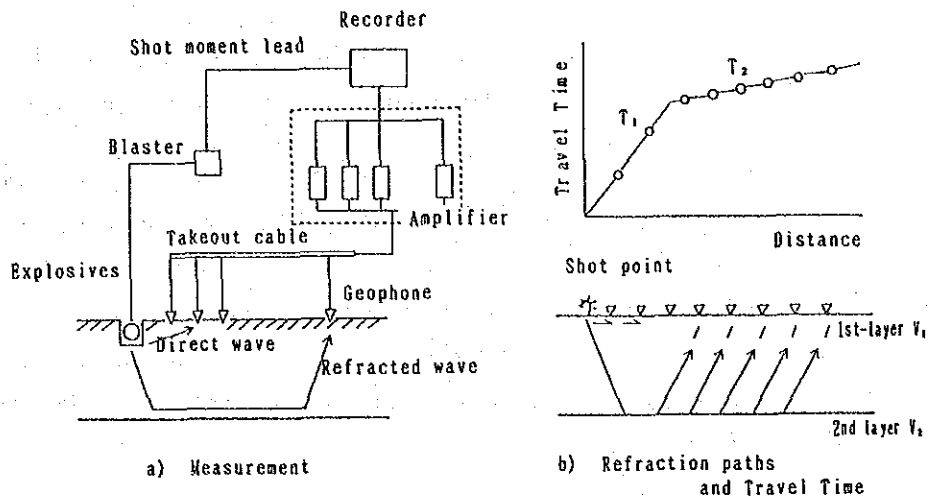
Diagram of Seismic Prospecting Method

A conceptual diagram of the seismic prospecting method is shown below.
