CHAPTER 15

FURTHER INVESTIGATION

CHAPTER 15 FURTHER INVESTIGATIONS

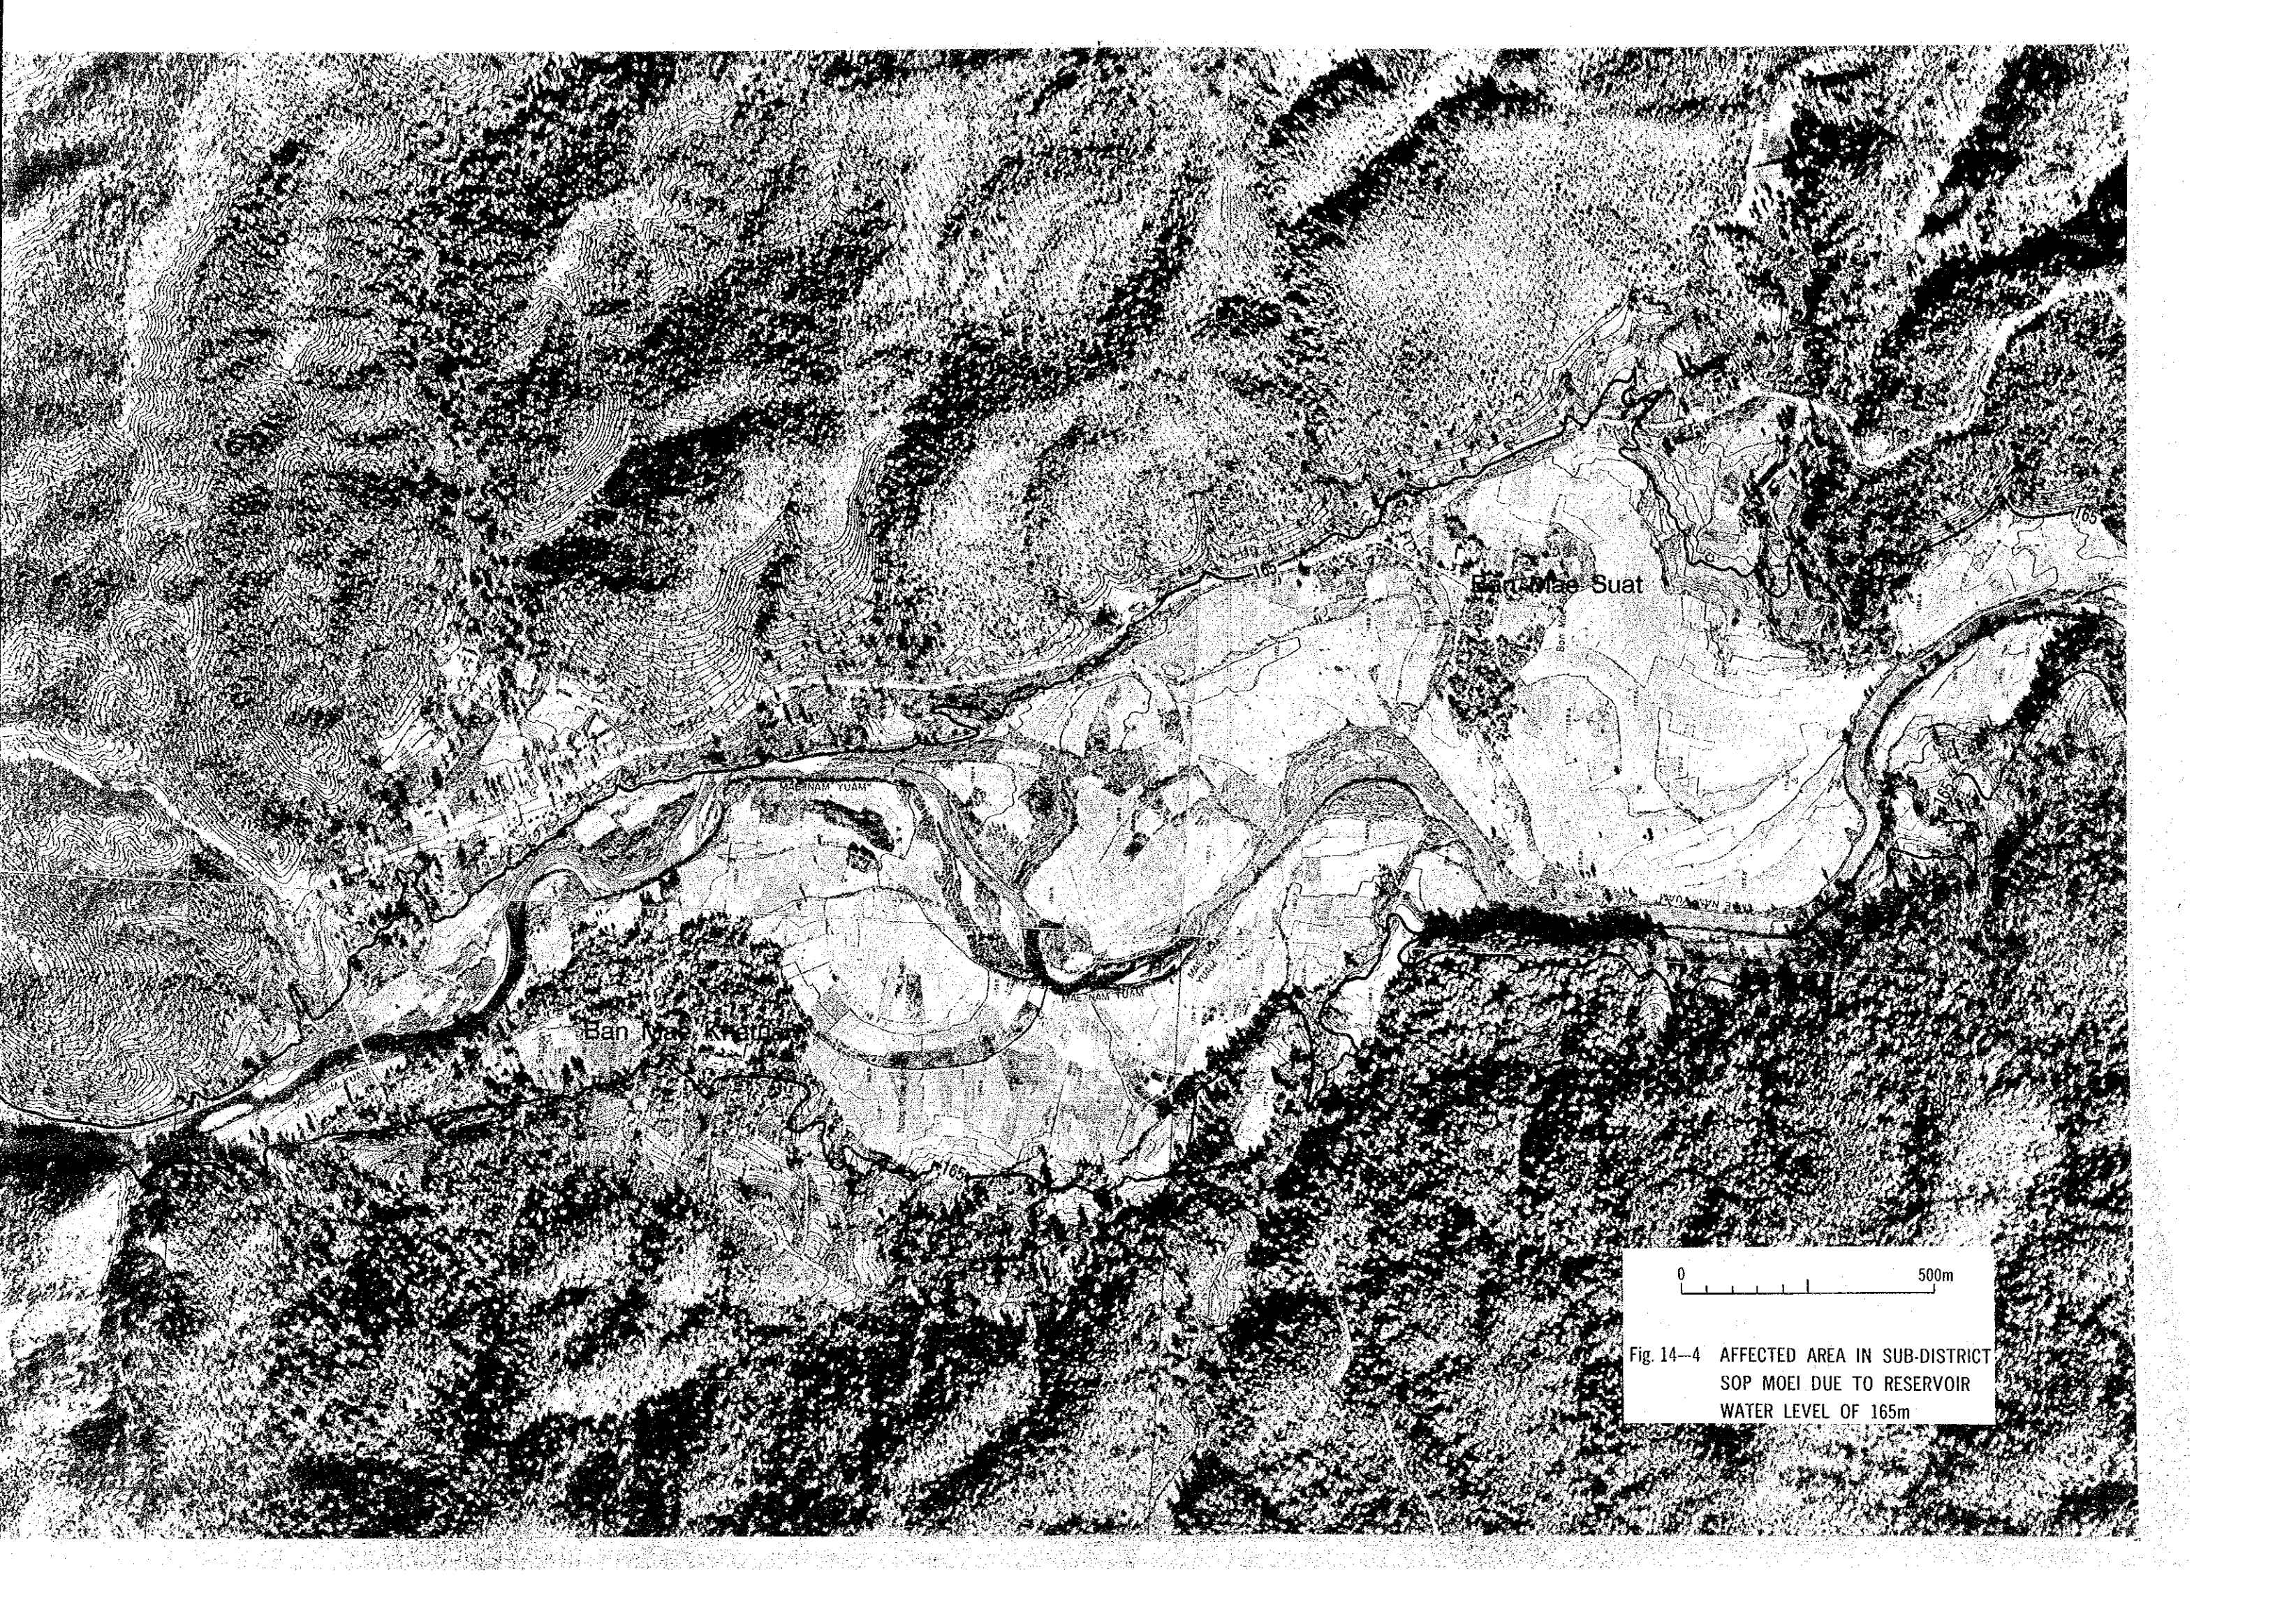
0 500m
Fig. 14-4 AFFECTED AREA IN SUB-DISTRICT
SOP MOEI DUE TO RESERVOIR
WATER LEVEL OF 165m
