第11章 基本設計

現在、水圧管路の破損と発電機器の故障により運転を1983年以降停止しているJulio Bravo水力発電所の修復計画において、技術的ならびに経済的な見地から最も実現性の高い修復の計画概要を示すと次の通りである。

JAPAN INTERNATIONAL COOPERATION AGENCY (JICA)
 INSTITUTO COLOMBIANO DE ENERGIA ELECTRICA (ICEL)
 FEASIBILITY STUDY ON SMALL-SCALE POWER PLANTS
 REHABILITATION PROJECT IN THE REPUBLIC OF COLOMBIA

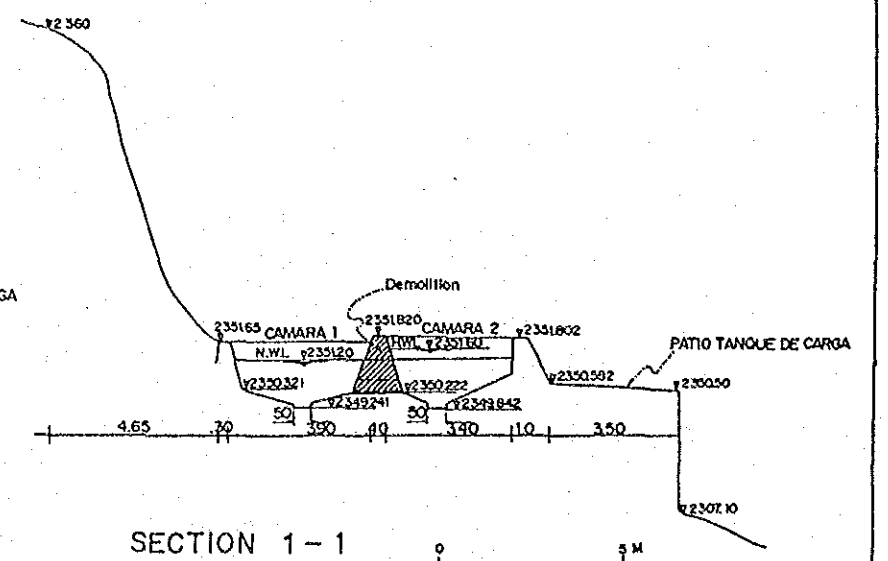
JAPAN INTERNATIONAL COOPERATION AGENCY (JICA)			
INSTITUTO COLOMBIANO DE ENERGIA ELECTRICA (ICEL)			
FEASIBILITY STUDY ON SMALL-SCALE POWER PLANTS			
REHABILITATION PROJECT IN THE REPUBLIC OF COLOMBIA			
HEAD TANK			
PLAN AND SECTIONS			
DRAWING NO.		JB-C-05	
SCALE	DATE

SECTION 3-3

SECTION 2-2

SECTION 1-1

SECTION 6-6

SECTION 7-7

PLAN A (Modification)

PLAN
