## CHAPTER 5: ROADS AND STREETS

### 5-2. Existing Road Network.

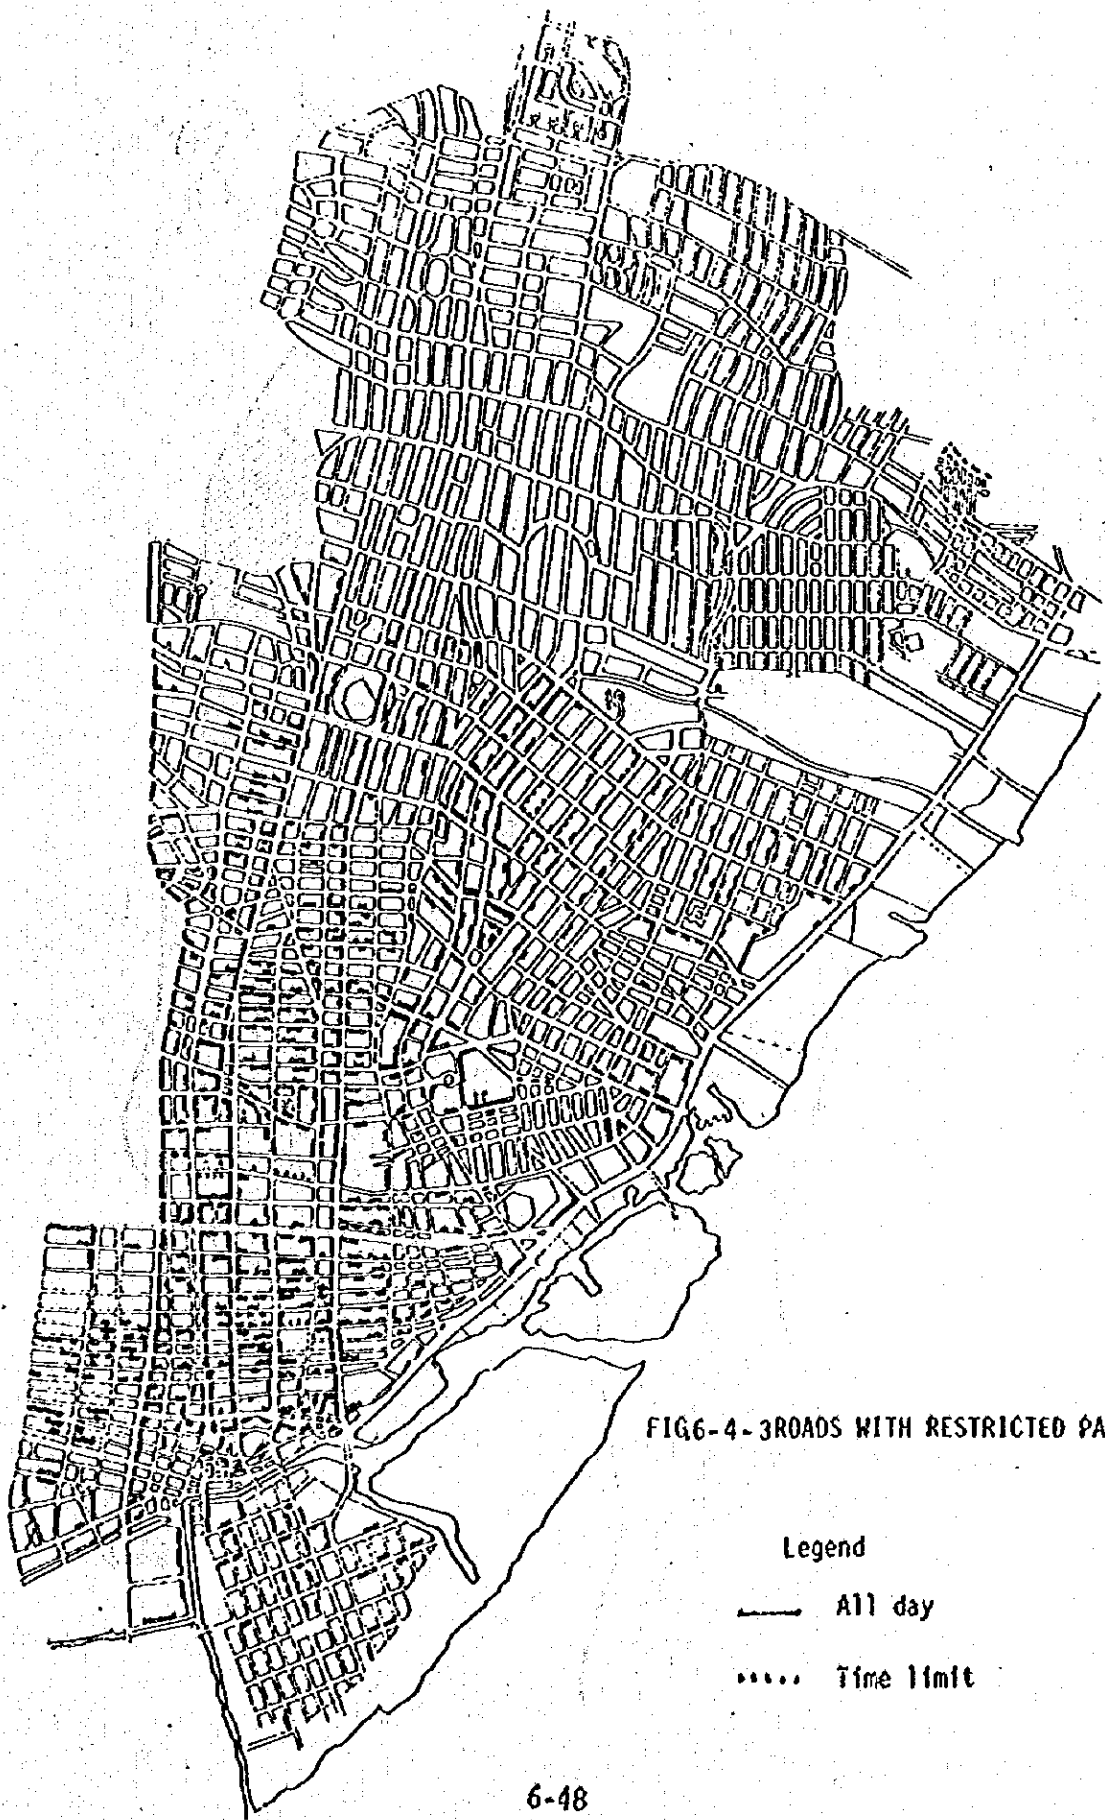
FIG6-4-3ROADS WITH RESTRICTED PARKING

—— All day

..... Time limit

Curb-parking controls in commercial and business areas are shown in Fig. 6-4-3. Curb-parking controls are enforced in the central areas. The curb-parking control rate, street extension (length) of regulatory parking capacity/ street extension (length) of physical parking capacity, is about 64% in P/T Zone No. 1, No. 3, No. 4, while it ranges from 30% to 50% in P/T Zone No. 6, No. 7, No. 8, of the Centro area. The value is relatively high in the Centro area surrounded by Carrera 38 - Calle 45 - Carrera 46 - Calle 30.

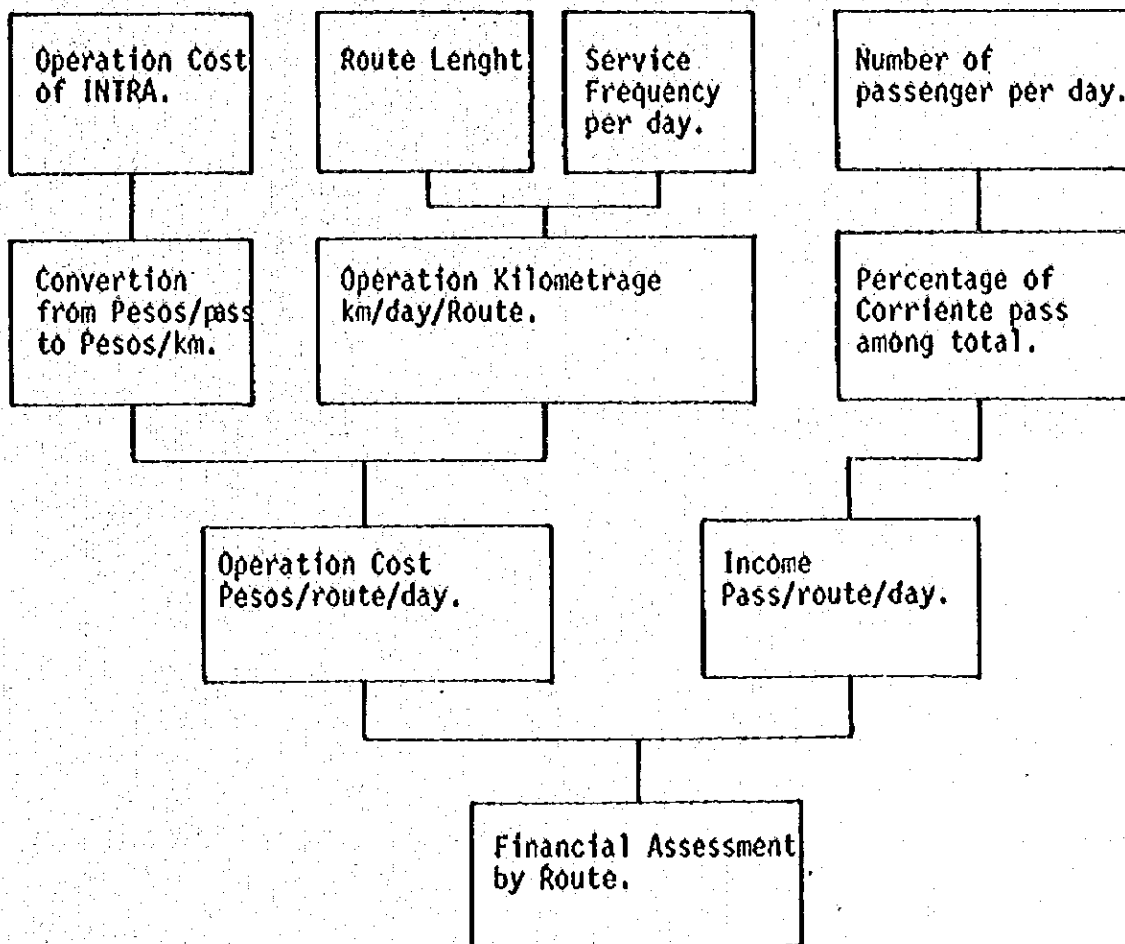
FIG. 7-5-5 FLOW CHART OF ANALYSIS ON FINANCIAL CONDITION BY BUS ROUTES SERVICES.

- (1) The operation cost of busetas is about 62.5% of that of buses. Consequently the routes using busetas only has high cost/benefit ratio.
- (2) The fare of TSS bus is almost double of that of corriente buses.

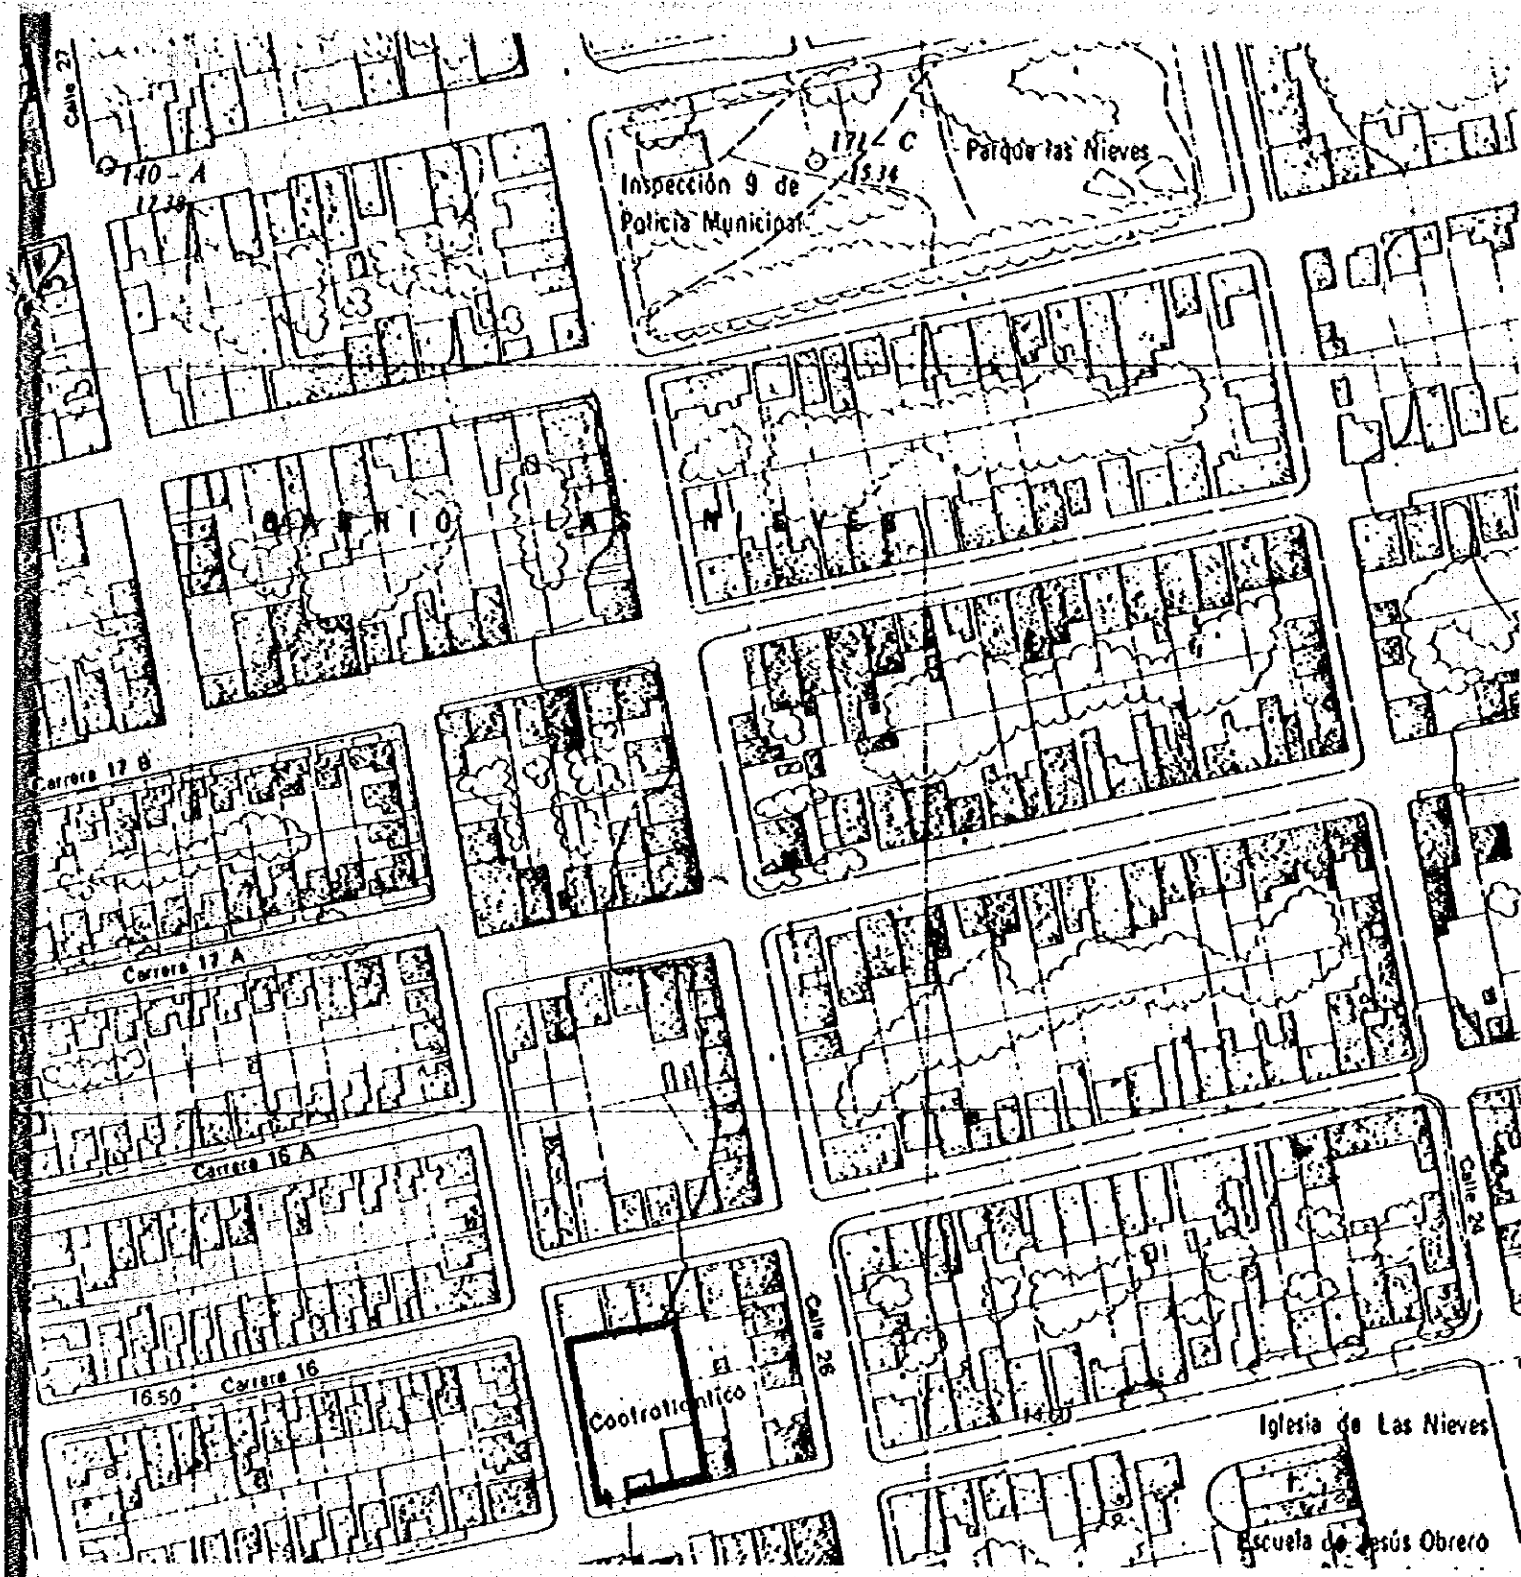
FIG. 7-5-11 TERMINAL OF COOTRATLANTICO

AREA: 3 000m<sup>2</sup>      AREA: \* 1.350m<sup>2</sup>

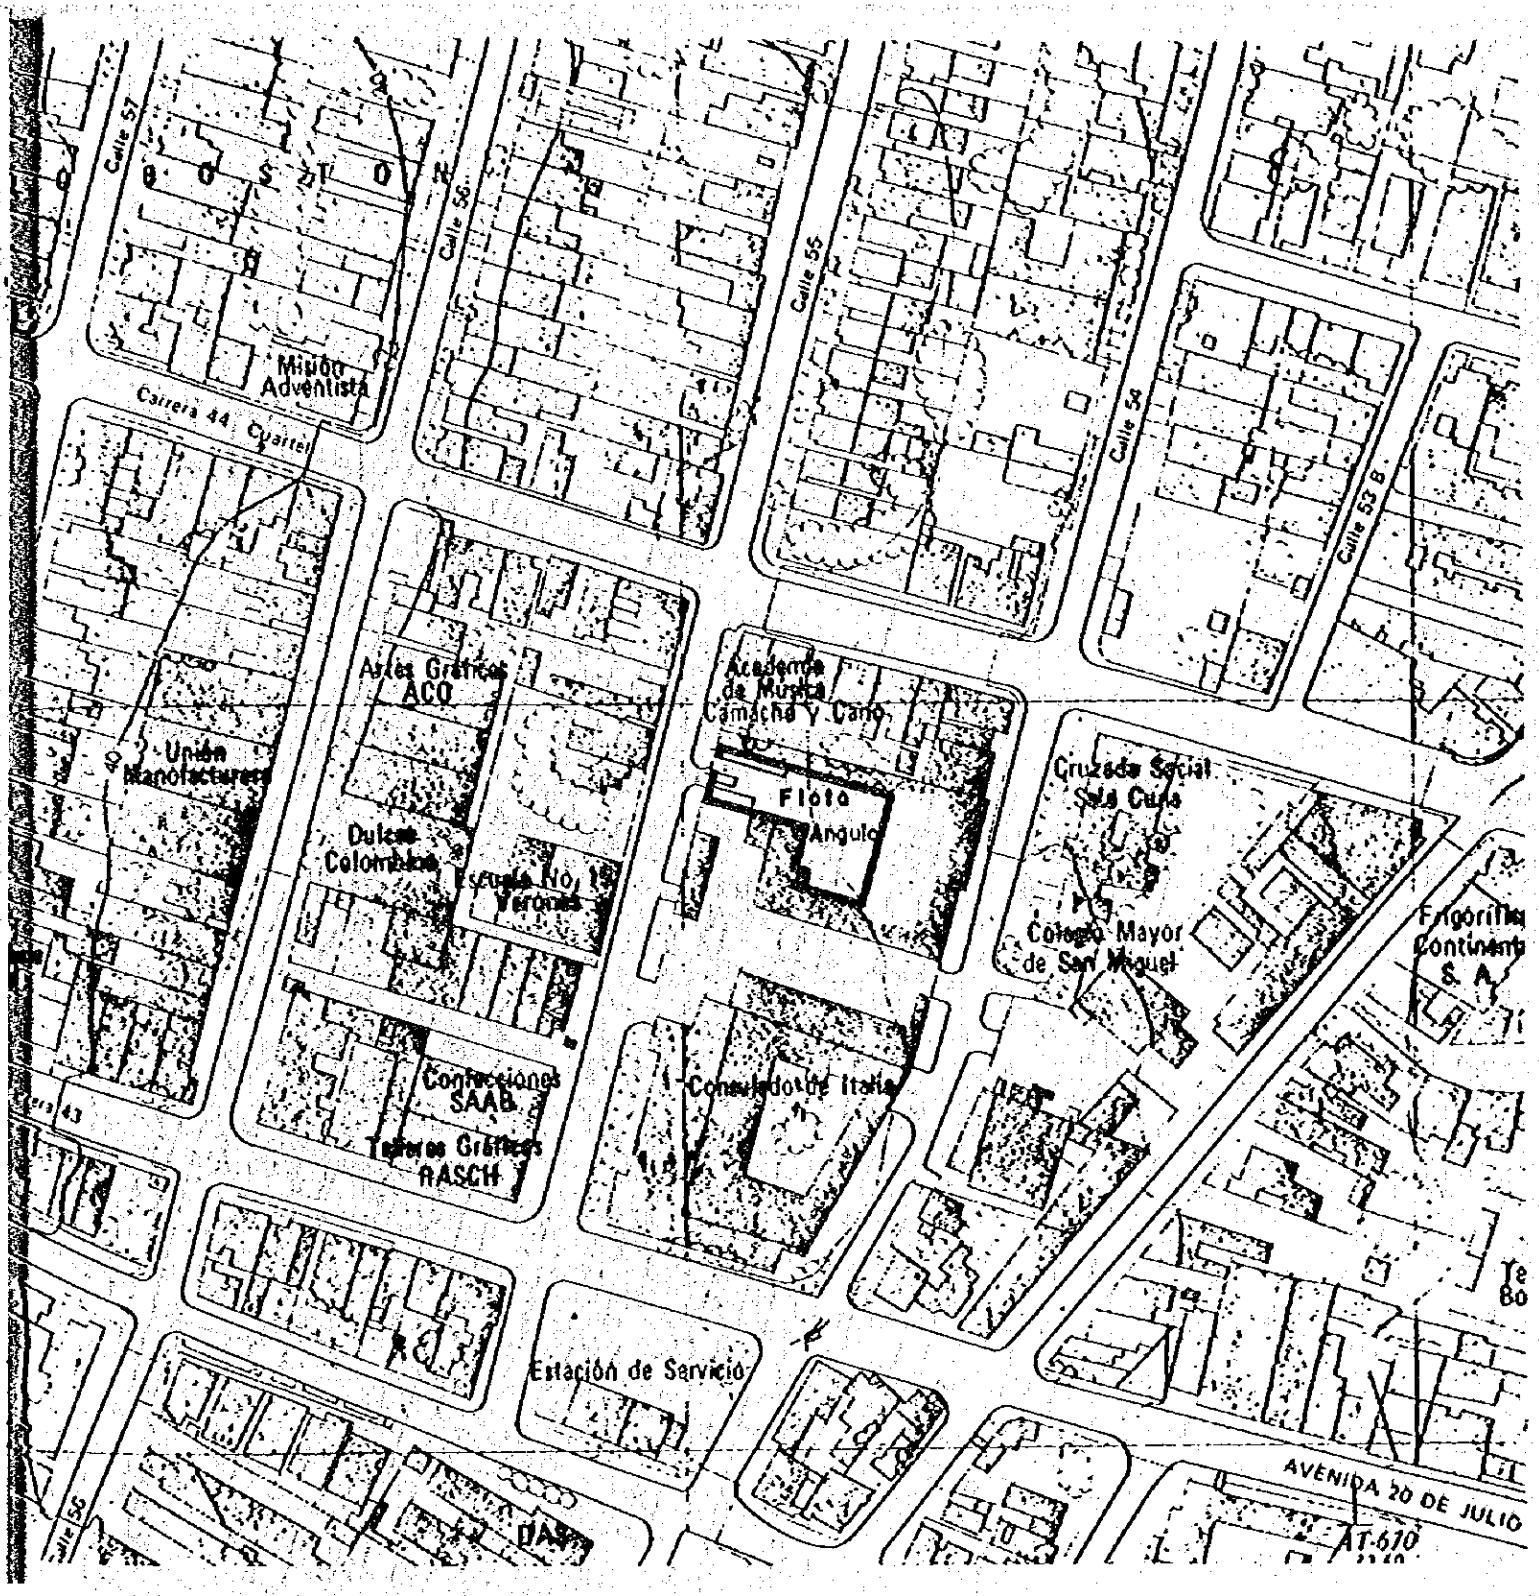
FIG. 7-5-19 TERMINAL OF FLOTA ANGULO LTDA

AREA: 330 m<sup>2</sup>      AREA: \*1600

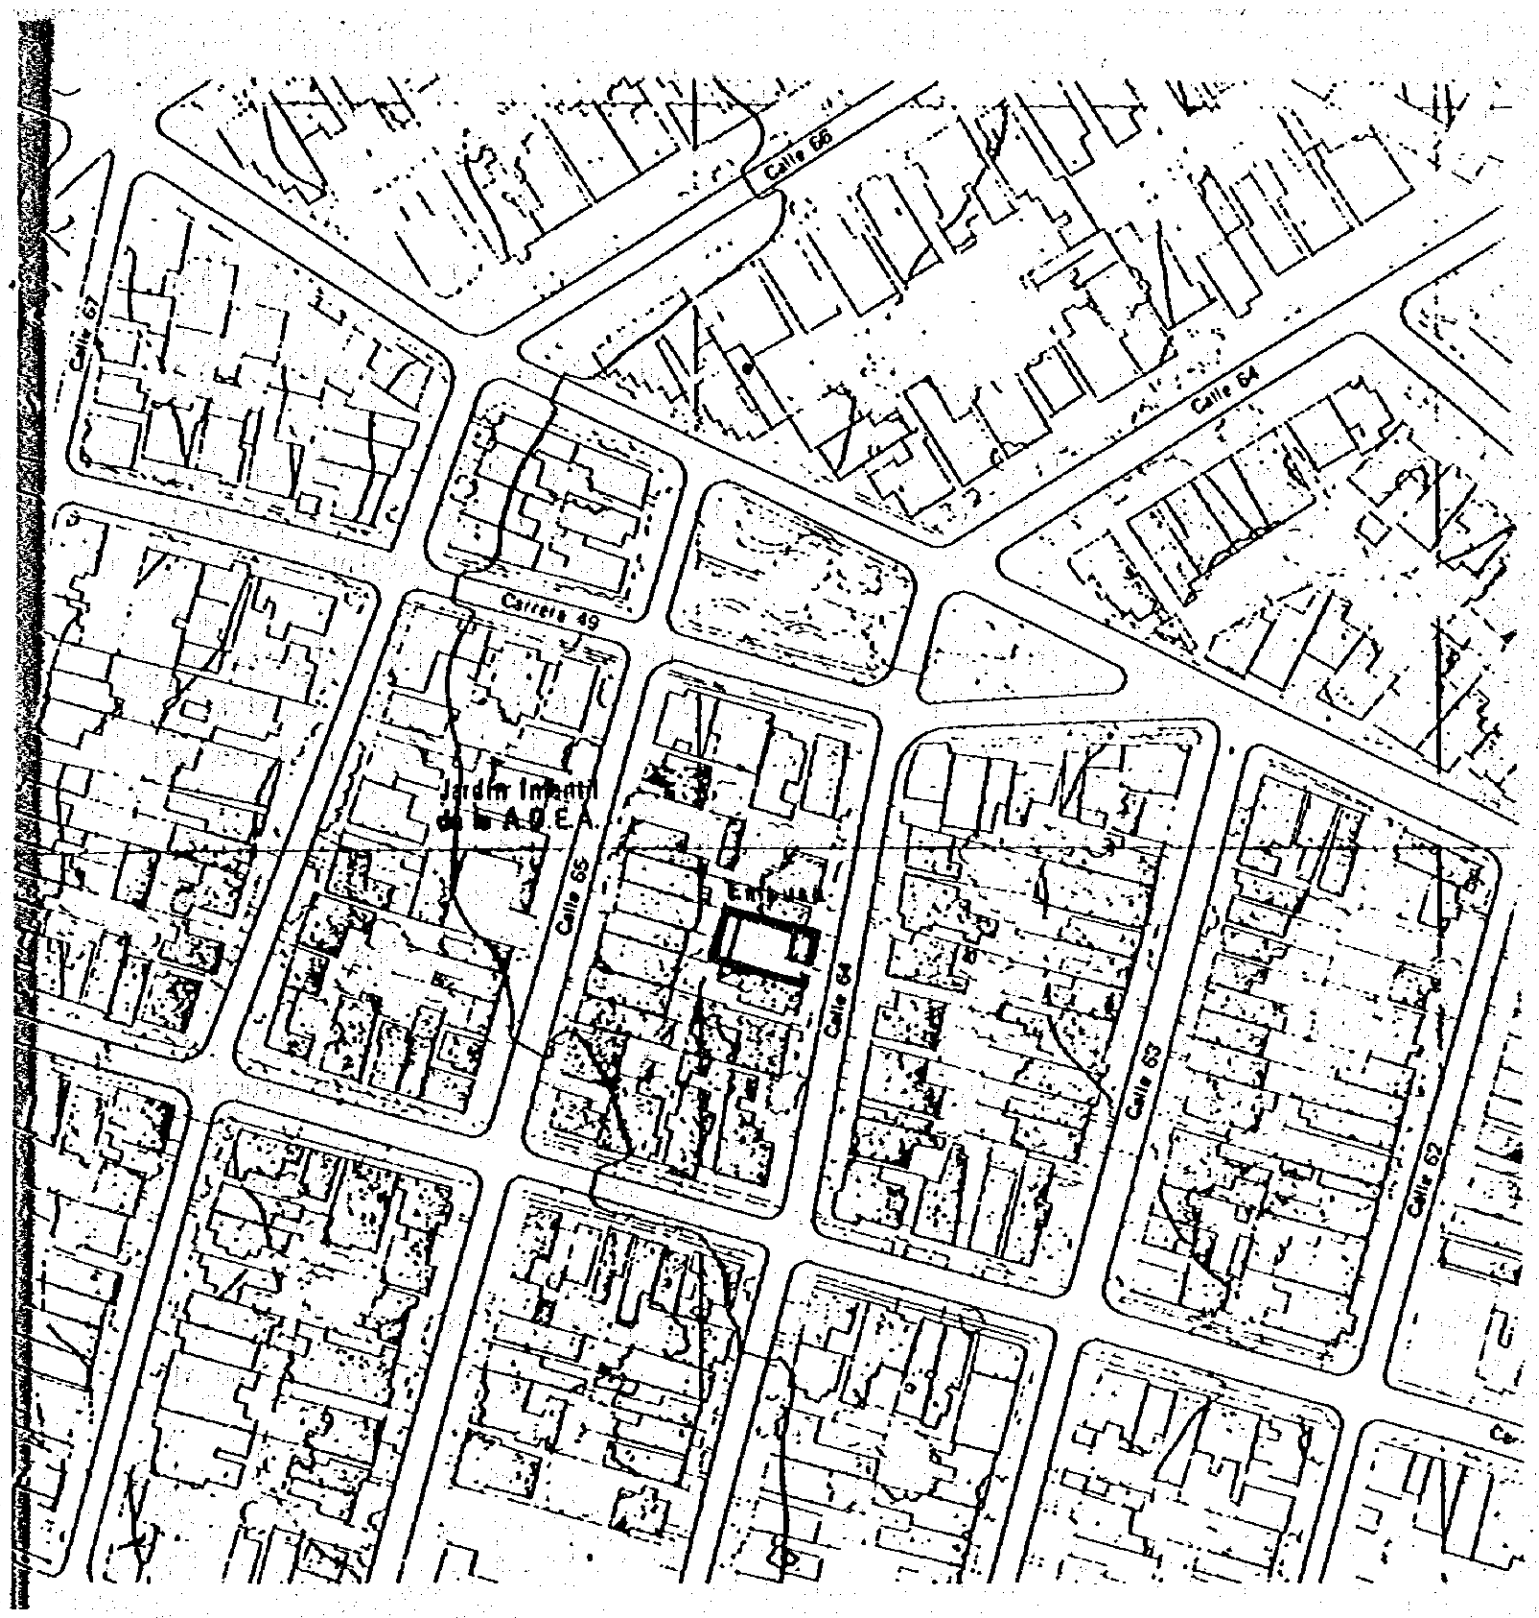
FIG. 7-5-20 TERMINAL OF EMBUSA LTDA.

AREA : 516 m<sup>2</sup>
