**APPENDIX 24**

**SOIL INVESTIGATION**

This report is a digest of the Soil Investigation Report.

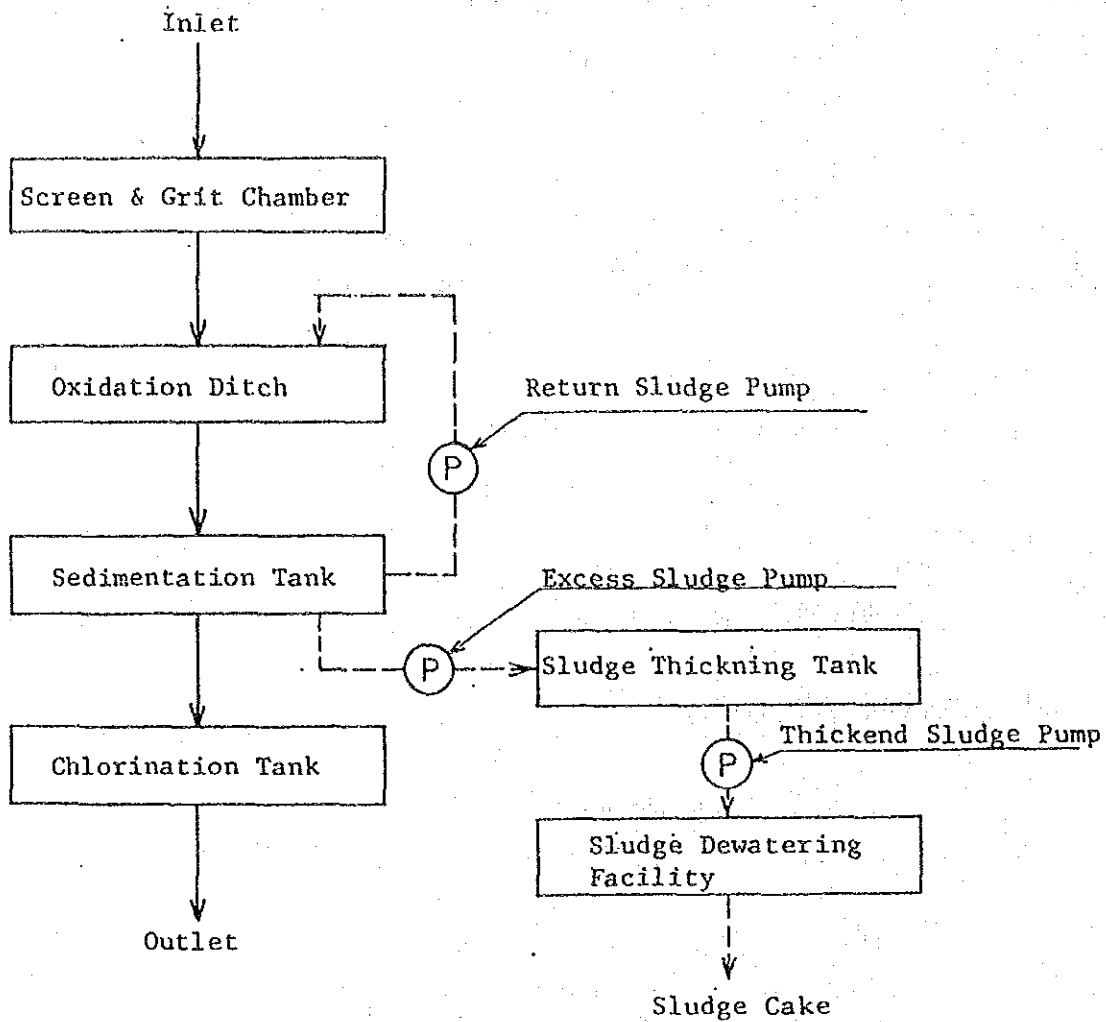
FIGURE A26-1 Flow Diagram of Oxidation Ditch System

Treatment method in this site must be able to cope with the sewage flow of  $2.5 \text{ m}^3/\text{s}$  within a limited plant area. In the three treatment methods selected in APPENDIX 19, only Oxidation Ditch System meets this condition, but mechanical dewatering facility will have to be employed because of the constraint in land area.
