THE STUDY ON FLOOD CONTROL AND DRAINAGE PROJECT
IN METRO MANILA, PHILIPPINES

JAPAN INTERNATIONAL COOPERATION AGENCY

PROBABLE DISCHARGE DISTRIBUTION
IN 2020 (SAN JUAN AND
PASIG-MARIKINA)

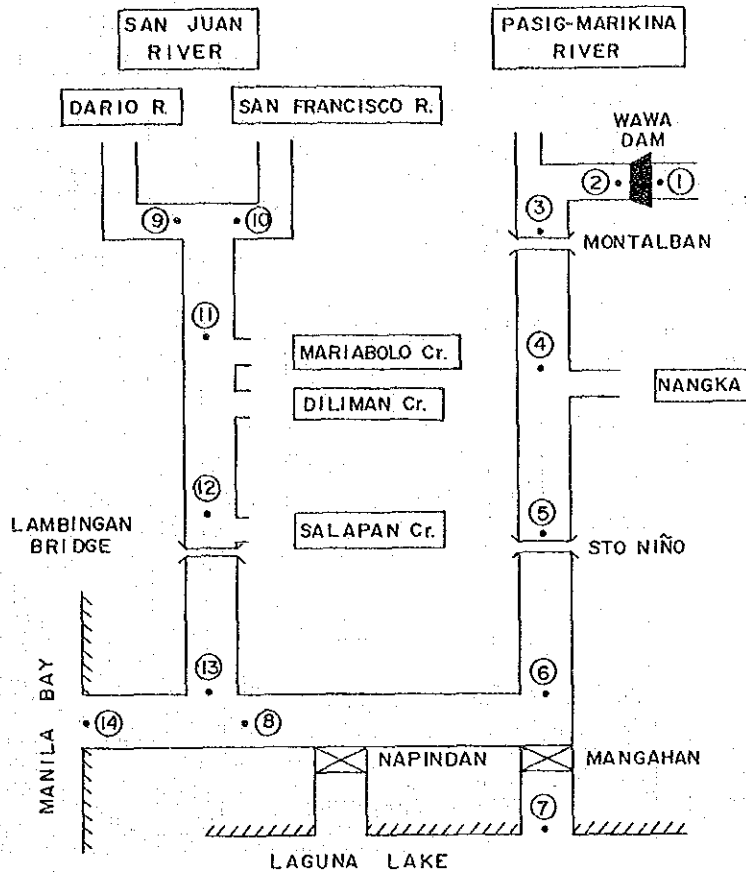
Fig. 2-6-11 (1/6)

UNIT: m³/s

W/O MARIKINA DAM & W/O MCGS
