The on-going Apia Port Development Project commenced in March, 1989 under a Japanese grant aid assistance and consists of the following major components.

2.3.4 Road Improvement Plan

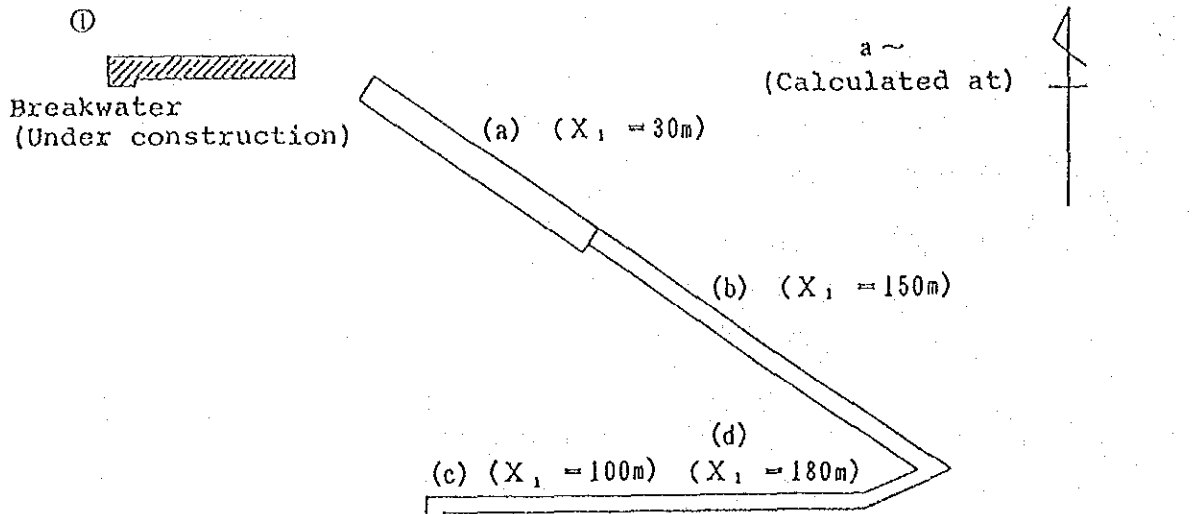
Fig. 4-1 Wave Height/Raise of Water Level Calculated

Fig. 4-1 illustrates the results of calculation. The design wave for the breakwater and seawall is superposition of waves propagating through shallow reef area from North and Northwest and the design wave height in front of these facilities is about 20% higher for the waves generated by the cyclone "Ofa" than those of the present design wave. While,

$H1/3$: Design Wave
 η : Raise of Water Level
 X_1 : Distance from West Reef Edge
 X_2 : Distance from North Reef Edge

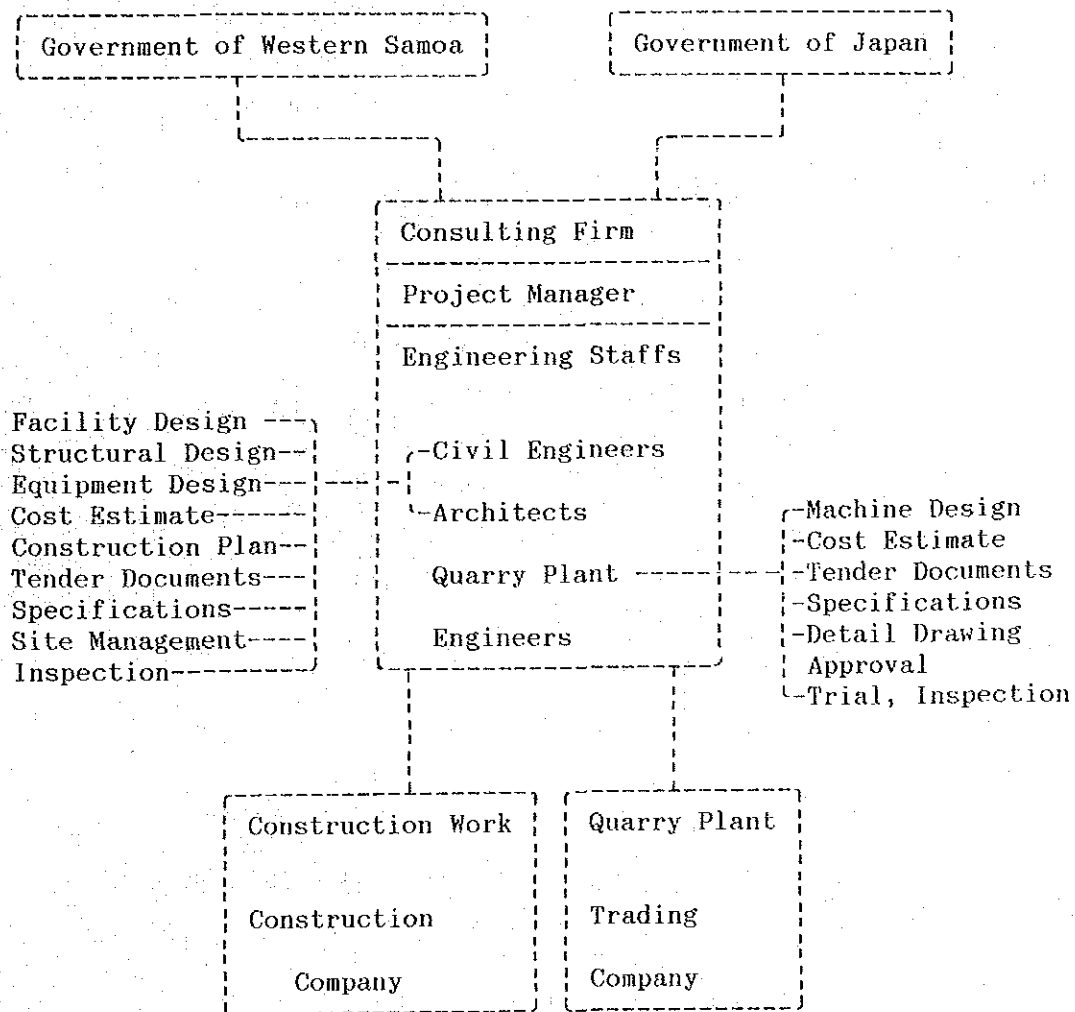
Fig. 4-20 Organization Chart of Project Implementation

MOT and PWD are the executing organizations of the Project in Western Samoa for the port facilities and the quarry plant respectively. For the execution of this project, close cooperation and arrangement between Japanese project group and MOT as well as PWD are required. A special attention should be paid the pavement project of the existing container yard financed by ADB to be carried out during the period of the grant aid project. Fig. 4-20 shows organization of construction management.
