COUNTRY: KENYA JOB No. MALEWA DAM POINT No. JWBM 17

ANNEX B

GEOLOGICAL INVESTIGATION

This report presents findings of geological investigation and their foundation engineering interpretation for the dam scheme in the Malewa river system, that is a part of the Greater Nakuru Water Supply Project.

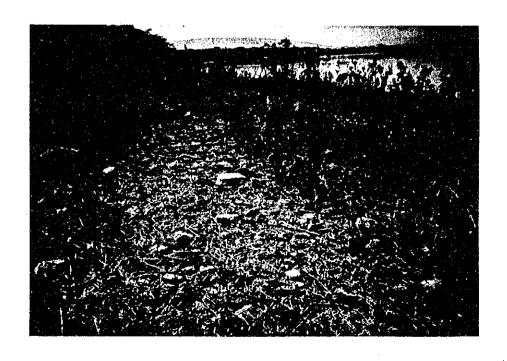
TYPE: BENCH MARK	DESCRIPTION: 50cm CONCRETE	PHOTO NO.
MAP SHEET No. 119/3	DATE: JUNE, 1990	SURVEYOR: Y. KOKUFU
NORTHING: 9 959 827.89	EASTING: 172 300.38	HEIGHT: 1 759.57

LOCATION DIAGRAM

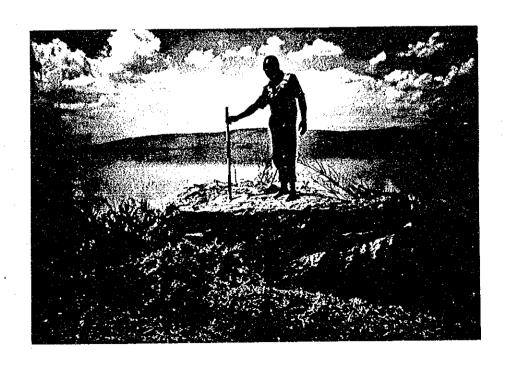
TYPE: BENCH MARK	DESCRIPTION:	ROCK	РНОТО NO.
MAP SHEET No. 119/3	DATE:	JUNE, 1990	SURVEYOR: Y. KOKUFU
NORTHING: 9 959 331.32	EASTING:	172 297.82	HEIGHT: 1 761.79

LOCATION DIAGRAM

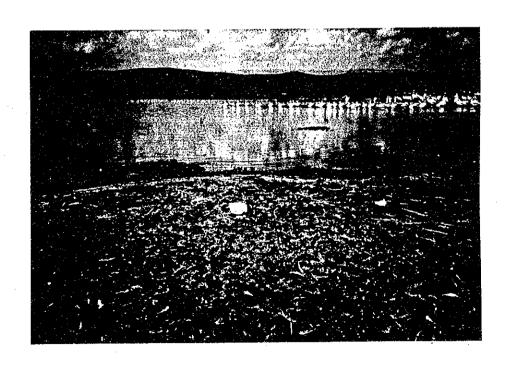
COUNTRY: KENYA	JOB No. MALEWA DAM	POINT No. JWBM 27
TYPE: BENCH MARK	DESCRIPTION: 50cm CONCRETE	РНОТО NO.
MAP SHEET No. 119/3	DATE: JUNE, 1990	SURVEYOR: Y. KOKUFU
NORTHING: 9 958 571.78	EASTING: 172 603.97	HEIGHT: 1 758.92

LOCATION DIAGRAM

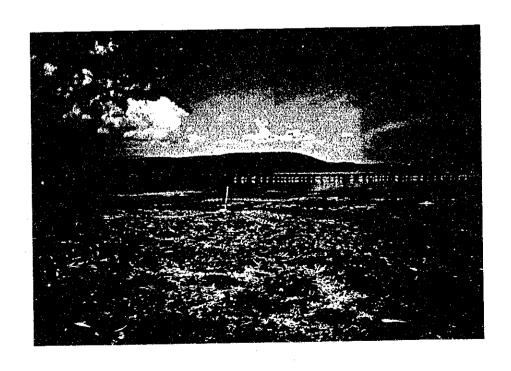
COUNTRY: KENYA	JOB No. MALEWA DAM	POINT No. JWBM 33
TYPE: BENCH MARK	DESCRIPTION: 50cm CONCRETE	РНОТО NO.
MAP SHEET No. 119/3	DATE: JUNE, 1990	SURVEYOR: Y. KOKUFU
NORTHING: 9 956 957.38	EASTING: 174 043.80	HEIGHT: 1 758.98

LOCATION DIAGRAM
