7.3.2 Geologies of Upper Kihansi and Lower Kihansi Project Area

KIHANSI HYDROELECTRIC POWER DEVELOPMENT PROJECT	
GEOLOGICAL PLAN OF UPPER DAM SITE	
Fig. 7 - 7	DATE

**GEOLOGICAL PLAN
OF
LOWER DAM SITE**

**GEOLOGICAL PLAN AND PROFILE
OF LOWER HEADRACE AND
PENSTOCK TUNNEL ROUTE**

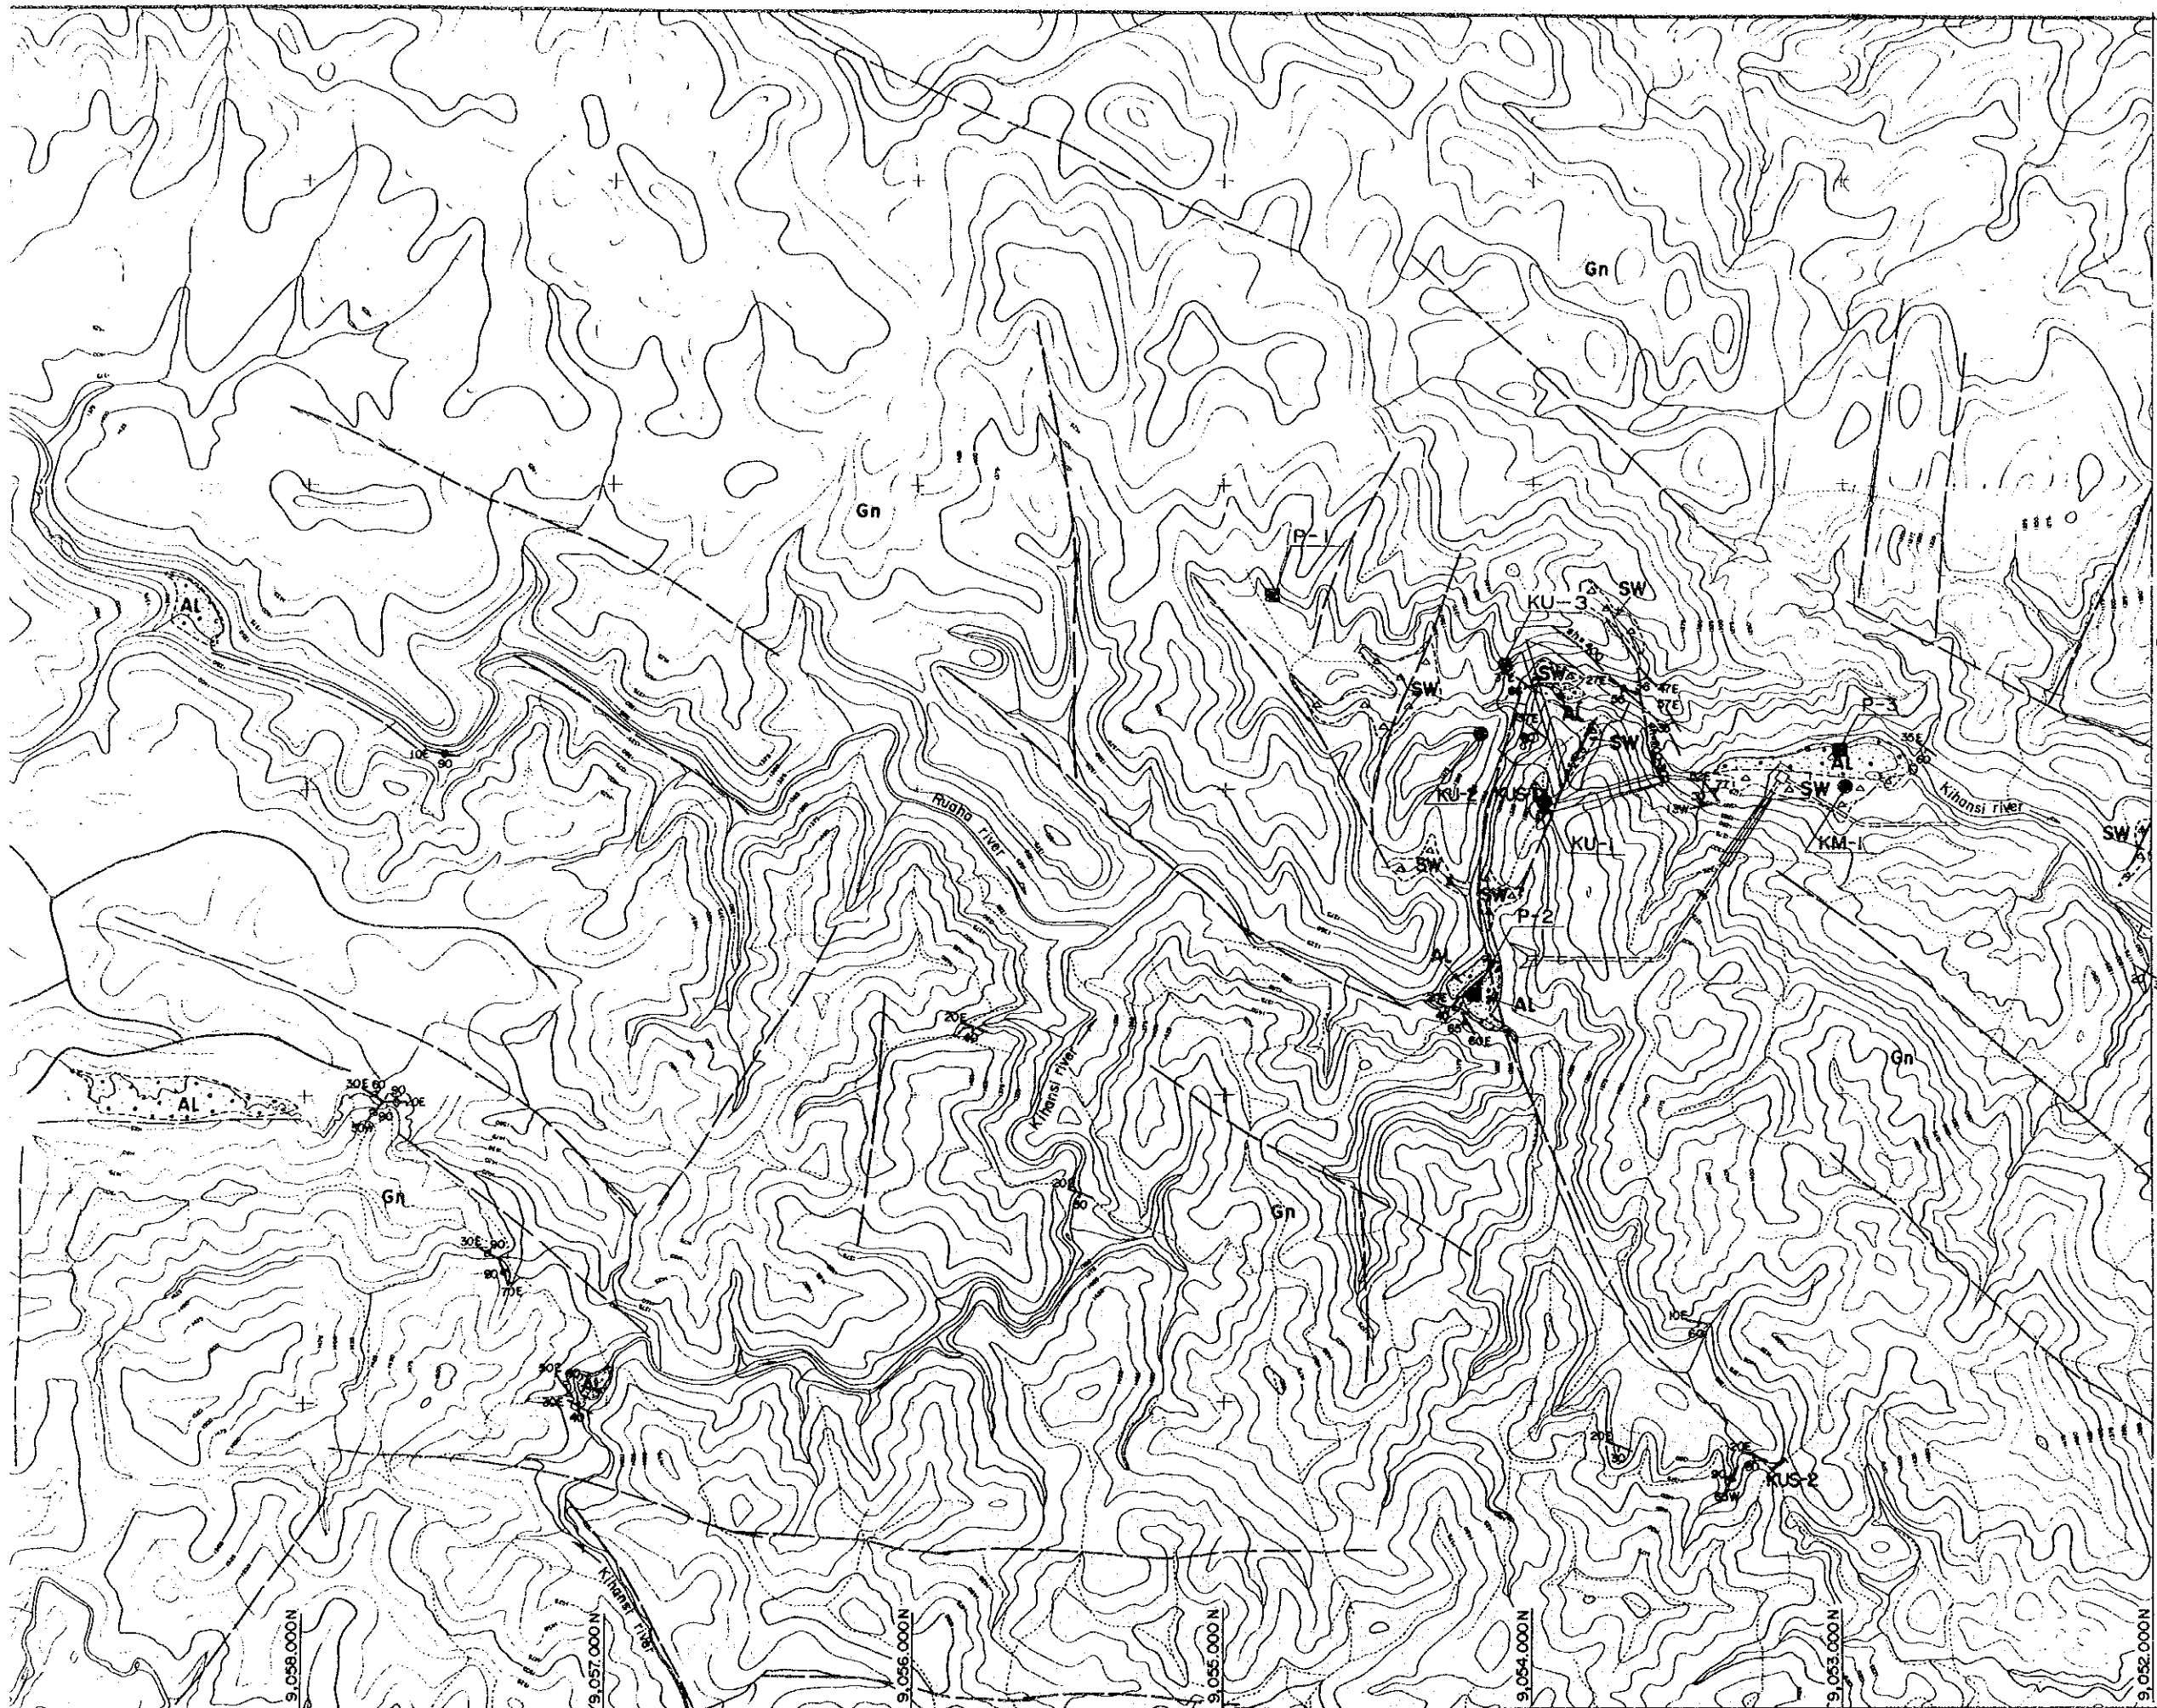
Fig. 7-4 DATE:

(UPPER KIHANSI PROJECT AREA)

The Upper Kihansi and Lower Kihansi project sites, as shown in Figs. 7-4 and 7-5, are composed of gneisses, and slope wash and alluvium which cover these gneisses at parts.

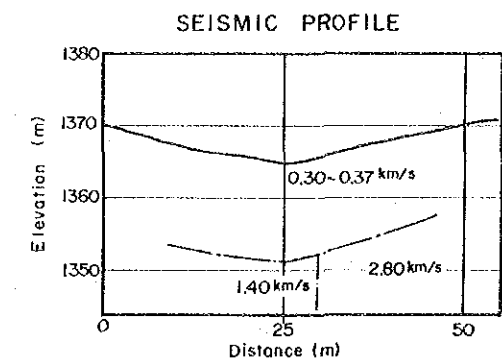
Fig. 7-6 DATE:

LOCATION MAP OF SEISMIC PROSPECTING

A - A
(KUS - 1)

B - B
(KUS - 2)

RESULT OF SEISMIC PROSPECTING
(UPPER KIHANSI RESERVOIR AREA)

The point approximately 2.5 km west-southwest of the dam site, as shown in Fig. 7-6, comprises a thin saddle. The results of seismic prospecting performed there with the purpose of investigating the geological properties are also shown in Fig. 7-6.
