3. GEOLOGICAL INVESTIGATION

3.1 General

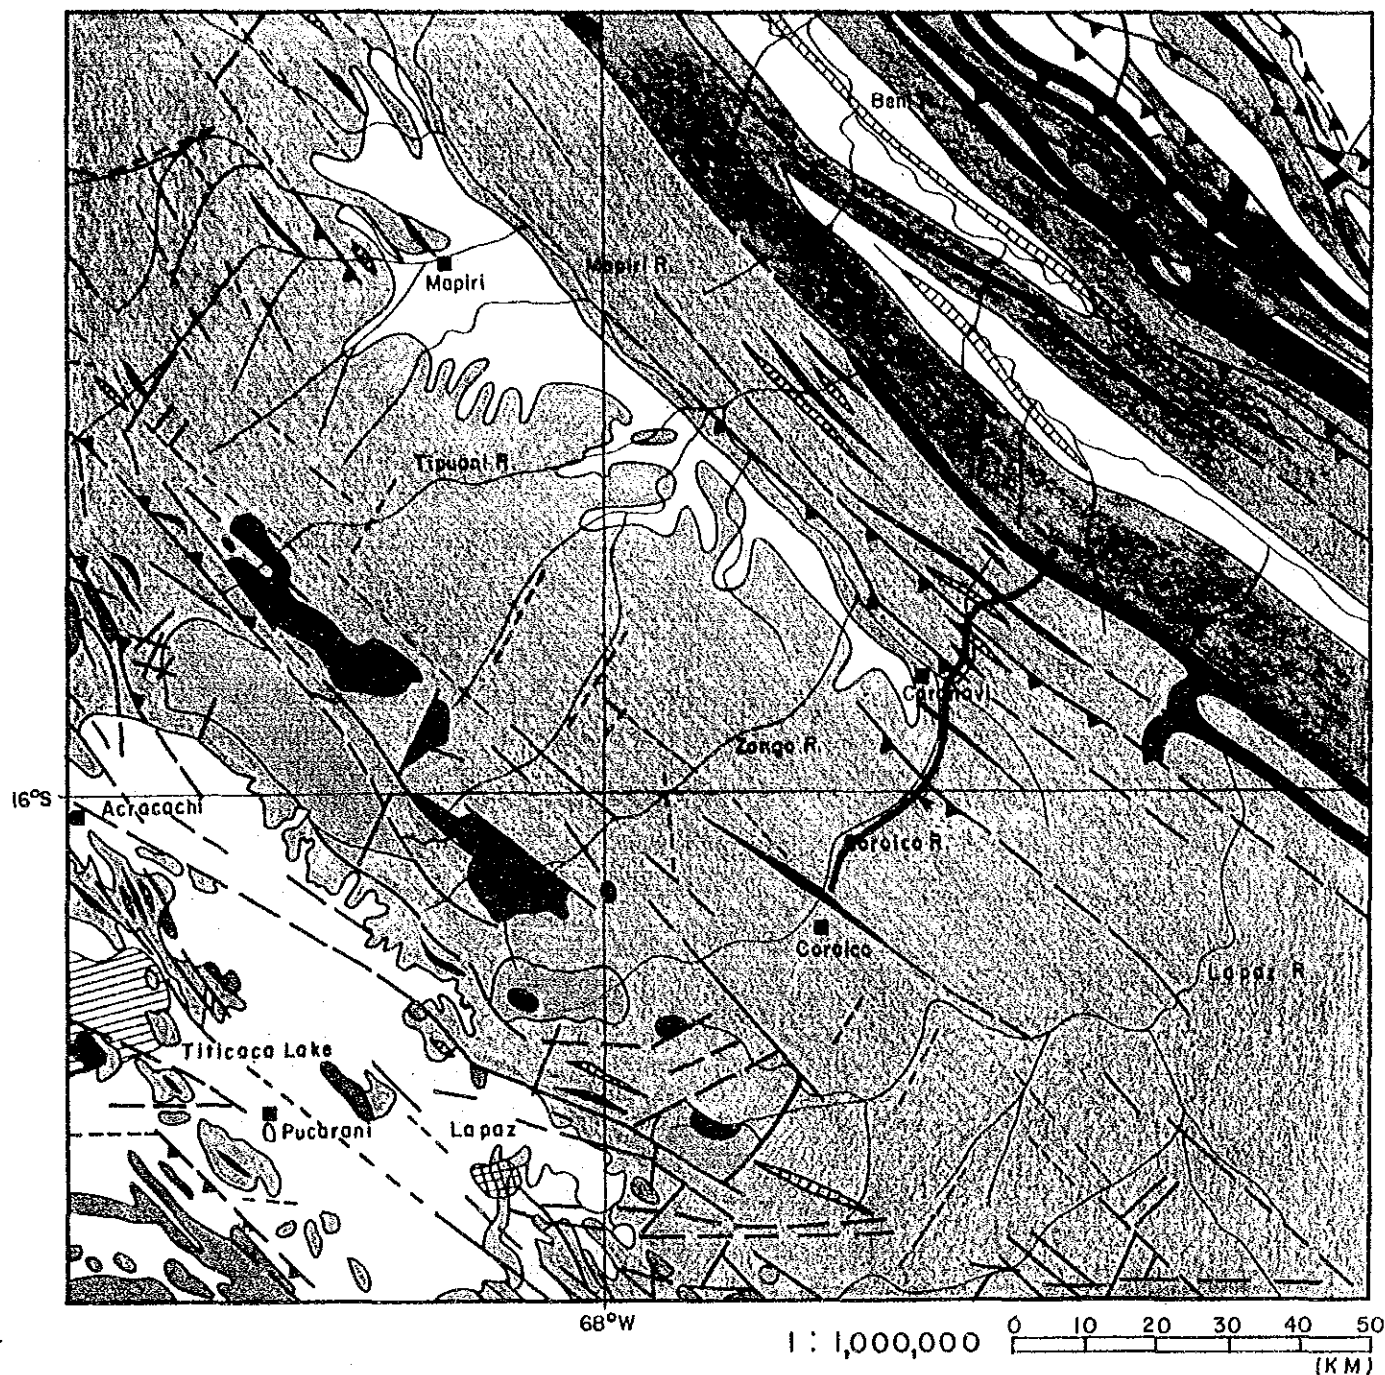
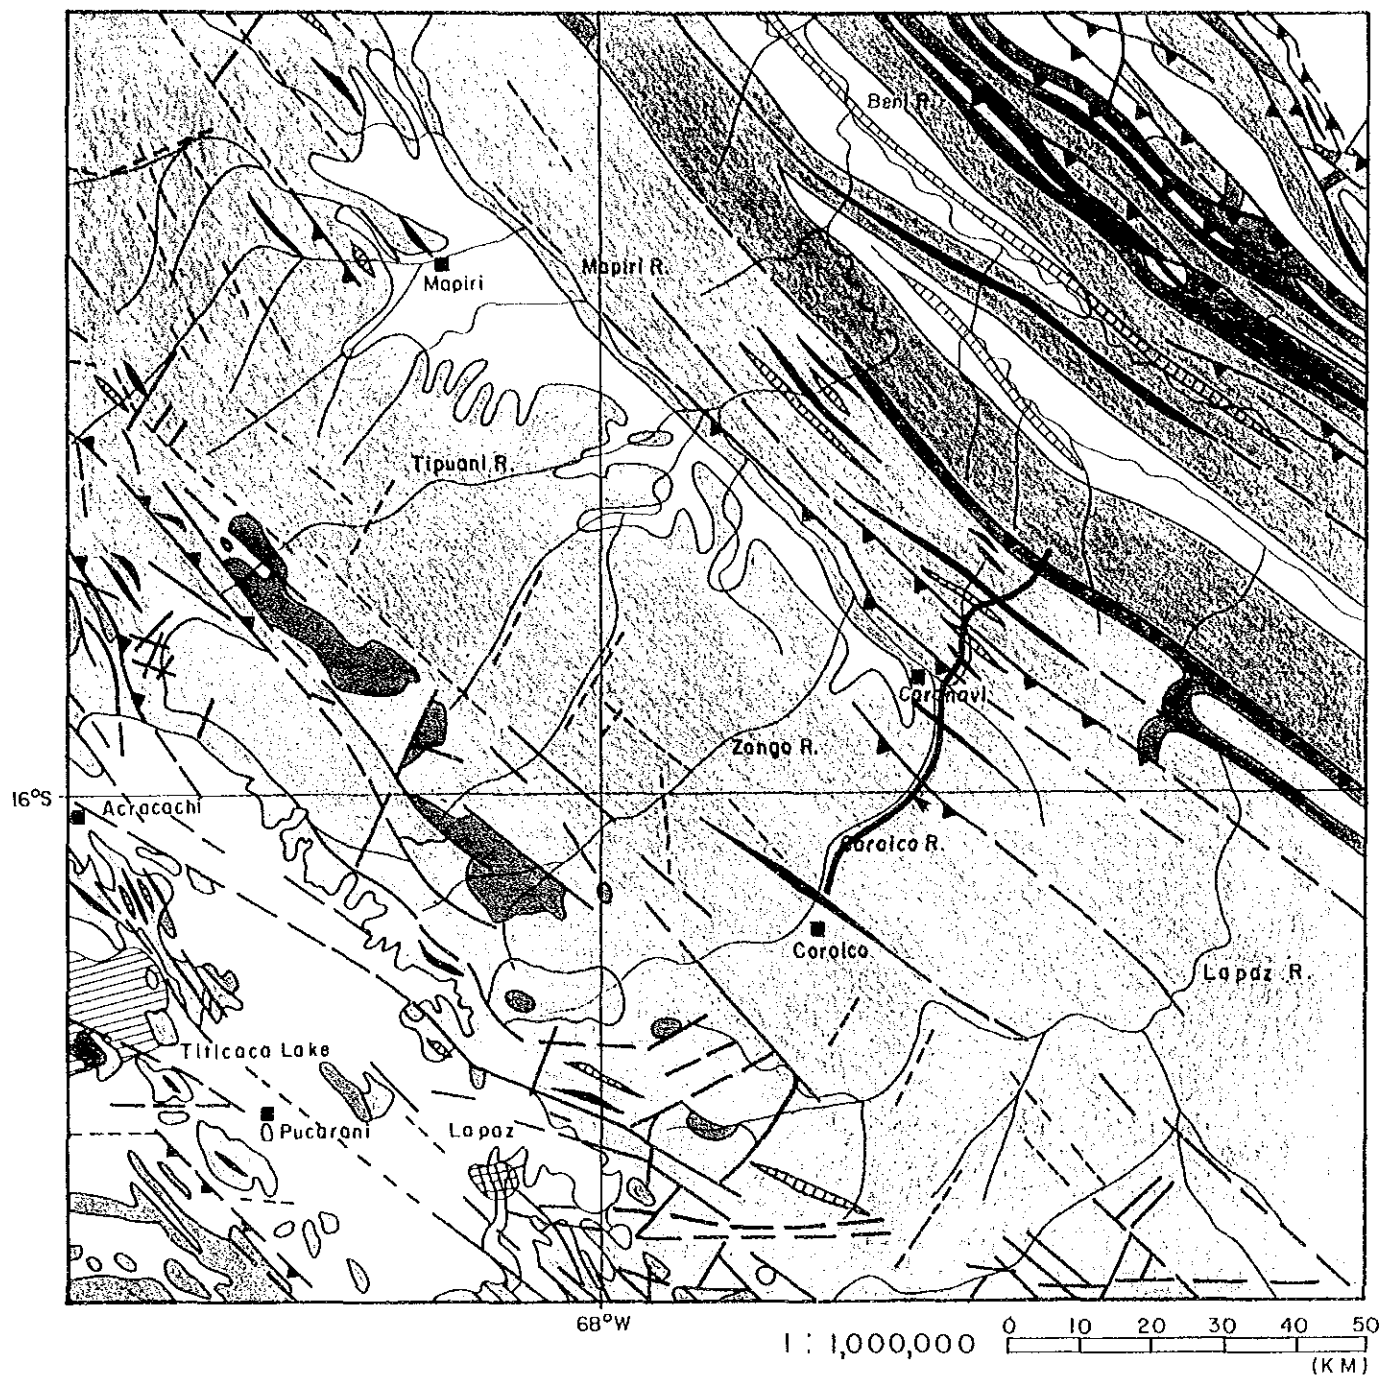
Fig.3. 1-2 Geological Map of the Northern Bolivia

Northern Bolivia is divided into six geological provinces stretching in belts from the north west to the south east. These provinces are titled;

- a) West Andes
- b) High Plateau (Altiplano)
- c) East Andes
- d) Sub-Andes Zone
- e) Amazonian Lowland
- f) Brazilian Shield

The West Andes are basically made up of Palaeozoic sedimentary rock with the north east slope covered with Tertiary and Quaternary volcanic rock.

A geomorphological map is shown in Fig. 3.1-1 and a geological map of northern Bolivia is shown in Fig. 3.1-2.

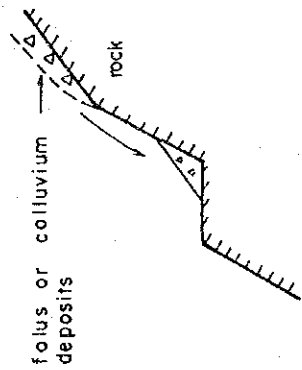
<p>a-1 Surface failure of soil</p>

The Slope failure (Type a) is divided into surface failure of soil and slope failure of rock. The Embankment failure (Type b) is divided into four types, each by the cause of failure, i.e.; lateral erosion by streams, displacement of embankment by rock material, displacement of filled soil and erosion by water from the road drainage. Rock falls are sub-divided into three categories; water erosion of soil material between boulders, control of open cracks and differential erosion speed among strata on slopes.

Along the investigation road, various slope failures were encountered. Those failures have been classified into several types for the geological investigation executed in the Study. The classification was identified in Fig. 2.3-1 in Section "2.3.2 Result of Site Reconnaissance". However, it has been sub-classified into more detail from a geological viewpoint as shown in Fig. 3.3-1.

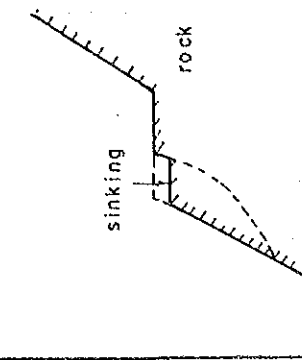
<p>b-2 Sinking terreplein of rock</p>
b : Terreplein failure		c : Rock fall

Although this failure type has been sub-divided into four categories, from Type B-1 to B-4, in Fig. 3.3-1, most of failures for this group in the study area belong to Type B-2 or B-3, which are failures due to displacement of the embankment itself. The difference of Type B-2 and B-3 is from fill material; i.e., Type B-2 is for the case that the fill material is soil, and Type B-3 is for the case of rock. In almost all of these cases, a slide of fill material is the surface of the natural slope beneath the embankment. In other words, failures occurred because the embankment was constructed directly on a steep natural slope without any preparation work such as bench-cutting.

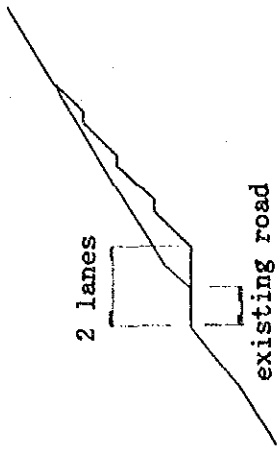
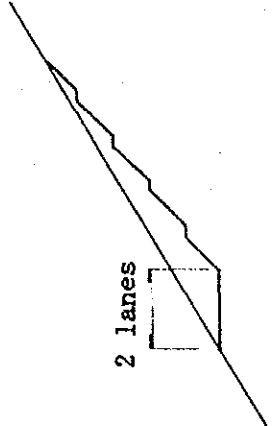
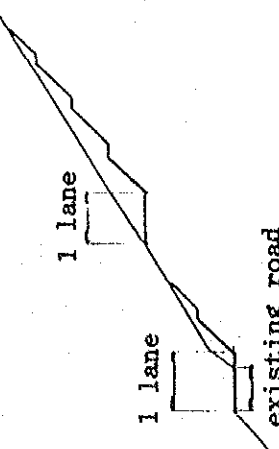
Table 4.3-1 Comparison Table For Method of Road Widening

<p>2 lanes existing road</p>

<p>2 lanes</p>

<p>1 lane 1 lane existing road</p>
Approx. Const. Cost	US\$ 1,277,000 /km	US\$ 1,950,000 /km	US\$ 1,635,000 /km
Economic Effect	Cost is the lowest	50% higher than the lowest	30% higher than the lowest
Obstruction of Traffic Flow	Reasonable	Reasonable	Inconvenience of going in and out the neighbouring area.
Comparison			
Ease of Construction	Construction is possible conducting time limit to traffic movement.	Construction is possible without obstruction of traffic movements.	Construction is possible if traffic flow is converted into the new alignment.
Traffic safety	Fair	Fair	Traffic movement is very safe due to the oneway
Comprehensive Evaluation	The alternative of "Improvement of Existing Road" is significantly superior to other alternatives from the view point of not only the cheapest cost but also the overall evaluation. Therefore, the alternative "Improvement of Existing Road" is adopted.
