5.4 Preliminary Facility Plan for Passenger Boat Service

6. NAVIGATION AIDS

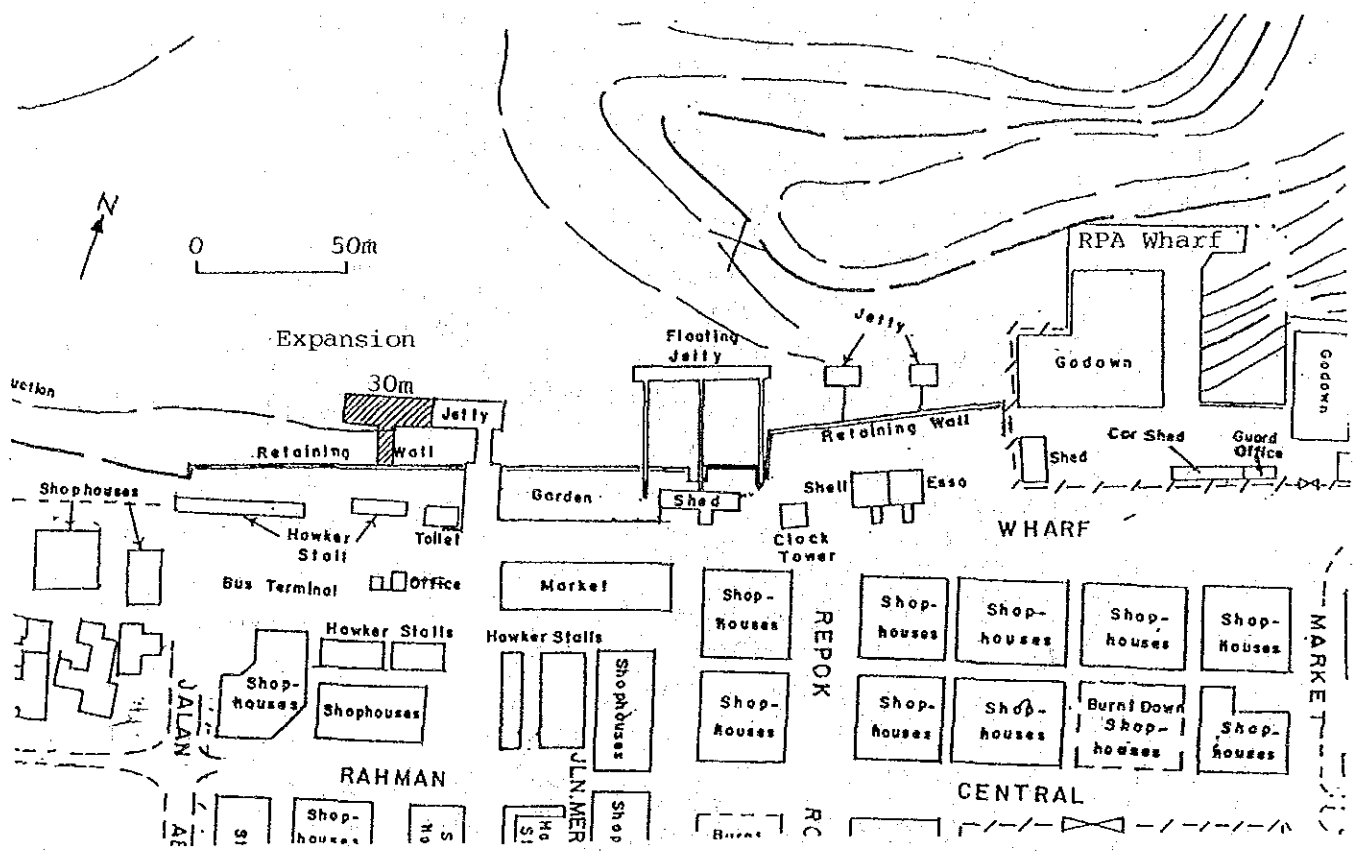
Figure-5.3.3.3 Expansion Plan of Existing Coastal Cargo Wharf at Sarikei
