Fig. 4.7 (1/9) PRESUMED SOIL MATERIALS ALONG THE RIVER

<u>Page</u>
1. SUMMARY	LF.1
2. OBJECTIVE	LF.3
3. LIQUEFACTION PHENOMENA	LF.4
3.1 General	LF.4
3.2 Earthquake Motion Causes Liquefaction	LF.4
3.3 Liquefaction Mechanism Induced by Cyclic Shear	LF.5
4. EARTHQUAKE	LF.7
4.1 16 July 1990 Earthquake	LF.7
4.2 Recorded Earthquakes in the Study Area	LF.7
4.3 Fault	LF.8
5. STUDY ON CASE HISTORY	LF.9
5.1 Earthquake Damage of River Dikes	LF.9
5.2 Damage of River Structures by 1978 Miyagikenoki Earthquake	LF.10
5.3 Settlement of Earth Structures Caused by The Nihonkai-Chubu Earthquake	LF.13
5.4 Countermeasures against Liquefaction of Ground under River Dikes	LF.15
6. SITE RECONNAISSANCE	LF.20
6.1 Dagupan City Area	LF.20
6.2 Middle Agno River	LF.23

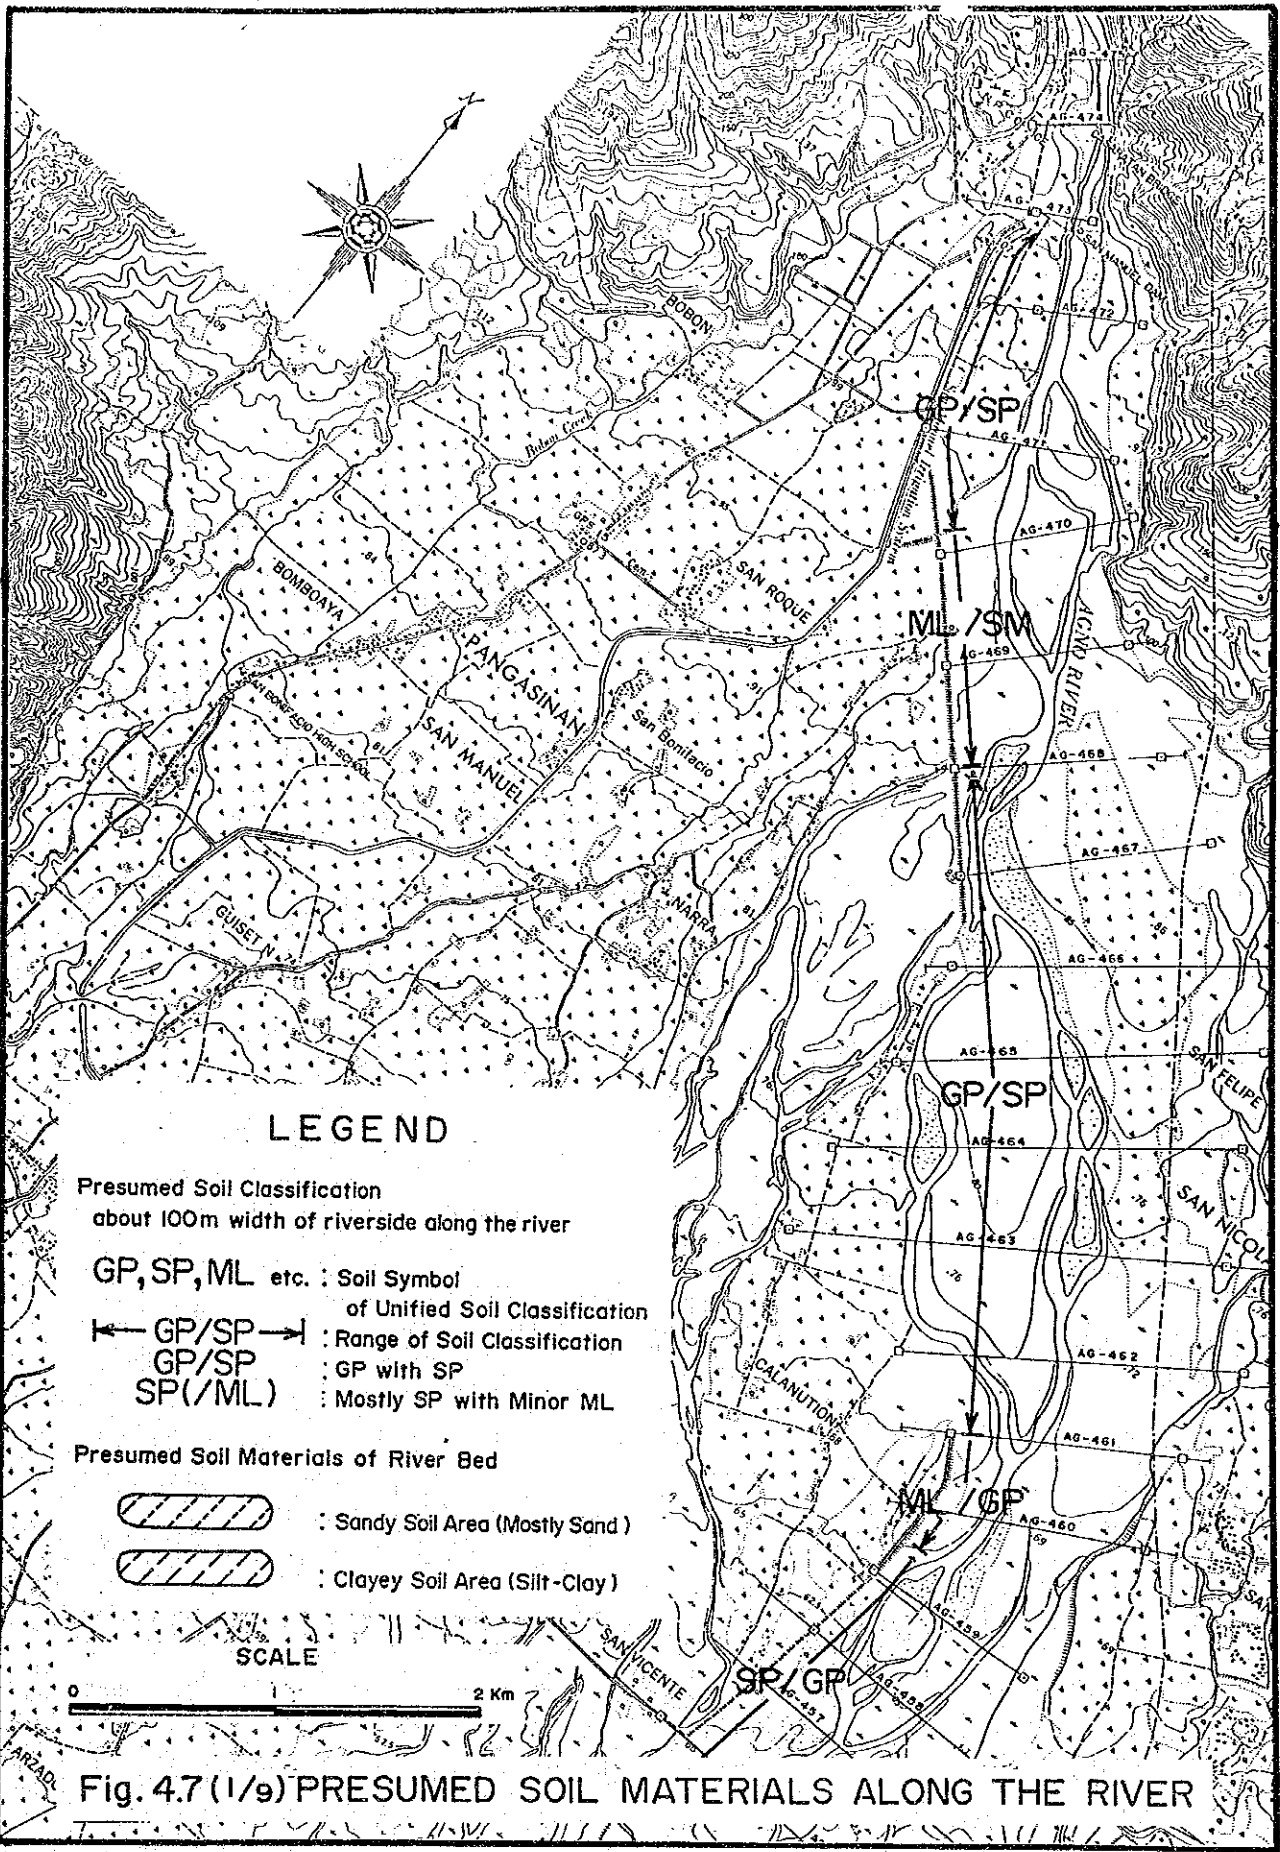
Presumed Soil Classification
about 100m width of riverside along the river

- GP, SP, ML etc. : Soil Symbol of Unified Soil Classification
- ← GP/SP → : Range of Soil Classification
- GP/SP : GP with SP
- SP(/ML) : Mostly SP with Minor ML

Presumed Soil Materials of River Bed

: Sandy Soil Area (Mostly Sand)
-

: Clayey Soil Area (Silt-Clay)

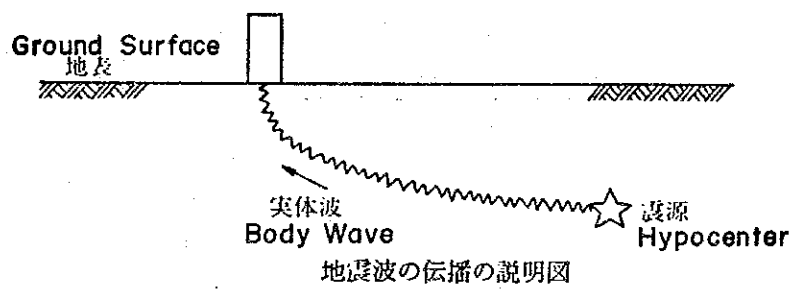
Fig. 3.1 EXPLANATION ON TRAVEL
OF EARTHQUAKE WAVE

The released energy generated during an earthquake becomes the wave motion which propagate in the ground and reach to the ground surface. This wave motion contains the body wave (Primary wave and Secondary wave) that propagate in the elastic ground and the surface wave (Rayleigh wave and Love wave) that propagate in the vicinity of the boundary of the semi infinite elastic ground. The velocity of body wave is slower in the layer close to the ground surface, therefore the wave motion which occurred in this depth is refracted as shown in Fig. 3.1 and both the Primary wave (hereinafter P wave) and the Secondary wave (hereinafter S wave) propagate from just near the ground surface. The soil element of surface layer is acted by cyclic compressive and tensile force in vertical direction by the P wave as shown in Fig. 3.2 (a). The S wave adds to the cyclic shear force in horizontal direction as shown in Fig. 4.2 (b).

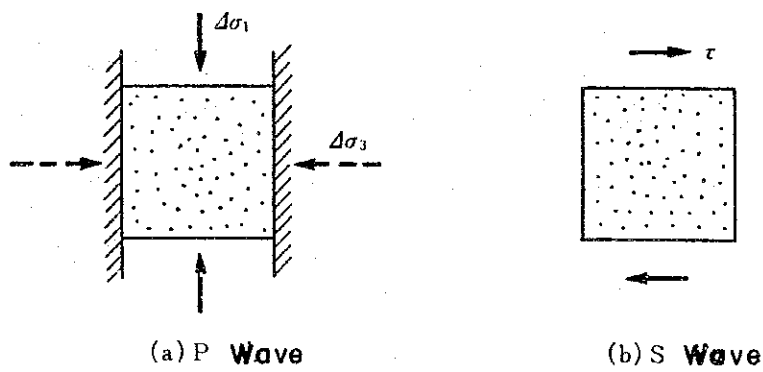
Fig.3.2 ACTING FORCE TO SOIL ELEMENT BY P WAVE AND S WAVE

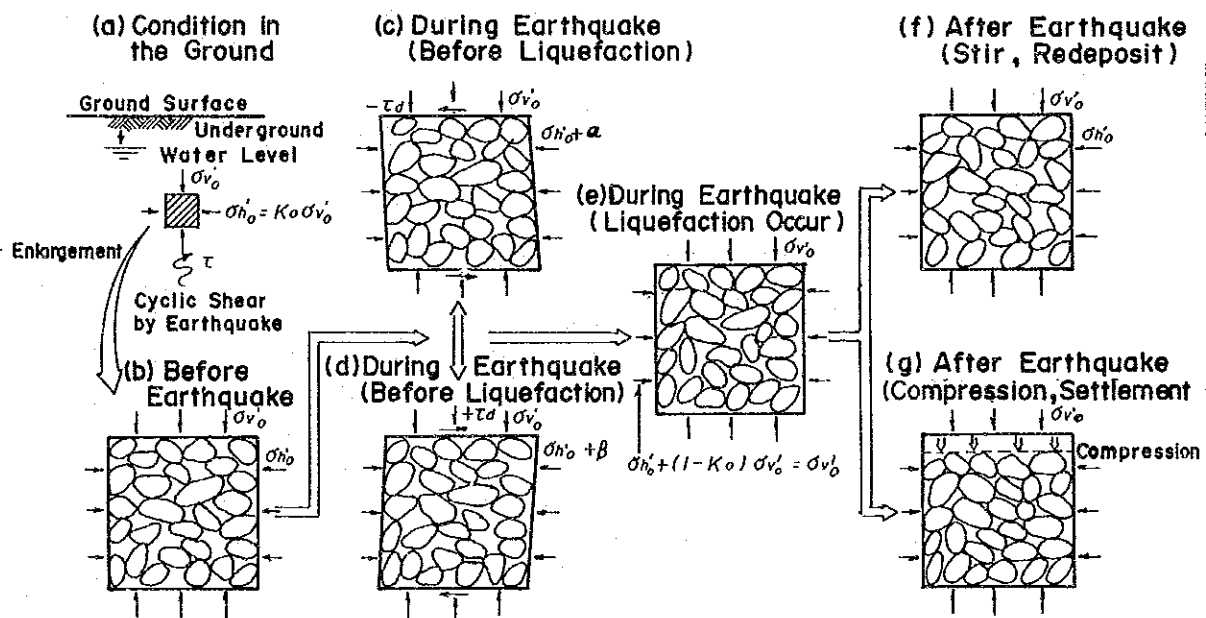
Fig. 3.3 LIQUEFACTION MECHANISM

The soil element in some depth under the horizontal ground is taken notice as shown in Fig. 3.3 (a), provided that this soil is composed of sandy soil deposited loosely and below the underground water level (i.e. the void among the soil particles is saturated with water).

Before an earthquake, i.e. usually, the force acting among soil particles support the pressure which act on the upper part of soil element (overburden pressure of soil above the soil element, effective overburden pressure) and the pressure which act on horizontal direction σ'_{ho} as shown in Fig. 3.3 (b). The pore water occur only at static water pressure below the underground level. In this condition the shear strength of soil τ_f is expressed as follows:

This strength can support the equivalent load of the structures. This soil element is acted by the cyclic shear during earthquake as shown in Fig. 3.3 (c) and (d), and destroyed of its particle structure (distribution). It is supposed that the soil is loose and the interlocking among the soil particles become loose gradually. This is caused by the negative dilatancy of granular material. The interlocking of soil particles become loose perfectly in the end as shown in Fig. 3.3 (e). This condition is same as muddy water that the soil particles are floating in the water. σ' becomes 0 in the equation (3.1), therefore $\tau_f = c$ which means shear stress 0 of sandy soil having no cohesion. This is the condition of perfect liquefaction. The pore water pressure should support the pressure of σ'_{vo} and σ'_{ho} which act round as before, and the pore water pressure overrise only the pressure of σ'_{vo} . (σ'_{ho} rise the value of

It is necessary that the floating condition of soil particles in the water such as in Fig. 3.3 (e) is in the undrained condition which the pore water does not drain or in the little drain condition. The main earthquake motion continues to several scores seconds and it is usually supposed that the condition is perfectly undrained during this motion. However, the permeable ground like sandy gravel ground is considered of the drain effect.
