BASIC DESIGN STUDY REPORT  
ON  
PROVISION OF HEAVY EQUIPMENT  
AND SPARE PARTS FOR  
MT. PINATUBO RELIEF  
AND REHABILITATION OPERATION  
IN  
THE REPUBLIC OF THE PHILIPPINES

FEBRUARY 1992

JAPAN INTERNATIONAL COOPERATION AGENCY

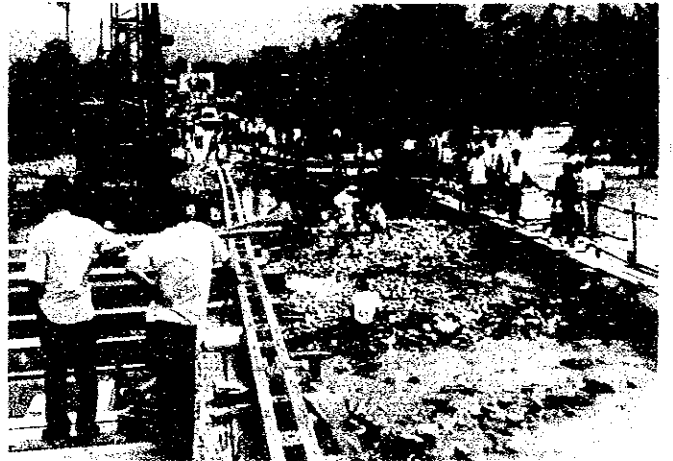
Construction of Tentative Bridge

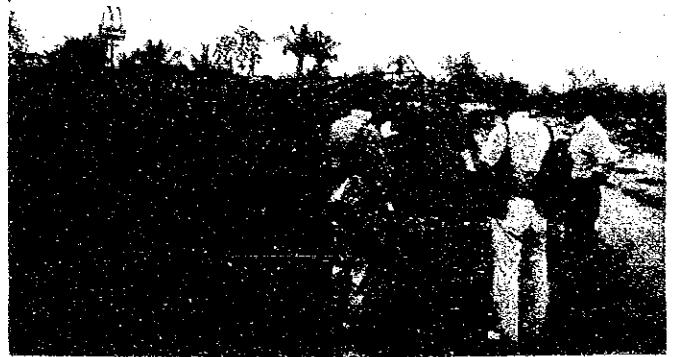
Gabion Net

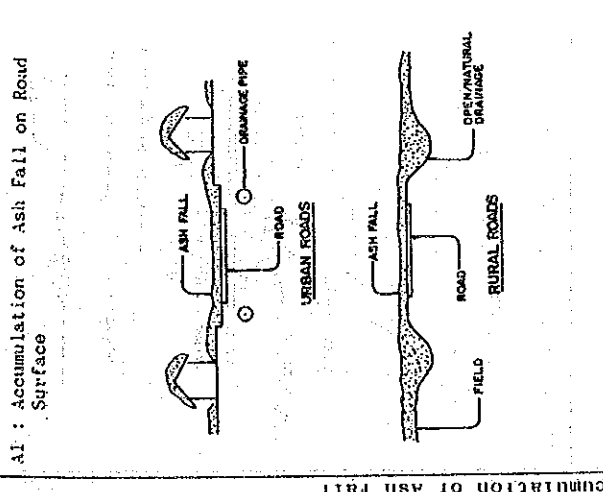
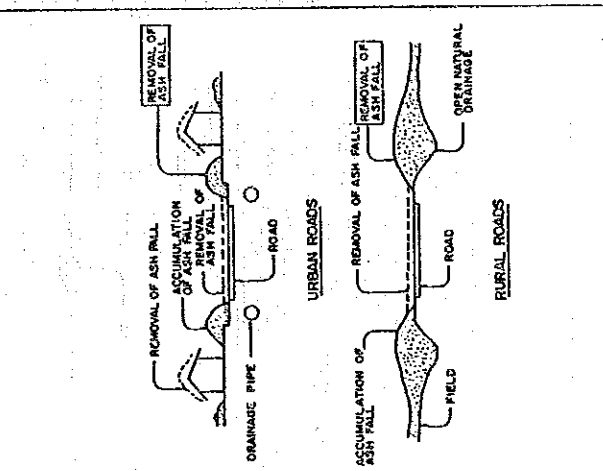
Type of Damage	Existing Condition	Rehabilitation Method / Objective	Procedure of Rehabilitation Work
<p>A1 : Accumulation of Ash Fall on Road Surface</p>

<p>Rehabilitation Method</p> <ul style="list-style-type: none"> <li>• Road Clearing / Rehabilitation</li> </ul> <p>Objective</p> <ul style="list-style-type: none"> <li>• Maintain Basic Transport Facilities</li> <li>• Removing of Traffic Obstructions</li> </ul>	<p>Procedure of Rehabilitation Work</p> <ul style="list-style-type: none"> <li>• Urban Roads : Loading (Wheel Loader) → Transportation (Dump Truck) → Leveling (Bulldozer) → Clearing (Water Jet)</li> <li>• Rural Roads : Excavation / Loading (Crawler Shovel) → Transportation (Dump Truck) → Leveling (Bulldozer) → Slope Adjustment of Open Drainage (Manpou-er)</li> </ul>
<p>A2 : Accumulation of Ash Fall inside Drainage System</p>

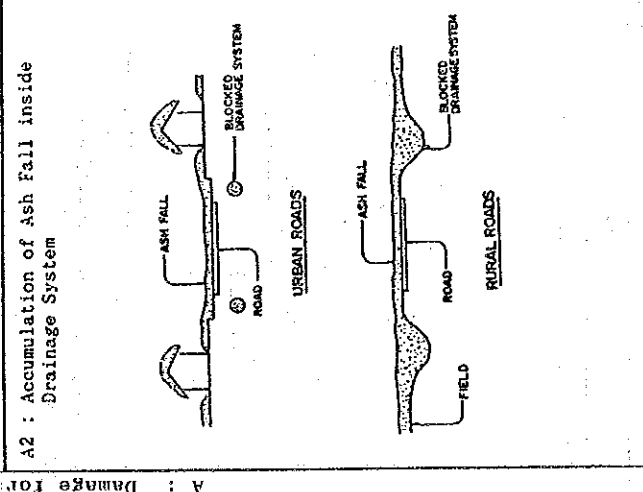
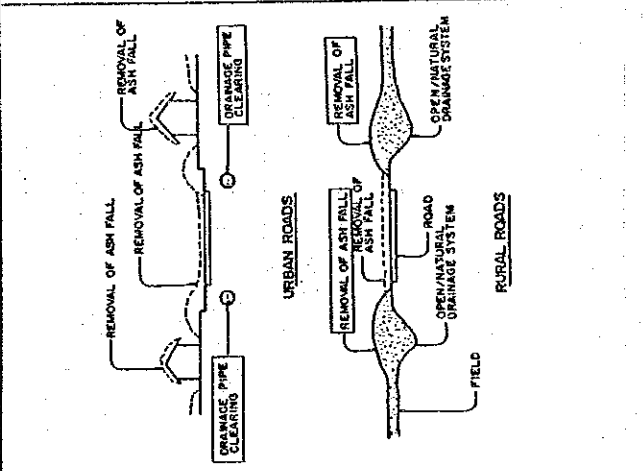
<p>Rehabilitation Method</p> <ul style="list-style-type: none"> <li>• Drainage Clearing / Rehabilitation</li> </ul> <p>Objective</p> <ul style="list-style-type: none"> <li>• Maintain Basic Transport Facilities</li> <li>• Removing of Traffic Obstructions</li> <li>• Securing people living in affected areas</li> </ul>	<p>Procedure of Rehabilitation Work</p> <ul style="list-style-type: none"> <li>• Urban Roads : Drainage Pipe Clearing / Loading (Sewer Vacuum) → Transportation (Dump Truck) → Leveling (Bulldozer) → Pipe Clearing (Water Jet) → Inlet Protection (Sand Bags / Gabion)</li> <li>• Rural Roads : Excavation / Loading (Crawler Shovel) → Transportation (Dump Truck) → Leveling (Bulldozer) → Protection against Sediment Flow into Drainage (Sand Bags / Gabion)</li> </ul>

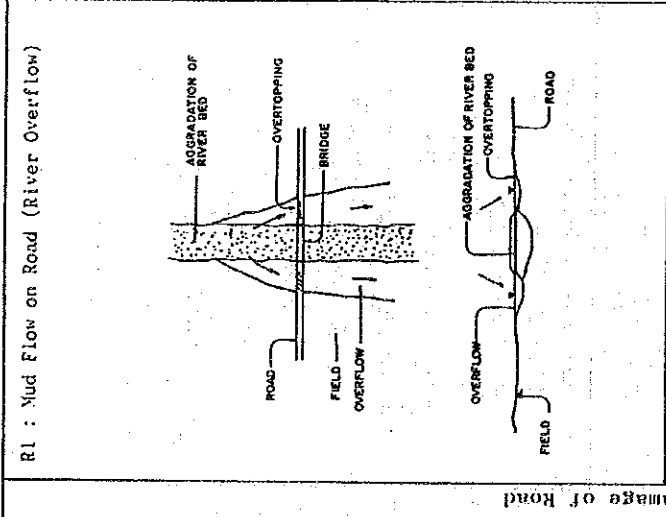
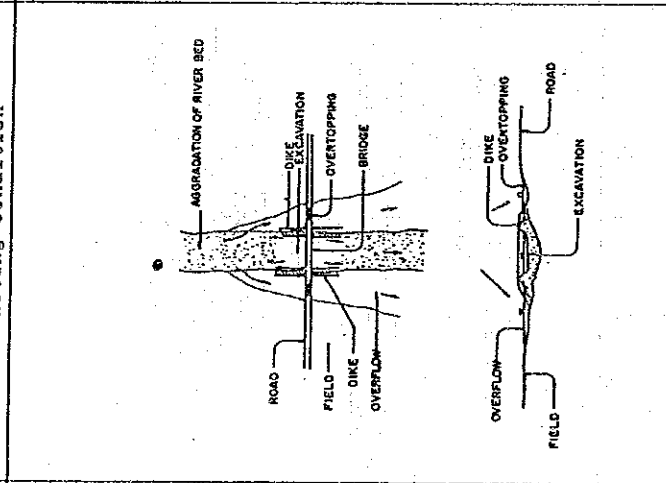
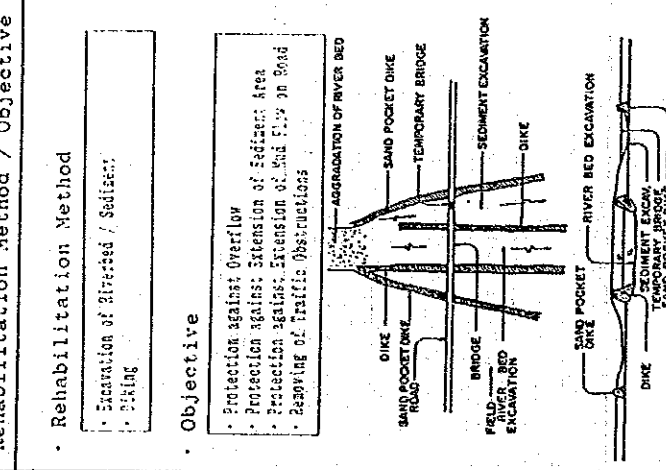
FIGURE 3.3-2 Type / Description / Rehabilitation Method of Damage (2/5)

Type of Damage	Existing Condition	Rehabilitation Method / Objective	Procedure of Rehabilitation Work
<p>R1 : Mud Flow on Road (River Overflow)</p>

<p>Rehabilitation Method</p> <ul style="list-style-type: none"> <li>Excavation of Riverbed / Sediment</li> <li>Diking</li> </ul> <p>Objective</p> <ul style="list-style-type: none"> <li>Protection against Overflow</li> <li>Protection against Extension of Sediment Area</li> <li>Protection against Extension of Mud Flow on Road</li> <li>Removal of Traffic Obstructions</li> </ul>

<p>Procedure of Rehabilitation Work</p> <ul style="list-style-type: none"> <li>Riverbed : <ul style="list-style-type: none"> <li>[Case 1] Excavation of Riverbed / Loading (Bulldozer, Crawler Shovel) → Transportation (Dump Truck) → Diking (Bulldozer) → Slope Protection (Gabion Machine, Truck Mounted Crane, Mighty Mite)</li> <li>[Case 2] Excavation of Riverbed / Loading / Transportation / Leveling (Towed Scraper) → Diking (Bulldozer) → Slope Protection (Gabion Machine, Truck Mounted Crane, Mighty Mite)</li> </ul> </li> <li>Overflow Area : <ul style="list-style-type: none"> <li>Excavation of Sediment / Loading (Swamp Bulldozer, Crawler Shovel) → Transportation (Dump Truck) → Diking (Bulldozer)</li> </ul> </li> <li>Temporary Bridge : <ul style="list-style-type: none"> <li>Set Bridge Footing on Road Surface (Jack Hammer, Diesel Hammer, Truck Mounted Crane, Crawl Shovel) → Erection of Temporary Bridge (Truck Mounted Crane, Mighty Mite)</li> </ul> </li> </ul>

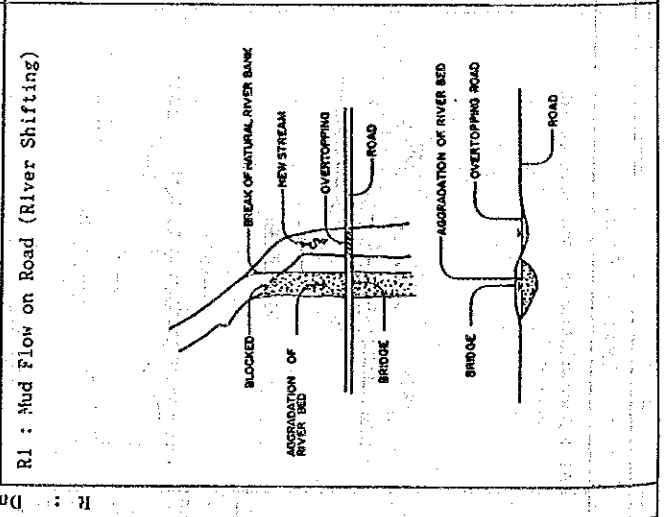
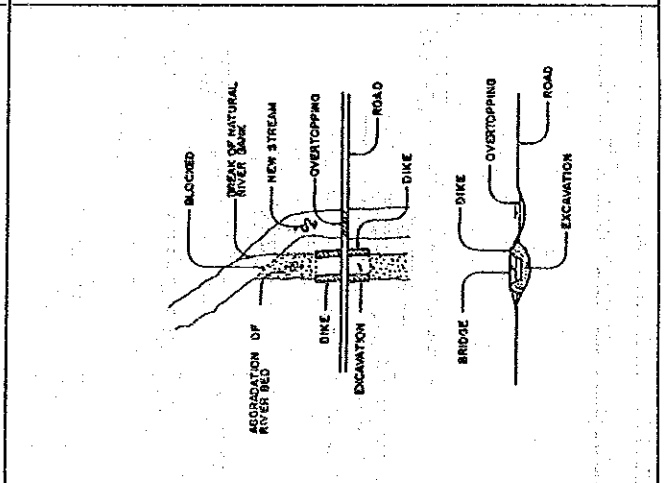
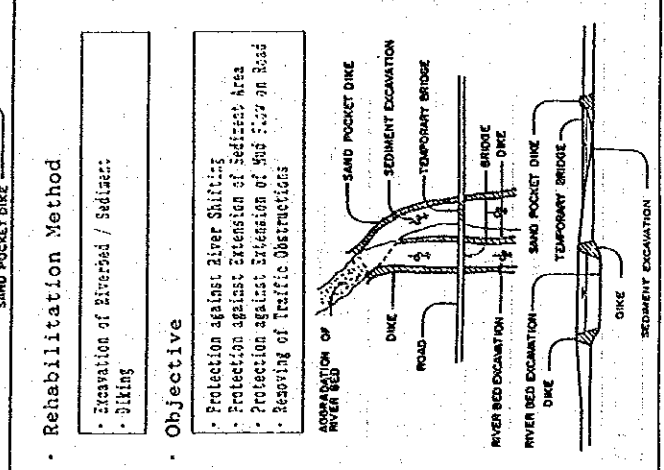
<p>R2 : Mud Flow on Road (River Shifting)</p>

<p>Rehabilitation Method</p> <ul style="list-style-type: none"> <li>Excavation of Riverbed / Sediment</li> <li>Diking</li> </ul> <p>Objective</p> <ul style="list-style-type: none"> <li>Protection against River Shifting</li> <li>Protection against Extension of Sediment Area</li> <li>Protection against Extension of Mud Flow on Road</li> <li>Removal of Traffic Obstructions</li> </ul>

<p>Procedure of Rehabilitation Work</p> <ul style="list-style-type: none"> <li>Riverbed : <ul style="list-style-type: none"> <li>[Case 1] Excavation of Riverbed / Loading (Bulldozer, Crawler Shovel) → Transportation (Dump Truck) → Diking (Bulldozer) → Slope Protection (Gabion Machine, Truck Mounted Crane, Mighty Mite)</li> <li>[Case 2] Excavation of Riverbed / Loading / Transportation / Leveling (Towed Scraper) → Diking (Bulldozer) → Slope Protection (Gabion Machine, Truck Mounted Crane, Mighty Mite)</li> </ul> </li> <li>River Shifting Area : <ul style="list-style-type: none"> <li>Excavation of Sediment / Loading (Swamp Bulldozer, Crawler Shovel) → Transportation (Dump Truck) → Diking (Bulldozer) → Slope Protection (Gabion Machine, Truck Mounted Crane, Mighty Mite)</li> </ul> </li> <li>Temporary Bridge : <ul style="list-style-type: none"> <li>Set Bridge Footing on Road Surface (Jack Hammer, Diesel Hammer, Truck Mounted Crane, Crawler Shovel) → Erection of Temporary Bridge (Truck Mounted Crane, Mighty Mite)</li> </ul> </li> </ul>

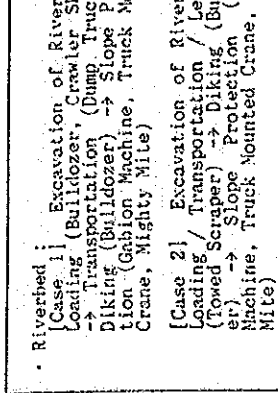
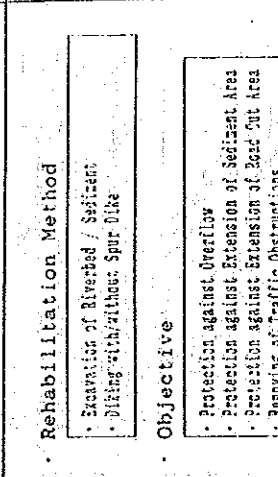
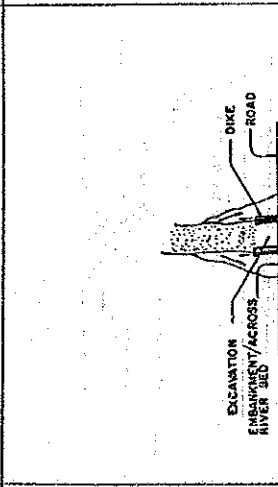
FIGURE 3.3-2 Type / Description / Rehabilitation Method of Damage (3/6)

Type of Damage	Existing Condition	Rehabilitation Method / Objective	Procedure of Rehabilitation Work
<p>R2 : Road Cut due to Overflow</p>

<p>Rehabilitation Method</p> <ul style="list-style-type: none"> <li>Excavation of Riverbed / Spillway</li> <li>Diking with/without Spur Dike</li> </ul> <p>Objective</p> <ul style="list-style-type: none"> <li>Protection against Overflow</li> <li>Protection against Extension of Sediment Area</li> <li>Protection against Extension of Road Cut Area</li> <li>Removing of Traffic Obstructions</li> </ul>

<p>Procedure of Rehabilitation Work</p> <ul style="list-style-type: none"> <li>Riverbed : [Case 1] Excavation of Riverbed / Loading (Bulldozer, Crawler Shovel) → Transportation (Dump Truck) → Diking (Bulldozer) → Slope Protection (Gabion Machine, Truck Mounted Crane, Mighty Mite)</li> <li>[Case 2] Excavation of Riverbed / Loading / Transportation / Leveling (Towed Scraper) → Diking (Bulldozer) → Slope Protection (Gabion Machine, Truck Mounted Crane, Mighty Mite)</li> <li>Overflow Area : Excavation of Sediment / Loading (Swamp Bulldozer, Crawler Shovel) → Transportation (Dump Truck) → Diking (Bulldozer) → Road Embankment (Bulldozer, Compaction Machinery) → Slope Protection (Gabion Machine, Truck Mounted Crane, Mighty Mite, Sand Bags)</li> <li>Temporary Bridge : Substructure (Jack Hammer, Diesel Hammer, Truck Mounted Crane, Crawler Shovel) → Erection of Temporary Bridge (Truck Mounted Crane, Mighty Mite) → Slope Protection (Gabion Machine, Truck Mounted Crane, Mighty Mite, Sand Bags)</li> </ul>

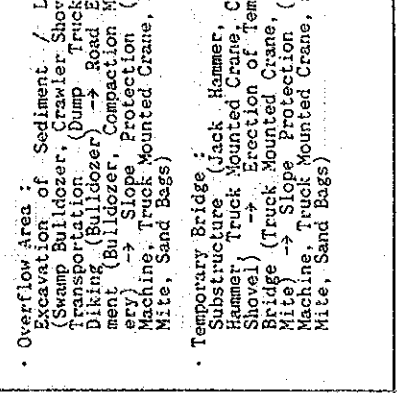
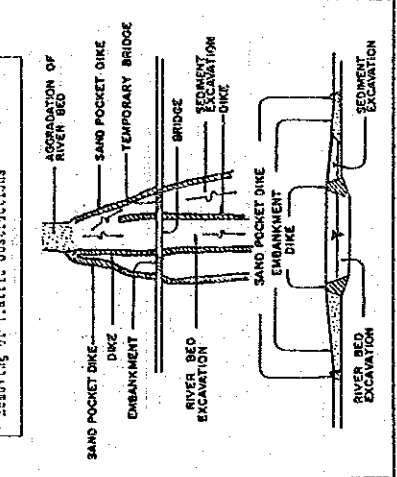
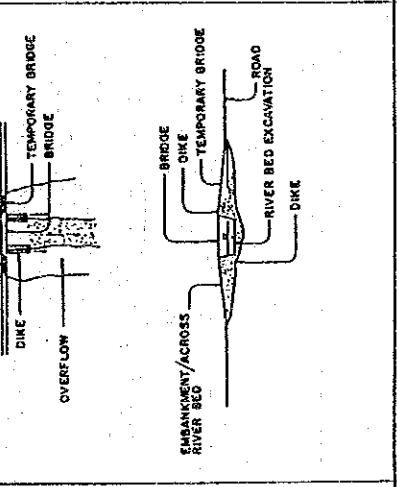
<p>R2 : Road Cut due to Shifting Flow</p>

<p>Rehabilitation Method</p> <ul style="list-style-type: none"> <li>Excavation of Riverbed / Sediment</li> <li>Diking with/without Spur Dike</li> </ul> <p>Objective</p> <ul style="list-style-type: none"> <li>Protection against River Shifting</li> <li>Protection against Extension of Sediment Area</li> <li>Protection against Extension of Road Cut Area</li> <li>Removing of Traffic Obstructions</li> </ul>

<p>Procedure of Rehabilitation Work</p> <ul style="list-style-type: none"> <li>Riverbed : [Case 1] Excavation of Riverbed / Loading (Bulldozer, Crawler Shovel) → Transportation (Dump Truck) → Diking (Bulldozer) → Slope Protection (Gabion Machine, Truck Mounted Crane, Mighty Mite)</li> <li>[Case 2] Excavation of Riverbed / Loading / Transportation / Leveling (Towed Scraper) → Diking (Bulldozer) → Slope Protection (Gabion Machine, Truck Mounted Crane, Mighty Mite)</li> <li>River Shifted Area : Excavation of Sediment / Loading (Swamp Bulldozer, Crawler Shovel) → Transportation (Dump Truck) → Diking (Bulldozer) → Slope Protection (Gabion Machine, Truck Mounted Crane, Mighty Mite)</li> <li>Temporary Bridge : Substructure (Jack Hammer, Diesel Hammer, Truck Mounted Crane, Crawler Shovel) → Erection of Temporary Bridge (Truck Mounted Crane, Mighty Mite) → Slope Protection (Gabion Machine, Truck Mounted Crane, Mighty Mite, Sand Bags)</li> </ul>

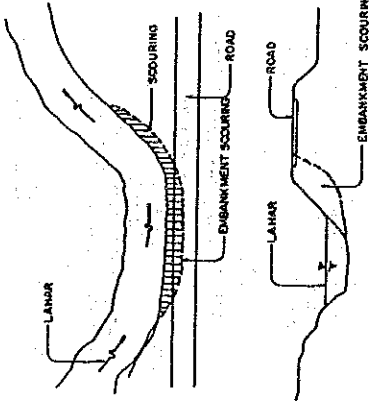
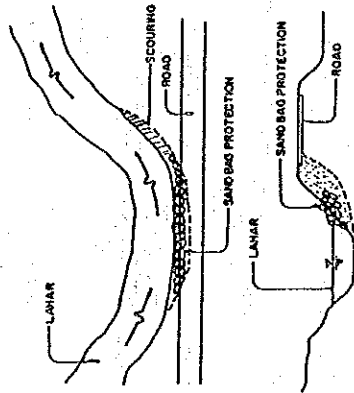
FIGURE 3.3-2 Type / Description / Rehabilitation Method of Damage (4/6)

Type of Damage	Existing Condition	Rehabilitation Method / Objective	Procedure of Rehabilitation Work
<p>R3 : Scouring of Embankment (Mud Flow: Parallel with Road)</p>

<p>Rehabilitation Method</p> <ul style="list-style-type: none"> <li>• Directed Excavation / Spur Dike</li> <li>• Slope Protection</li> </ul> <p>Objective</p> <ul style="list-style-type: none"> <li>• Protection against Overflow</li> <li>• Protection against Extension of Embankment Scouring</li> <li>• Removing of Traffic Obstructions</li> </ul>

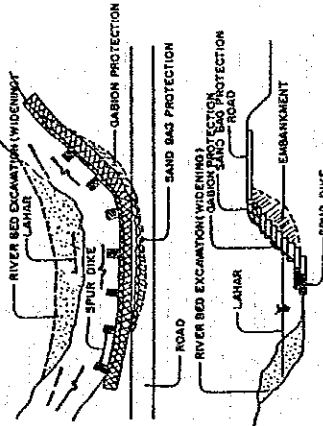
<p>Procedure of Rehabilitation Work</p> <ul style="list-style-type: none"> <li>• Riverbed Widening : Excavation of Riverbed (Swamp Bulldozer, Bulldozer, Crawler Shovel) → Loading Transportation (Dump Truck) → Road Embankment (Bulldozer, Compaction Machinery, Mighty Mite)</li> <li>• Spur Dike : Leveling of Riverbed (Swamp Bulldozer, Crawler Shovel) → Gabion Crane, Mighty Mite, Truck Mounted Crane, Mighty Mite</li> <li>• Protection by Gabion : Leveling of Riverbed (Swamp Bulldozer, Crawler Shovel) → Foundation (Gabion Machine, Truck Mounted Crane, Mighty Mite) → Slope Protection (Truck Mounted Crane, Mighty Mite, Sand Bags)</li> </ul>

Figure 3.3-1 shows type of disaster and rehabilitation work in the area. The type of damage in each area is divided into 6 and equipment used in rehabilitation method is shown in Figure 3.3.2 in which type of equipment is clarified to match with the rehabilitation method.

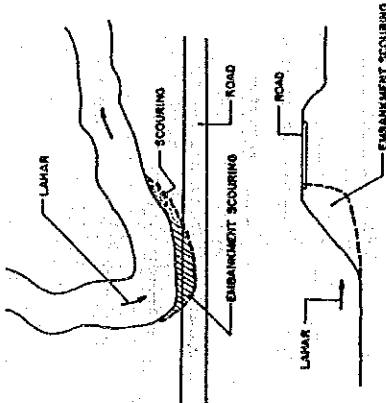
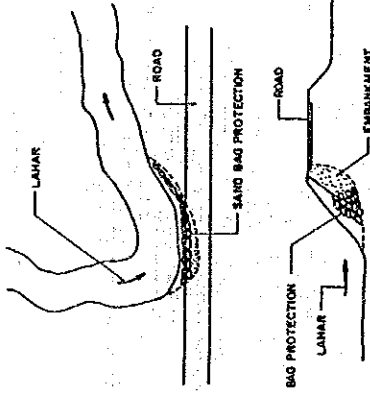
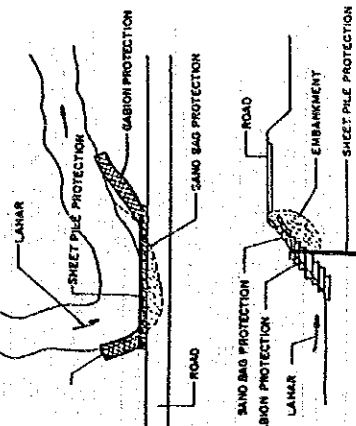
<p>R3 : Scouring of Embankment (Mud Flow: Vertical on Road)</p>

<p>Rehabilitation Method</p> <ul style="list-style-type: none"> <li>• Slope Protection</li> </ul> <p>Objective</p> <ul style="list-style-type: none"> <li>• Protection against Overflow</li> <li>• Protection against Extension of Embankment Scouring</li> <li>• Removing of Traffic Obstructions</li> </ul>

<p>Procedure of Rehabilitation Work</p> <ul style="list-style-type: none"> <li>• Protection by Sheet Pile : Piling of Sheet Pile (Jack Hammer, Diesel Hammer, Truck Mounted Crane) → Road Embankment (Crawler Shovel, Dump Truck, Bulldozer, Compaction Machinery)</li> <li>• Protection by Gabion : Leveling of Riverbed (Swamp Bulldozer, Crawler Shovel) → Foundation (Gabion Machine, Truck Mounted Crane, Mighty Mite) → Slope Protection (Truck Mounted Crane, Mighty Mite, Sand Bags)</li> </ul>

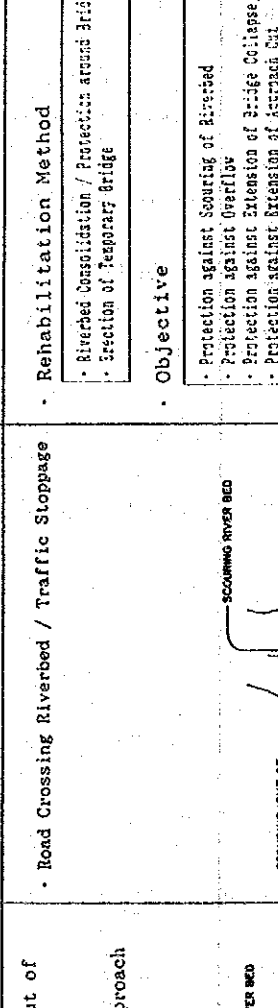
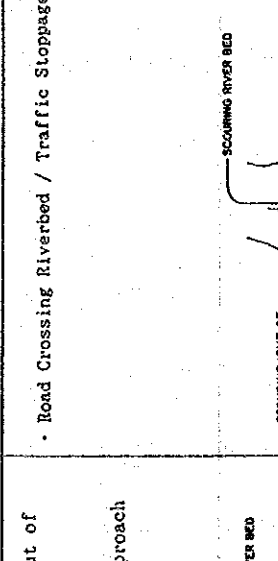
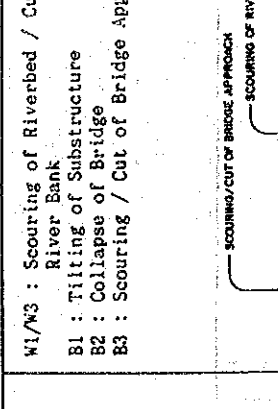
Type of Damage	Existing Condition	Rehabilitation Method / Objective	Procedure of Rehabilitation Work
<p>W1/W3 : Scouring of Riverbed / Cut of River Bank                      B1 : Tilting of Substructure                      B2 : Collapse of Bridge                      B3 : Scouring / Cut of Bridge Approach</p>

<p>Road Crossing Riverbed / Traffic Stoppage</p>

<p>Rehabilitation Method</p> <ul style="list-style-type: none"> <li>• Riverbed Consolidation / Protection around Bridge</li> <li>• Erection of Temporary Bridge</li> </ul> <p>Objective</p> <ul style="list-style-type: none"> <li>• Protection against Scouring of Riverbed</li> <li>• Protection against Overflow</li> <li>• Protection against Extension of Bridge Collapse</li> <li>• Protection against Extension of Approach Cut</li> <li>• Removing of Traffic Obstructions</li> </ul>

<p>Procedure of Rehabilitation Work</p> <ul style="list-style-type: none"> <li>• Riverbed Consolidation by Gabion Leveling of Riverbed (Swamp Bulldozer, Crawler Shovel) → Riverbed Consolidation (Gabion Machine, Truck Mounted Crane, Mighty Mite)</li> <li>• Slope Protection by Gabion : Slope Adjust (Crawler Shovel, Bulldozer) → Slope Protection (Gabion Machine, Truck Mounted Crane, Mighty Mite)</li> <li>• Protection by Sheet Pile : Piling of Sheet Pile (Jack Hammer, Diesel Hammer, Truck Mounted Crane) → Reclamation (Crawler Shovel, Bulldozer, Compaction Machinery)</li> <li>• Temporary Bridge : Substructure (Jack Hammer, Diesel Hammer, Truck Mounted Crane, Crawler Shovel) → Erection of Temporary Bridge (Truck Mounted Crane, Mighty Mite)</li> </ul>

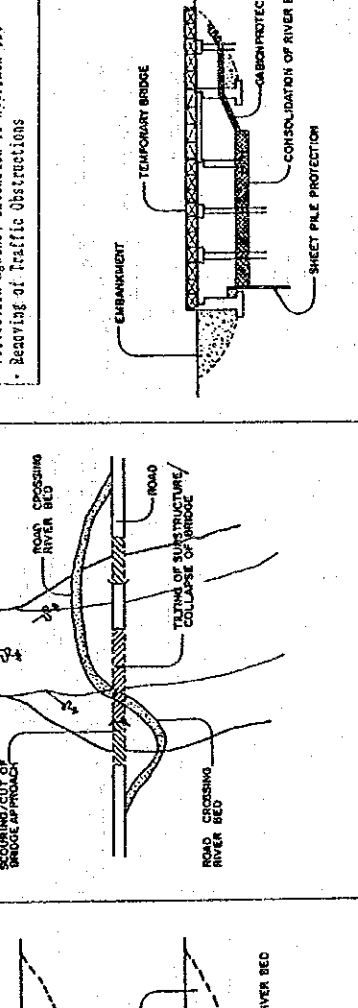
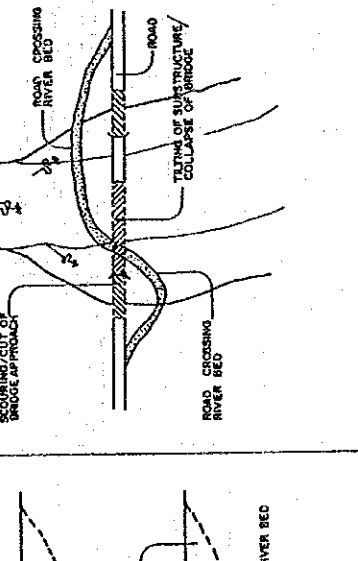
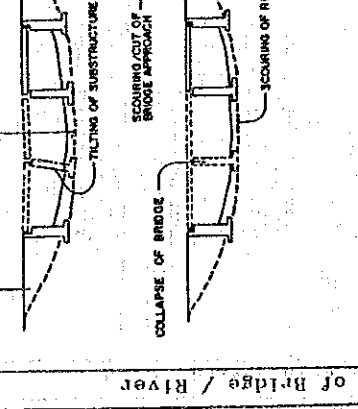
<p>W2/W3 : Sediment of Riverbed / Cut of River Bank                      B1 : Flooded to Superstructure                      B2 : Scouring / Cut of Bridge Approach</p>

<p>Temporary Bridge / Crossing Riverbed / Traffic Stoppage</p>

<p>Rehabilitation Method</p> <ul style="list-style-type: none"> <li>• Excavation of Riverbed around Bridge</li> <li>• Diking / Protection around Bridge</li> <li>• Erection of Temporary Bridge</li> </ul> <p>Objective</p> <ul style="list-style-type: none"> <li>• Protection against Overflow / River Shifting</li> <li>• Protection against Extension of Excement Area</li> <li>• Protection against Extension of Road Cut Area</li> <li>• Protection against Extension of Bridge Collapse</li> <li>• Removing of Traffic Obstructions</li> </ul>

<p>Procedure of Rehabilitation Work</p> <ul style="list-style-type: none"> <li>• Riverbed : [Case 1] Excavation of Riverbed / Loading (Bulldozer, Crawler Shovel) → Transportation (Dump Truck) → Diking (Bulldozer) → Road Embankment (Bulldozer, Compaction Machinery)</li> <li>• [Case 2] Excavation of Riverbed / Loading / Transportation / Leveling (Towed Scraper) → Diking (Bulldozer) → Road Embankment (Bulldozer, Compaction Machinery)</li> <li>• Slope Protection by Gabion : Swamp Slope Adjust (Bulldozer, Swamp Bulldozer, Crawler Shovel) → Slope Protection (Gabion Machine, Truck Mounted Crane, Mighty Mite)</li> <li>• Temporary Bridge : Substructure (Jack Hammer, Diesel Hammer, Truck Mounted Crane, Crawler Shovel) → Erection of Temporary Bridge (Truck Mounted Crane, Mighty Mite)</li> </ul>

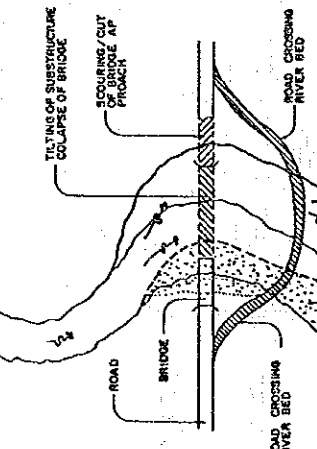
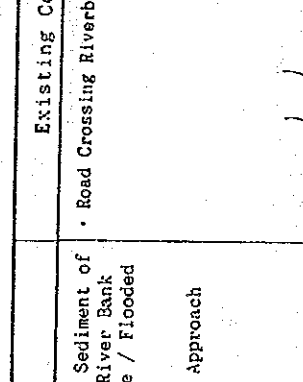
Type of Damage	Existing Condition	Rehabilitation Method / Objective	Procedure of Rehabilitation Work
<p>W1/W2/W3 : Partial Scouring / Sediment of Riverbed / Cut of River Bank</p> <p>B1 : Tilting of Superstructure / Flooded to Superstructure</p> <p>B2 : Collapse of Bridge</p> <p>B3 : Scouring / Cut of Bridge Approach</p>	<p>Road Crossing Riverbed / Traffic Stoppage</p>

<p>Rehabilitation Method</p> <ul style="list-style-type: none"> <li>• Scavation of Riverbed around Bridge / Diking</li> <li>• Riverbed Consolidation / Protection around Bridge</li> <li>• Erection of Temporary Bridge</li> </ul> <p>Objective</p> <ul style="list-style-type: none"> <li>• Protection against Overflow / River Shifting</li> <li>• Protection against Extension of Sediment Area</li> <li>• Protection against Scouring of Riverbed</li> <li>• Protection against Extension of Road Cut Area</li> <li>• Protection against Extension of Bridge Collapse</li> <li>• Removing of Traffic Obstructions</li> </ul>

<p>Sediment Area :</p> <p>[Case 1] Excavation of Riverbed / Loading (Bulldozer, Crawler Shovel) → Transportation (Dump Truck) → Diking (Bulldozer)</p> <p>[Case 2] Excavation of Riverbed / Loading / Transportation / Leveling (Towed Scraper) → Diking (Bulldozer)</p> <ul style="list-style-type: none"> <li>• Riverbed Consolidation by Gabion</li> <li>• Leveling of Riverbed (Swamp Bulldozer, Crawler Shovel) → Riverbed Consolidation (Gabion Machine, Truck Mounted Crane, Mighty Mite)</li> <li>• Slope Protection by Gabion : Slope Adjust (Bulldozer, Swamp Bulldozer, Crawler Shovel) → Slope Protection (Gabion Machine, Truck Mounted Crane, Mighty Mite)</li> <li>• Protection by Sheet Pile : Piling of Sheet Pile (Jack Hammer, Diesel Hammer, Truck Mounted Crane) → Reclamation (Crawler Shovel, Bulldozer, Compaction Machinery)</li> <li>• Temporary Bridge : Substructure (Jack Hammer, Diesel Hammer, Truck Mounted Crane, Crawler Shovel) → Erection of Temporary Bridge (Truck Mounted Crane, Mighty Mite)</li> </ul>

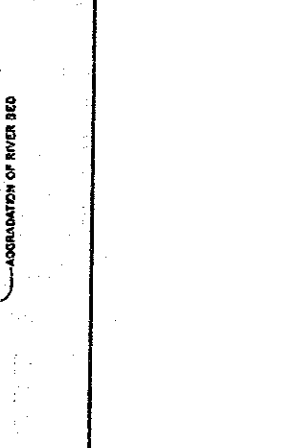
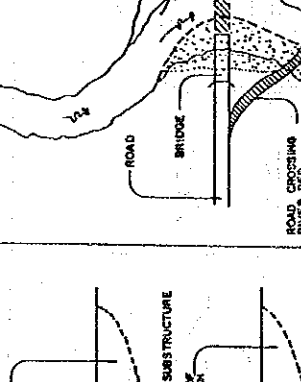
<p>W/B : Damage of Bridge / River</p>

<p>Road Crossing Riverbed / Traffic Stoppage</p>

<p>Rehabilitation Method / Objective</p> <ul style="list-style-type: none"> <li>• Scavation of Riverbed around Bridge / Diking</li> <li>• Riverbed Consolidation / Protection around Bridge</li> <li>• Erection of Temporary Bridge</li> </ul> <p>Objective</p> <ul style="list-style-type: none"> <li>• Protection against Overflow / River Shifting</li> <li>• Protection against Extension of Sediment Area</li> <li>• Protection against Scouring of Riverbed</li> <li>• Protection against Extension of Road Cut Area</li> <li>• Protection against Extension of Bridge Collapse</li> <li>• Removing of Traffic Obstructions</li> </ul>

<p>Sediment Area :</p> <p>[Case 1] Excavation of Riverbed / Loading (Bulldozer, Crawler Shovel) → Transportation (Dump Truck) → Diking (Bulldozer)</p> <p>[Case 2] Excavation of Riverbed / Loading / Transportation / Leveling (Towed Scraper) → Diking (Bulldozer)</p> <ul style="list-style-type: none"> <li>• Riverbed Consolidation by Gabion</li> <li>• Leveling of Riverbed (Swamp Bulldozer, Crawler Shovel) → Riverbed Consolidation (Gabion Machine, Truck Mounted Crane, Mighty Mite)</li> <li>• Slope Protection by Gabion : Slope Adjust (Bulldozer, Swamp Bulldozer, Crawler Shovel) → Slope Protection (Gabion Machine, Truck Mounted Crane, Mighty Mite)</li> <li>• Protection by Sheet Pile : Piling of Sheet Pile (Jack Hammer, Diesel Hammer, Truck Mounted Crane) → Reclamation (Crawler Shovel, Bulldozer, Compaction Machinery)</li> <li>• Temporary Bridge : Substructure (Jack Hammer, Diesel Hammer, Truck Mounted Crane, Crawler Shovel) → Erection of Temporary Bridge (Truck Mounted Crane, Mighty Mite)</li> </ul>
