**SUPPORTING REPORT B**  
**INVESTIGATION ON WATER RESOURCES**

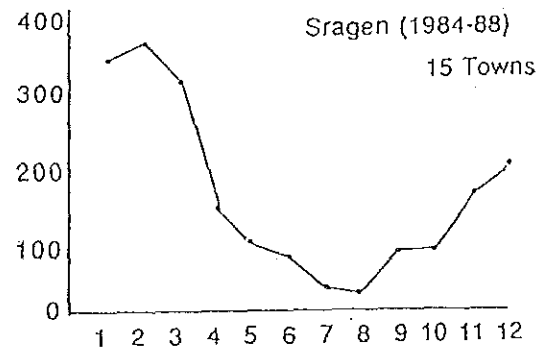
Fig. B 1. 2  
Annual Rainfall

(Central Java) 1/3

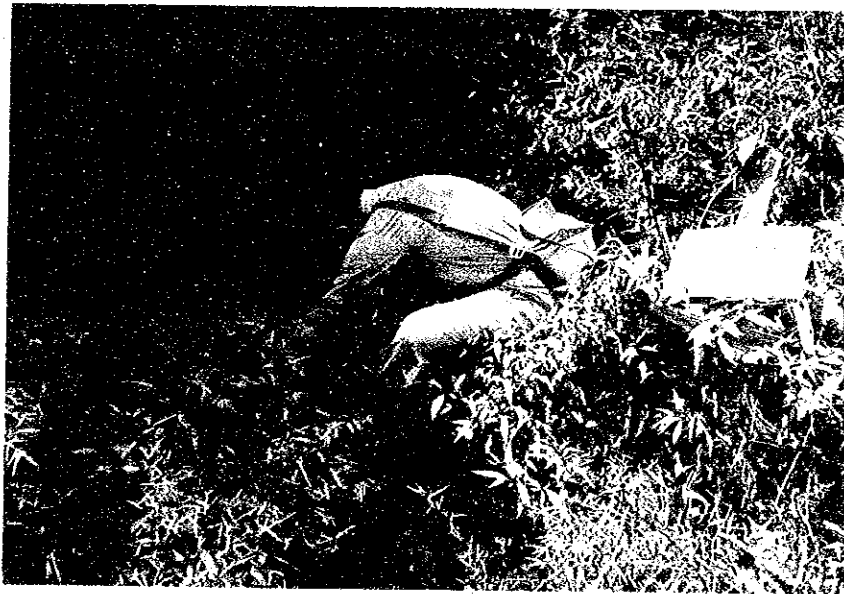
Trabawulan Spring at The Northern Part of  
Desa Petuguran, IKK Punggelan

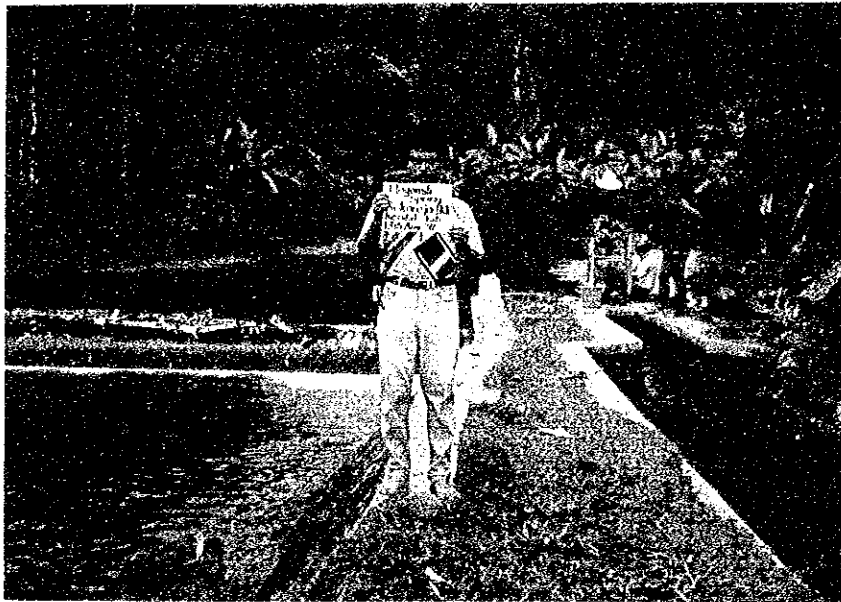
Tlogomili Spring at Desa Tlogo Payung in Kec. Plantungan

There isn't any useful spring in the IKK area. A large spring called "Tlogomili" is present in Desa Tlogo Payung, Kecamatan Plantungan at 15 km south-west. This spring consists of several springs and is located at a riverhead. Its water is used for irrigation, but there is no problem to take its water in a new water supply system. A picture of this spring is attached on the following page.

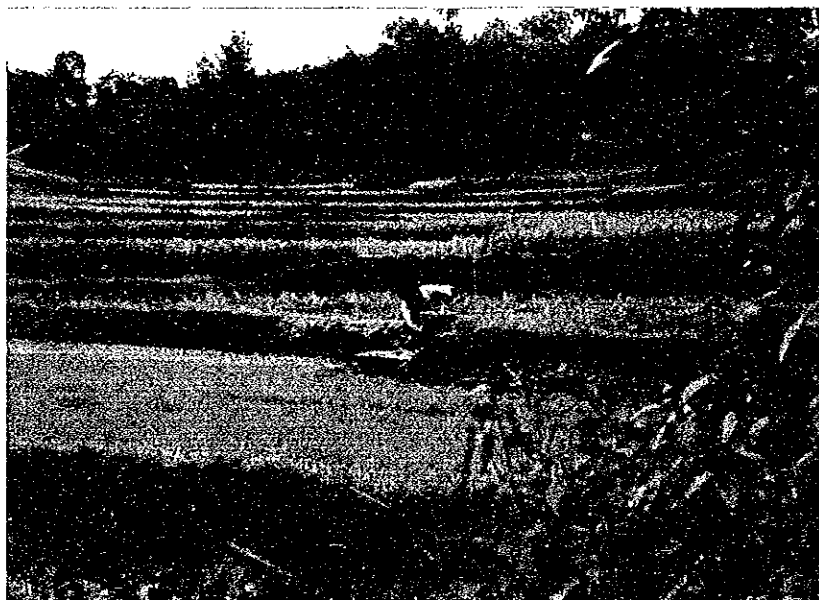
A Flowing P2AT Well That Exists in Desa Soko

Potential water sources are small springs in Desa Waru on the Kapur Utara Hill on the north of Desa Soko and groundwater in Desa Soko at 9 km north of IKK. However, water from the springs in Desa Waru has already been used for waterworks and irrigation by local communities and a military complex in Kota Blara; consequently, these springs have no surplus capacity for a new demand. Two P2AT test wells exist in Desa Soko on the south slope of the Kapur Utara Hill consisting of faulted limestones. The yield capacity of these wells was confirmed by pumping tests including a test of this time; it is 2 l/s for one well and 5 l/s for the other one of flowing well. Since the groundwater is borne in fissures, its productivity is comparatively low.

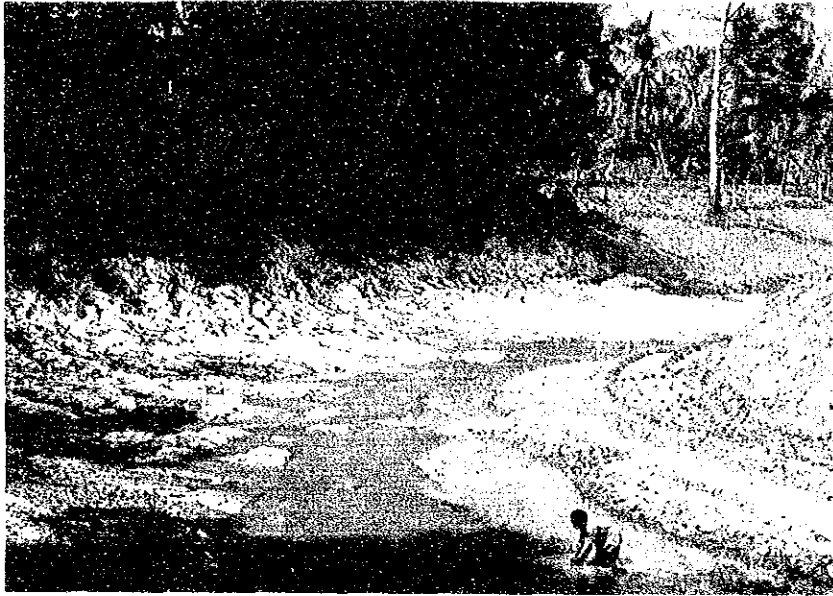
Photo ①  
Chalk Outcrop  
on Draw Surface

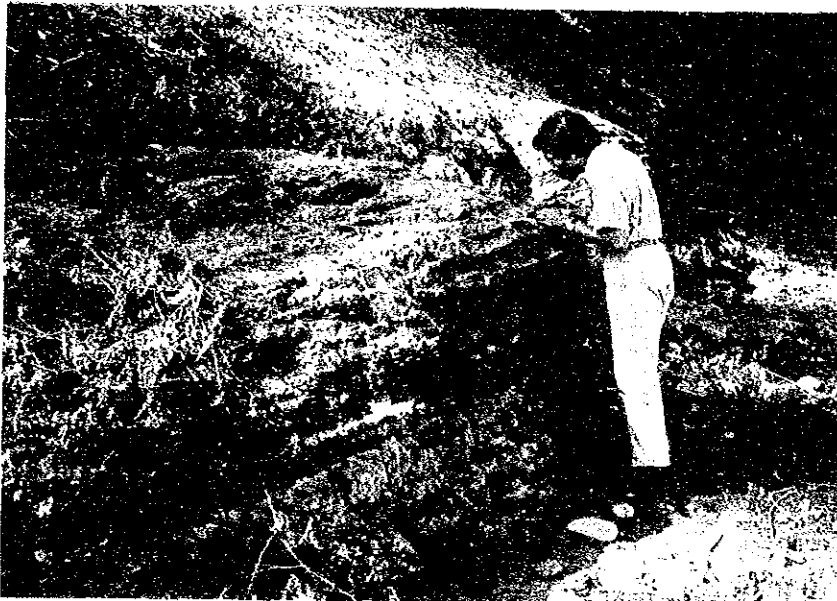
Photo ②  
Rocks Laminated  
with Limestones  
and Sandstones,  
N 70°E/15°N

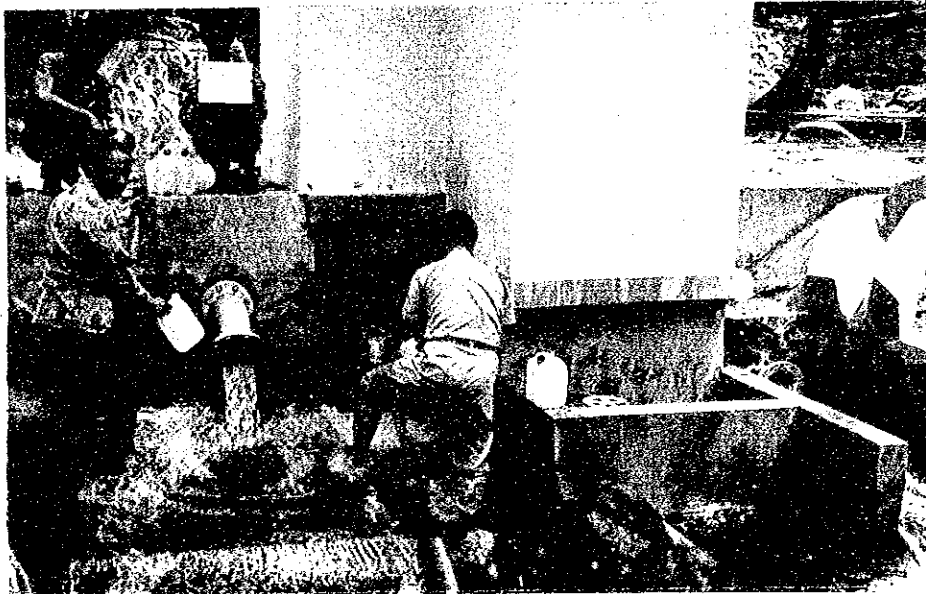
Umbul Spring at Dusun Kalibening, Kec. Jambu,  
Proposed for IKK Bawen. This Facility was  
Constructed by DINAS Cipta Karya in 1990

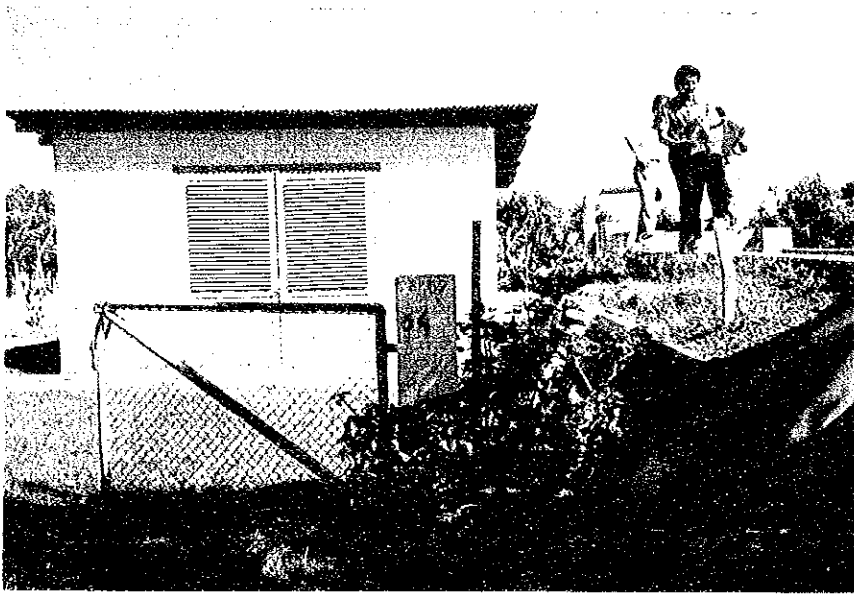
Pump Station of P2AT SP-67 Well in Desa Suwalan

This town is developed on seaside lowlands along beautiful beach of Tuban Bay. The IKK area extends to the west where limestone hills stretch in a row. In Desa Suwalan, near the west boundary of IKK, there is P2AT well SP-67(64). Unfortunately, this well was not in operation during our surveys in 1990 and 1991, but it is said that the maximum well capacity is 80 l/s. A pump station picture of this well is shown below.

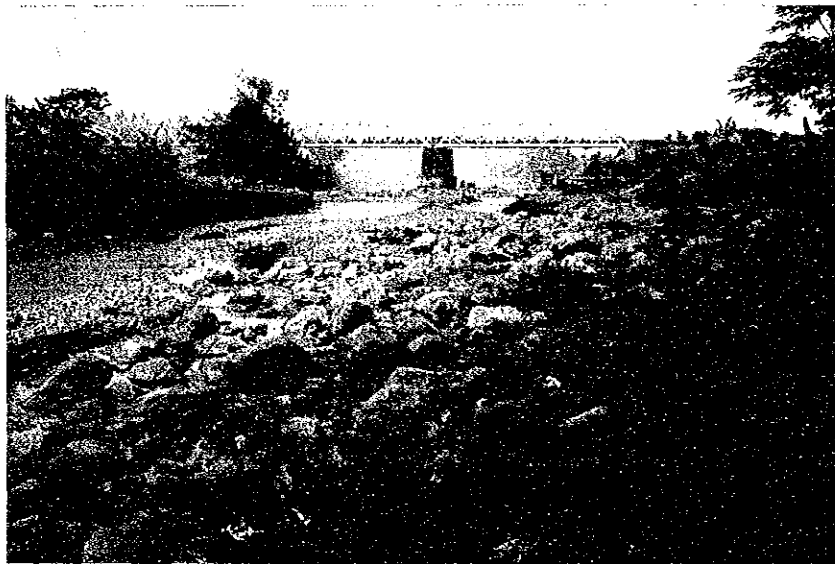
Kali Mudjur on The West Boundary of kecamatan Tempeh

Tempeh: Along the west boundary of Kecamatan Tempeh, Besuktunggeng (Mudjur) river flows. To the west of this river, active volcano called Mt. Semeru (El. +3676 m) rises. It is said that a former road bridge that had been built across the river was washed away by a recent pyroclastic flow generated by Mt. Semeru. Existing bridge was originally built for the railroad. There are many rolling stones and gravels on the riverbed (see a picture shown below). The river water is one of water resources hereabouts.

The river banks are composed of breccias, pyroclastics and terrace gravels, which implies that the IKK area is underlain mainly by volcanic products that include satisfactory aquifers.

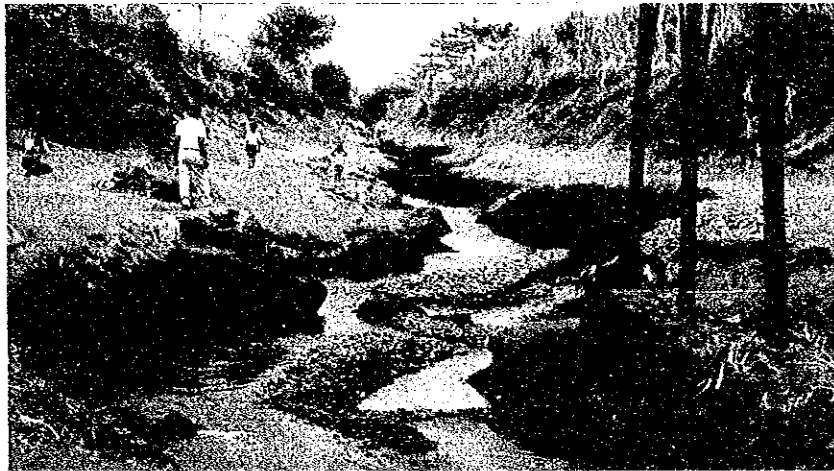
Kali Paser (kelar) Running in IKK Sumberasih

This IKK is located on part of flat lands near Strait of Madura. Although the sea is 5 km north, the IKK area is underlain by young Quaternary volcanic products erupted by Mt. Bromo on the south. There is no spring in the IKK area. The land is generally covered by brown soil stratum 10-15 m thick. Dug wells about 15 m deep are useful all the year round. A gully with stream on the lower riverbed runs in the IKK area from south to north. After flooding, gravels are sedimented on the lower riverbed and silty sands on the higher riverbed (see the picture below).

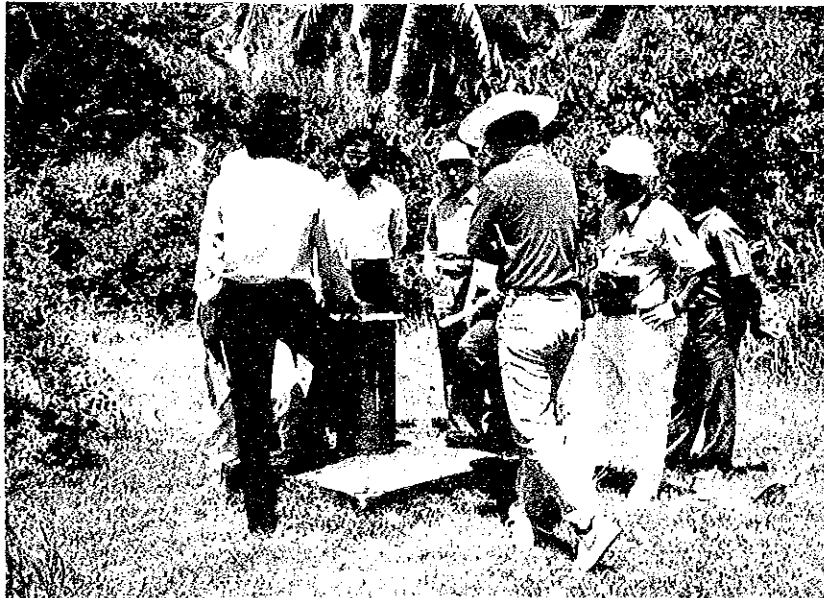
Test Well TPW2 in Desa Batubulan at 3 km West of Ketewel

This Desa is located on coastal terrace and is underlain by Quaternary volcanic products, locally overlain by alluvium. There is no appreciable spring in and around the Desa. In Desa Batubulan at 3 km west of the Desa, there are one deep well in operation and one test well being not in use. The operational well (160 m depth, 6" dia., 5 l/s pump capacity) is worked only 3 hours a day. The test well (TPW2; 200 m depth, 8" dia., 50 l/s normal capacity) was completed in October 1988 with intention to supply water to Denpasar City, but up to the present day its embodiment has not been materialized and the well is in a position to be used for an area other than Denpasar. A picture of TPW2 is shown below.

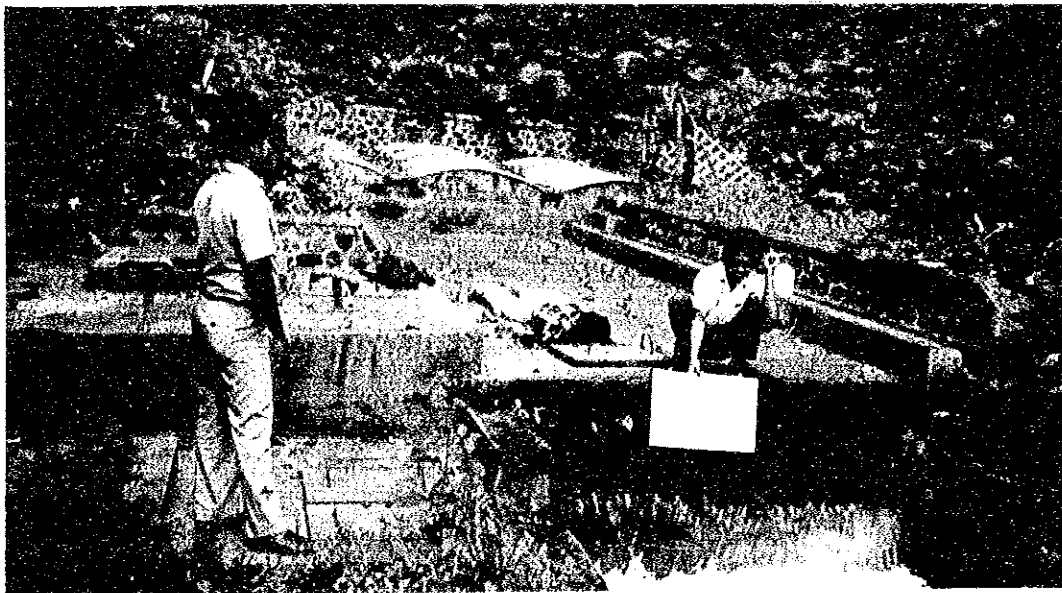
Gerubug Spring on a horseshoe shape valley in Banjar Tegenan

They are located on part of the southern foot of Mt. Agung and the land is underlain by Quaternary volcanic products such as tuffs and lahar deposits including breccias. There is neither dug well nor drilled well in these Desa areas. Most homes get water from springlets and seepages being thereabouts. Available springs are Gerubug spring (280 l/s) for IKK Menanga and Dukuh Muding spring (27 l/s) for Desa Sibetan. Their photographs are attached below.
